# Inspection Photos

**Operator:** QB Energy Operating LLC #10844

**Location ID:** 324238

**Inspection Doc:** 719200487

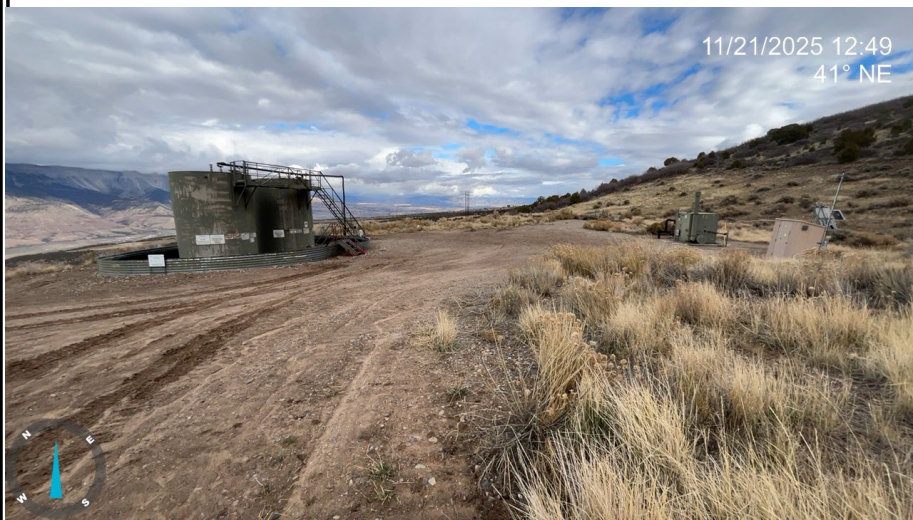
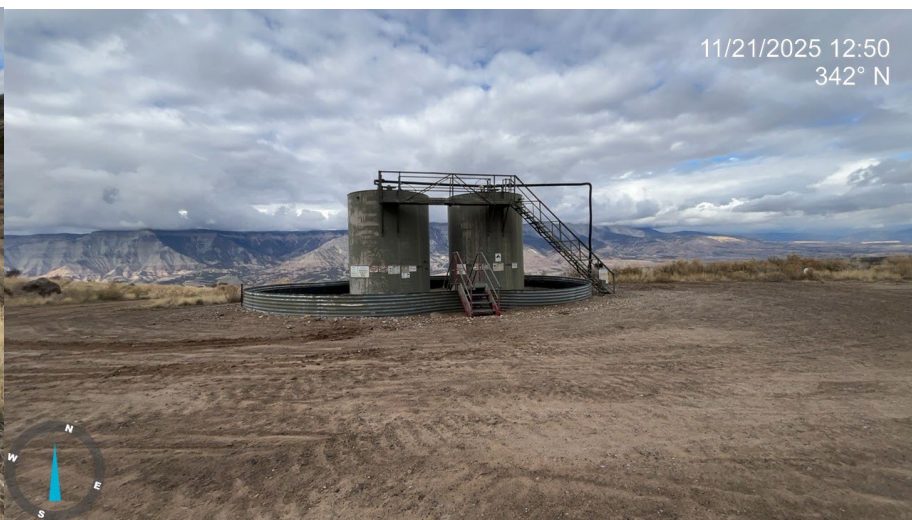
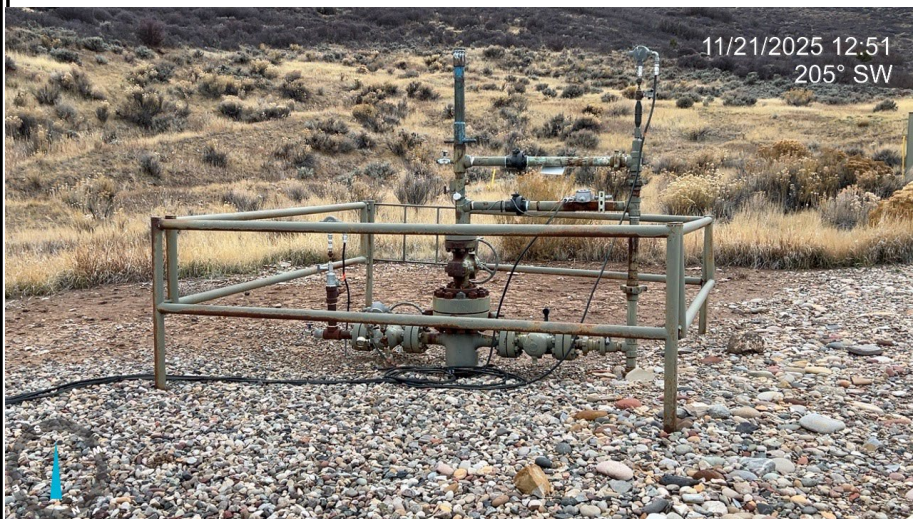
**Photo 1:** Photos showing an overview of the location looking northeast (top left), north (top right) and the wellhead looking southwest (bottom left).

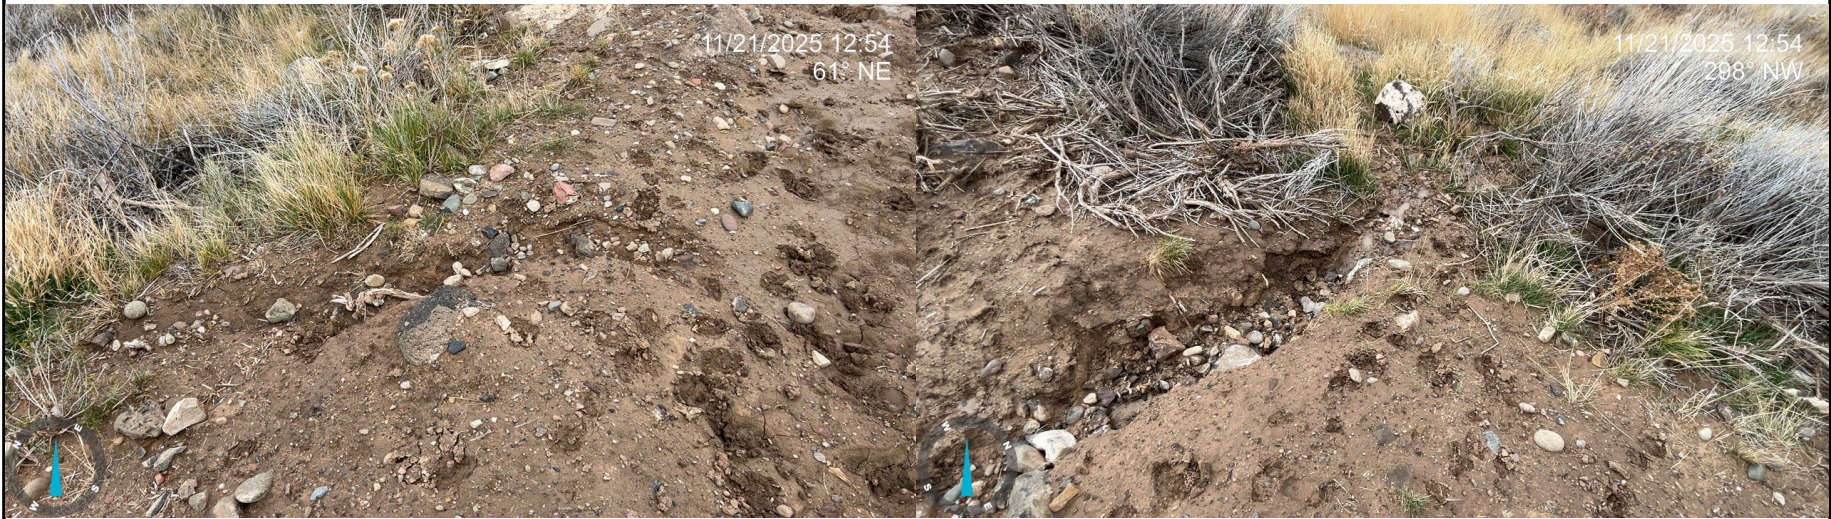
**Photo 2:** Photos showing rilling and erosion is occurring on the northwestern portion of the location behind production tank equipment. Stormwater controls appear missing or insufficient; comply with 1002.f.

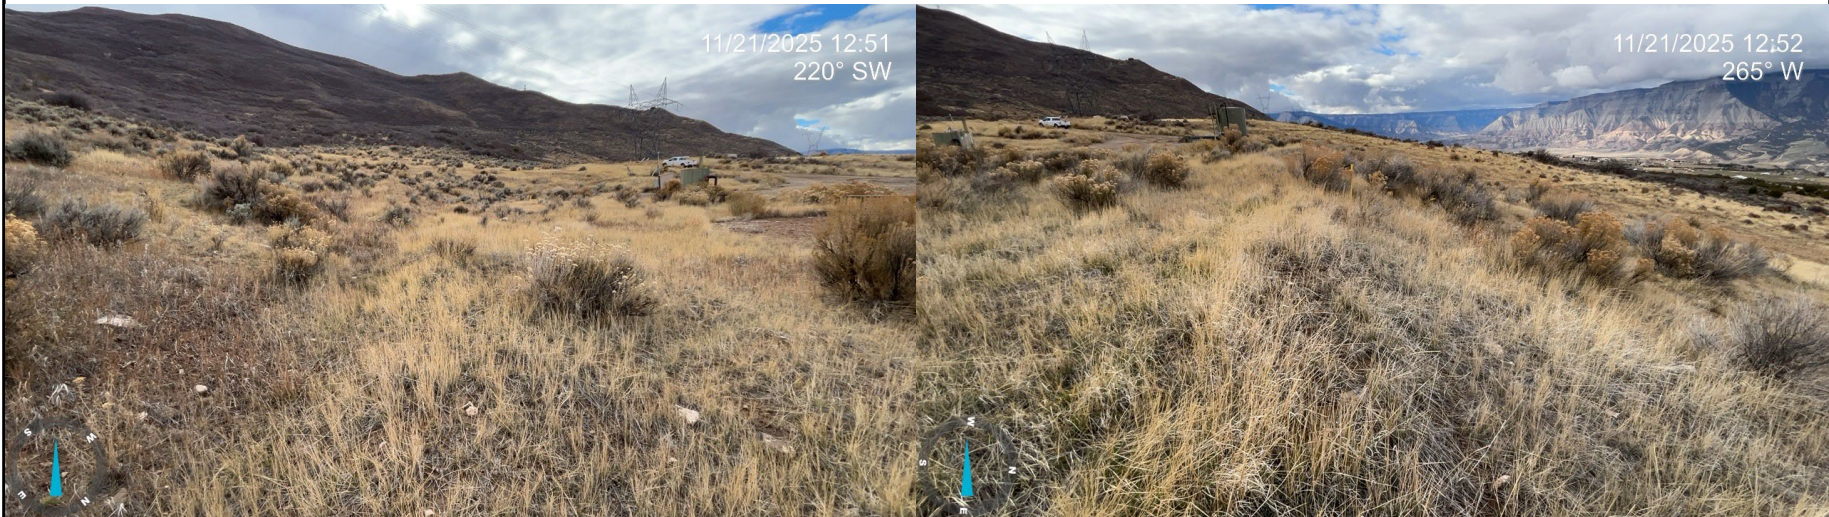
**Photo 3:** Photos showing an overview of the northern and southern interim areas, respectively. The interim areas are well-established and desirable, uniform and perennial vegetation is present. Overall, interim areas at the location are progressing towards 1003 reclamation requirements.
