Inspection Photos

Operator: QB Energy Operating LLC #10844

Location ID: 334625

Inspection Doc: 719200493

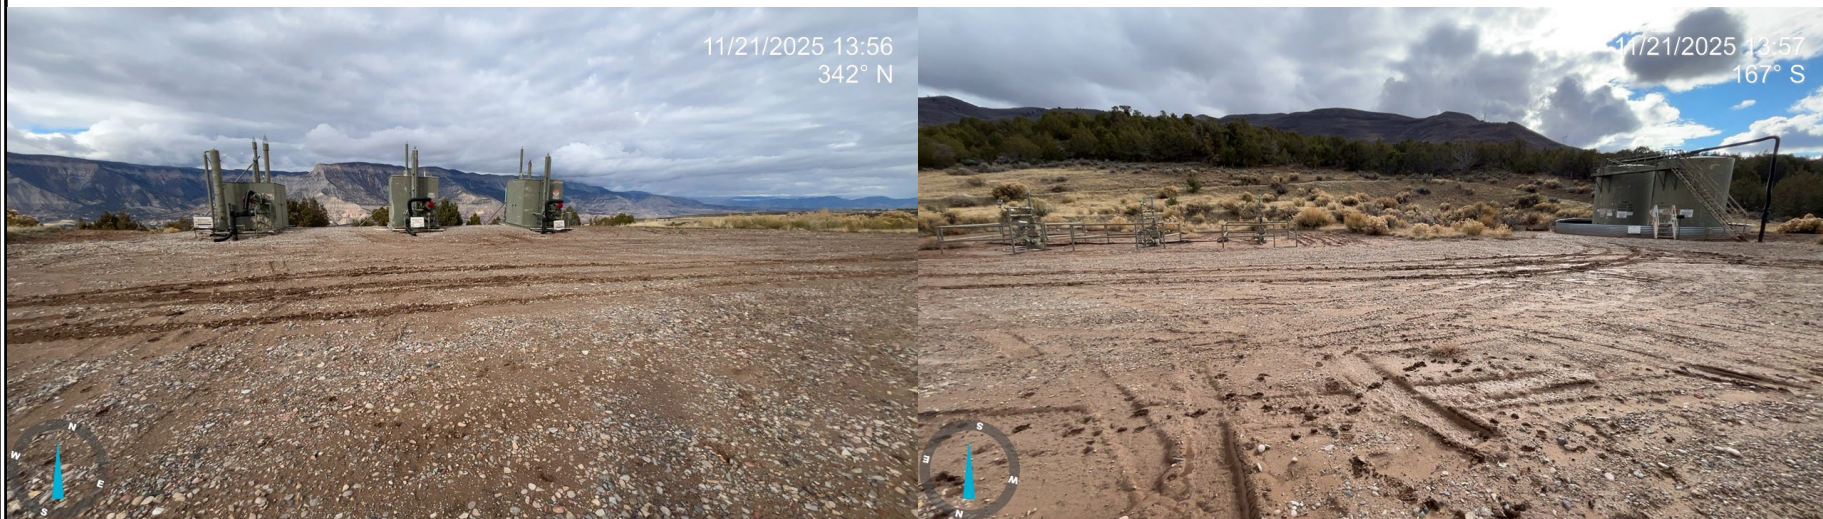
Photo 1: Photos showing an overview of the location looking north and south, respectively.

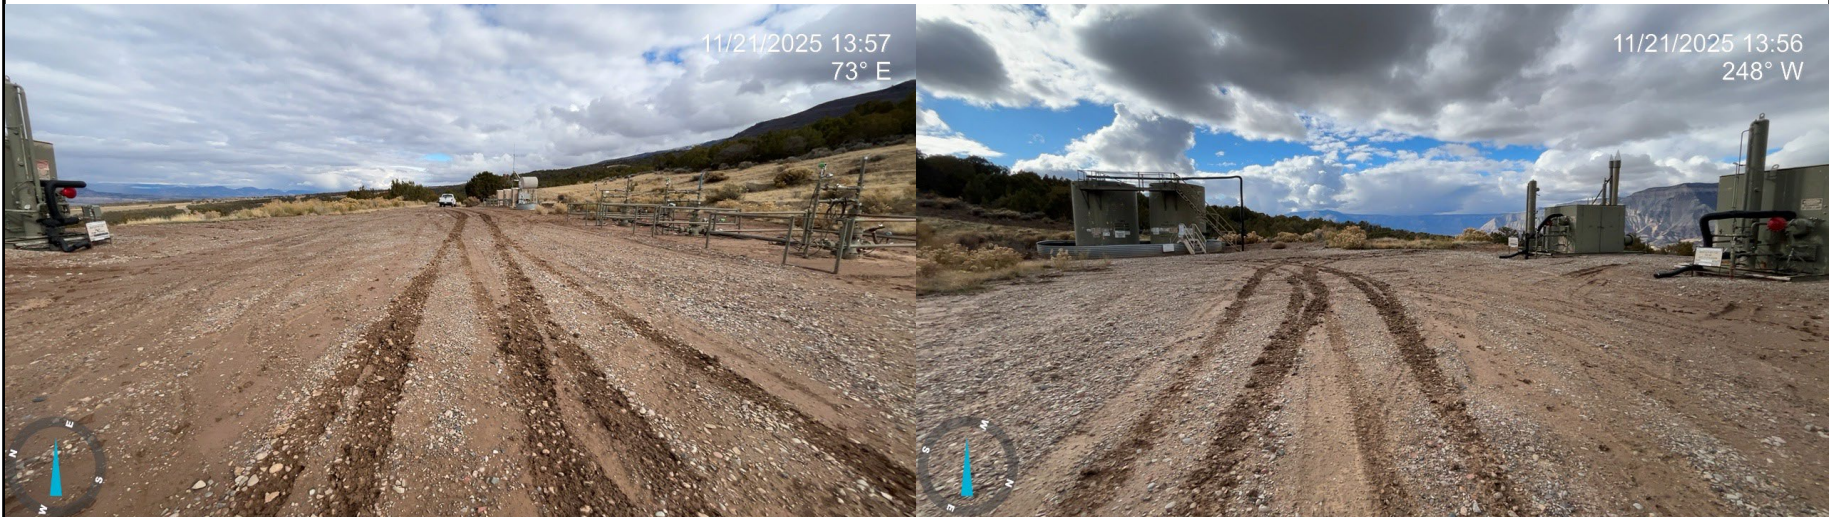
Photo 2: Photos showing an overview of the location looking east and west, respectively. Vehicle rutting and tracking is occurring on the working pad surface and gravel is sparse in areas. Comply with 1002.f. and maintain stormwater BMPs.

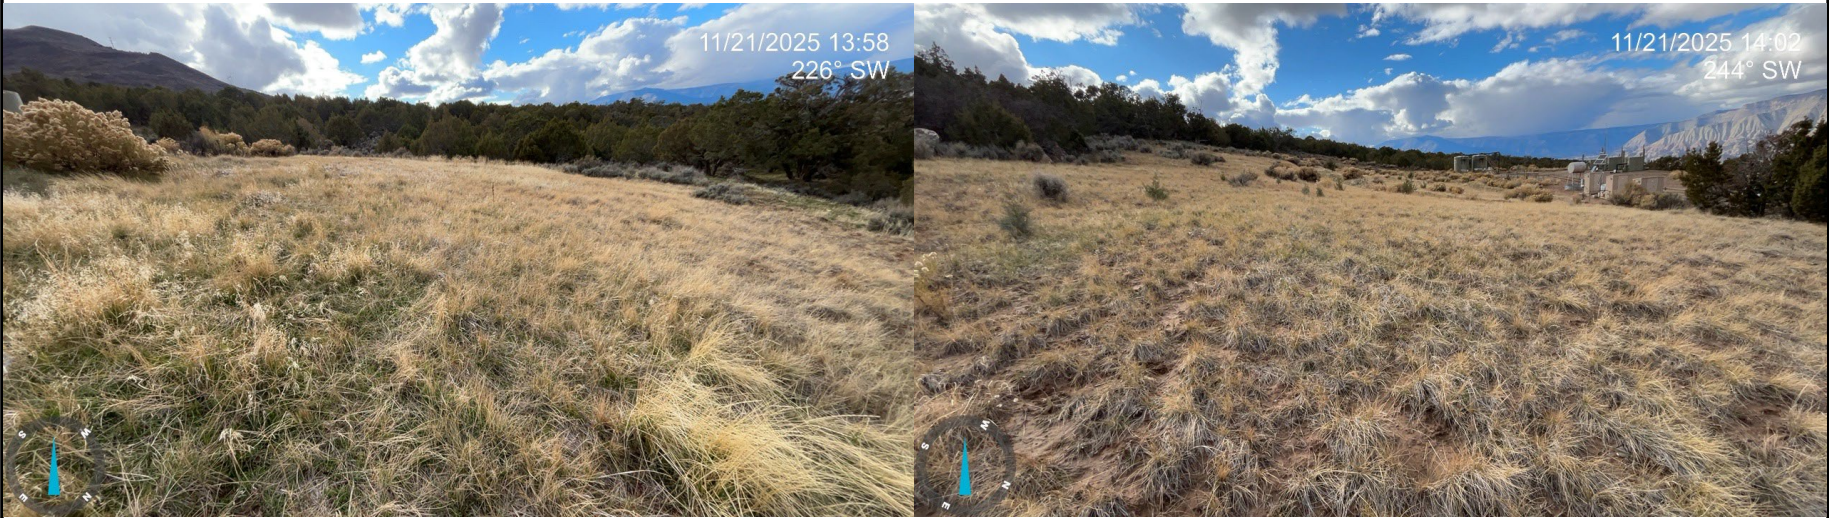
Photo 3: Photos showing an overview of the northern and southern interim areas, respectively. Desirable, perennial and uniform vegetation is present. Interim areas at the location are progressing towards 1003 reclamation requirements.

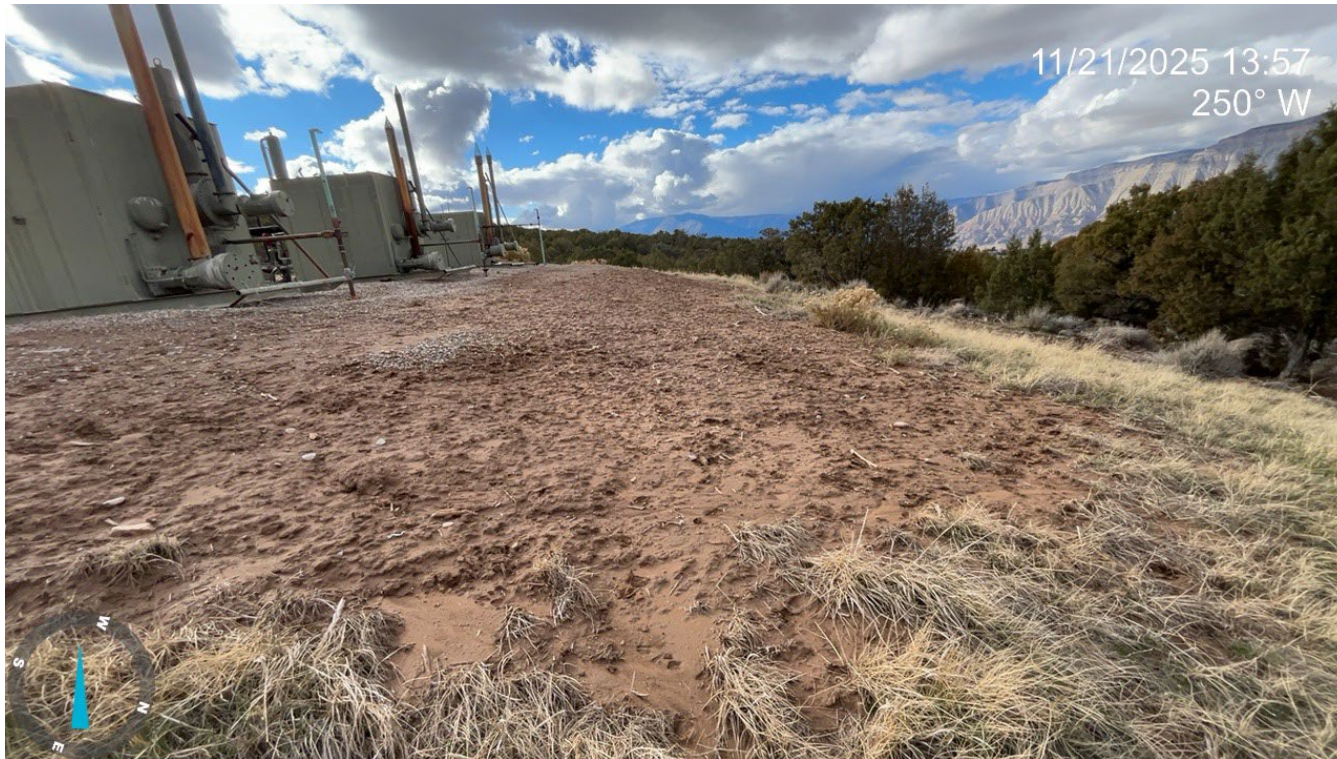
Photo 4: The area behind production equipment at the location is predominantly bare and is at risk of erosion and degradation. No stormwater issues were observed in this area during the time of inspection; however, additional stabilization efforts and/or reclamation efforts may be required in the future.
