Final Reclamation Inspection

Operator: Kerr McGee Oil & Gas Onshore - 47120

Location ID: 332086

Location Name: Rusch 33-15

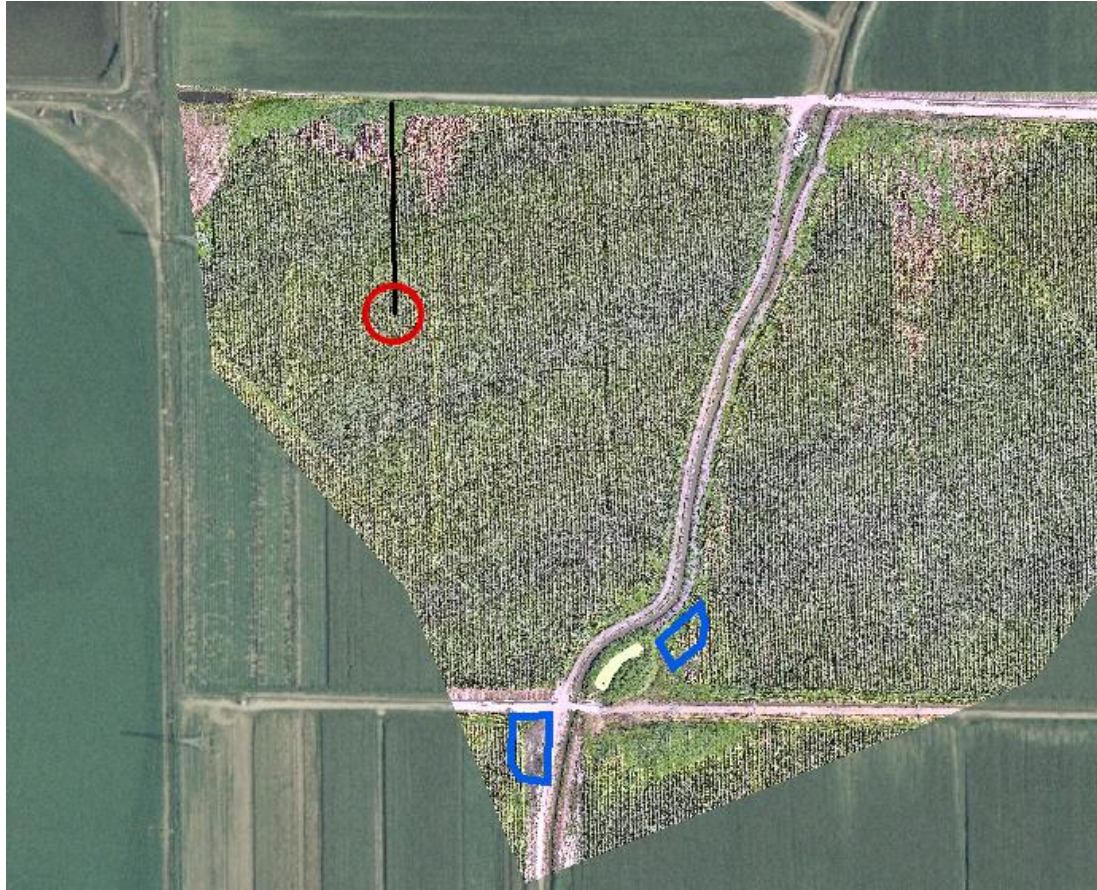
Photo 2. Orthomosaic (drone) imagery taken 8/20/2025 and NAIP aerial imagery (2023) illustrating the well location (red circle) and associated tank battery (blue polygon).

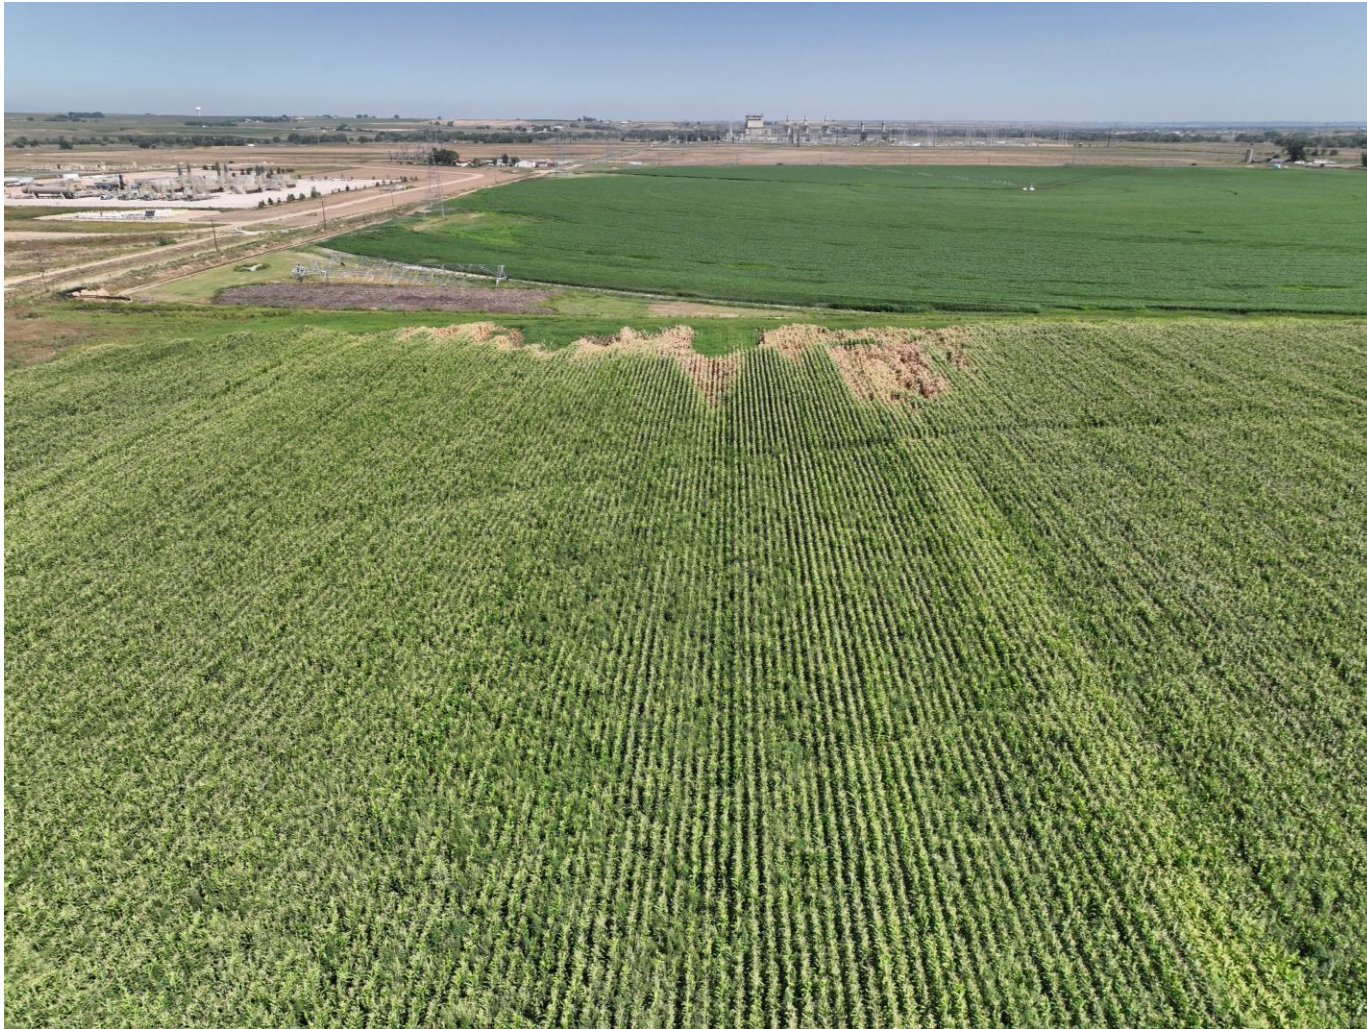
Photo 3. Drone aerial imagery taken south of well location, facing north (displaying the well and access road).

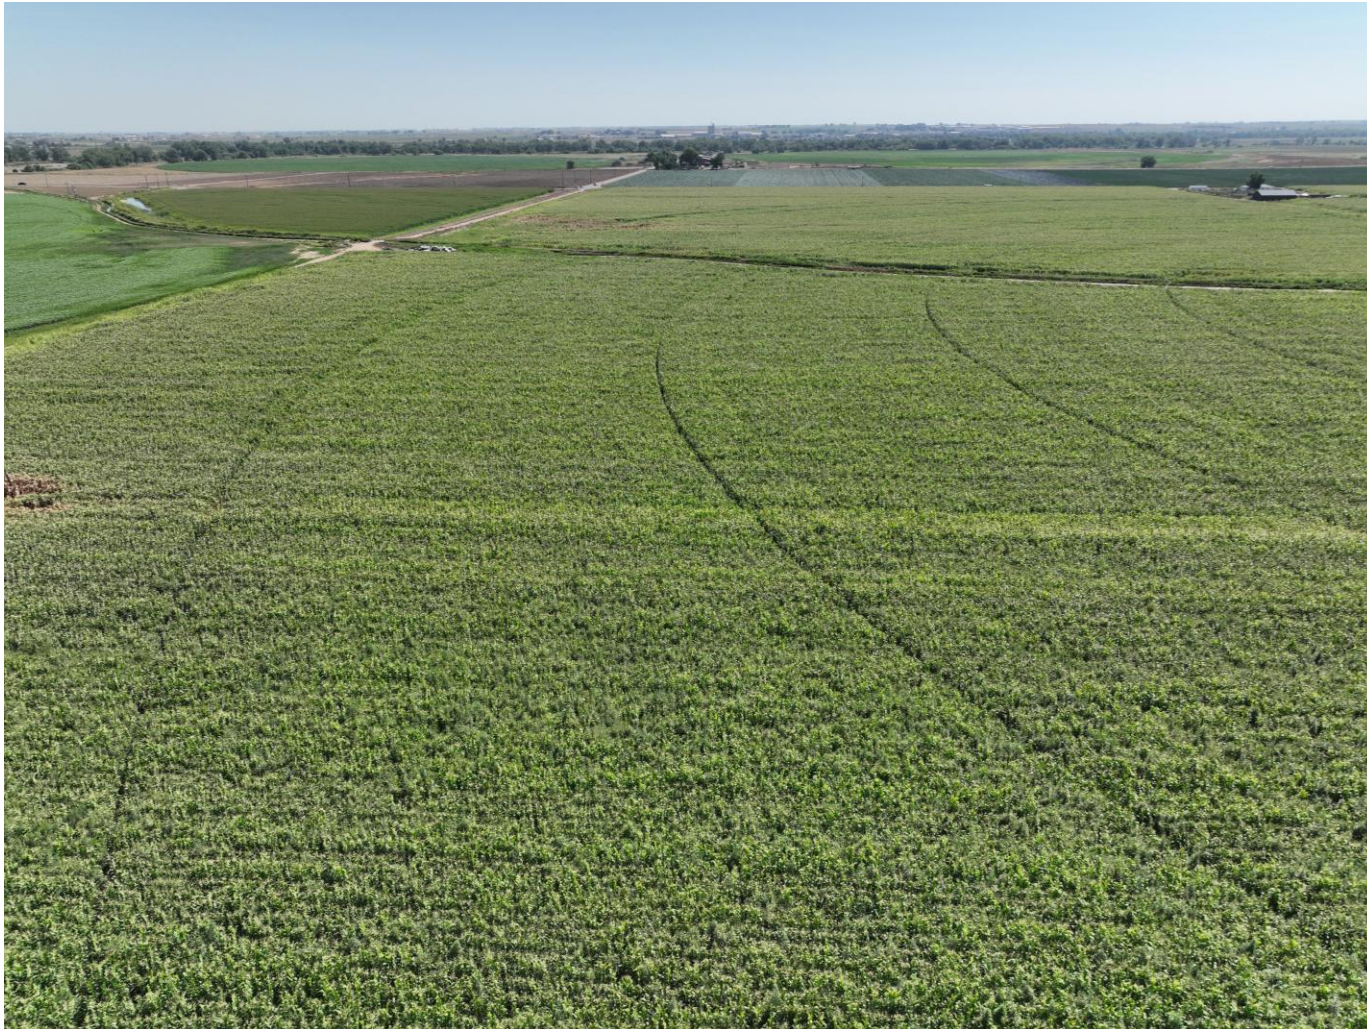
Photo 4. Drone aerial imagery taken west of well location, facing east (displaying the well, access road, and presumed flowline location).

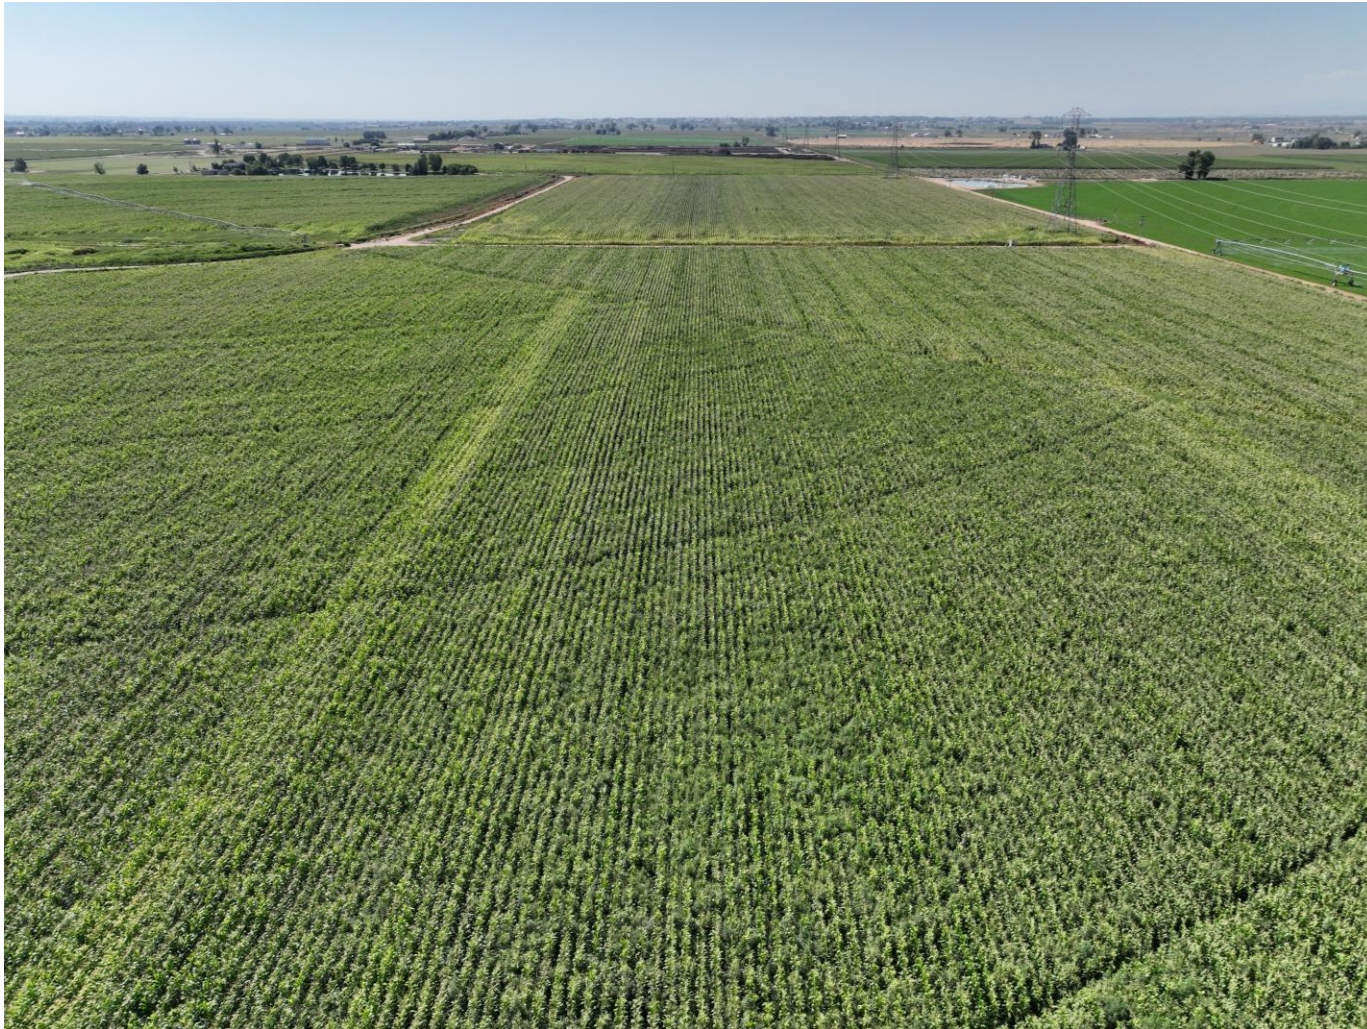
Photo 5. Drone aerial imagery taken north of well location, facing south (displaying the well, TB, access road, and presumed flowline).

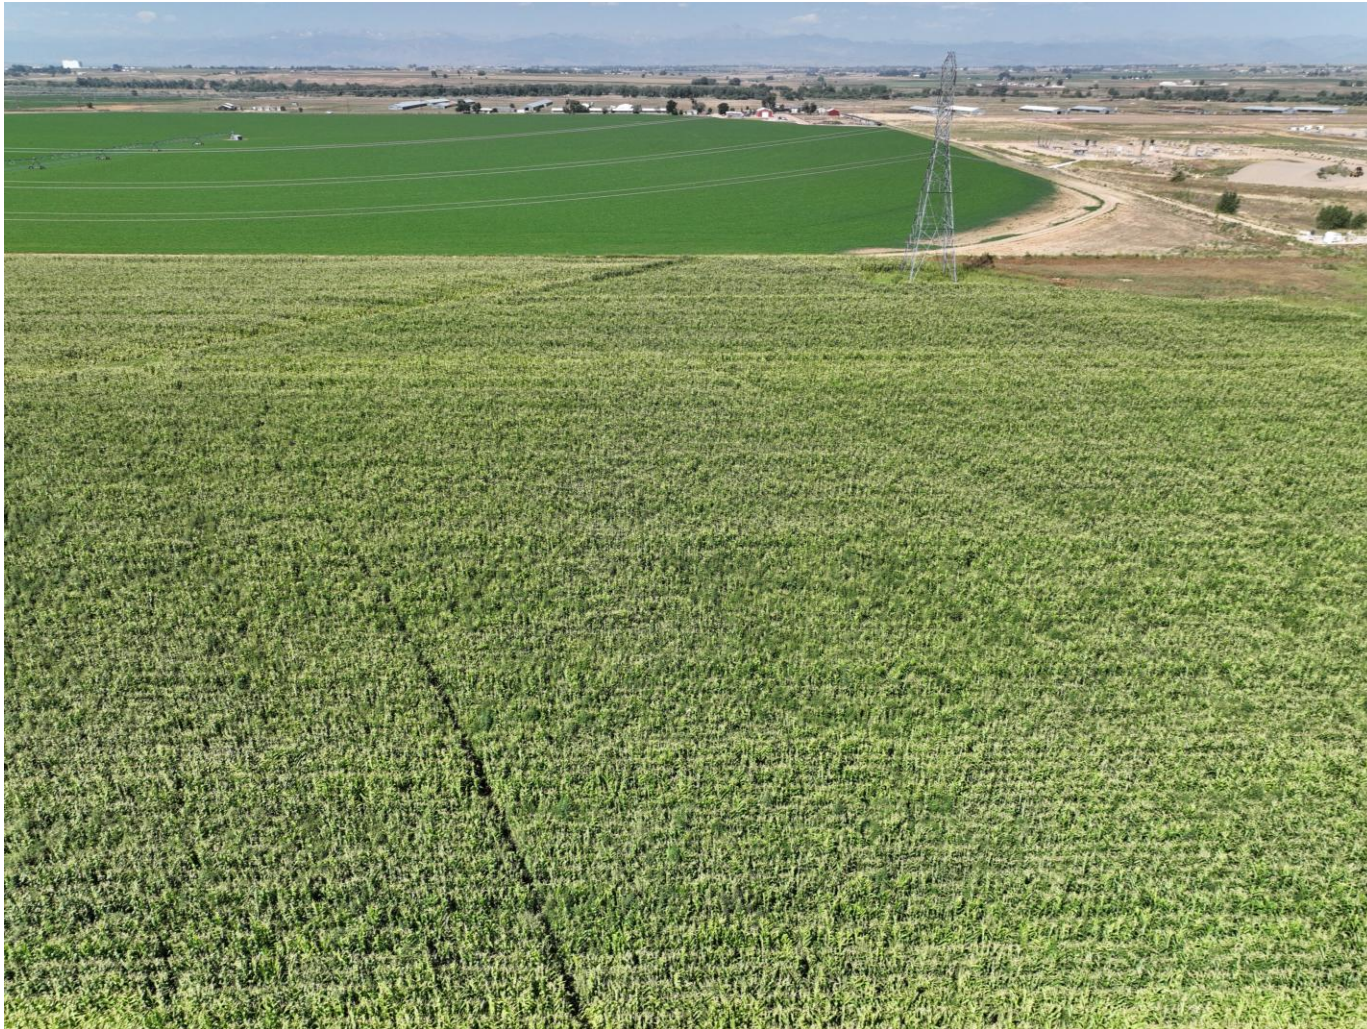
Photo 6. Drone aerial imagery taken east of well location, facing west (displaying the well and access road). Crop vegetation at the well pad and access road appears consistent with adjacent reference areas.

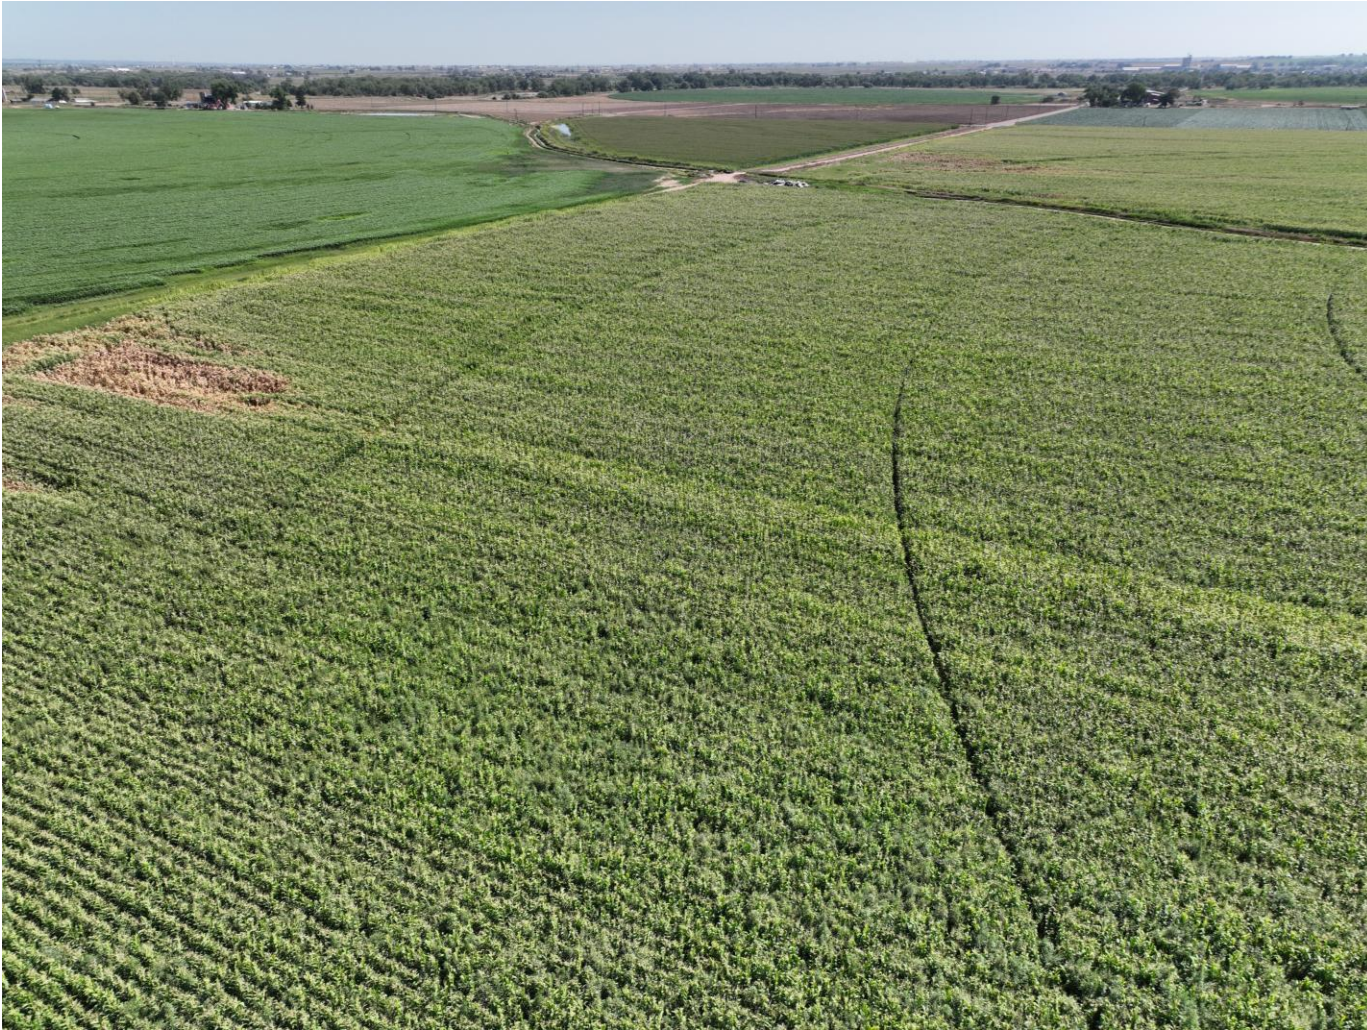
Photo 7. Drone aerial imagery taken northwest of well location, facing southeast (displaying the well, and presumed flowline location).

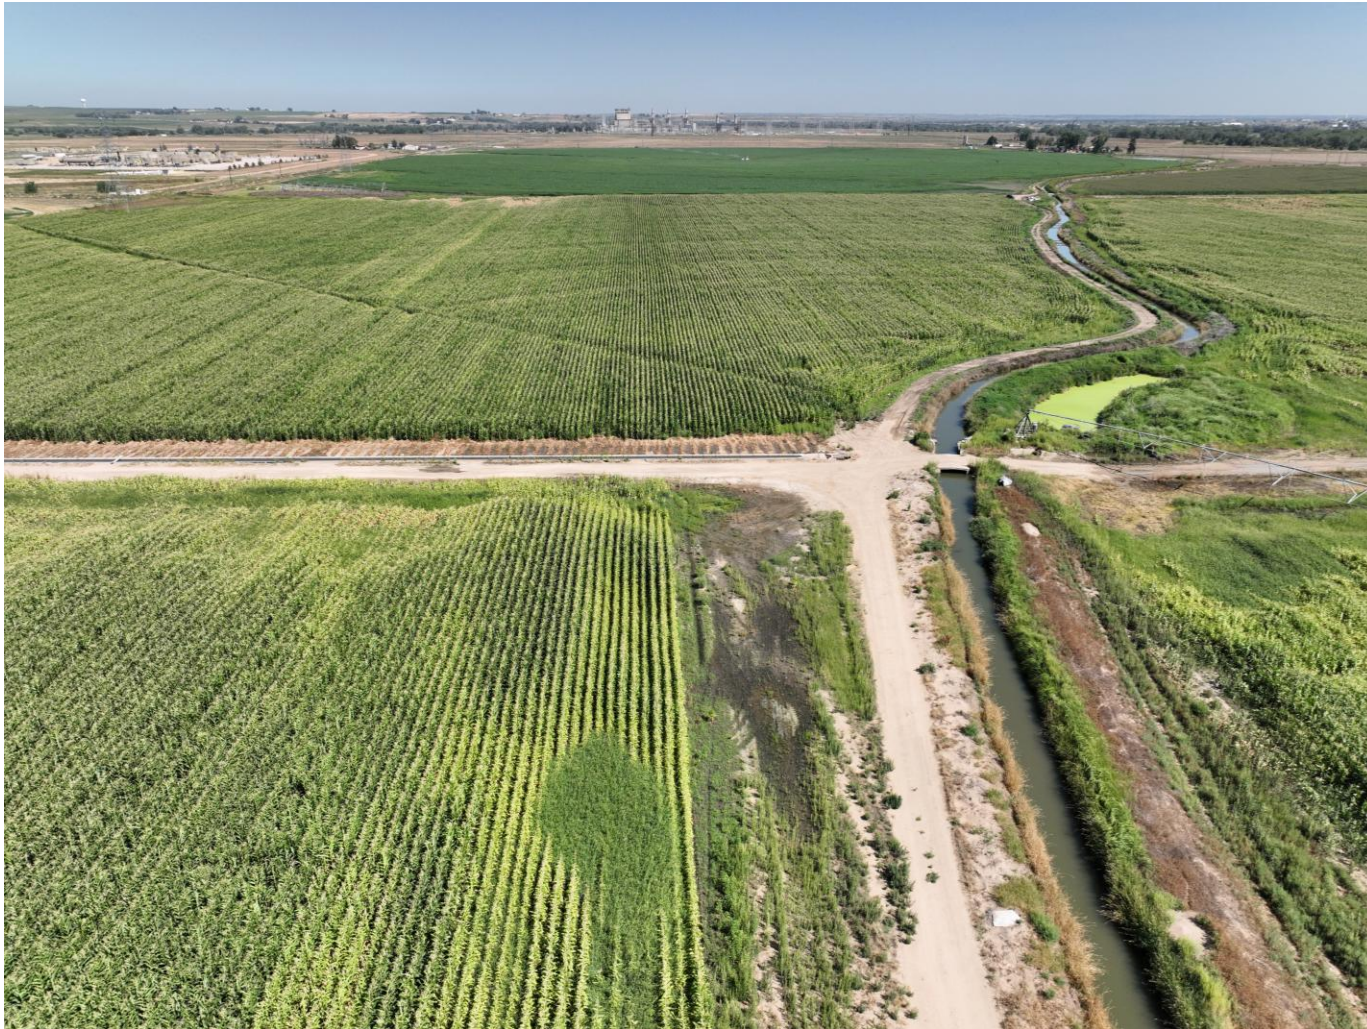
Photo 8. Drone aerial imagery taken south of the TB location, facing north (displaying the TB, well and presumed flowline). Crop establishment issues observed at the well pad, area does not appear consistent with adjacent reference areas.

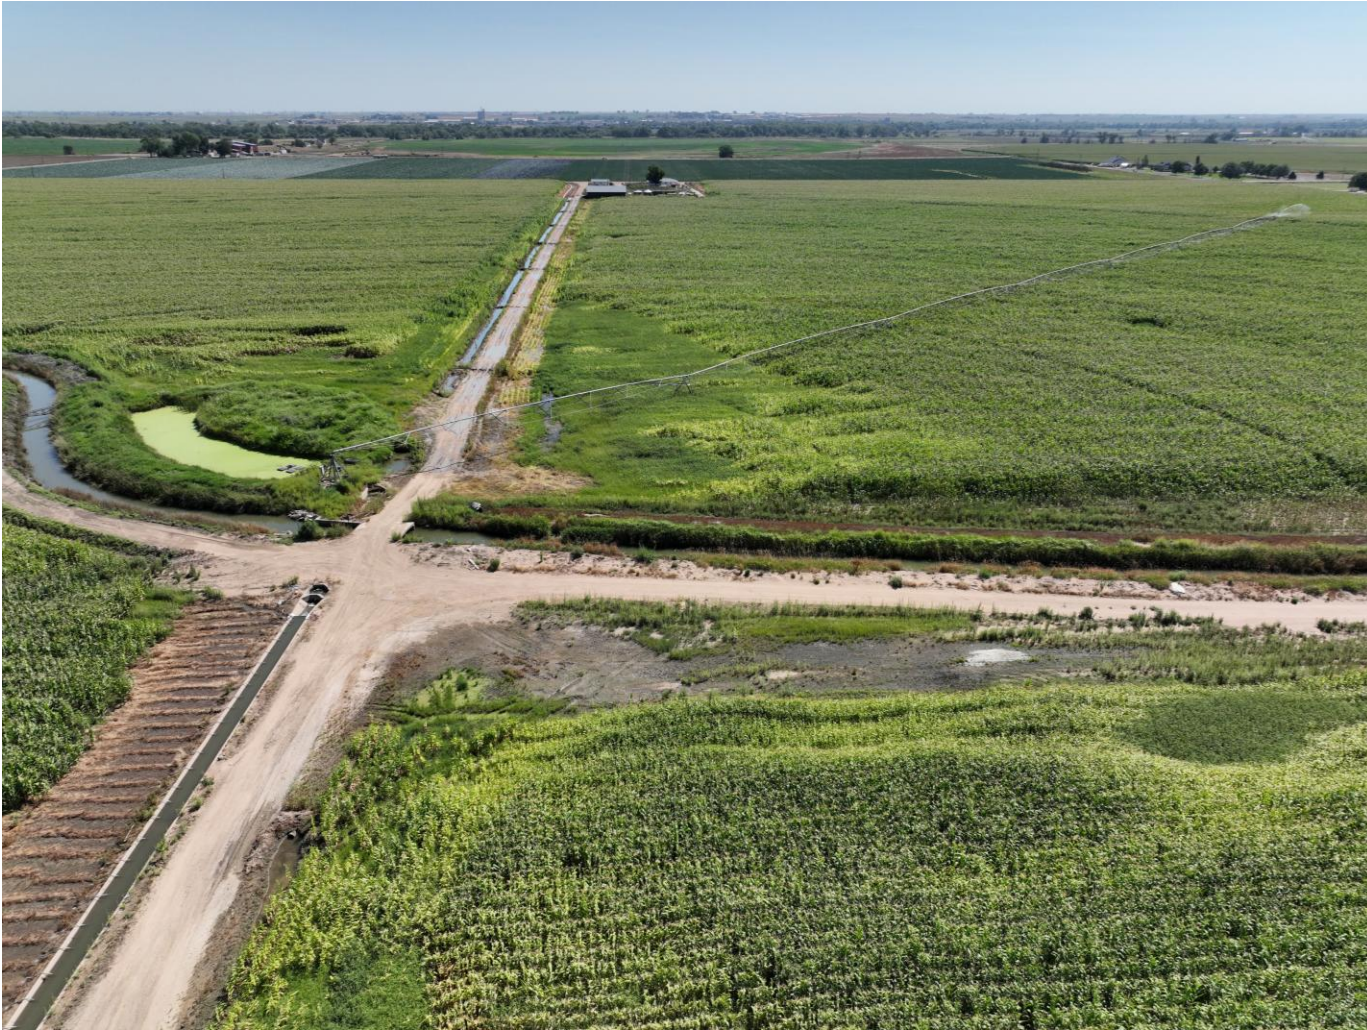
Photo 9. Drone aerial imagery taken west of the TB location, facing east (displaying the TB).

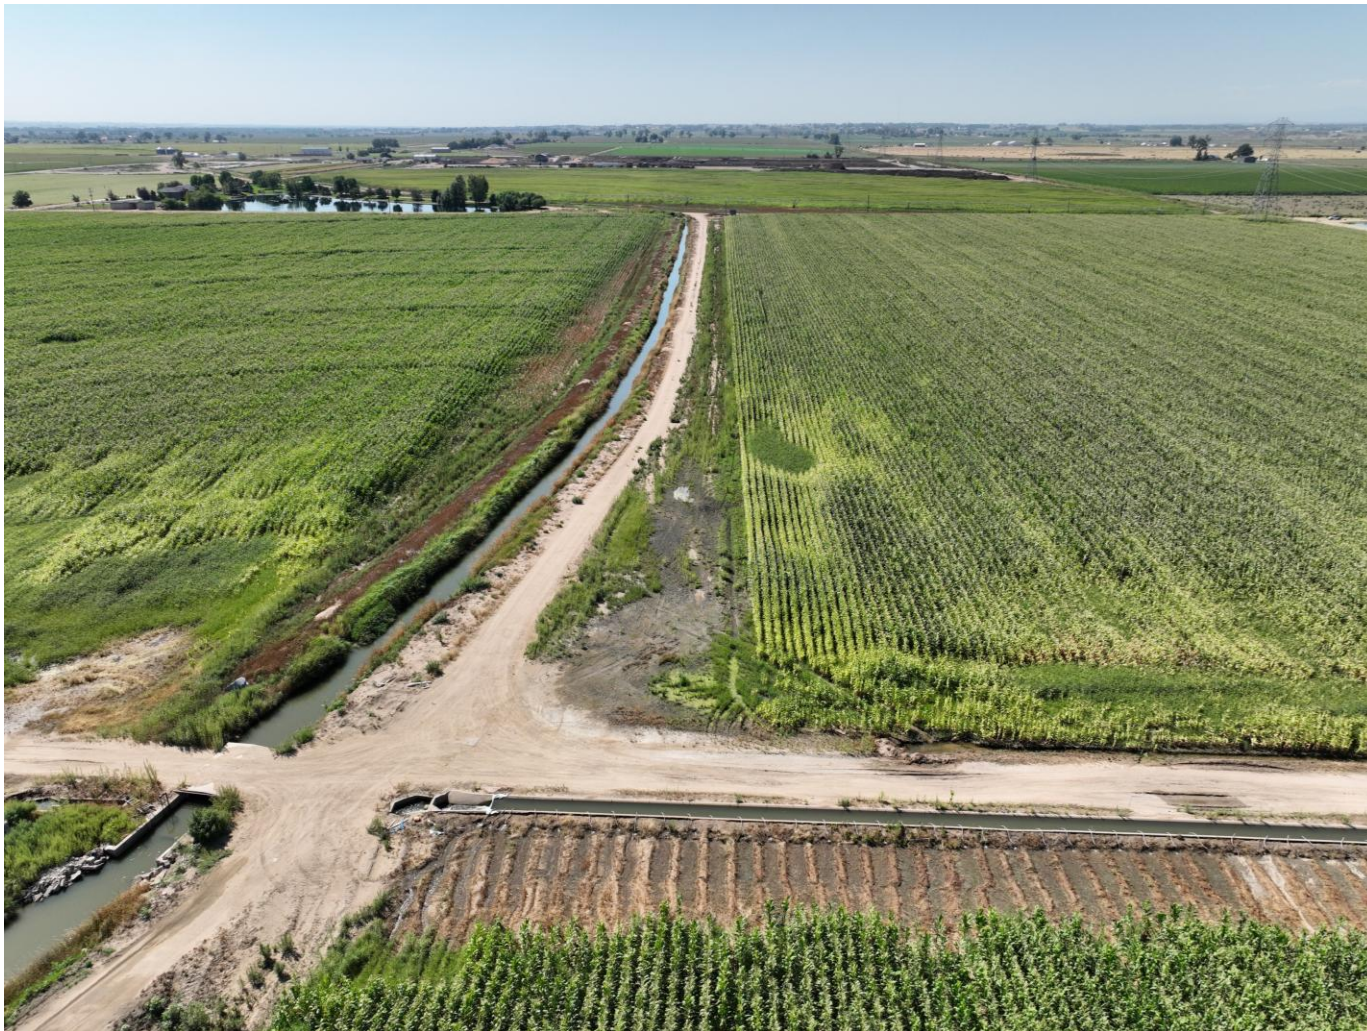
Photo 10. Drone aerial imagery taken north of the TB location, facing south (displaying the TB).

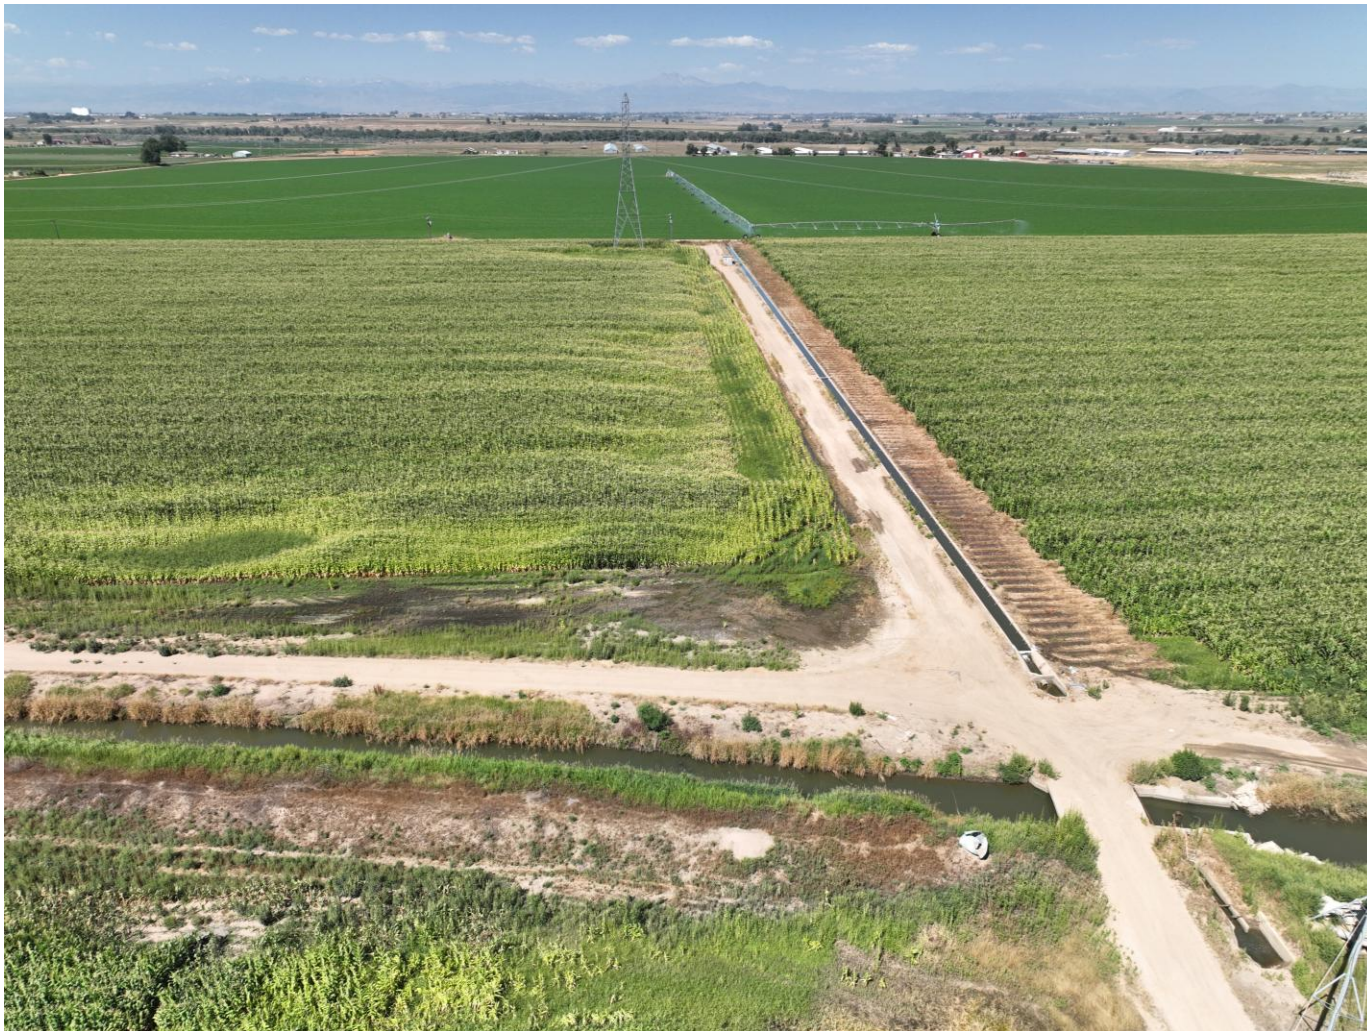
Photo 11. Drone aerial imagery taken east of the TB location, facing west (displaying the TB).

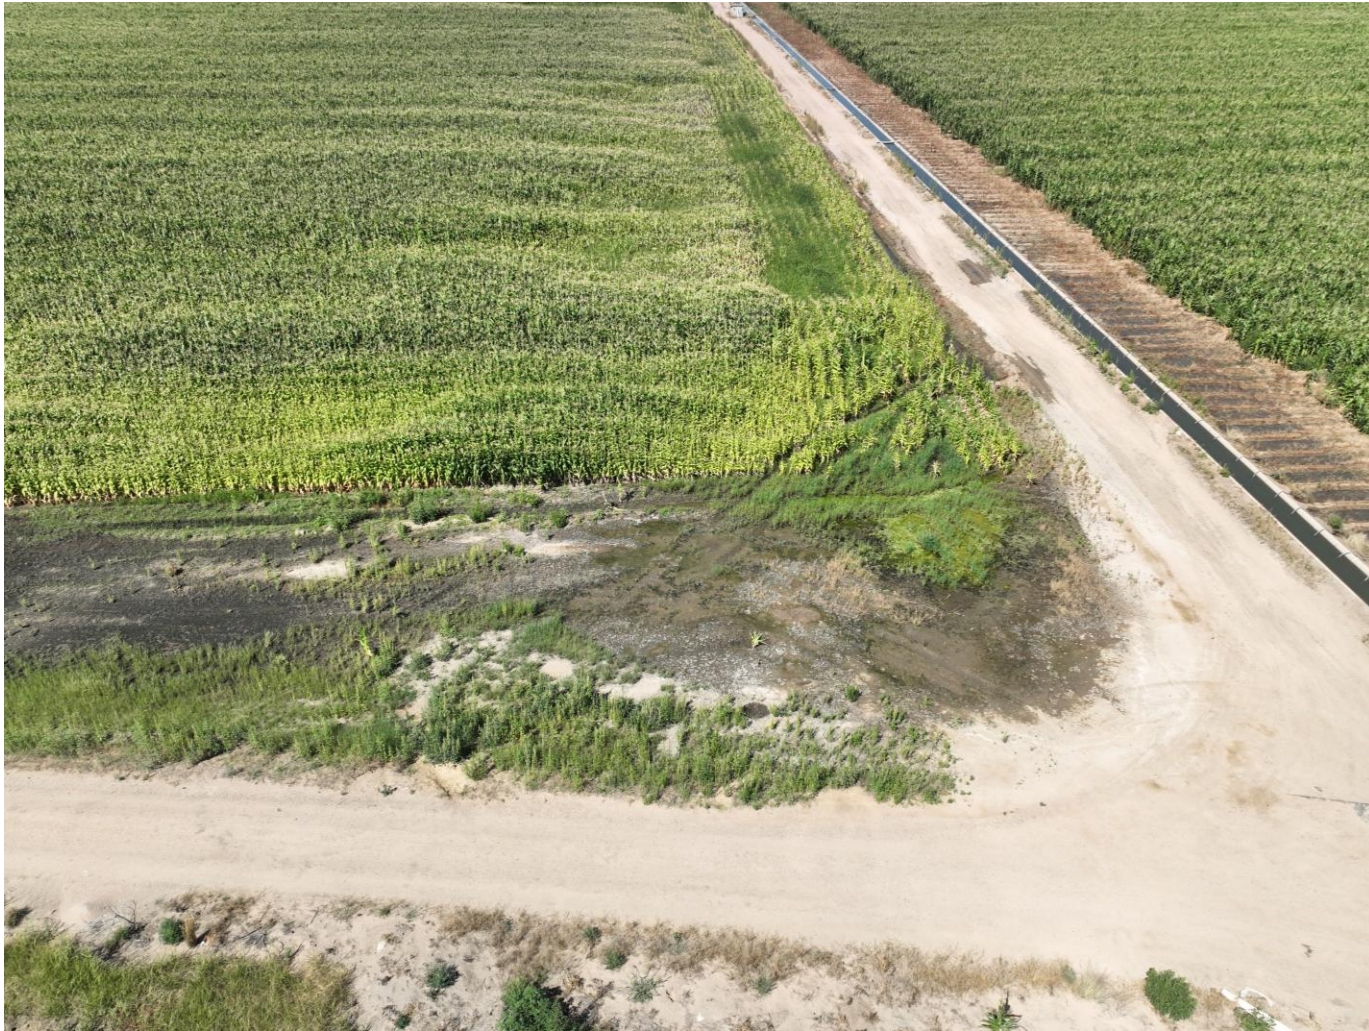
Photo 12. Drone aerial imagery taken east of the TB location, facing west (displaying the TB).

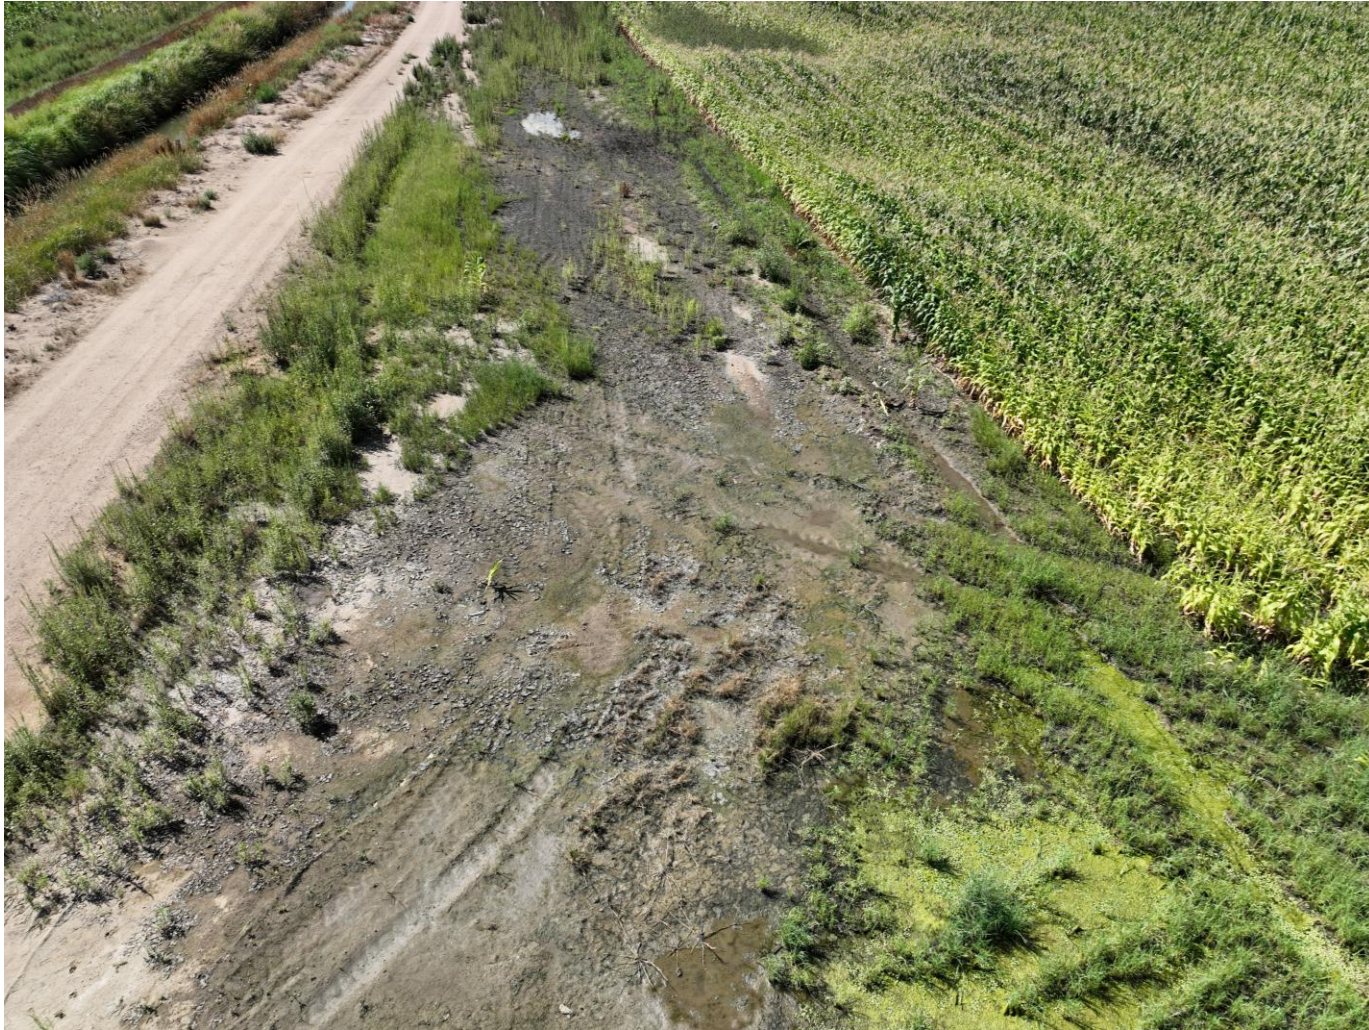
Photo 13. Drone aerial imagery taken from above the TB location, facing downward (displaying stunted corn at the edge of the field).
