Inspection Photos

Operator: QB Energy Operating LLC #10844

Location ID: 323909

Inspection Doc: 719200505

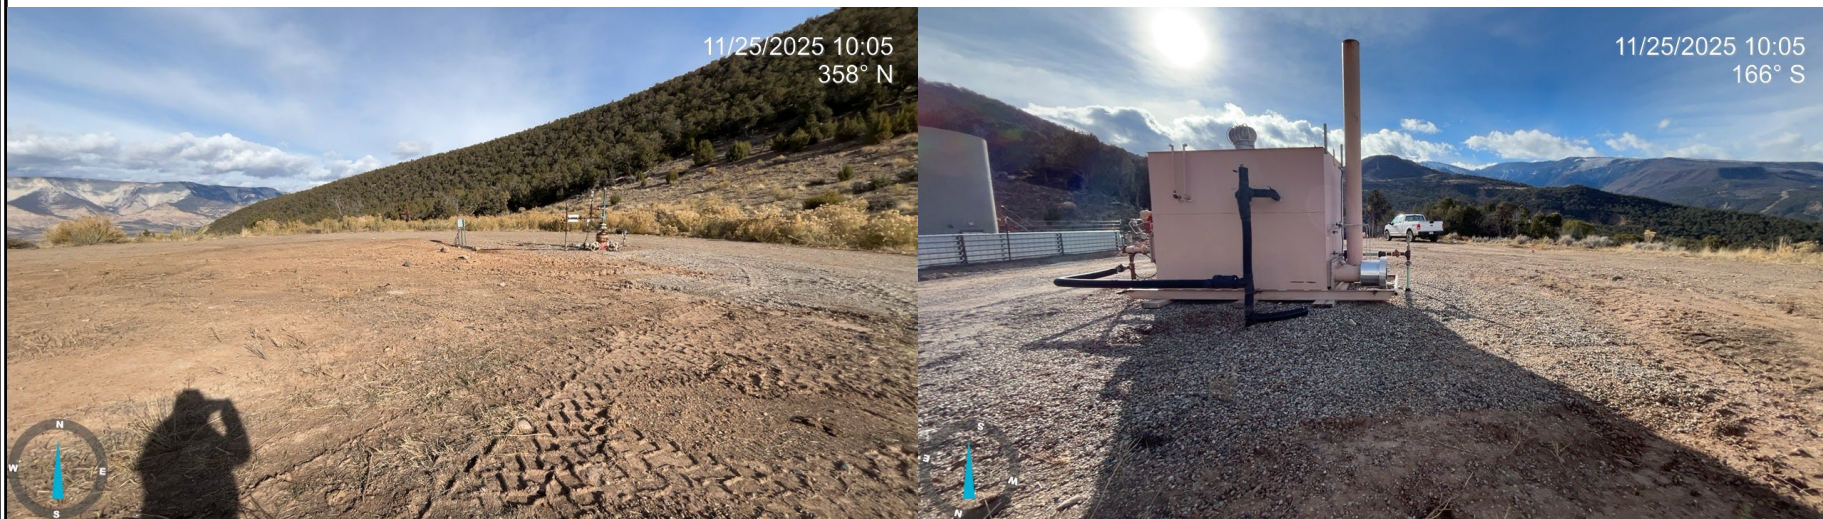
Photo 1: Photos showing an overview of the location looking northeast and southwest, respectively.

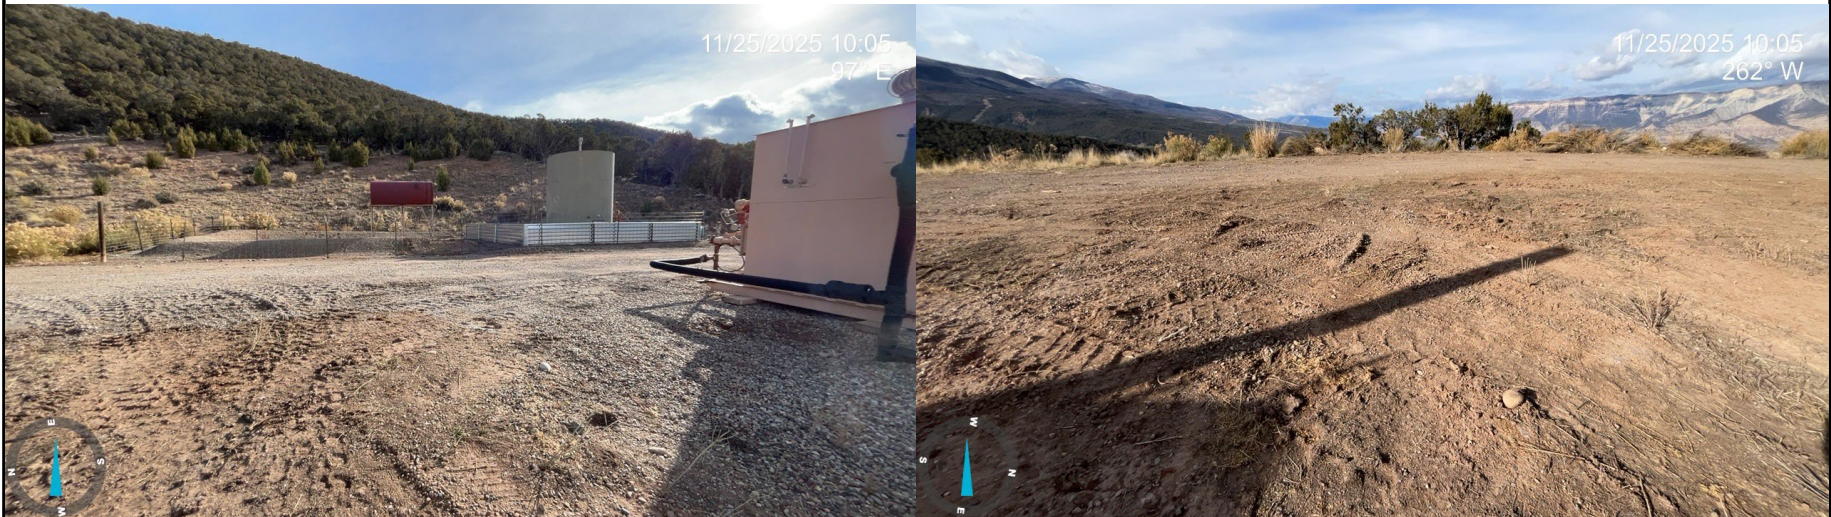
Photo 2: Photos showing an overview of the location looking east and west, respectively.

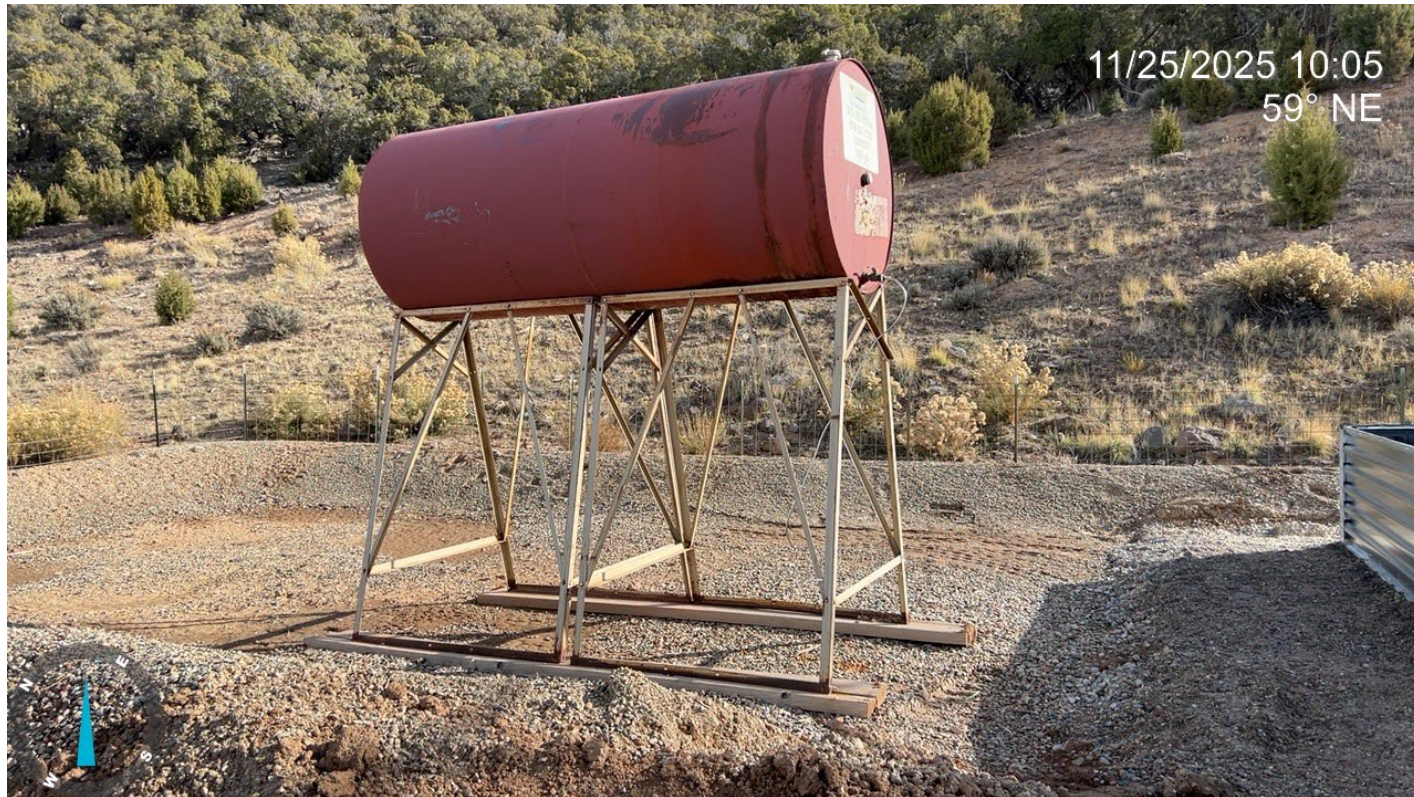
Photo 3: At the time of inspection, tank equipment at the location does not appear to be in use. Comply with Rule 606.a. and remove unused equipment.

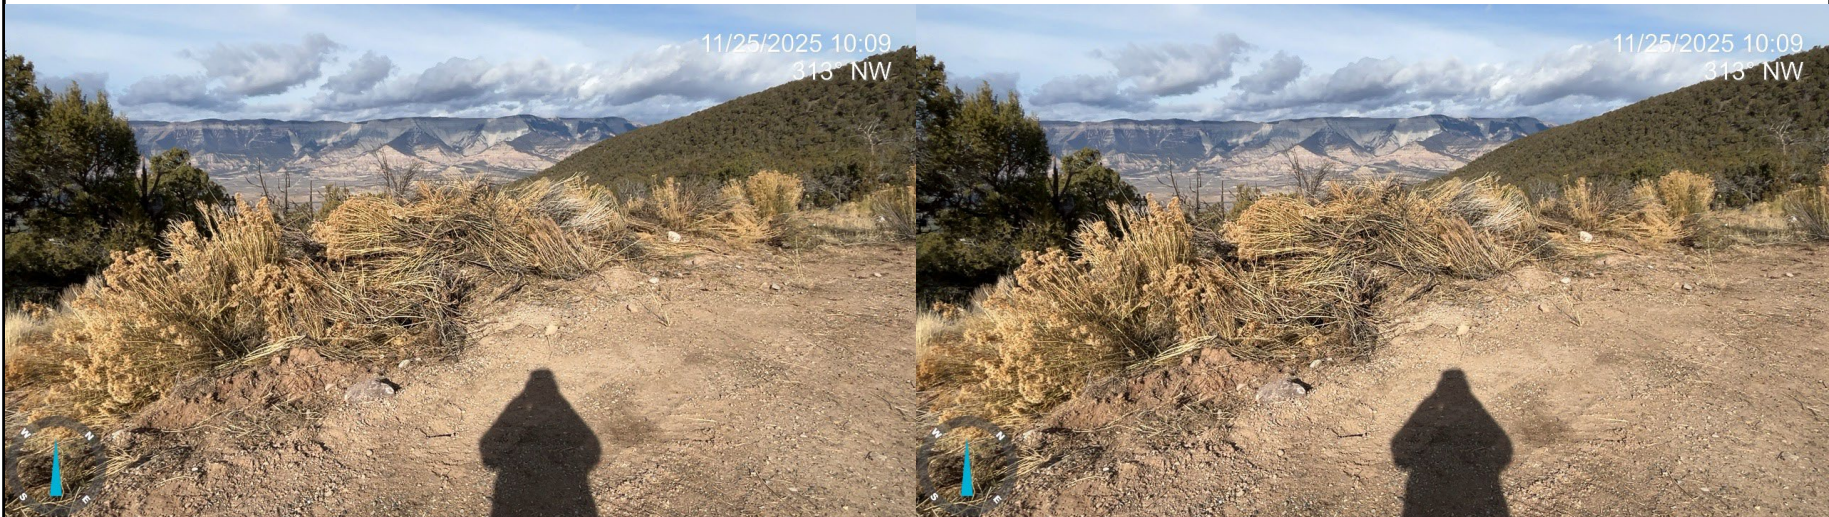
Photo 4: Photos showing an example of vegetative debris that appears to have been removed from the working pad surface and pushed to the margins of the interim areas. Comply with Rule 606.d. and remove vegetative debris.

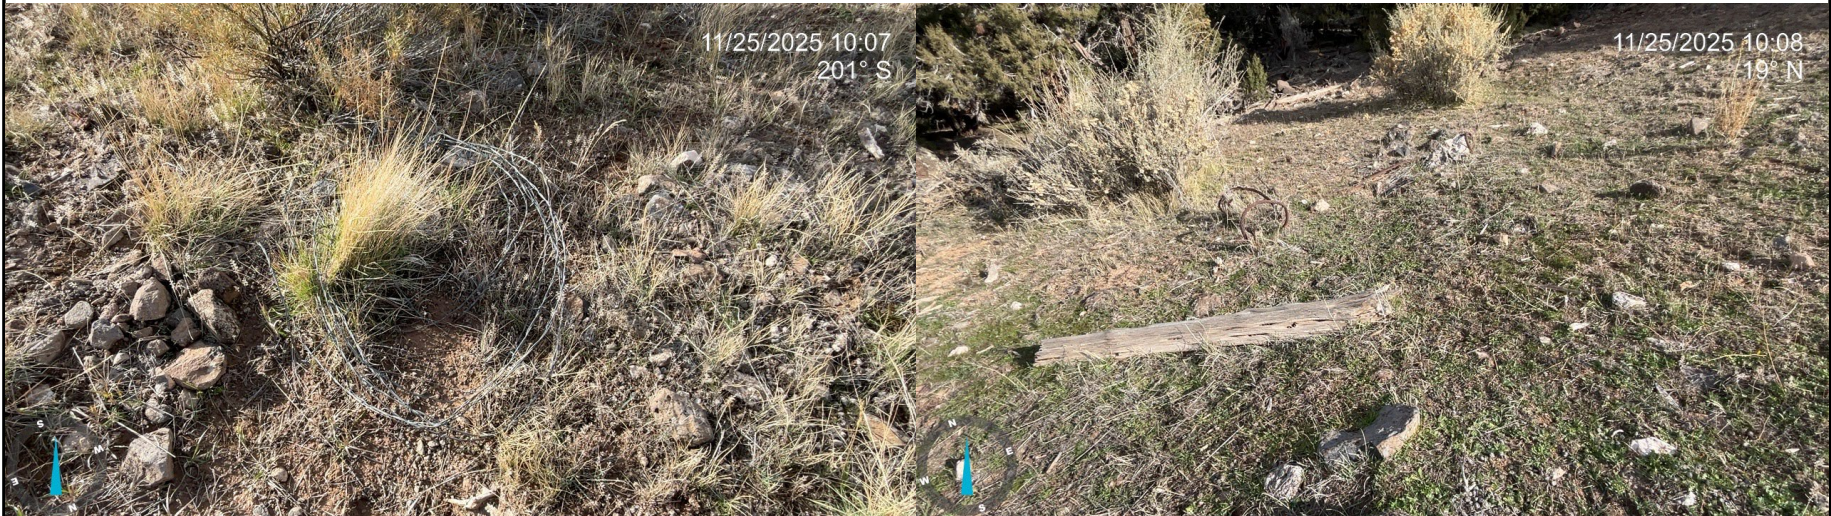
Photo 5: Photos showing an example of debris, such as barbed wire, wooden posts and steel cable is present in the northernmost portion of the location. Removal is required; comply with Rule 606.d.

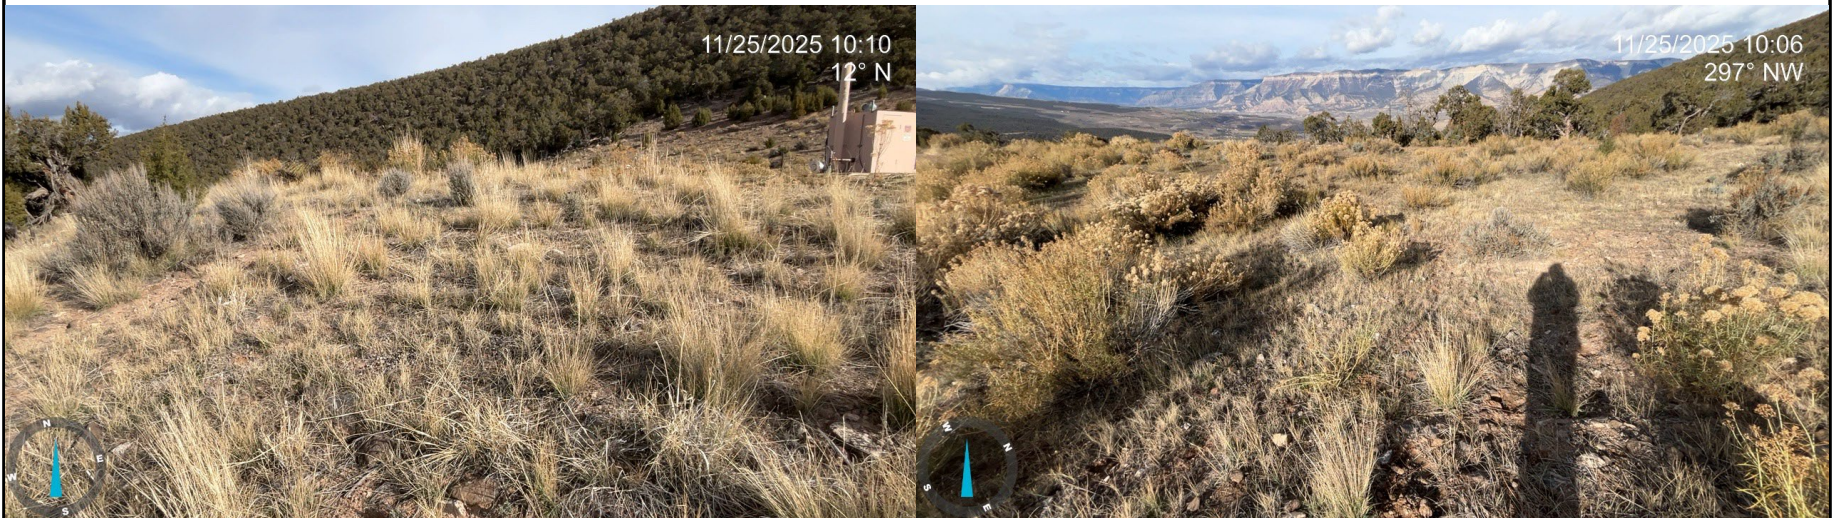
Photo 6: Photos showing an example of the western and northern interim areas, respectively. Desirable, perennial and uniform vegetation has established. Interim areas at the location are progressing towards 1003 reclamation requirements.
