Final Reclamation and Stormwater Inspection

Location ID: 318195

Well Name: GRANT #2

Inspection Document #: 718601206

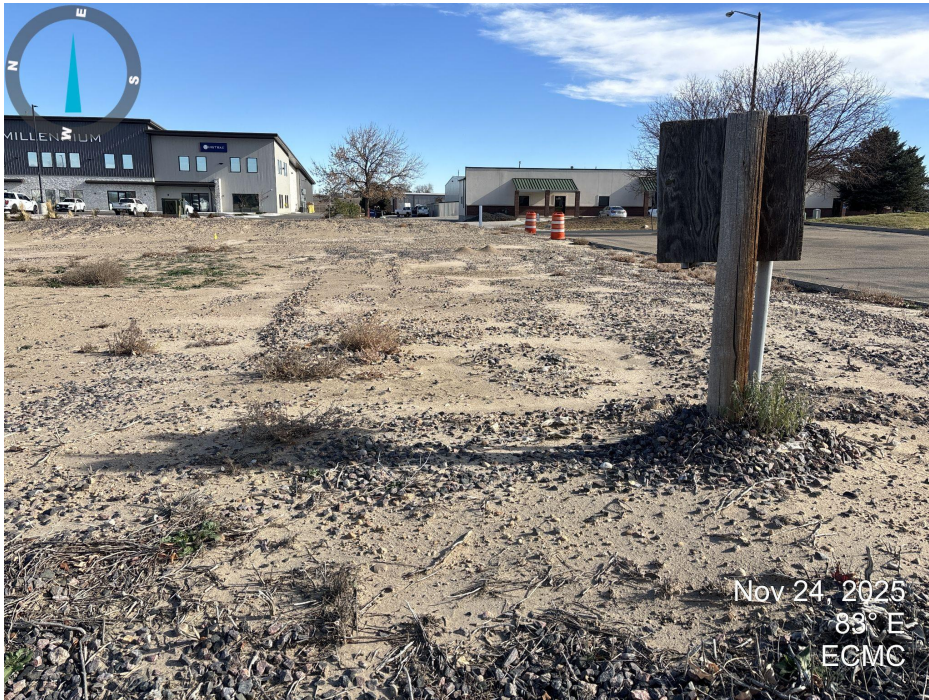
Photo 1. Picture taken at the southwest side of the location. Electric meter and post remain.

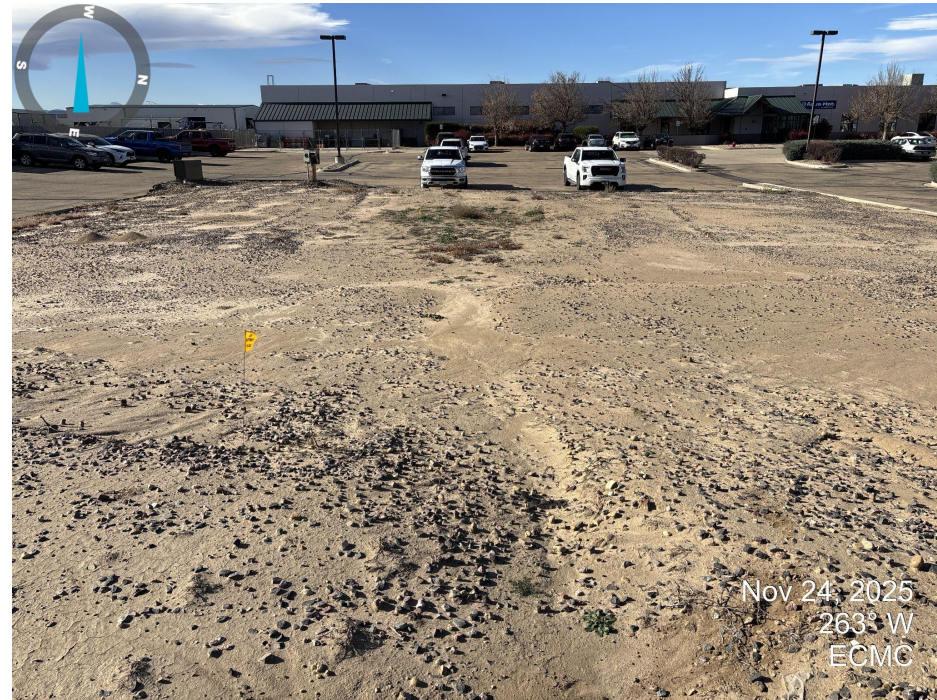
Photo 2. Looking west across the location. Location is bare soil and gravel. Some undesirable weeds such as a kochia are present. Stormwater erosion channels are visible.

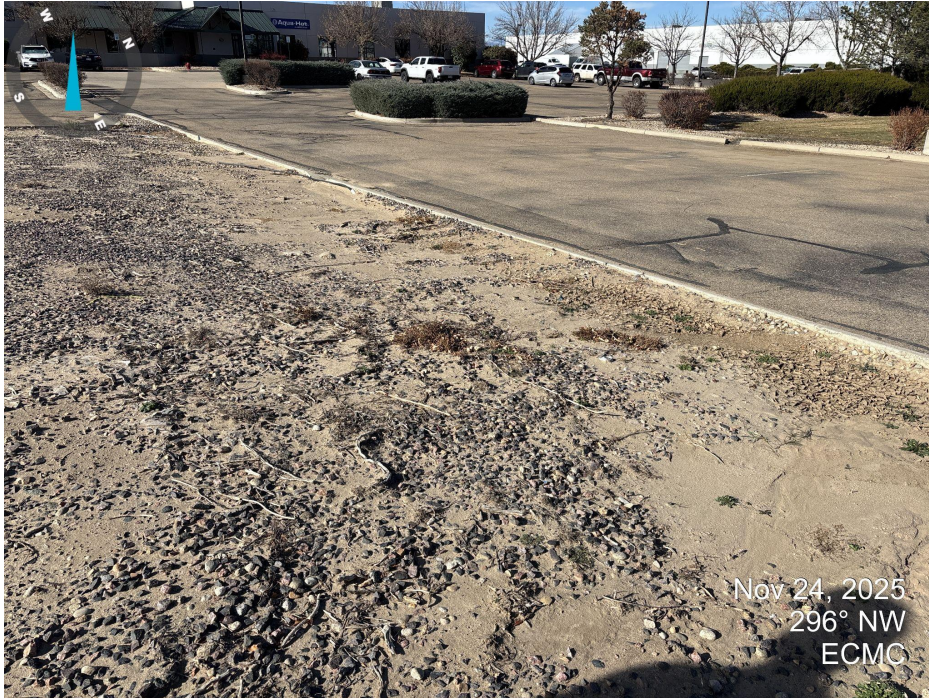
Photo 3. Looking west down the north side of the location. Sediment appears to be moving to this area of the location through stormwater erosion.

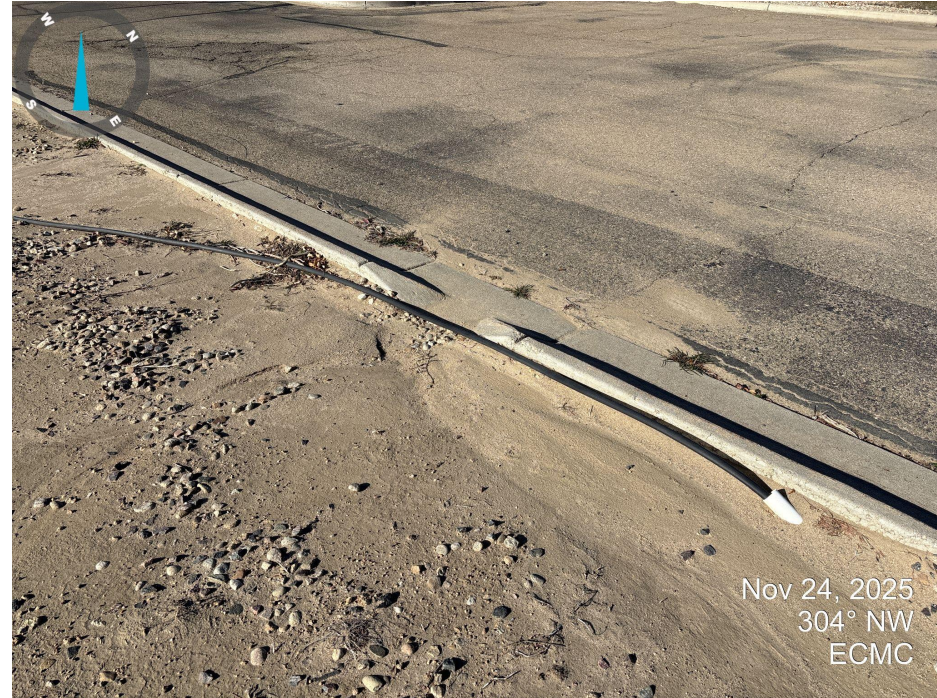
Photo 4. Photo taken on the north side of the location. It appears that sediment is leaving the location through this drain in the curb.
