# Inspection Photos

Operator: QB Energy Operating LLC #10844

Location ID: 334667

Inspection Doc: 719200513

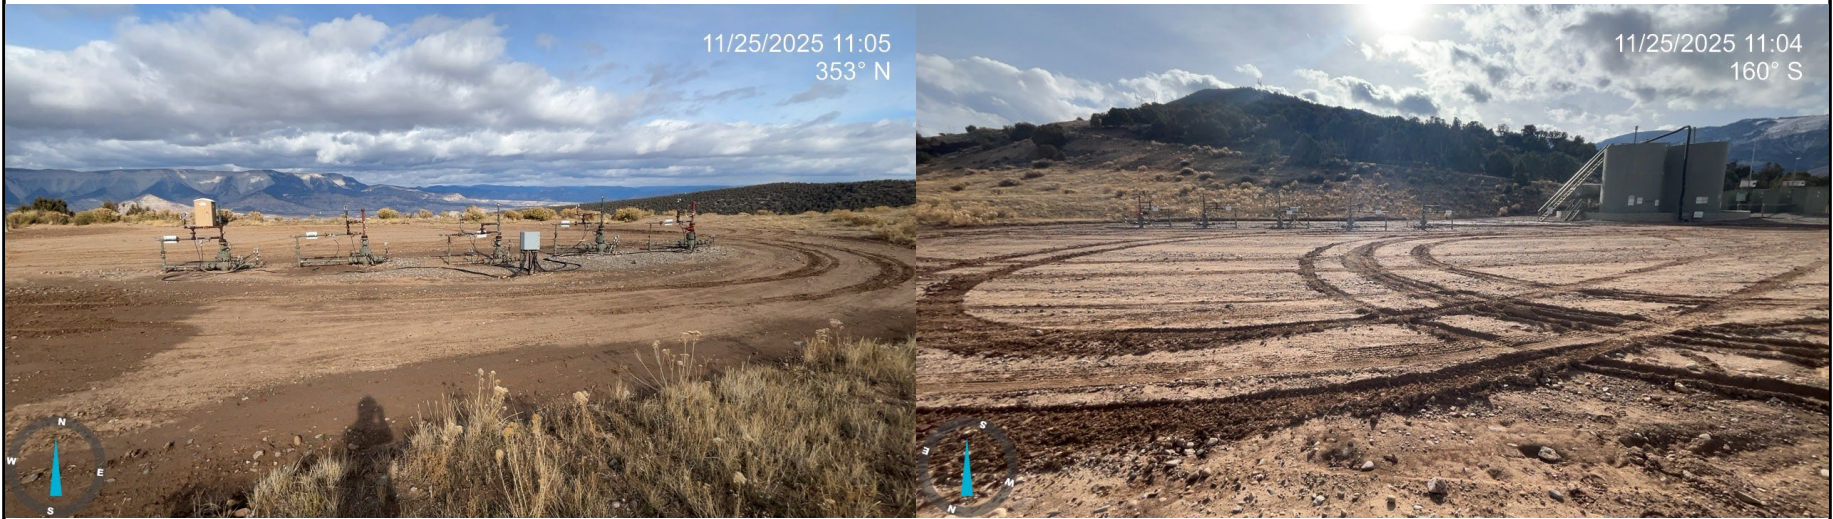
**Photo 1:** Photos showing an overview of the location looking north and south, respectively.

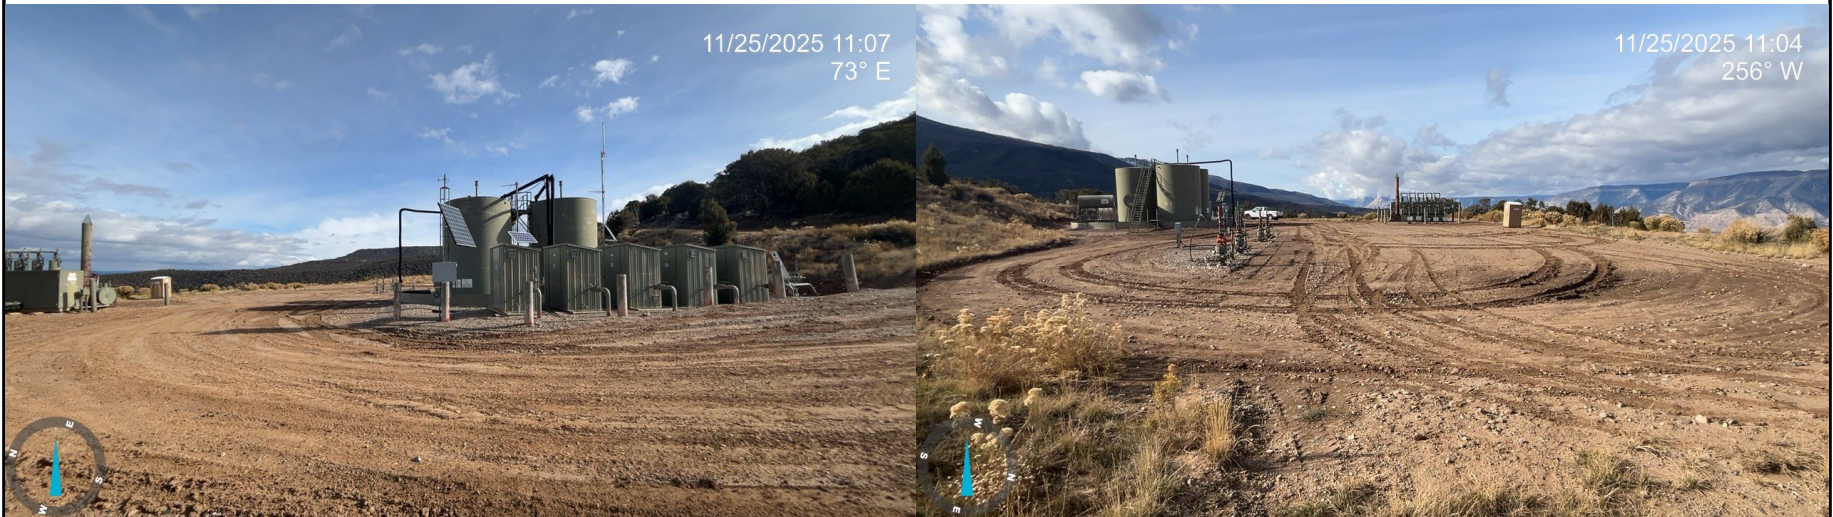
**Photo 2:** Photos showing an overview of the location looking east and west, respectively.

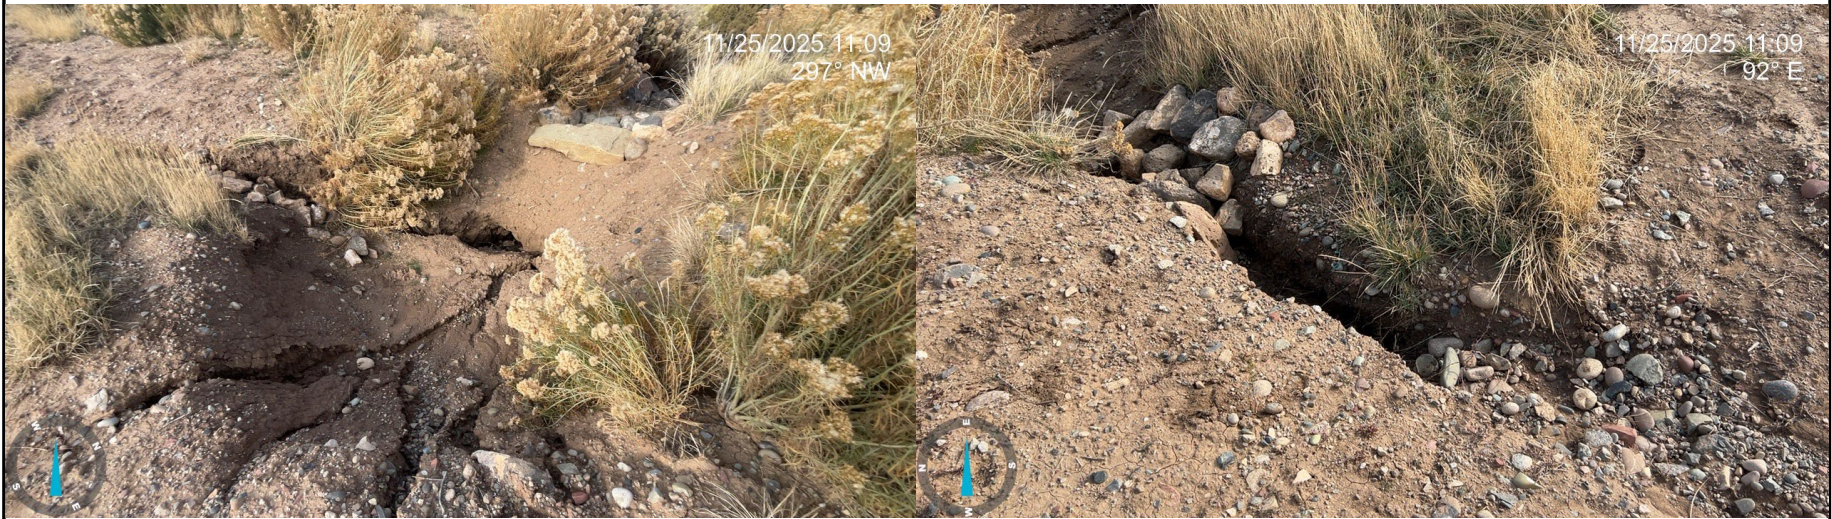
**Photo 3:** Photos showing a sediment trap on the northern edge of the working pad surface. Erosion, rilling and subsidence is occurring. Comply with 1002.f. and maintain stormwater BMPs.

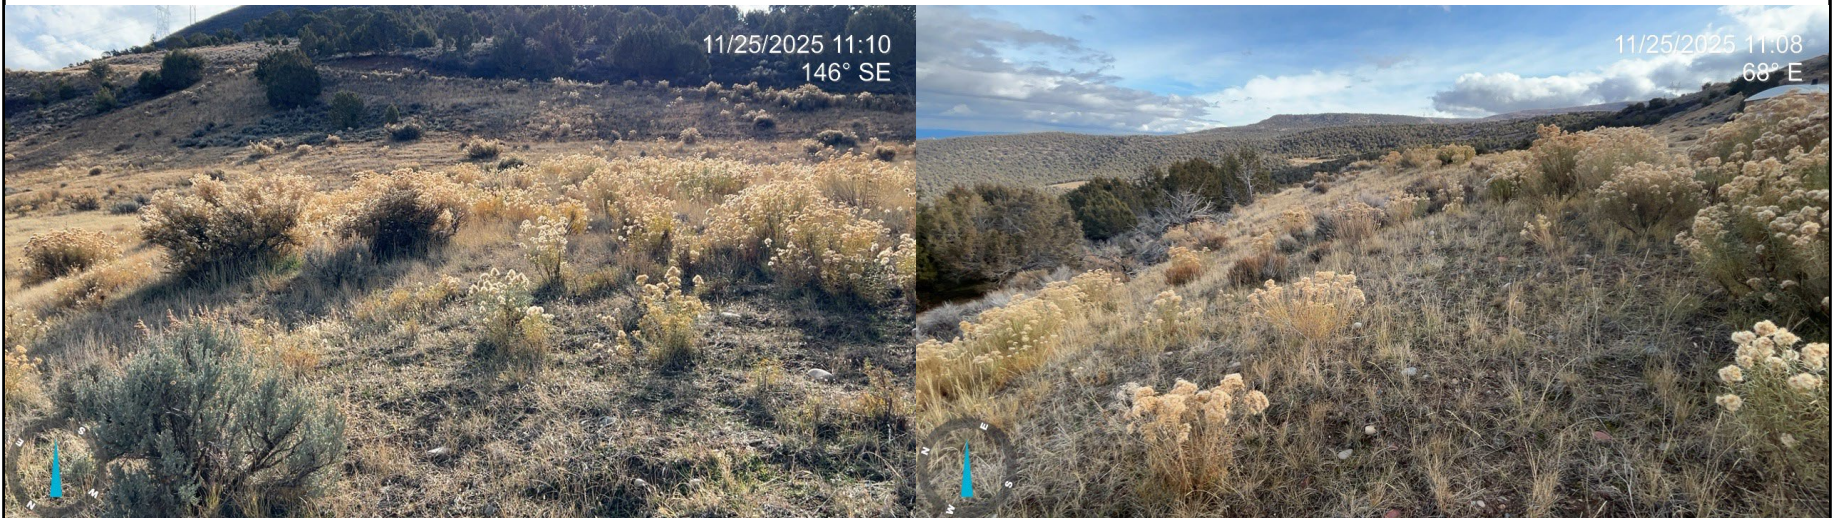
**Photo 4:** Photos showing the eastern and northern interim areas, respectively. Desirable, perennial and uniform vegetation is present. Interim areas are progressing towards 1003 reclamation requirements.

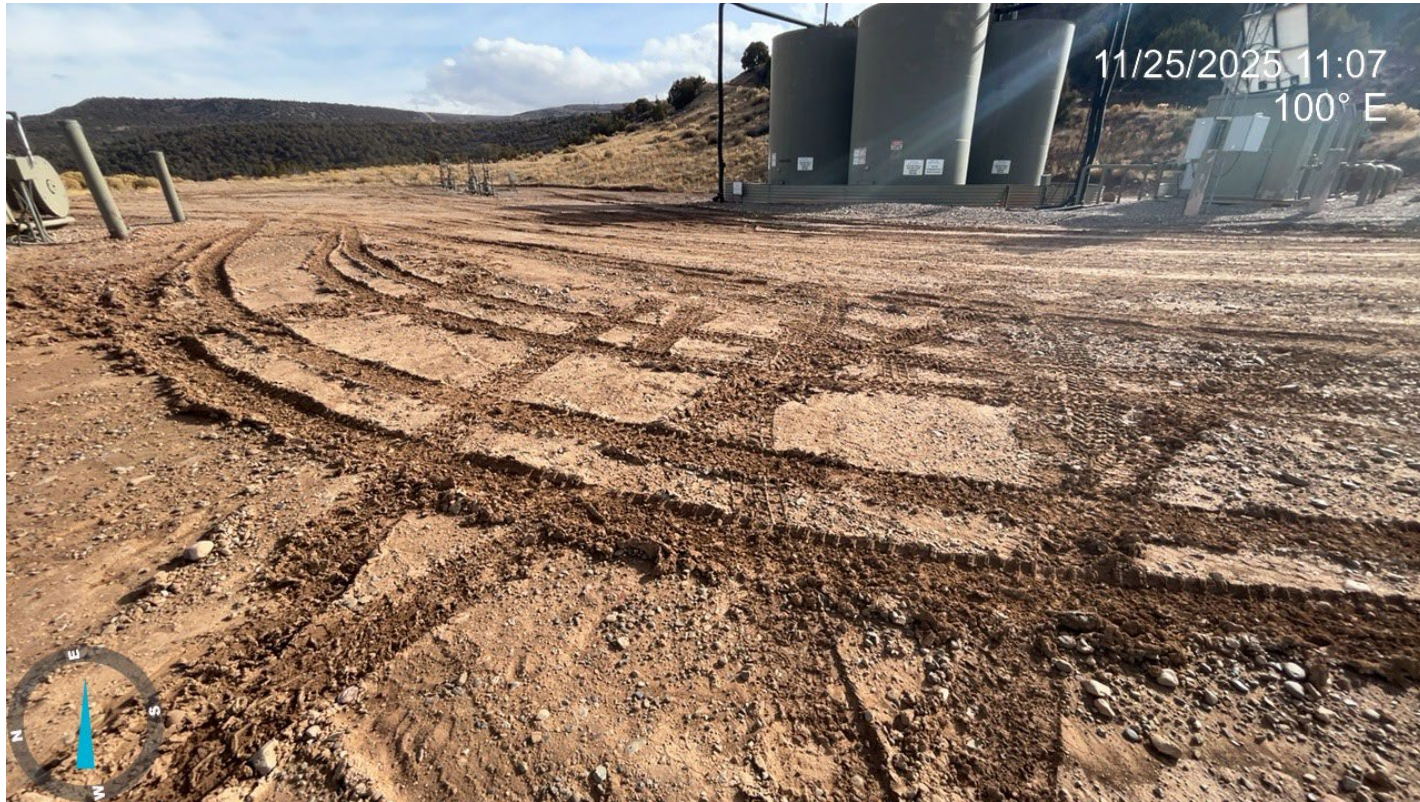
**Photo 5:** Vehicle rutting is present throughout the working pad surface and gravel is sparse in some areas. Comply with 1002.f.

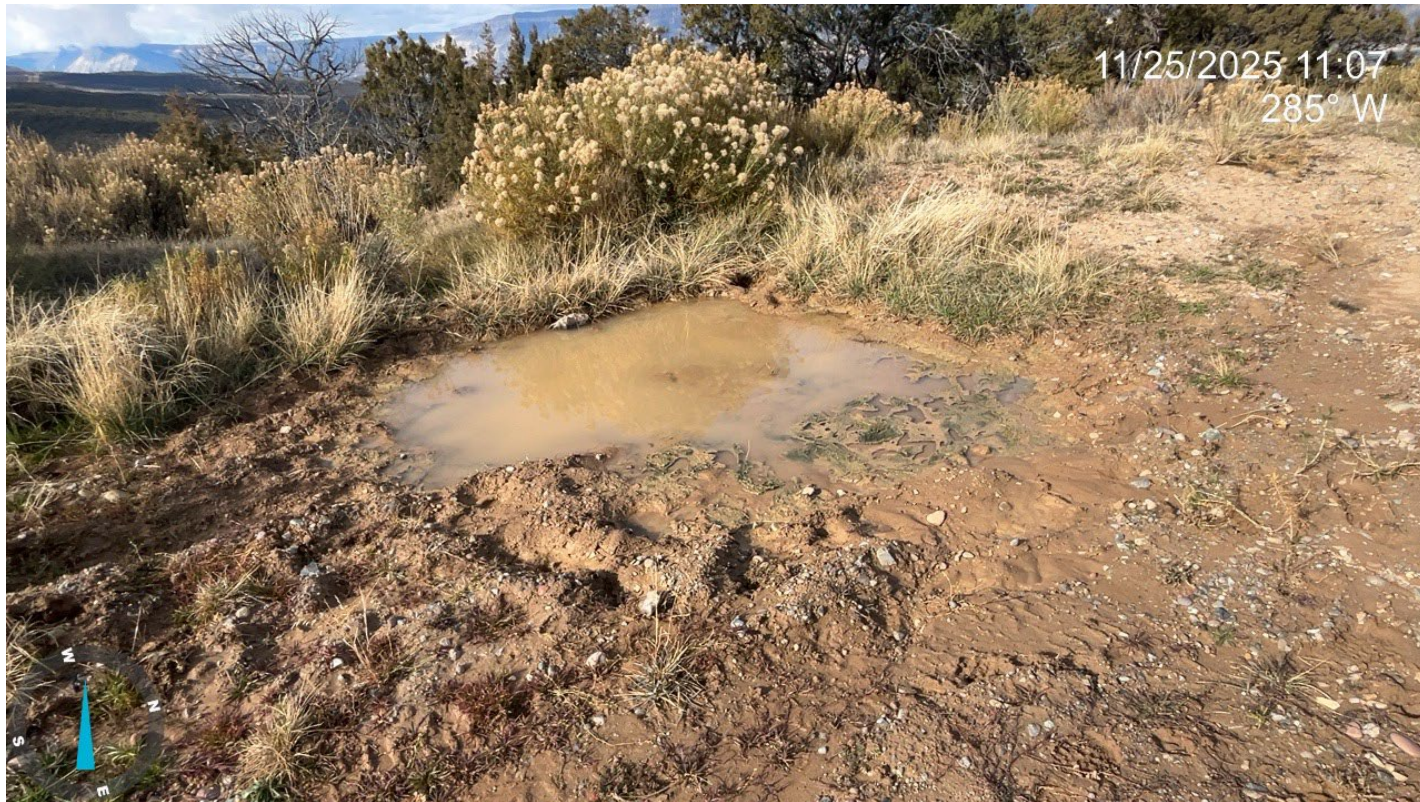
**Photo 6:** A stormwater control on the western edge of the working pad surface appears to be laden with sediment and has reached capacity. Comply with 1002.f. and implement or maintain stormwater BMPs.
