Inspection Photos

Operator: QB Energy Operating LLC #10844

Location ID: 334637

Inspection Doc: 719200517

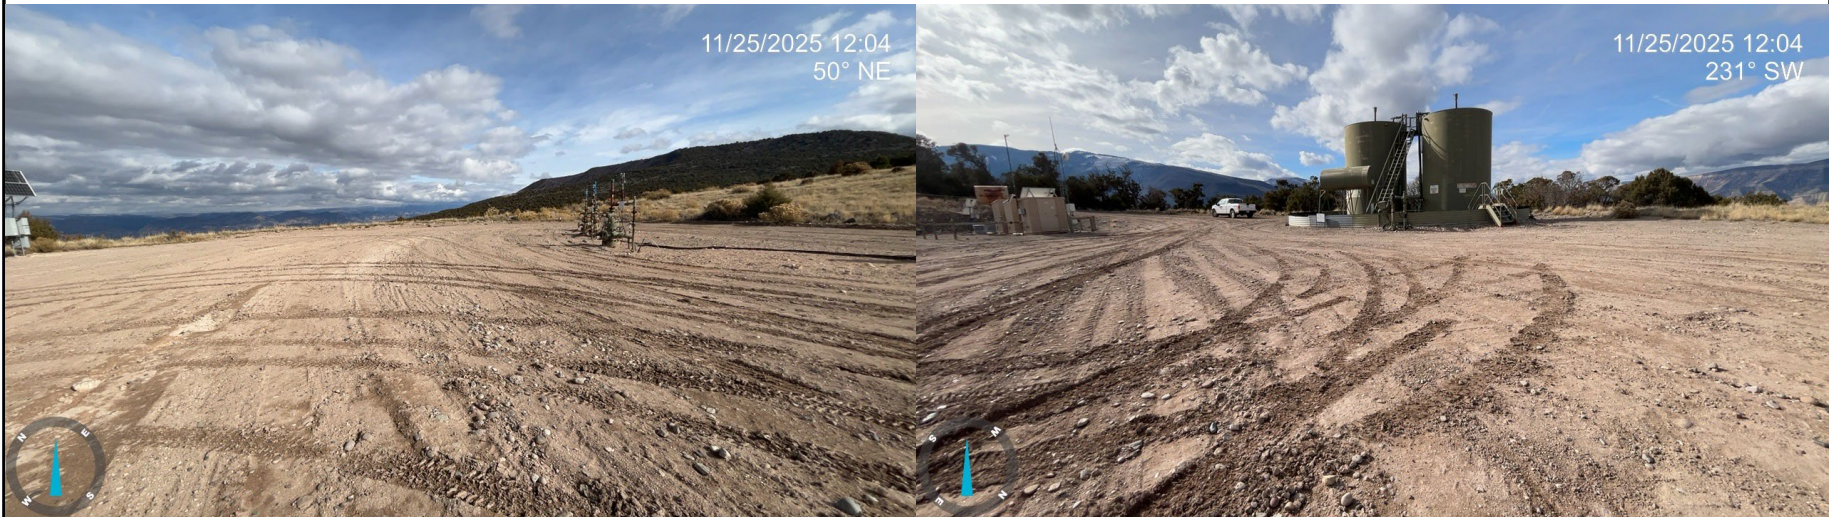
Photo 1: Photos showing an overview of the location looking northeast and southwest, respectively. Vehicle tracking is present on the working pad surface and gravel is sparse in some areas. Maintenance is recommended.

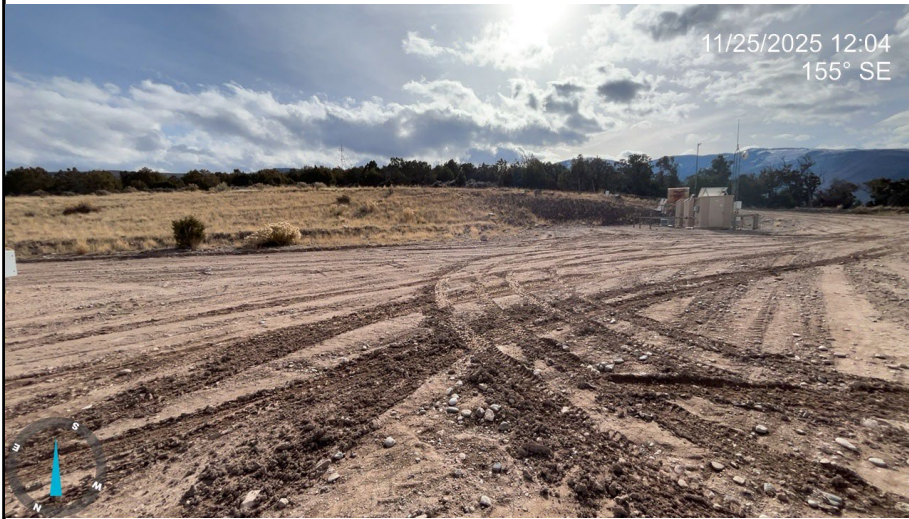
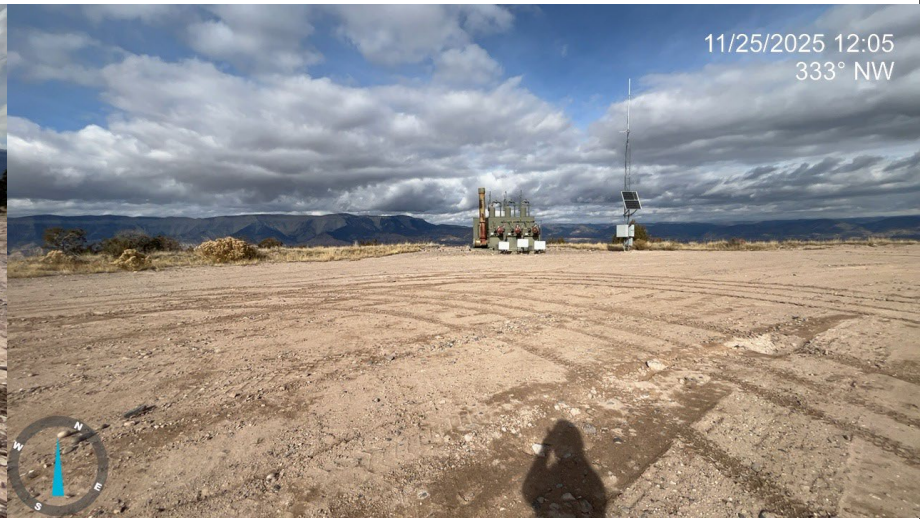
Photo 2: Photos showing an overview of the location looking southeast and northwest, respectively. Vehicle tracking is present on the working pad surface and gravel is sparse in some areas. Maintenance is recommended.

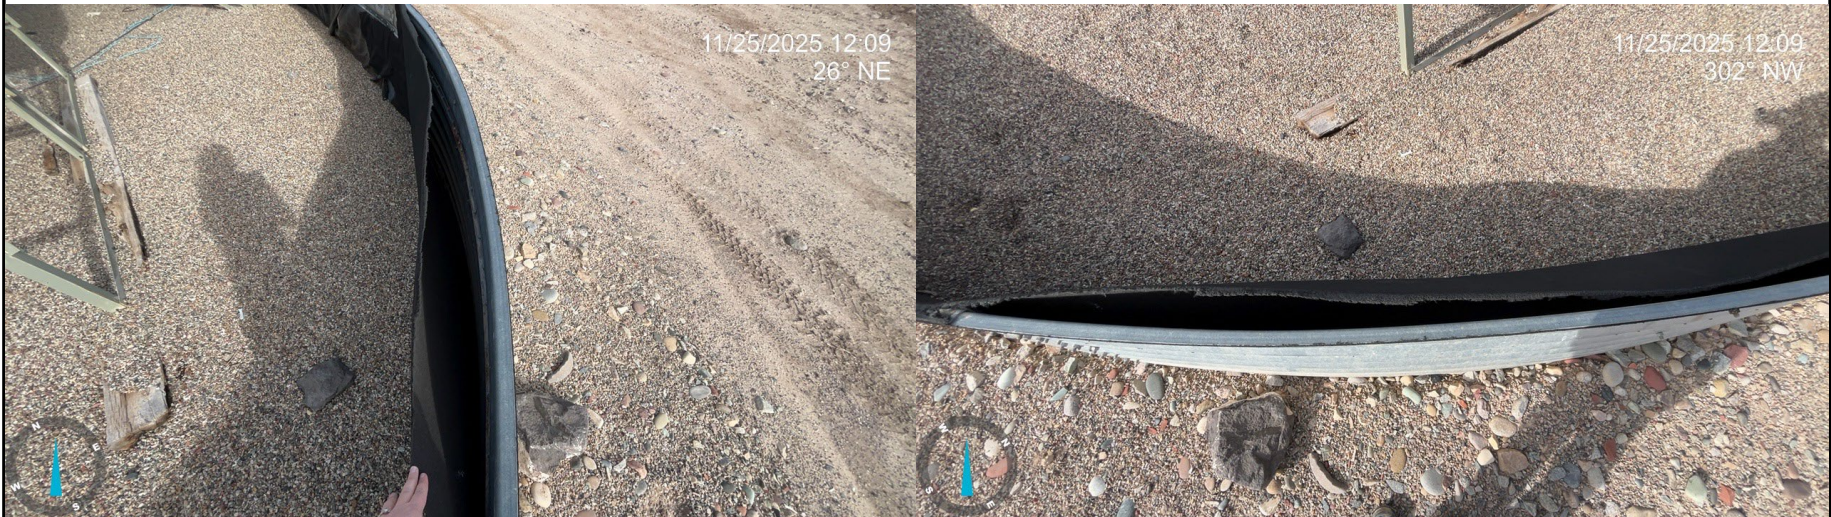
Photo 3: Photos showing the secondary containment liner at tank equipment is no longer sufficiently impervious. Comply with Rile 603.o.

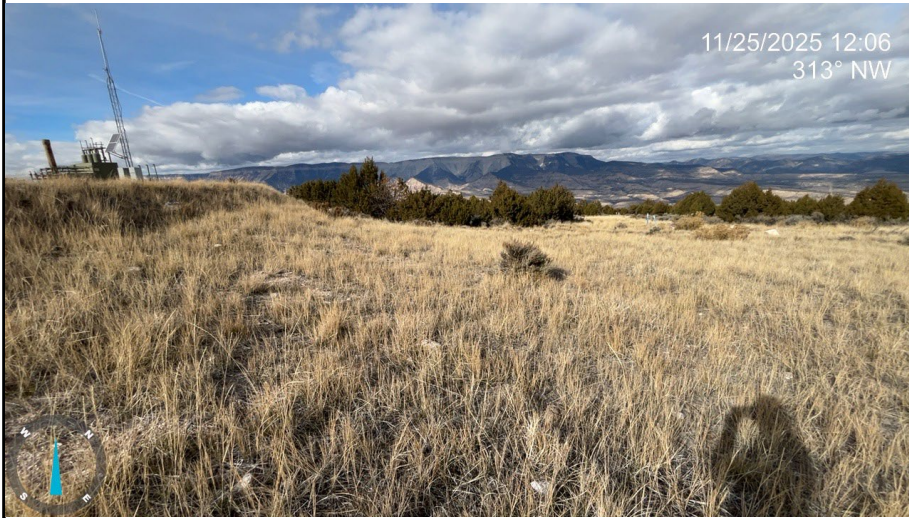
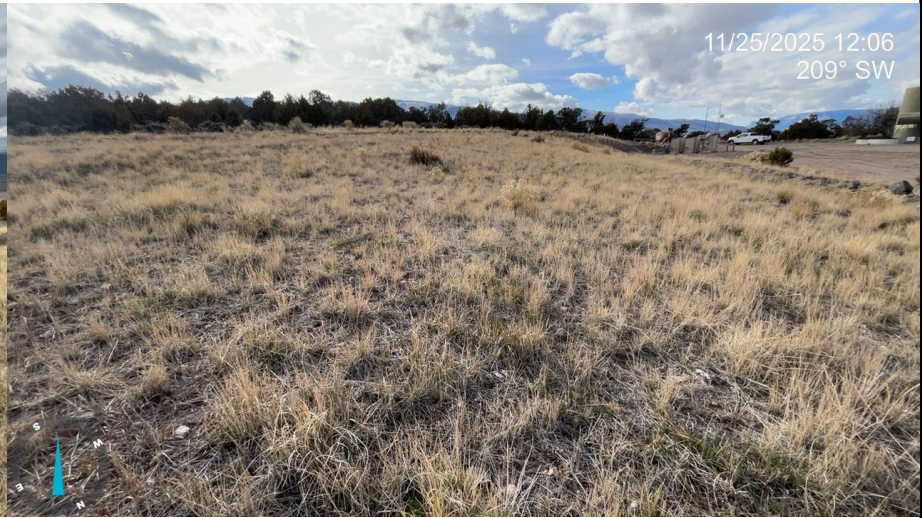
Photo 4: Photos showing an overview of the northwestern and southern interim areas, respectively. Desirable, uniform and perennial vegetation is present. The location is progressing towards 1003 reclamation requirements.
