Chevron Rockies Business Unit

Field Qualitative Criteria for ECMC Reporting Associated with the Discovery of Potentially Impacted Material

Location name: RICHARDSON-64N64W 10NWSW

Form 19 Information Summary

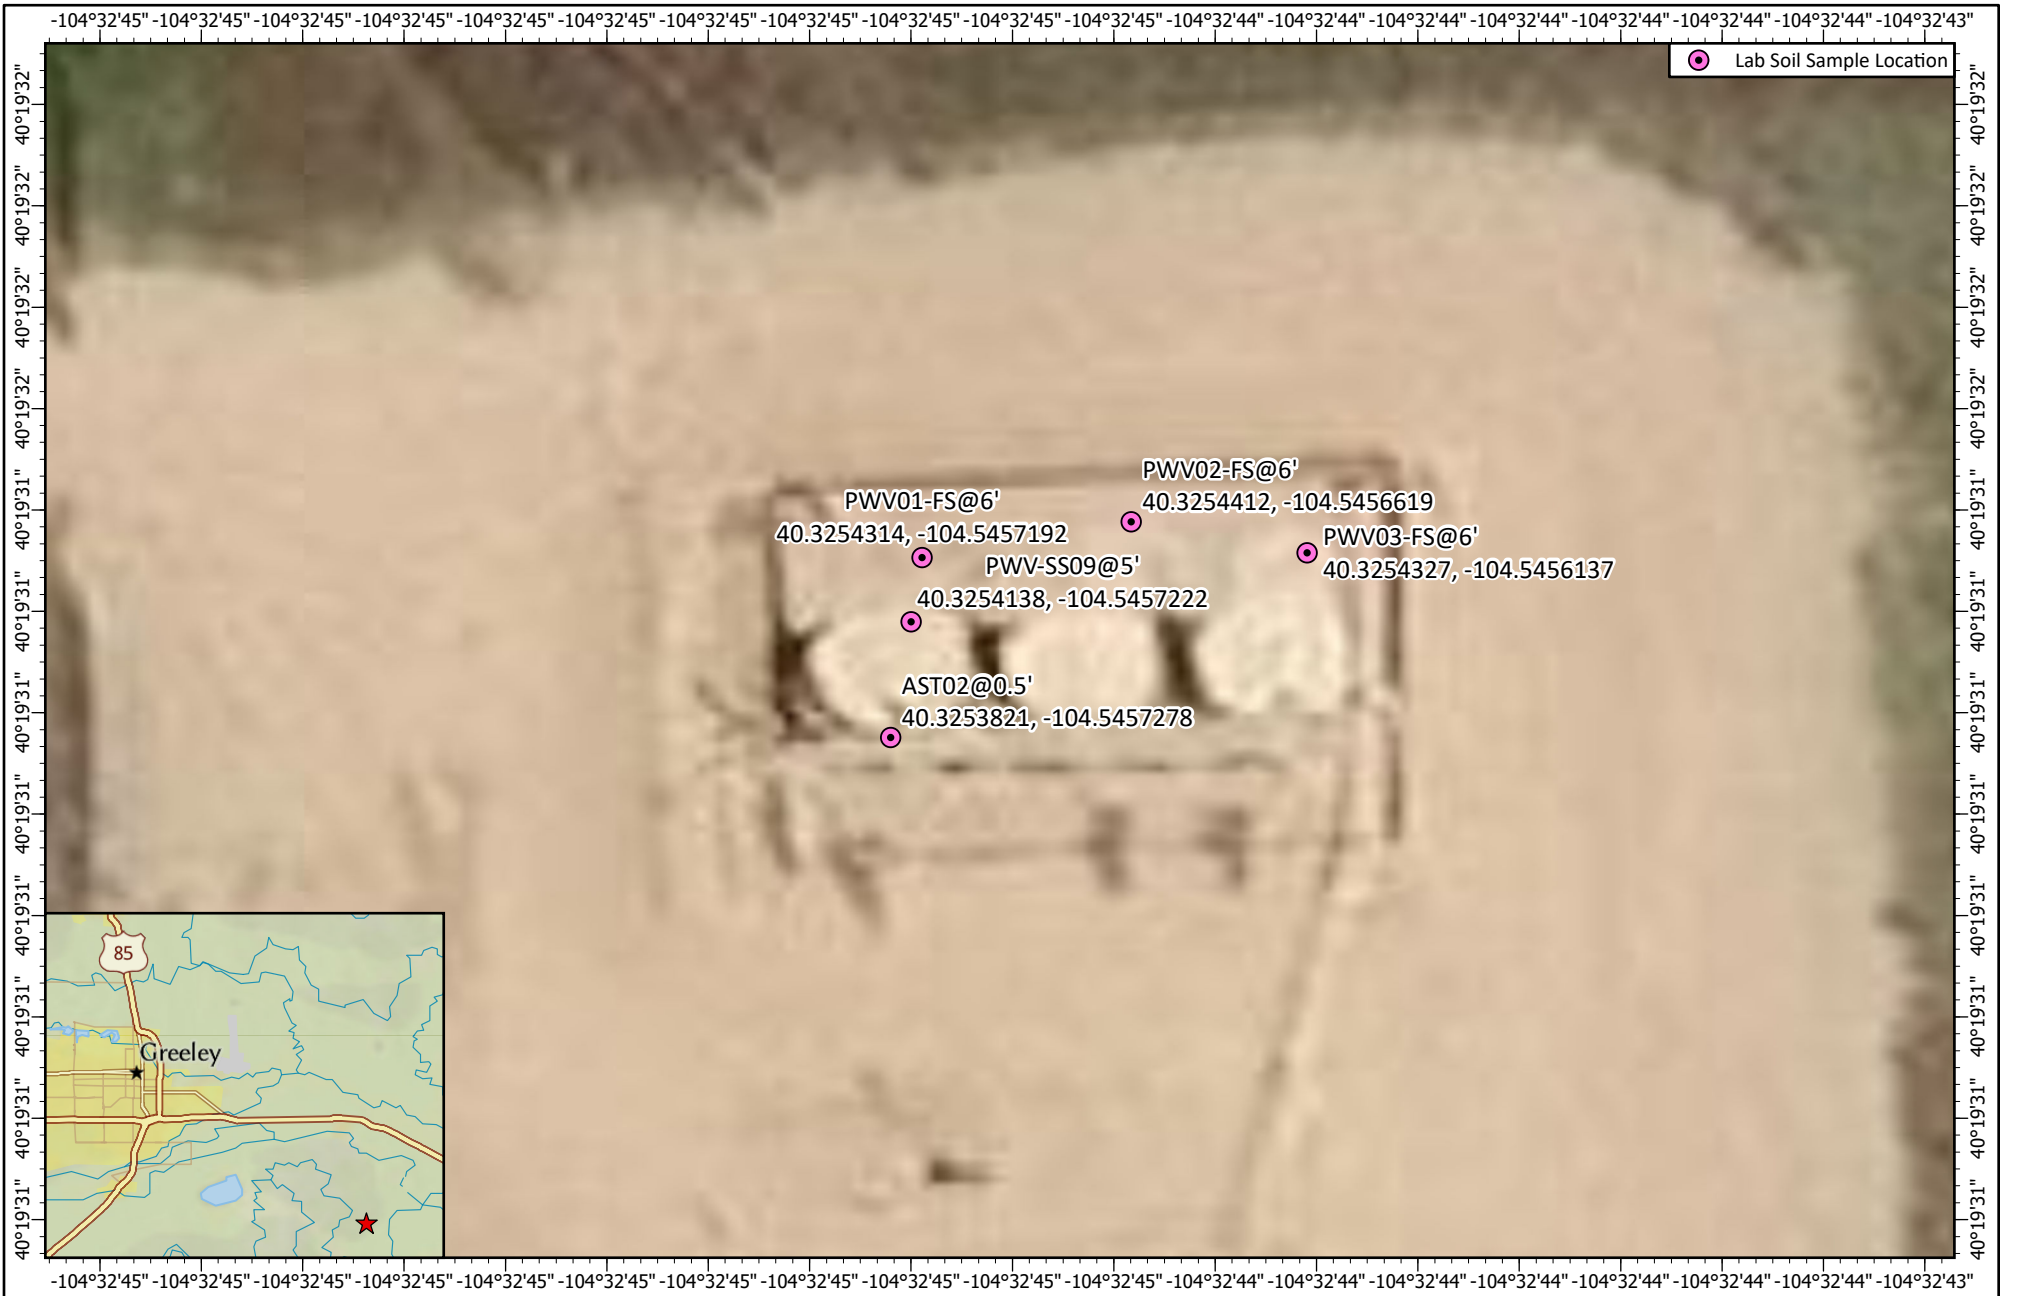
Figure 2

Potential Release Locations (12/05/25)
Richardson 64N64W 10NWSW

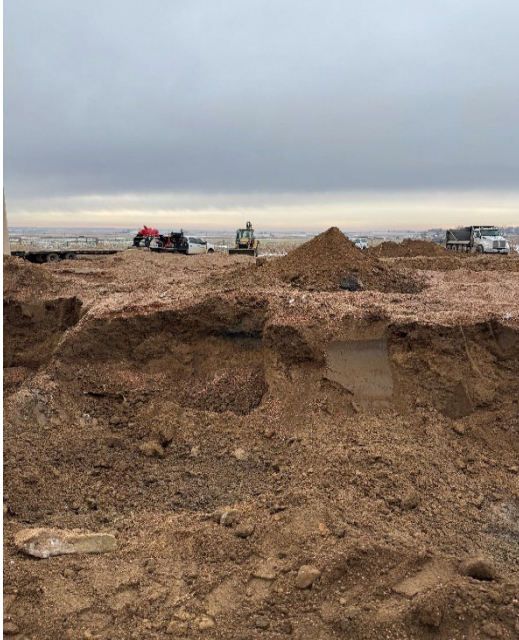
| Photo: 1 | Date: 12/05/2025 | Description: Representative picture of soil excavation associated with the PWV01, PWV02, PWV03 sample locations (40.325431, -104.545719; 40.325441, -104.545662; and 40.325433, -104.545614, respectively) at a depth of approximately six (6) feet below ground surface (bgs) in well graded sand (SW). Soil staining and petroleum odor observed. |

Visibly stained soils were observed in the excavation associated with produced water vessels PWV-01, PWV-02, and PWV-03 at depths at least 6 feet below ground surface (bgs). The dimensions of the excavation associated with the PWVs was approximately 41 feet long, 21 feet wide, and 6 feet deep. Staining and petroleum odors were still present in Site soils at this location following the excavation. Soils samples were collected from the excavation floor at sample locations PWV01-FS (40.325431, -104.545719), PWV02-FS (40.325441, -104.545662), and PWV03-FS (40.325433, -104.545614) at approximately six feet bgs, and at samples location PWV-SS09 (PWV excavation south-western sidewall; 40.325414, -104.545722) at approximately five (5) feet bgs. As shown on Table 1 (Field Data Summary Table; attached), photoionization detector (PID) readings collected from these sample locations ranged from 2.6 parts per million (ppm) to 89.0 ppm. The excavated material was removed from the Site and transported to Buffalo Ridge Landfill for proper disposal. The excavation was partially backfilled with clean fill material.

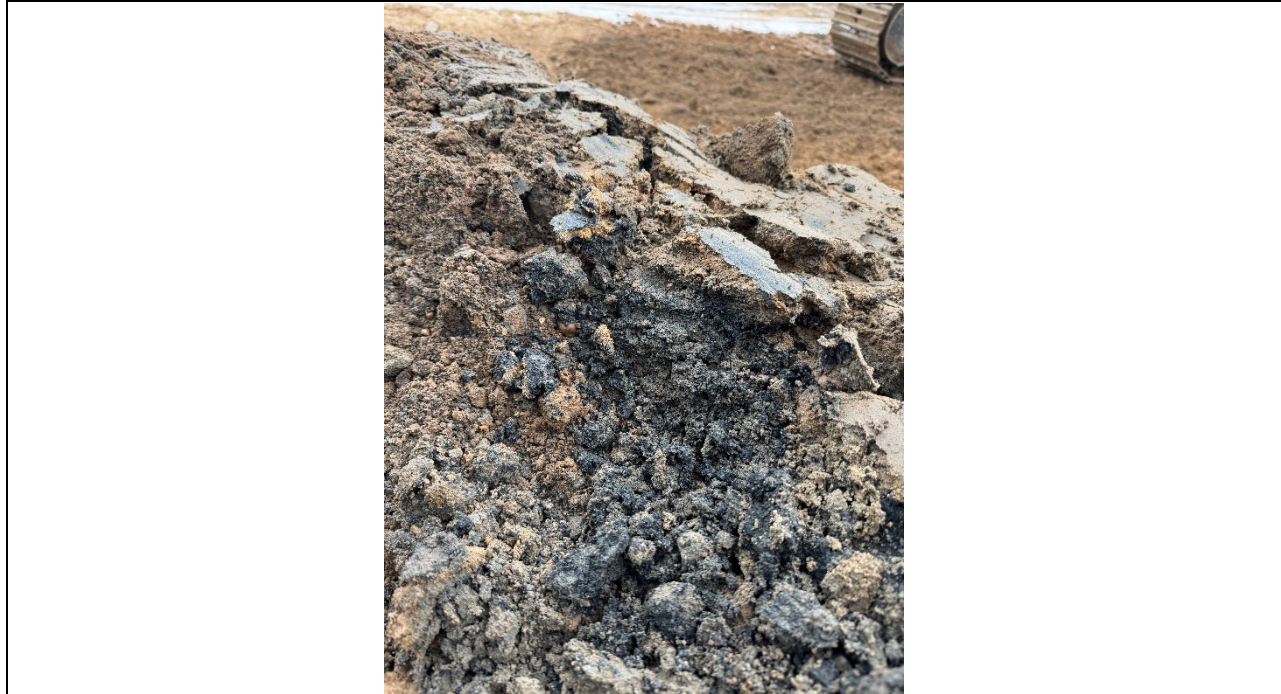
| Photo: 2 | Date: 12/05/2025 | Description: Soil staining in well graded sand (SW) excavated at the former PWV01, PWV02, and PWV03 locations. |

| Photo: 3 | Date: 12/05/2025 | Description: Soil staining in well graded sand (SW) excavated at the former PWV01, PWV02, and PWV03 locations. |

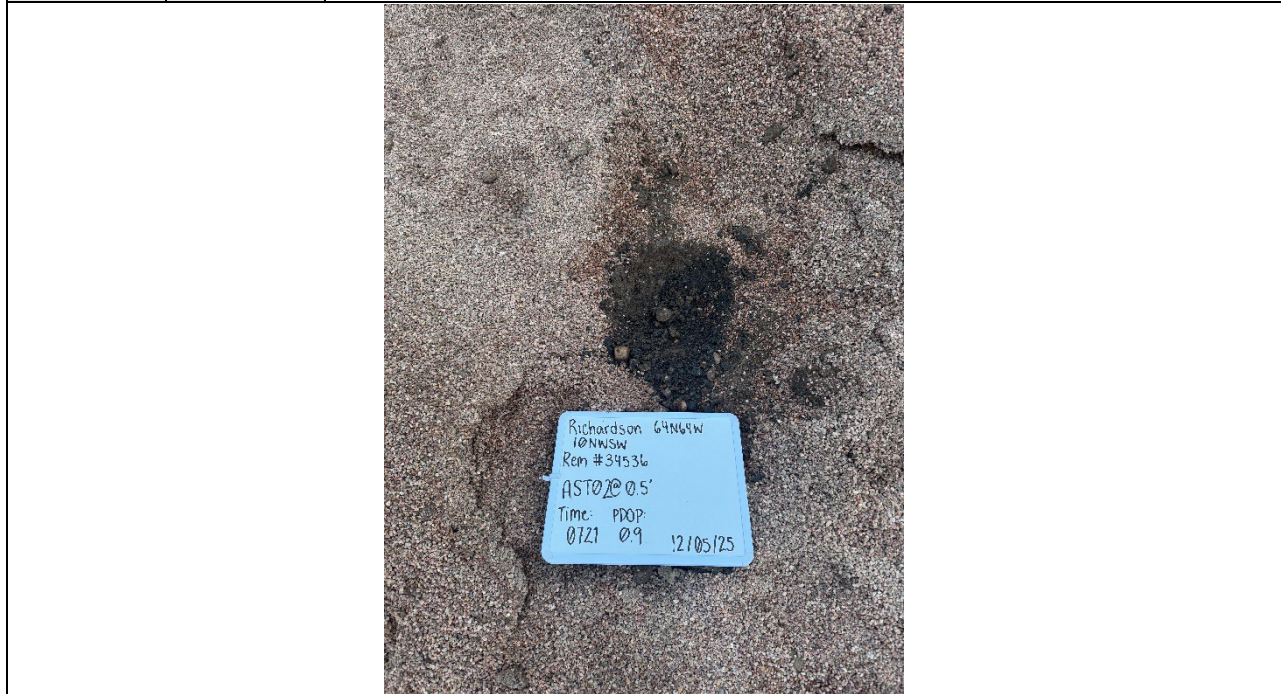
| Photo: 4 | Date: 12/05/2025 | Description: Representative picture of soils at sampling location AST02 (above ground storage tank; 40.325382, -104.545728) at a depth of approximately 0.5 feet bgs in well graded sand (SW) (PID: 3.6ppm). Staining and petroleum odor observed. |

Stained soils that produced a petroleum odor were also encountered at the aboveground storage tank sample location AST-02 (40.325382, -104.545728) at the ground surface to approximately 0.5 feet bgs. A maximum PID reading of 3.6 ppm was measured from this material. A soil sample was collected from the AST-02 sample location at a depth of approximately 0.5 feet bgs. Surficial soils were not excavated at the AST-02 sample locations.

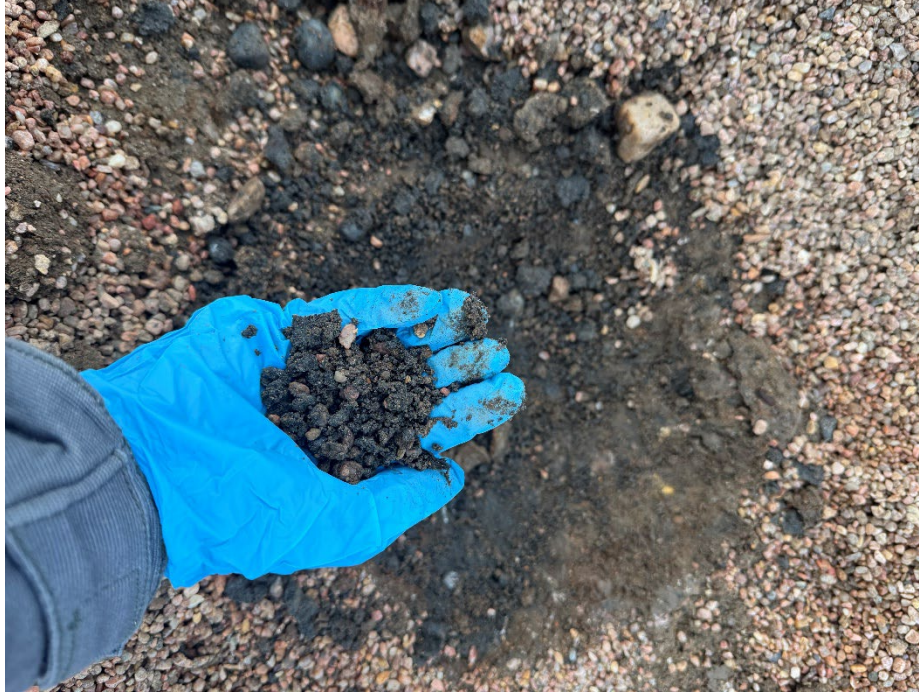
| Photo: 5 | Date: 12/05/2025 | Description: Soil staining in well graded sand (SW) at sampling location AST02 (40.325382, -104.545728) at a depth of approximately 0.5 feet bgs (PID: 3.6ppm). |
