WELL NAME: HILL RANCH 12-04, API #: 071-09849, INSP. # 716301782

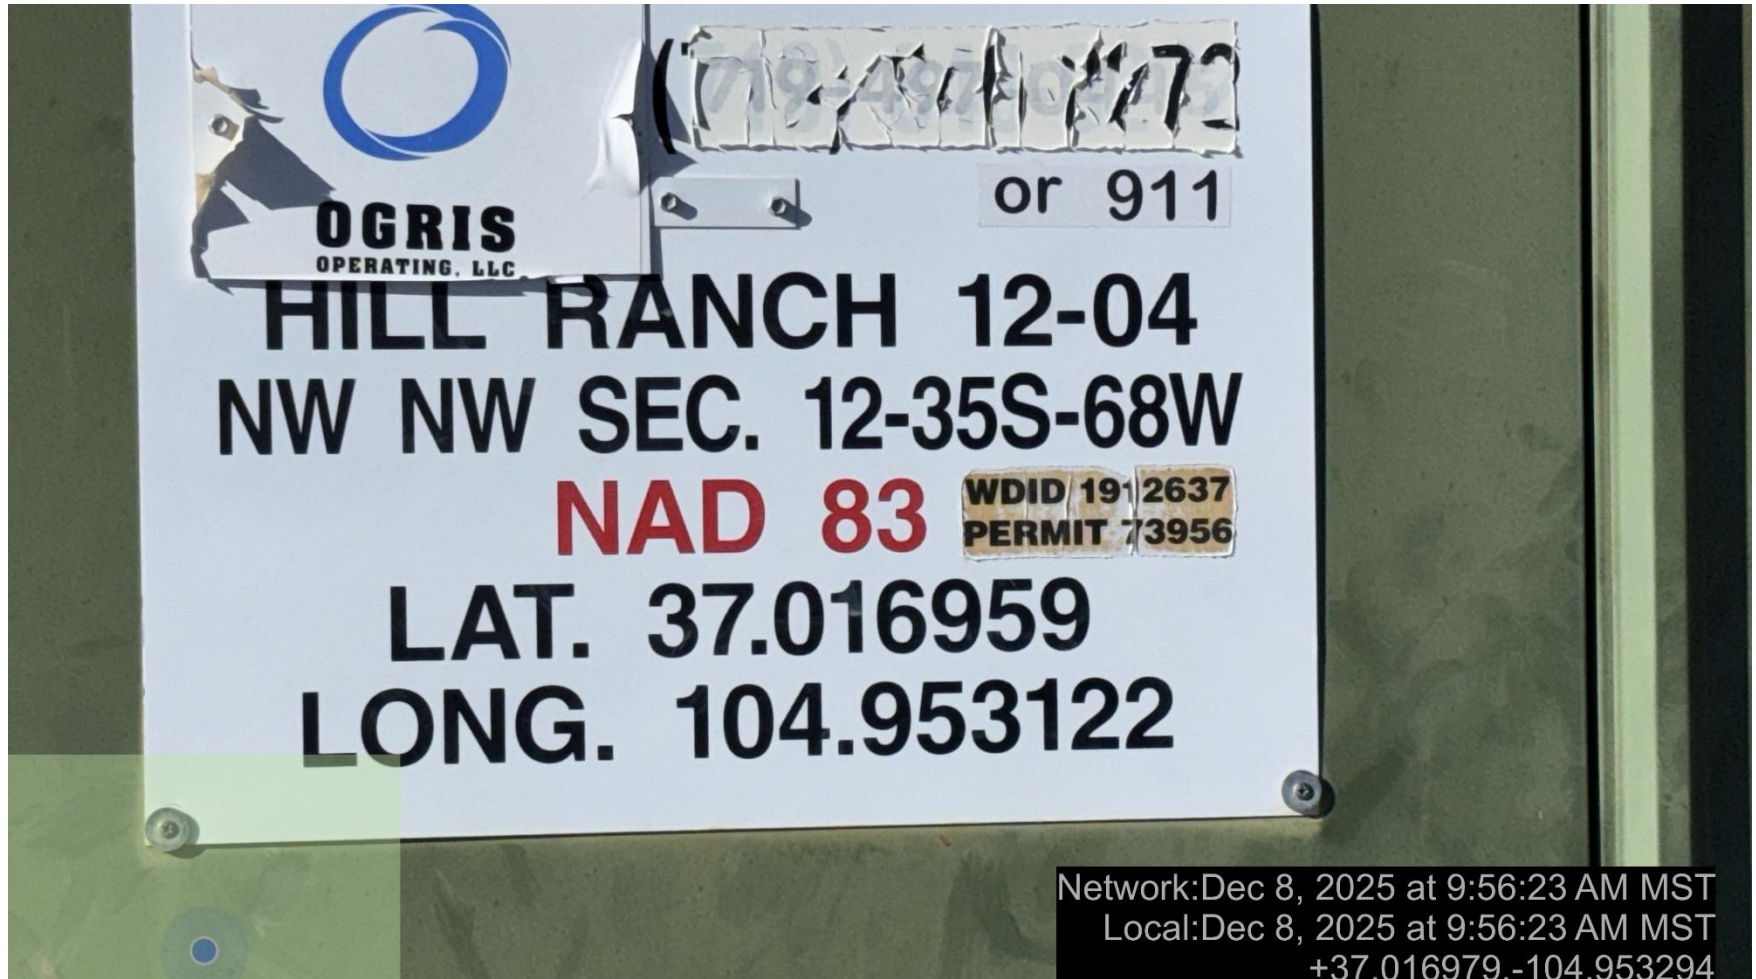
PHOTO 1: EMERGENCY CONTACT # IS FAIDED AND NOT LEGIBLE AND NO API # POSTED. POST SIGN IN ACCORDANCE WITH RULE 605. CA DATE 1-8-2026.

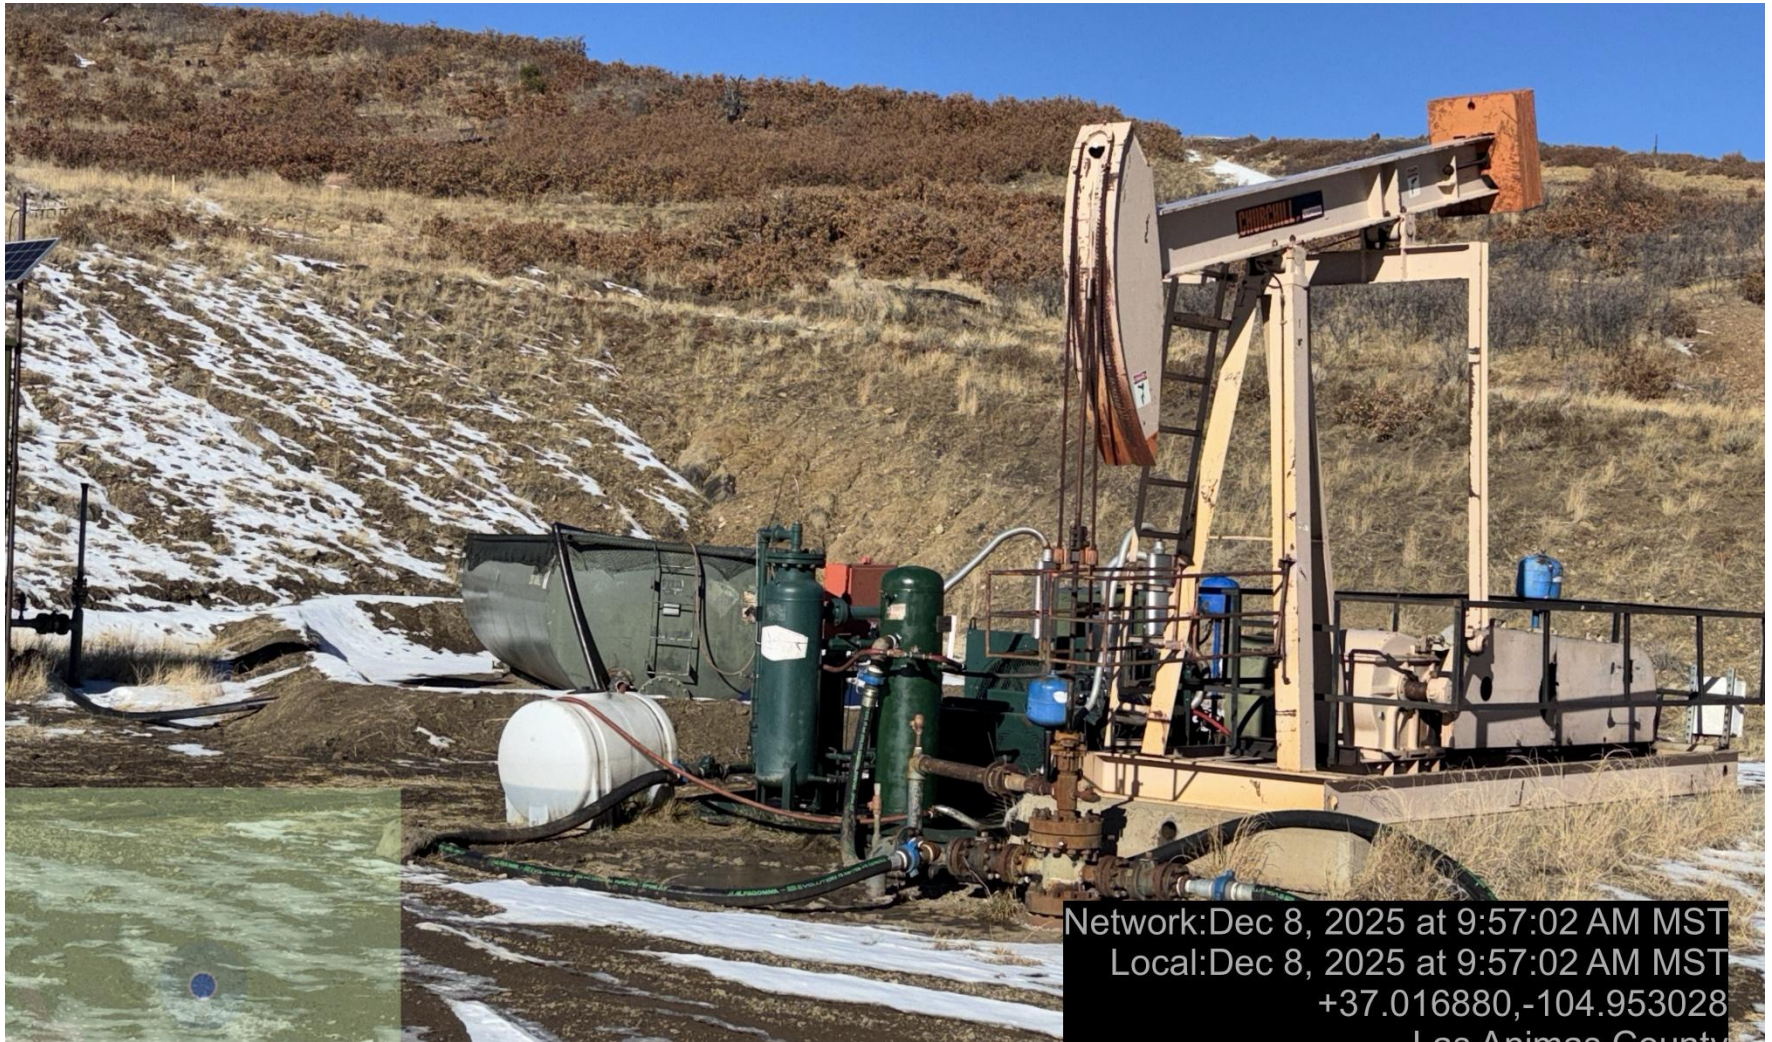
**PHOTO 3: WELLHEAD AND EQUIPMENT.**

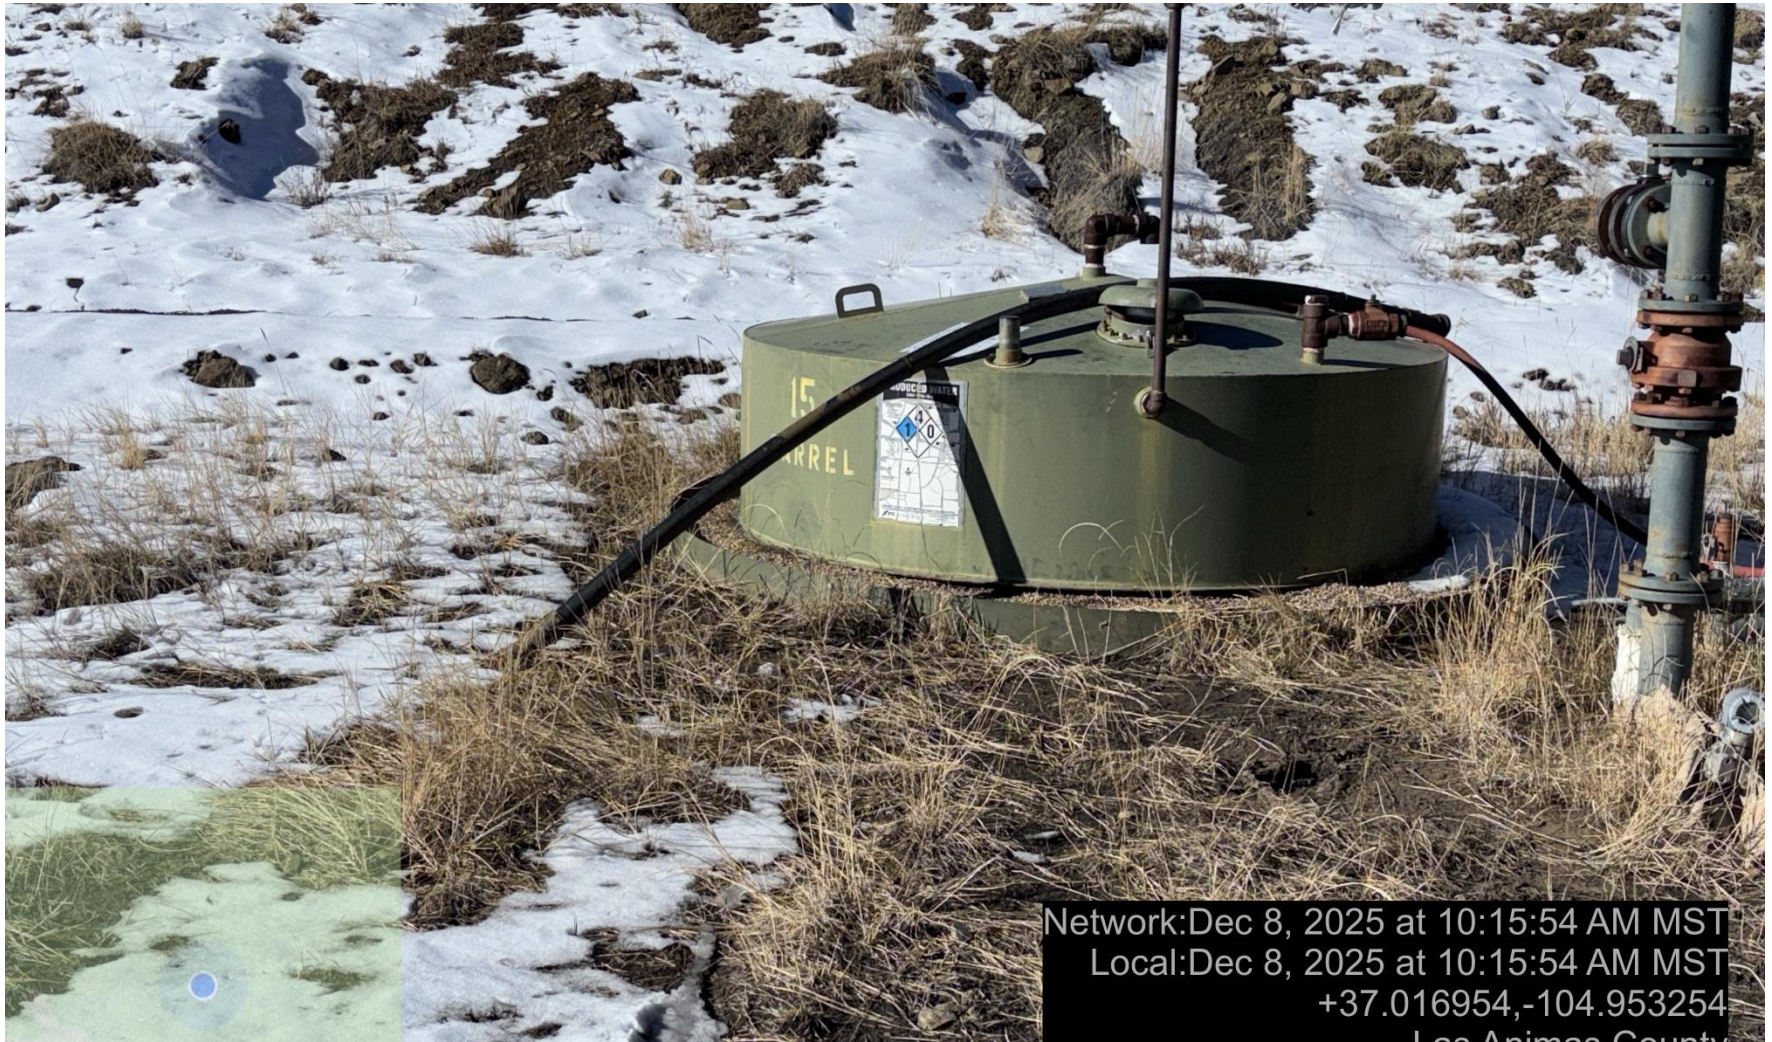
**PHOTO 4: UNUSED EQUIPMENT (2" POLY PIPE ON 15 BBL TANK). REMOVE UNUSED EQUIPMENT PER RULE 606. CA DATE 12-15-2025.**

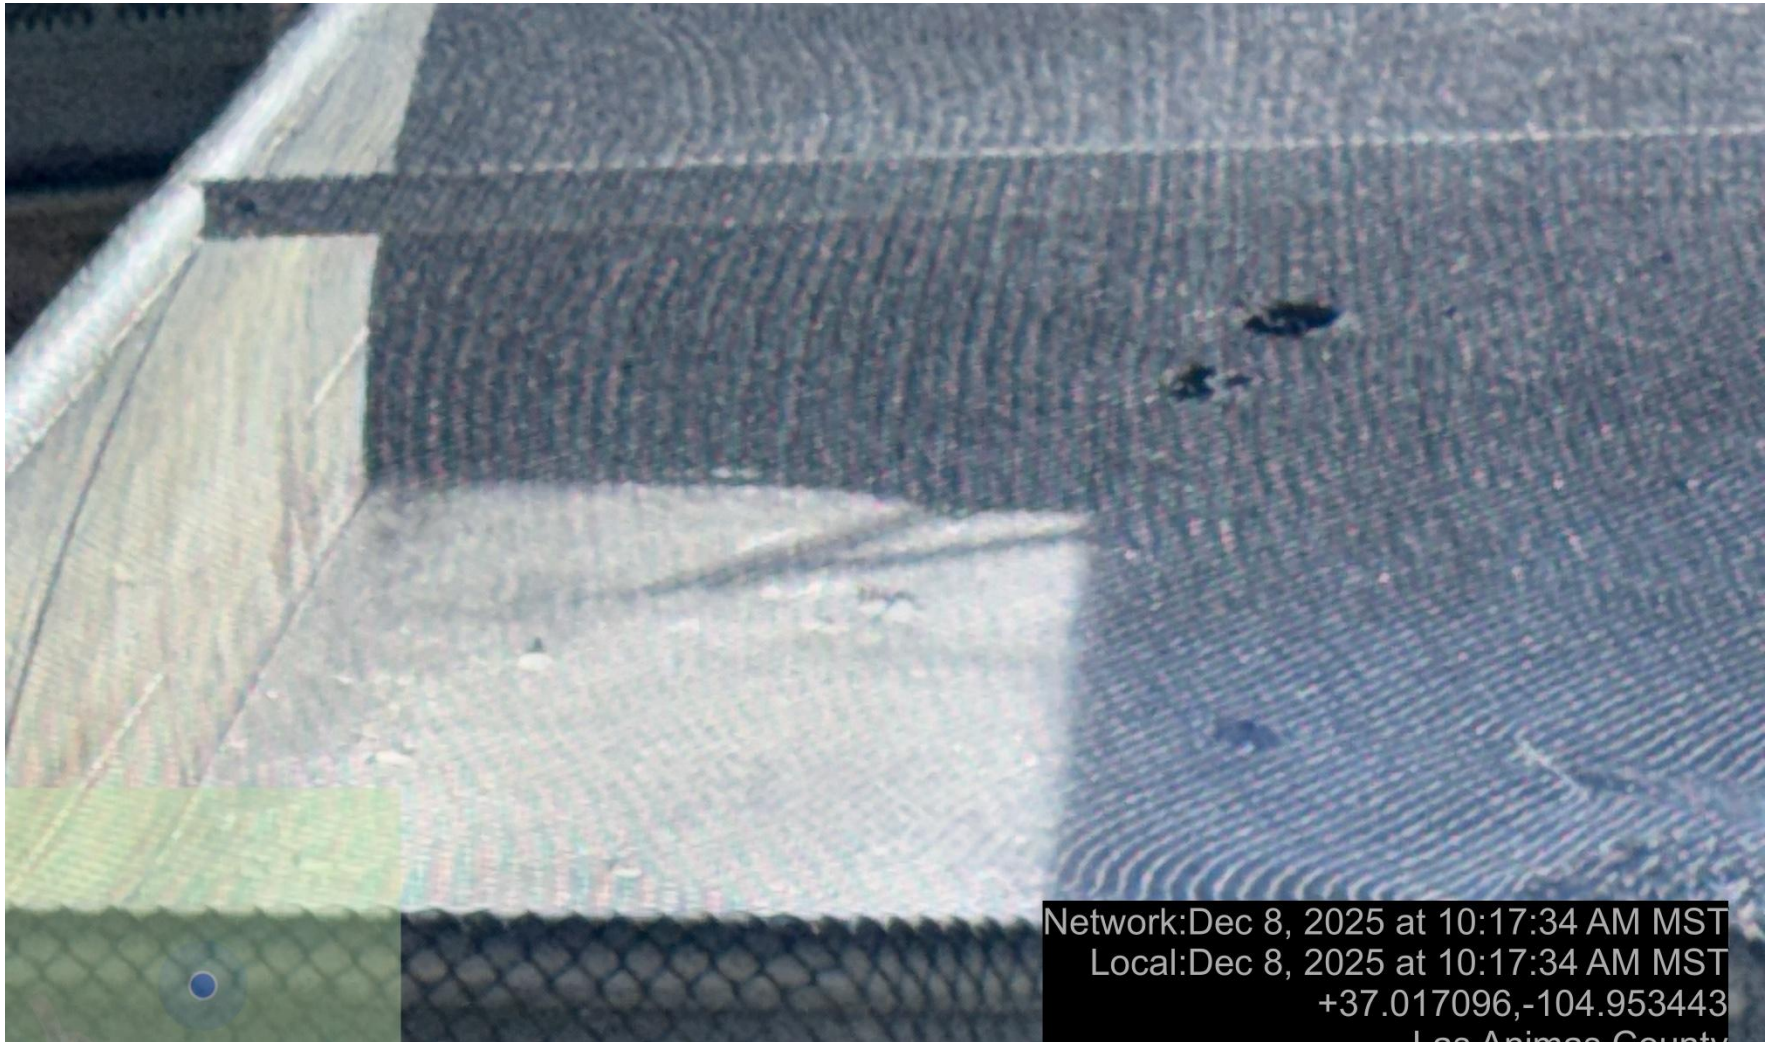
**PHOTO 5: Netting on open top tanks inadequate. Install or repair wildlife protection equipment per rule 608.a.(13). CA DATE 12-15-2025.**

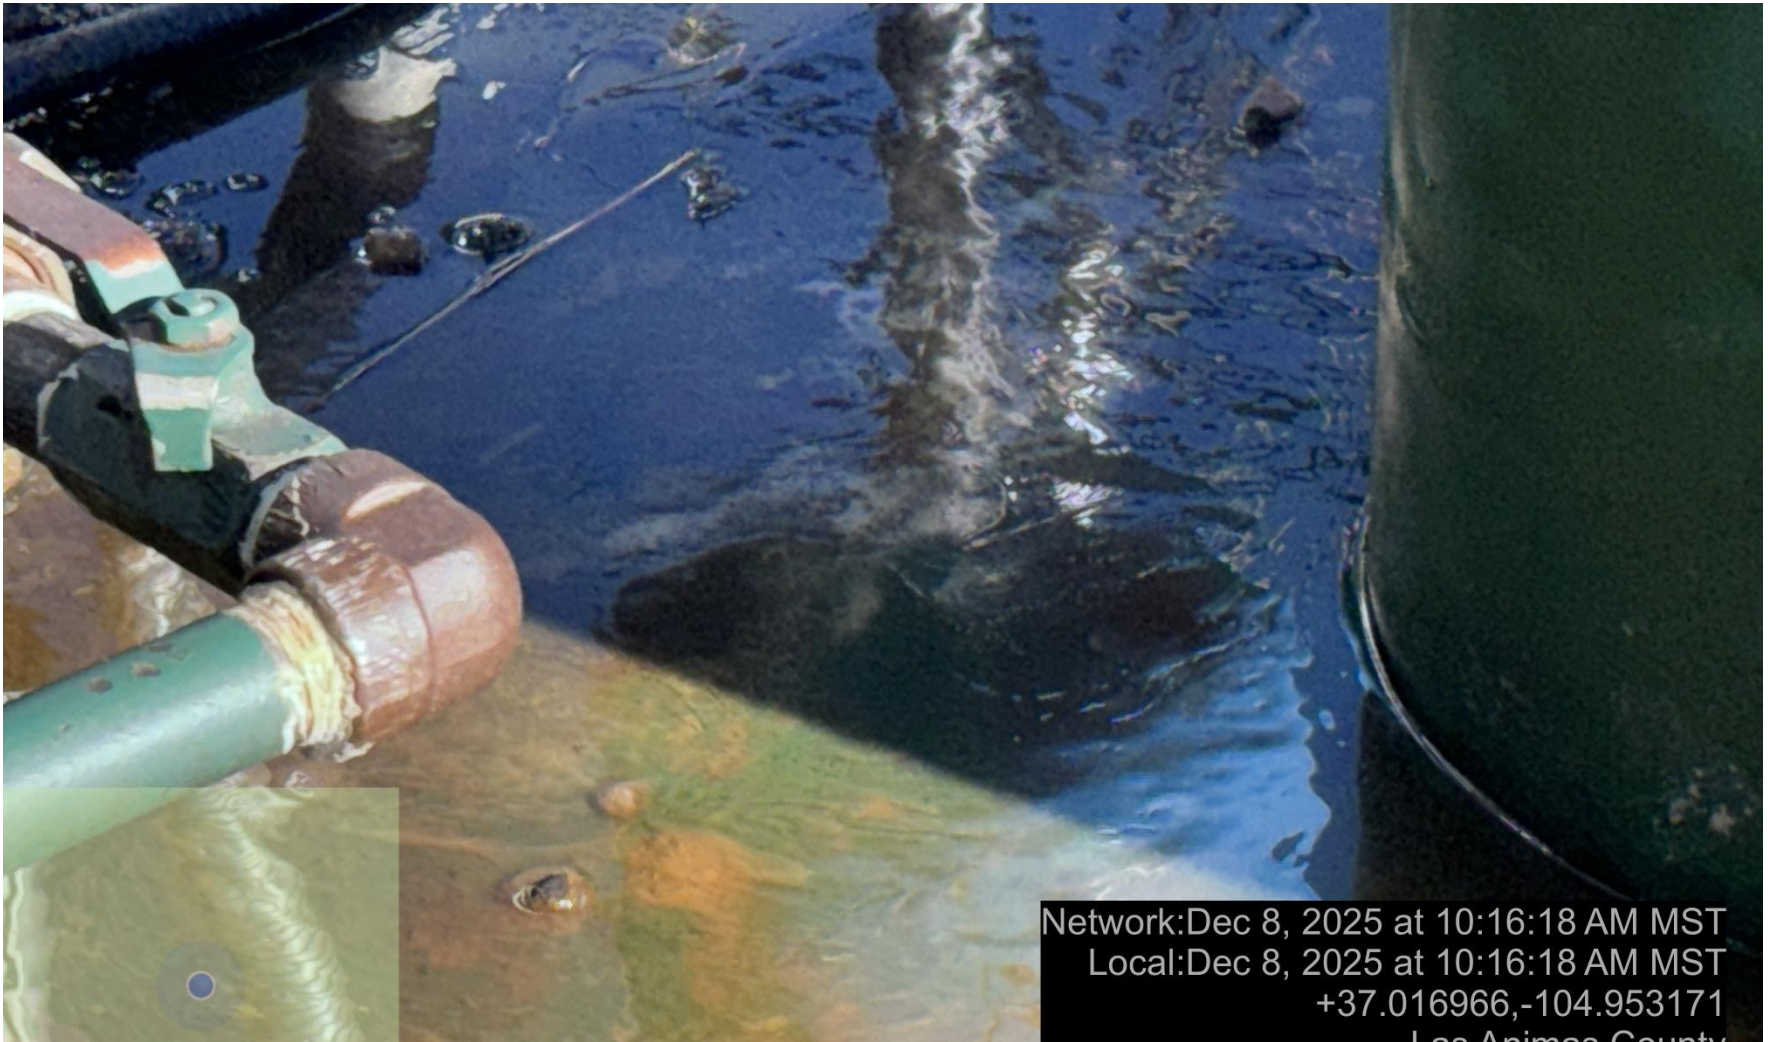
**PHOTO 6: OILY FILM IN COMPRESSOR SKID. DRAIN OILY WASTE REPAIR ALL LEAKS AND REMOVE IMPACTED SOIL PER RULE 1002..(2).D & 1002.f.(2)B, Comply with general provisions of the oil and gas act for wildlife protection AND SB-181. CA DATE 12-9-2025.**
