WELL NAME: HILL RANCH 36-13, API #: 071-08253, INSP. # 716301790

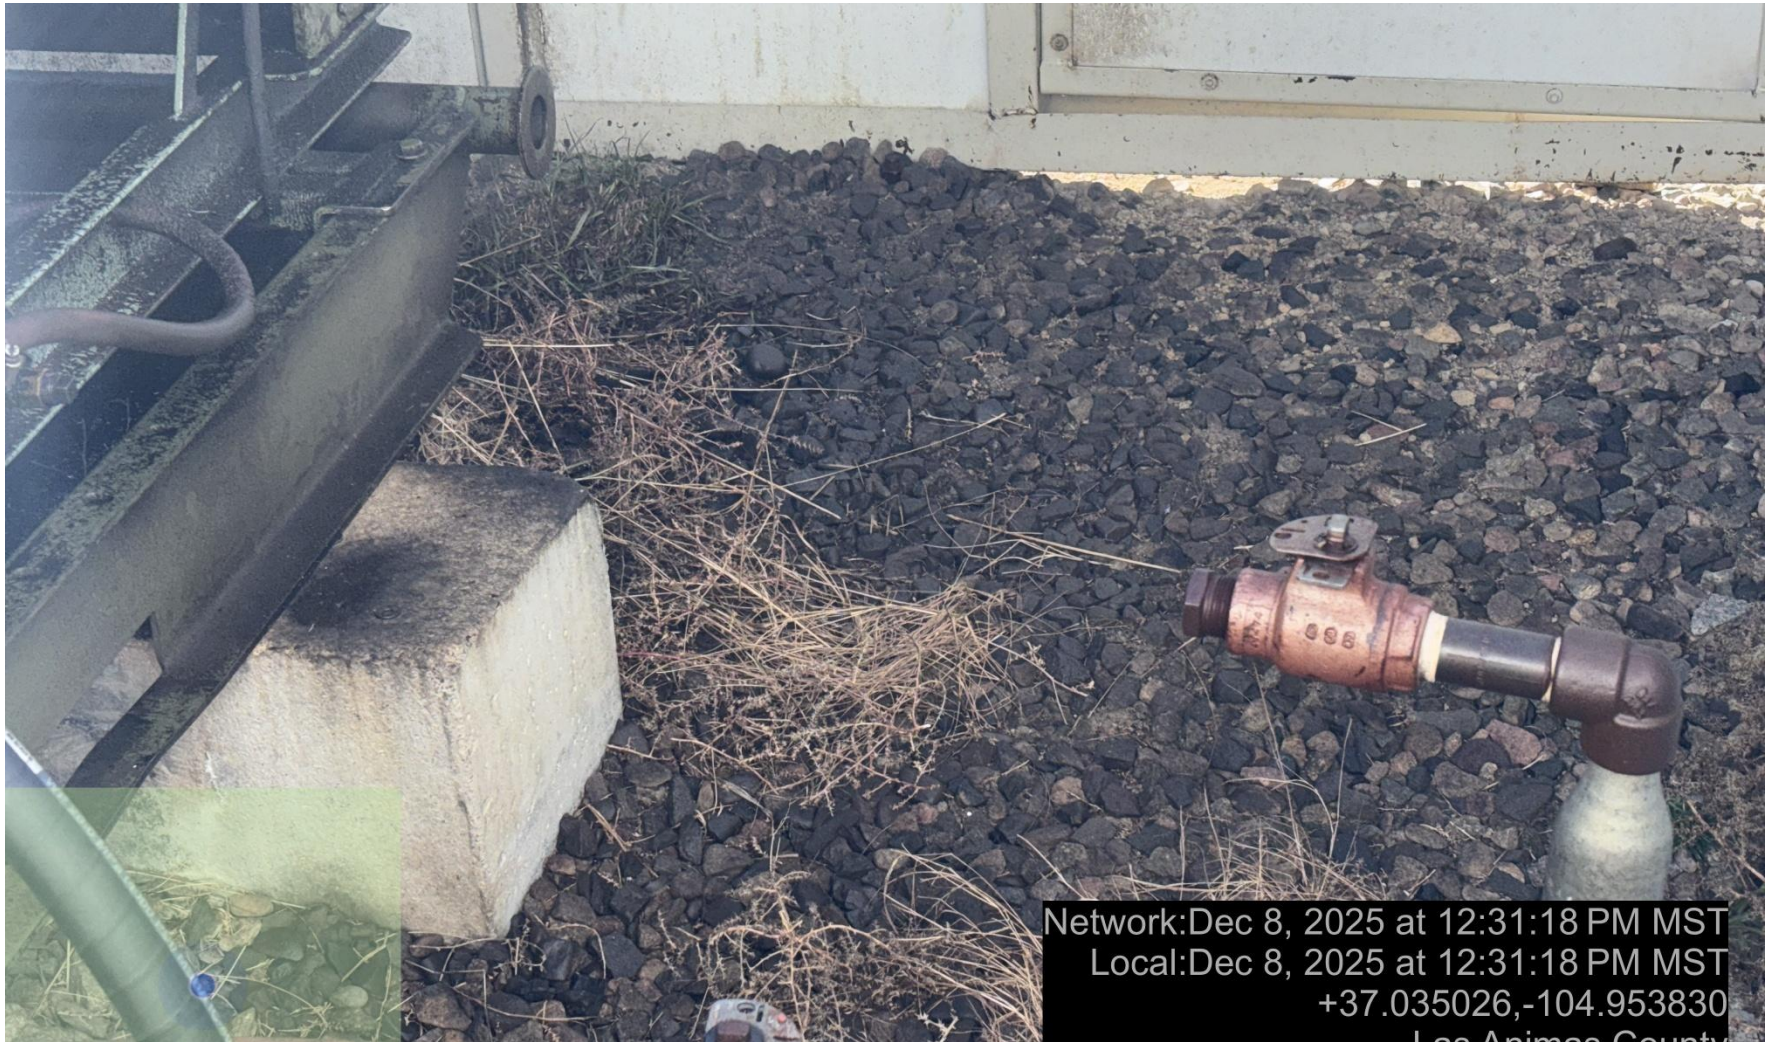
PHOTO 4: IMPACTED OIL NEAR PRIME MOVER SKID. Conduct maintenance on equipment, cleanup stained material and review self inspection processes. COMPLY WITH RULE 1002,(2).D. CA DATE 12-15-2025.

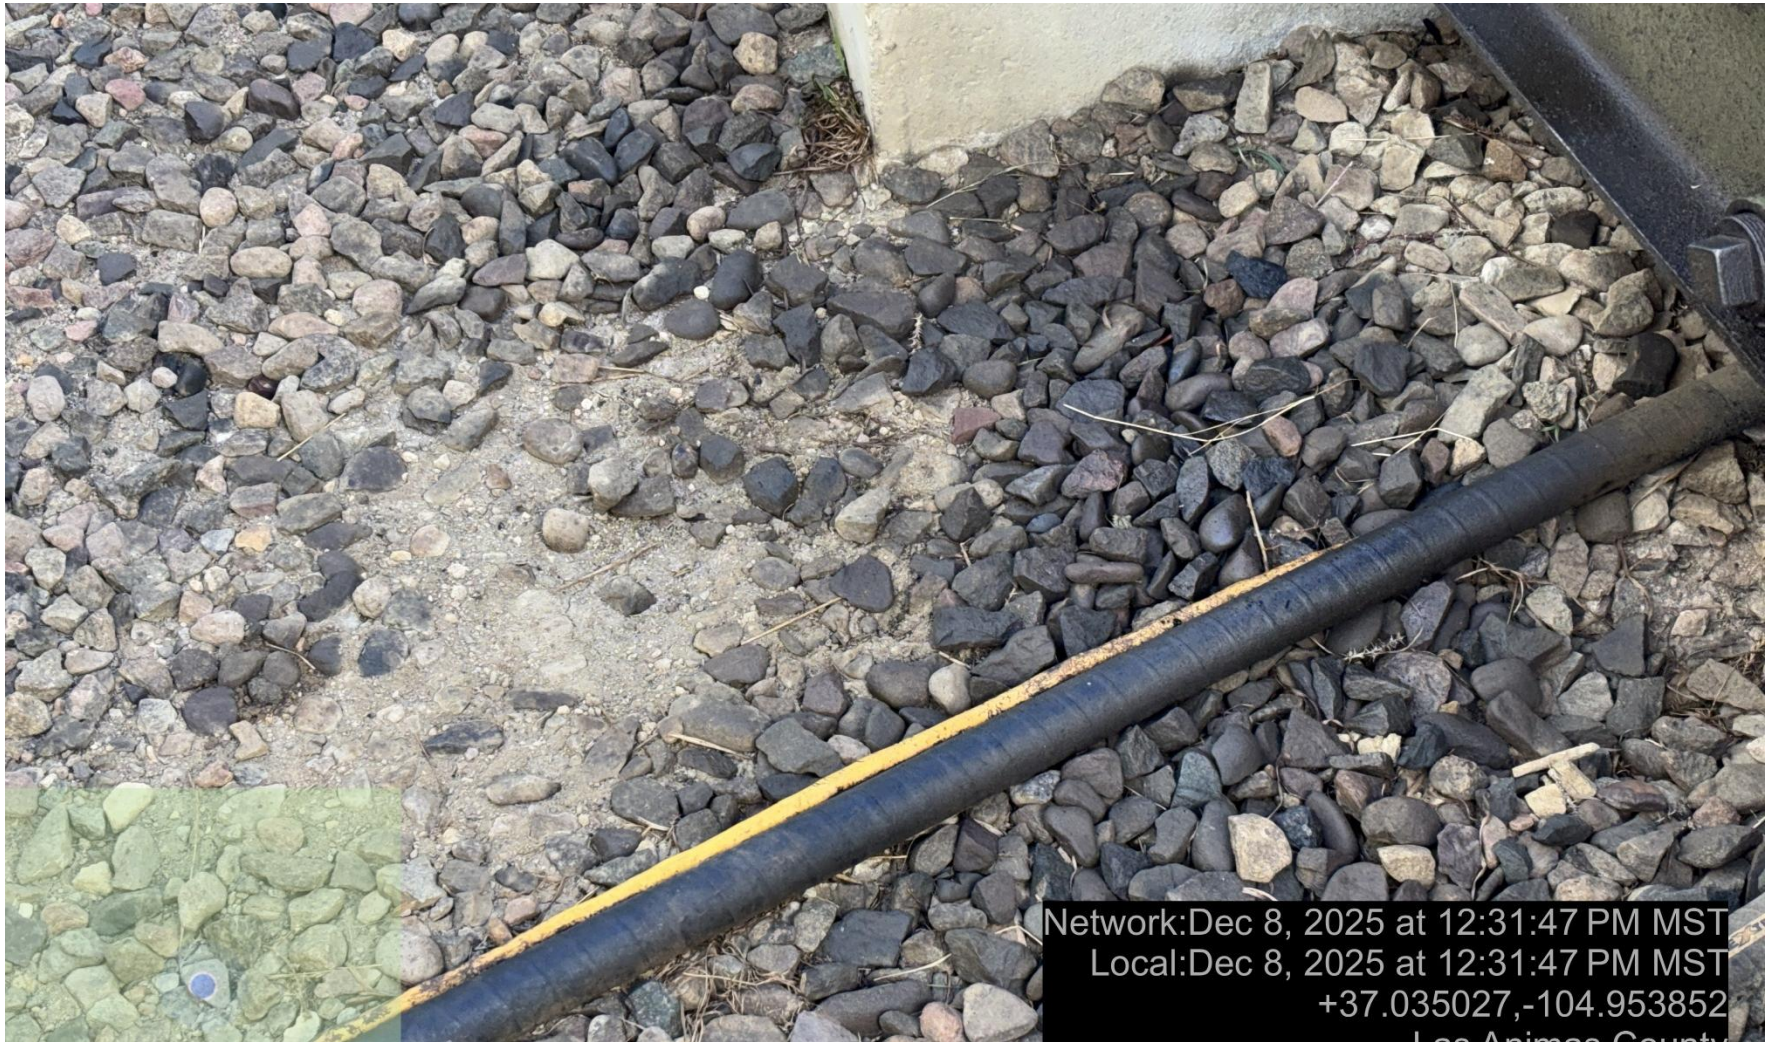
PHOTO 5: IMPACTED OIL NEAR PRIME MOVER SKID. Conduct maintenance on equipment, cleanup stained material and review self inspection processes. COMPLY WITH RULE 1002,(2).D. CA DATE 12-15-2025.

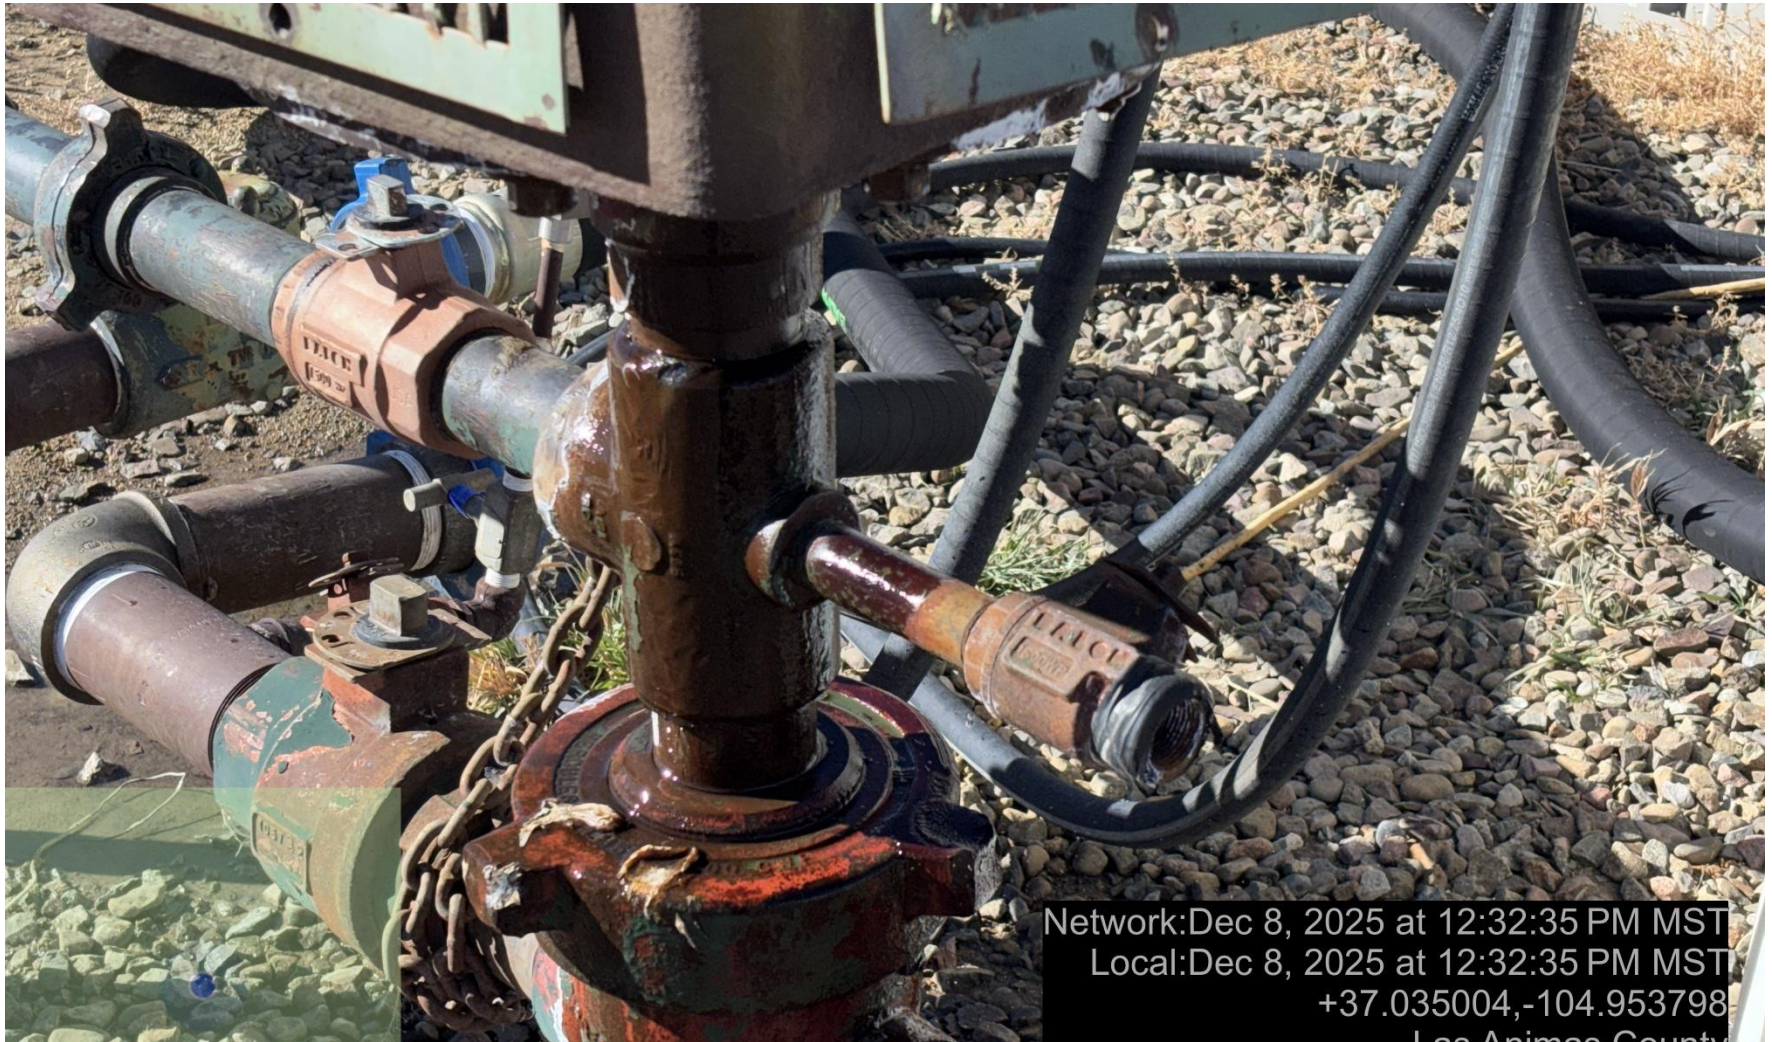
PHOTO 6: PACKING IS LEAKING ON TBG. Securely fasten all valves, pipes, fittings, and Production Facilities to ensure good mechanical condition, inspect at regular intervals and maintain in good mechanical condition. Engineer, operate, and maintain equipment within the manufacturer's recommended specifications per Rule 608.e. CA DATE 12-9-2025.

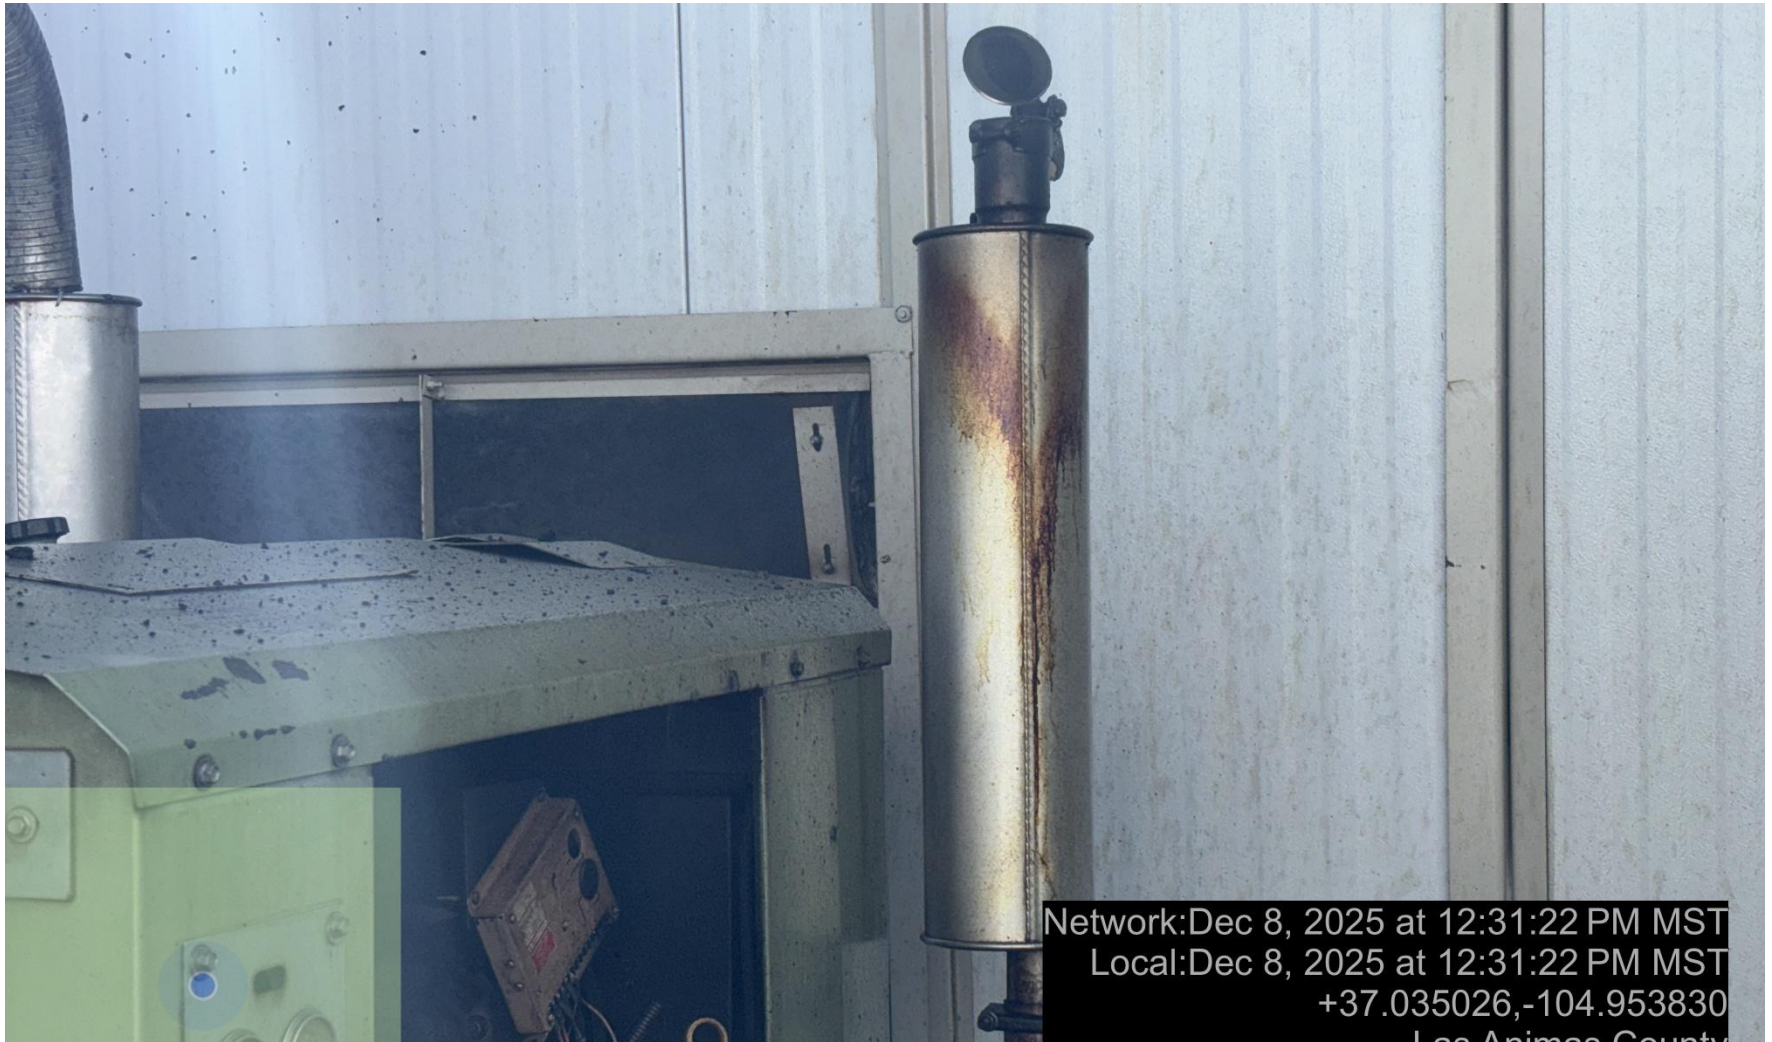
PHOTO 7: PRIME MOVER IS BLOWING OIL OUT OF EXHAUST PIPES. Securely fasten all valves, pipes, fittings, and Production Facilities to ensure good mechanical condition, inspect at regular intervals and maintain in good mechanical condition. Engineer, operate, and maintain equipment within the manufacturer's recommended specifications per Rule 608.e. CA DATE 12-9-2025.

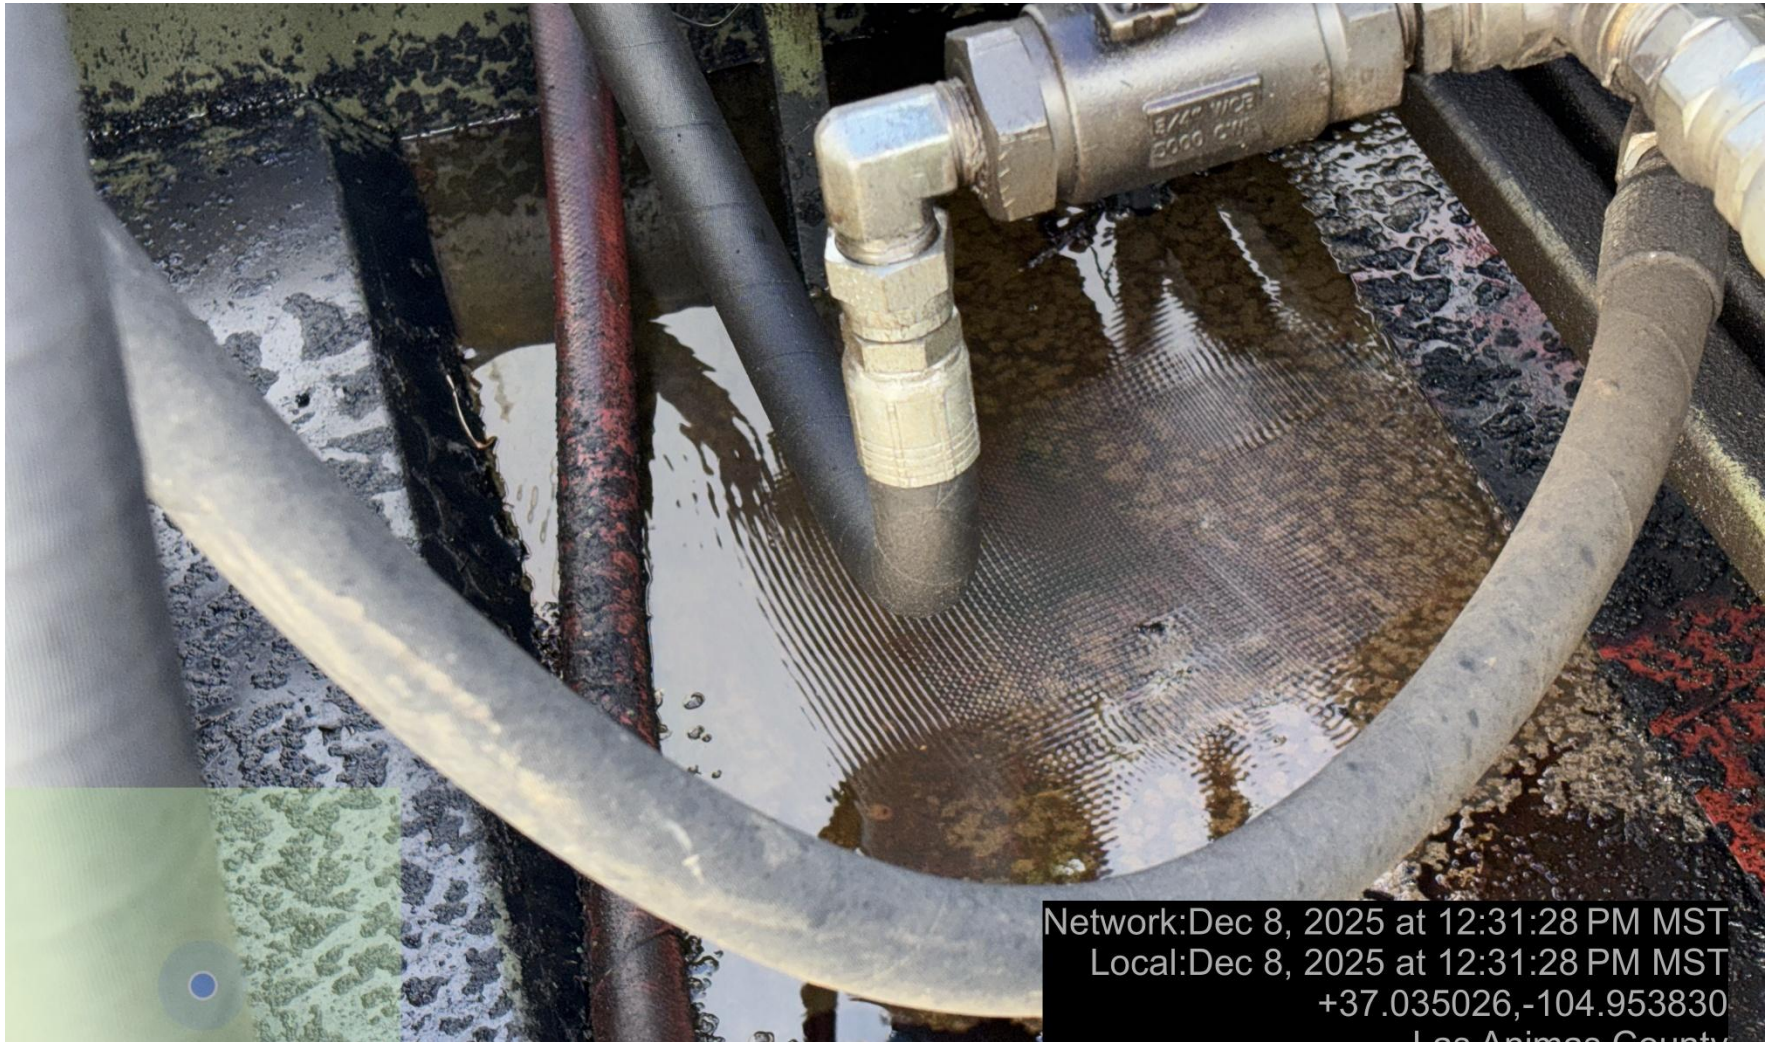
PHOTO 8: OILY WASTE IS PRIME MOVER SKID. DRAIN OILY WASTE REPAIR ALL LEAKS AND REMOVE IMPACTED SOIL PER RULE 1002.(2).D & 1002.f.(2)B, Comply with general provisions of the oil and gas act for wildlife protection AND SB-181. CA DATE 12-9-2025.
