Final Reclamation Inspection

Operator: PDC ENERGY INC - 69175

Location ID: 330632

Inspection Photos
Location Name: LATHAM #7-2
Location ID: 330632

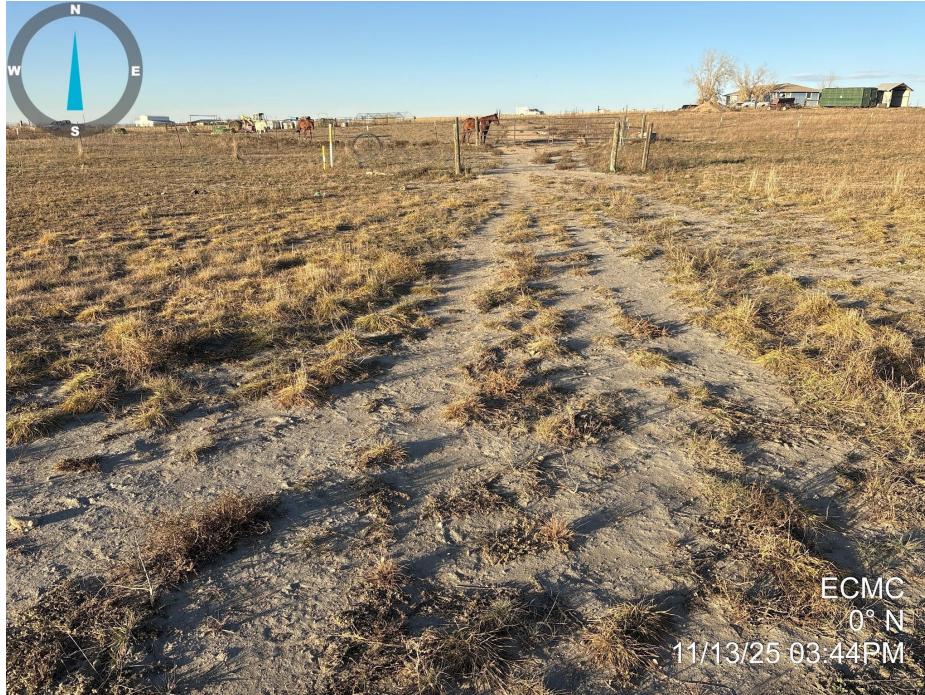
Photo 1. Photo taken of the well location, facing north. Photo illustrates that final reclamation activities have taken place, but vegetation establishment does not meet Rule 1004 standards. Bare ground and weedy annual vegetation, including kochia (*Bassia scoparia*), were observed across the location.

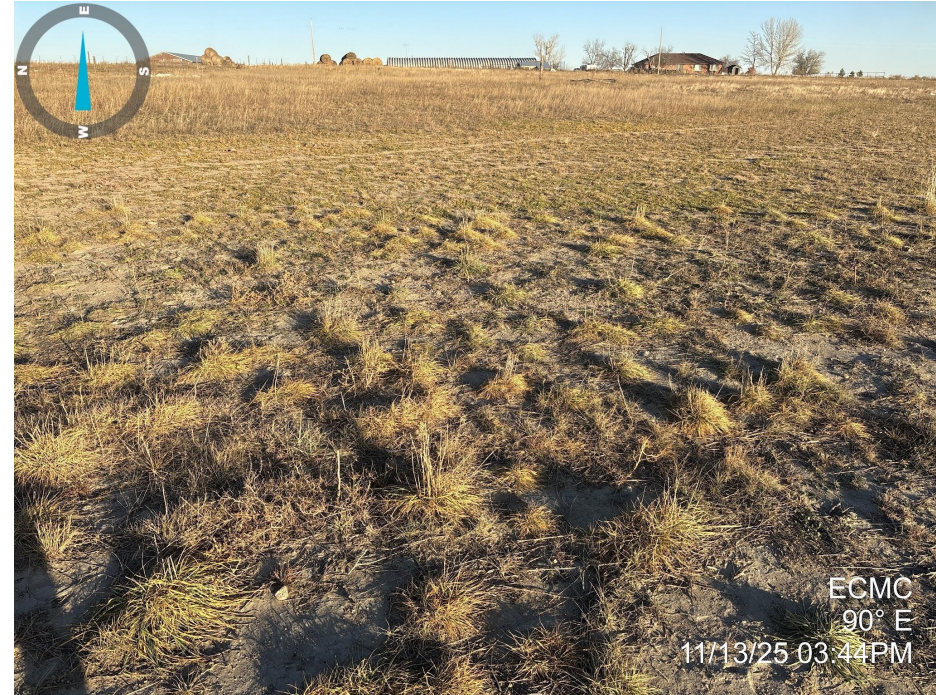
Photo 2. Photo taken of the well location, facing east. See comments under Photo 1.

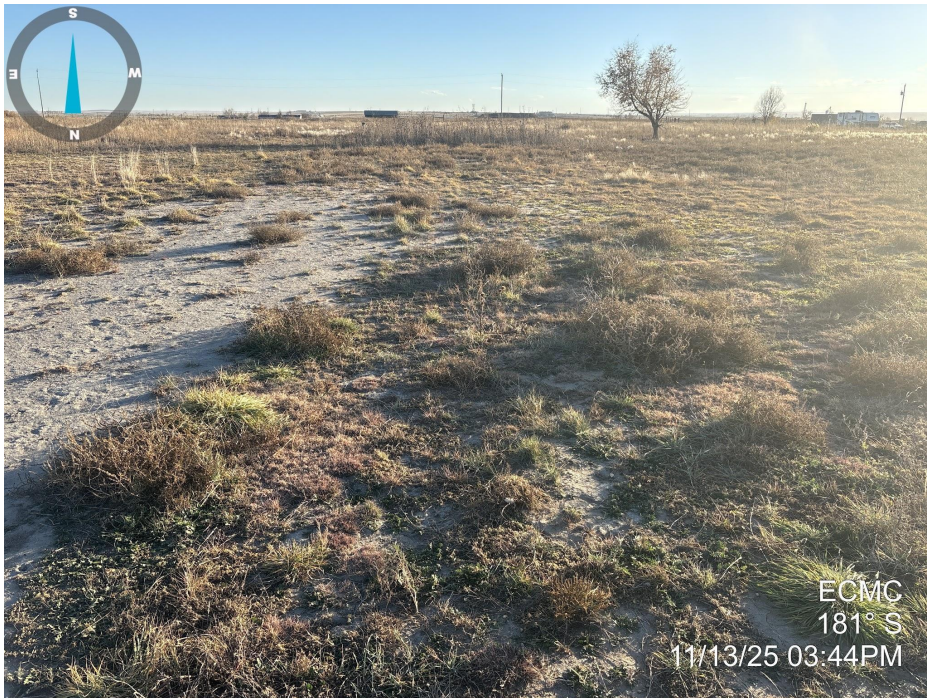
Photo 3. Photo taken of the well location, facing south. See comments under Photo 1.

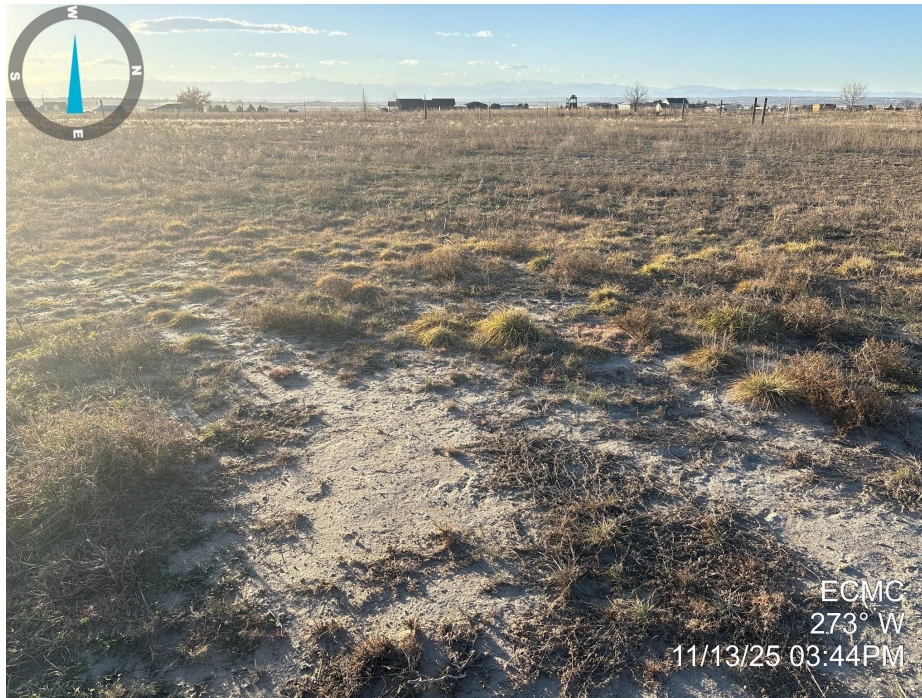
Photo 4. Photo taken of the well location, facing west. See comments under Photo 1.

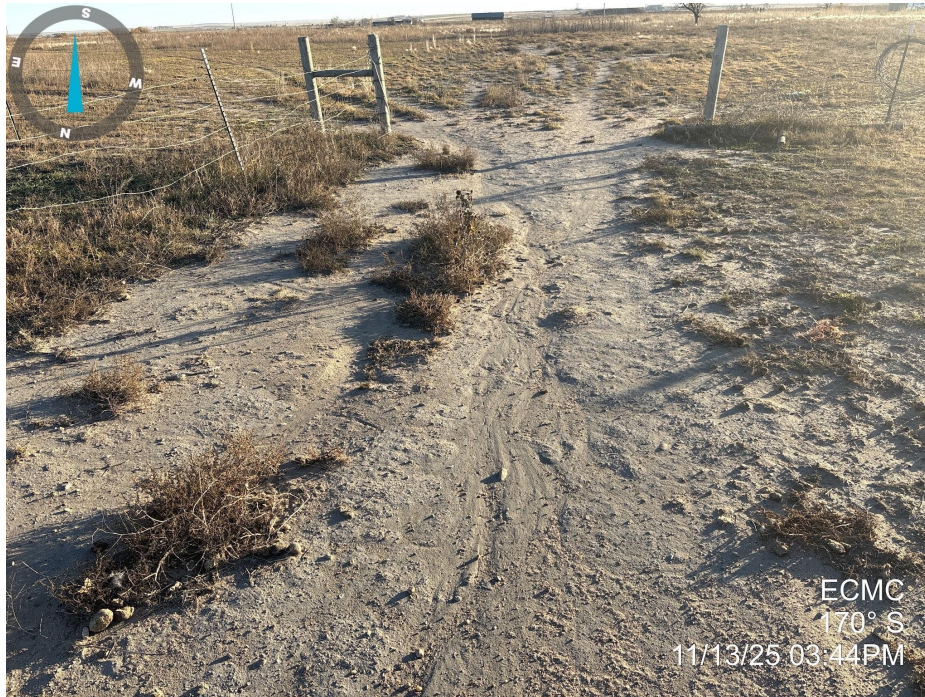
Photo 5. Photo taken of the access road to the well location, facing south, towards the location. Photo illustrates that final reclamation activities have taken place, but vegetation has not established to Rule 1004 standards.

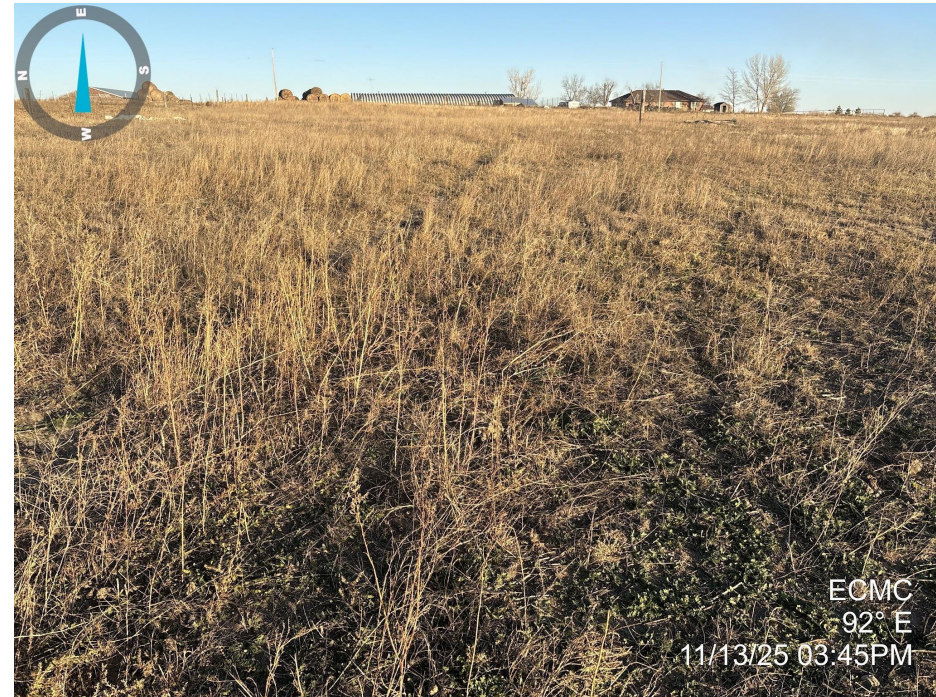
Photo 6. Photo taken of the reference area to the location, east of the location, facing east. Photo illustrates perennial grass vegetation.
