Final Reclamation Inspection

November 13, 2025

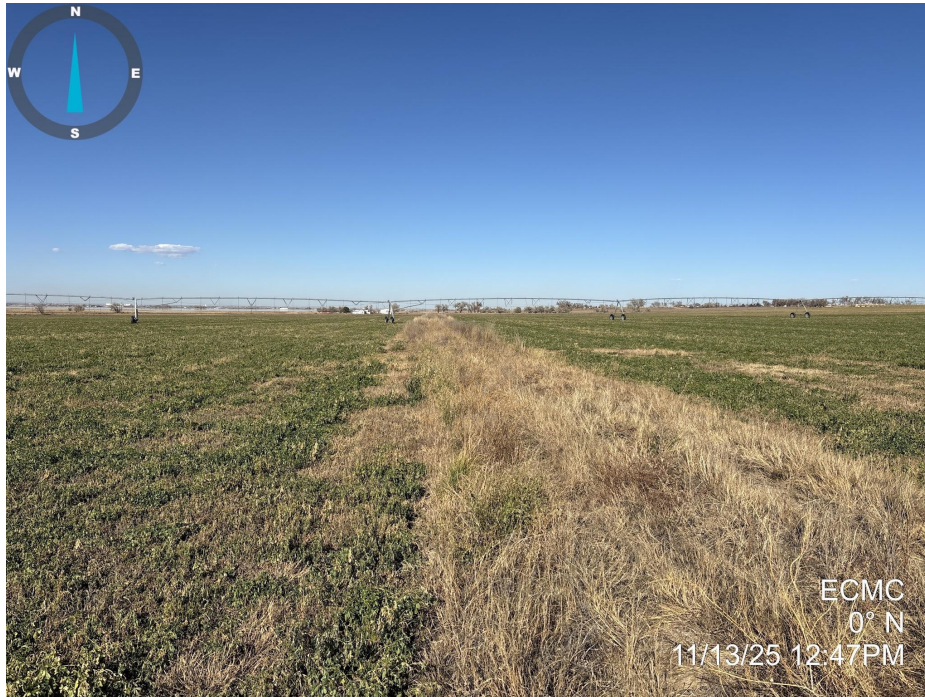
Photo 1. Photo taken of the well location, facing north. Photo illustrates that final reclamation activities have taken place, but vegetation has not established to Rule 1004 standards as weedy annual vegetation including kochia (*Bassia scoparia*) was observed at the eastern portion of the multi-well location. The access road remains in place for a TA well location.

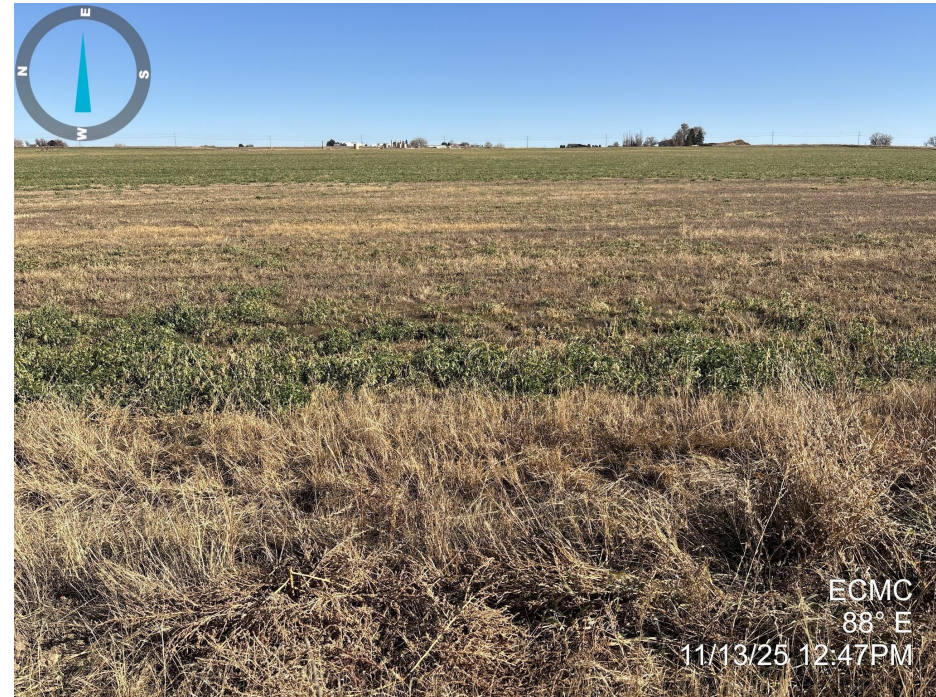
Photo 2. Photo taken of the well location, facing east. Photo illustrates that alfalfa has not established to reference area conditions at this portion of the location.

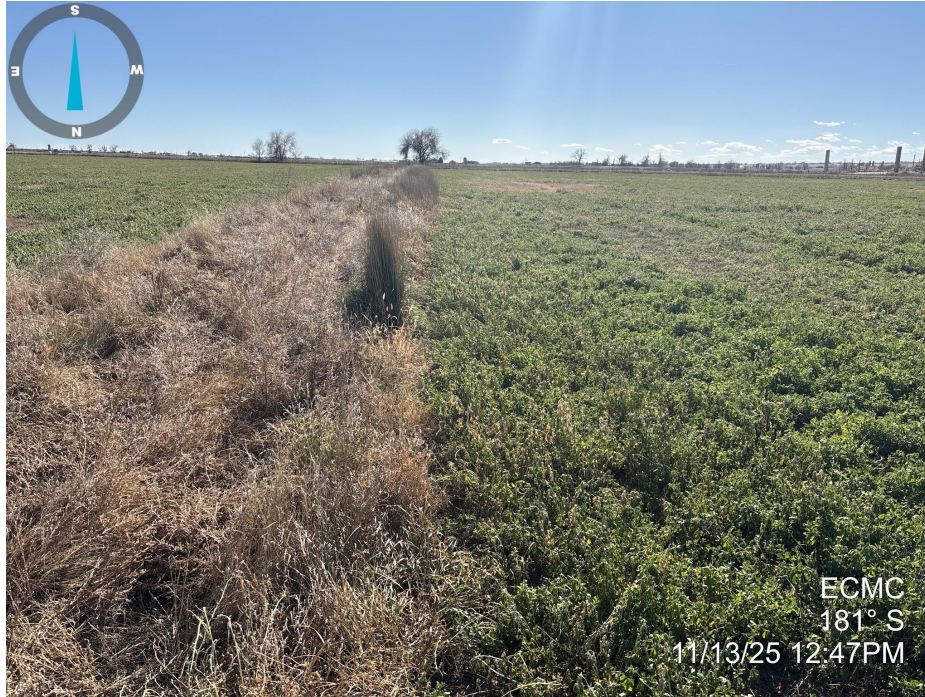
Photo 3. Photo taken of the well location, facing south. See comments under Photo 1.
