Final Reclamation Inspection

November 13, 2025

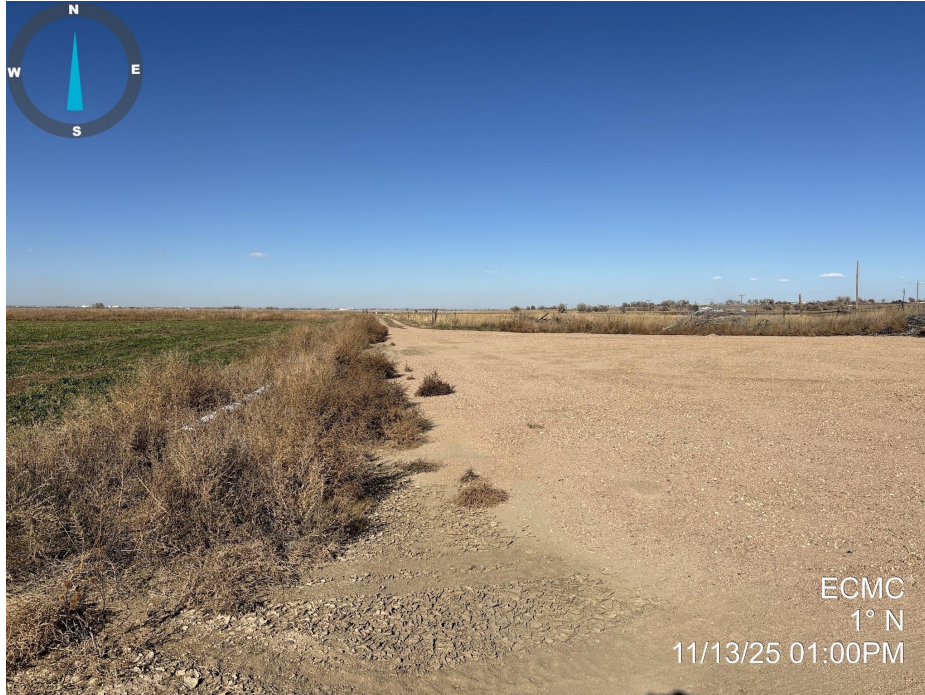
Photo 1. Photo taken of the well location, facing north. Photo illustrates that final reclamation does not meet Rule 1004 standards at the well location. Bare ground and weedy annual vegetation, including kochia (*Bassia scoparia*), were observed at the location.

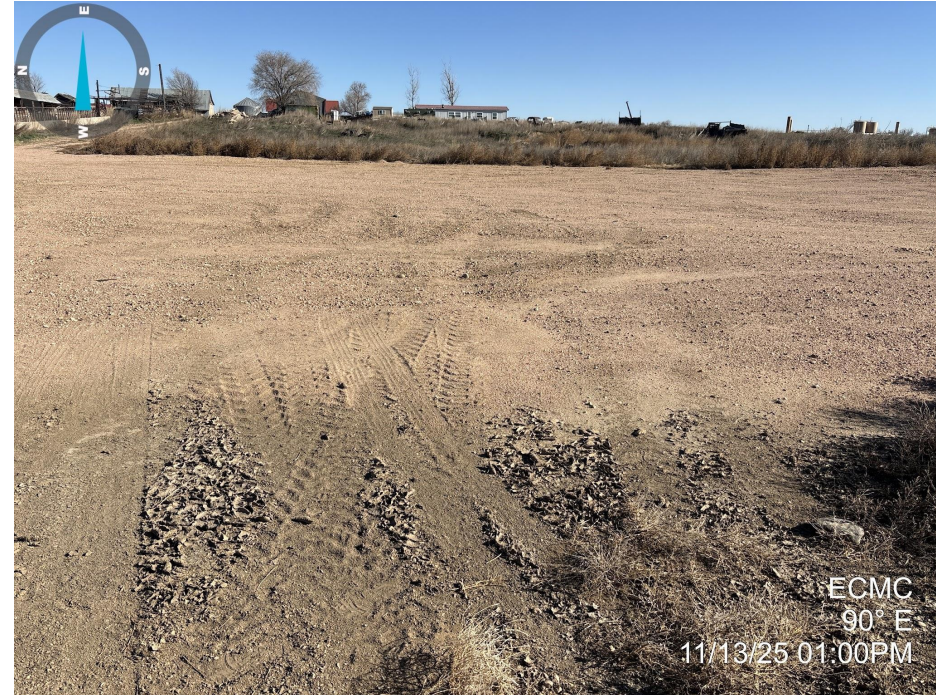
Photo 2. Photo taken of the well location, facing east. See comments under Photo 1.
