Final Reclamation Inspection

Operator: NOBLE ENERGY INC - 100322

Location ID: 317689

Inspection Photos
Location Name: STATE #4
Location ID: 317689

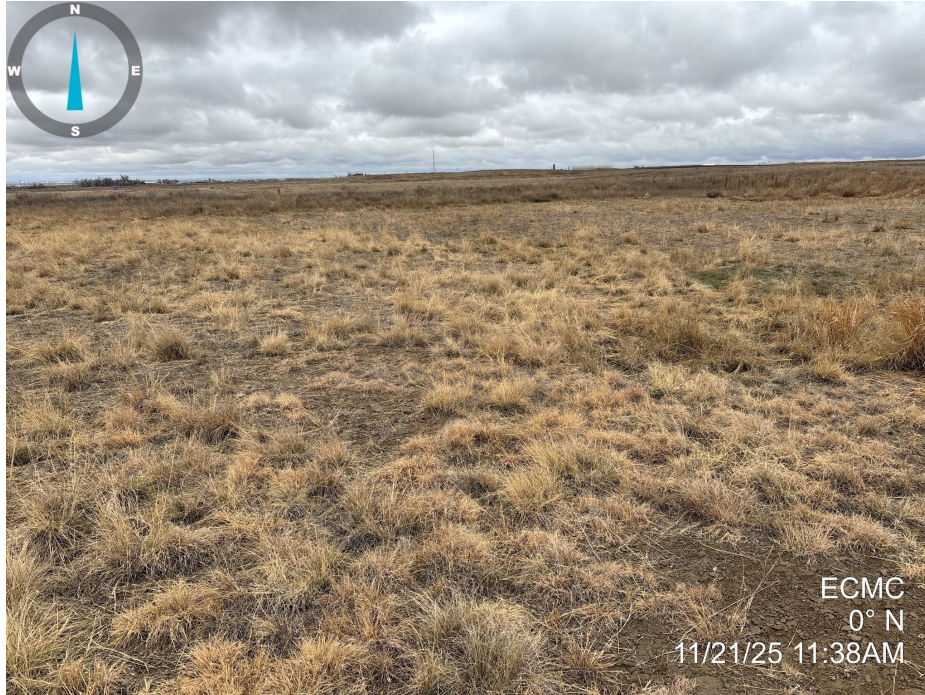
Photo 1. Photo taken of the well location, facing north. Photo illustrates that final reclamation activities have taken place, but vegetation establishment does not meet Rule 1004 standards as weedy annual vegetation was observed across the location, including cheatgrass (*Bromus tectorum*).

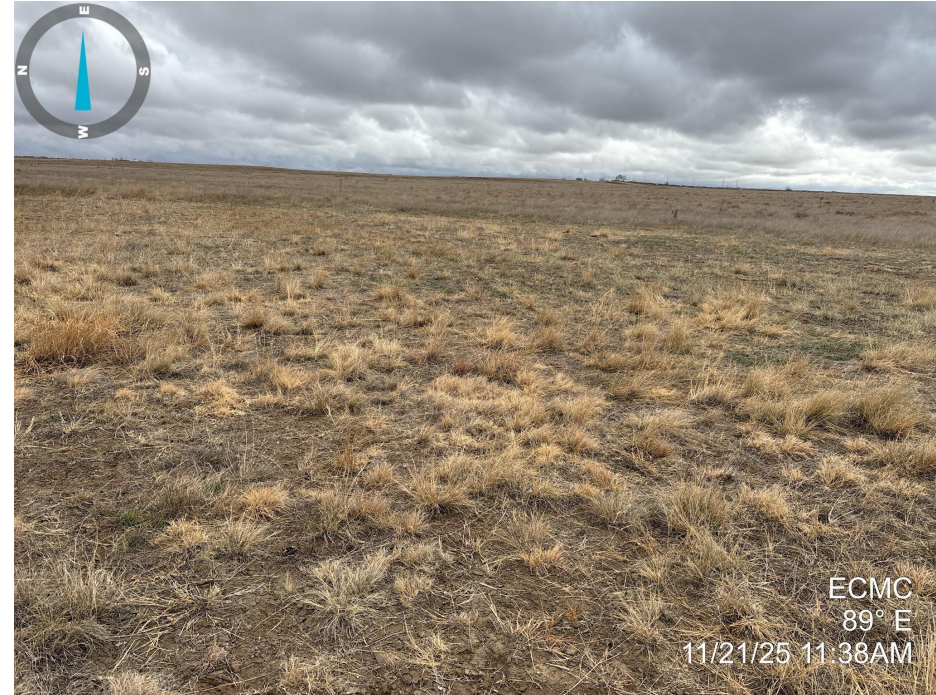
Photo 2. Photo taken of the well location, facing east. See comments under Photo 1.

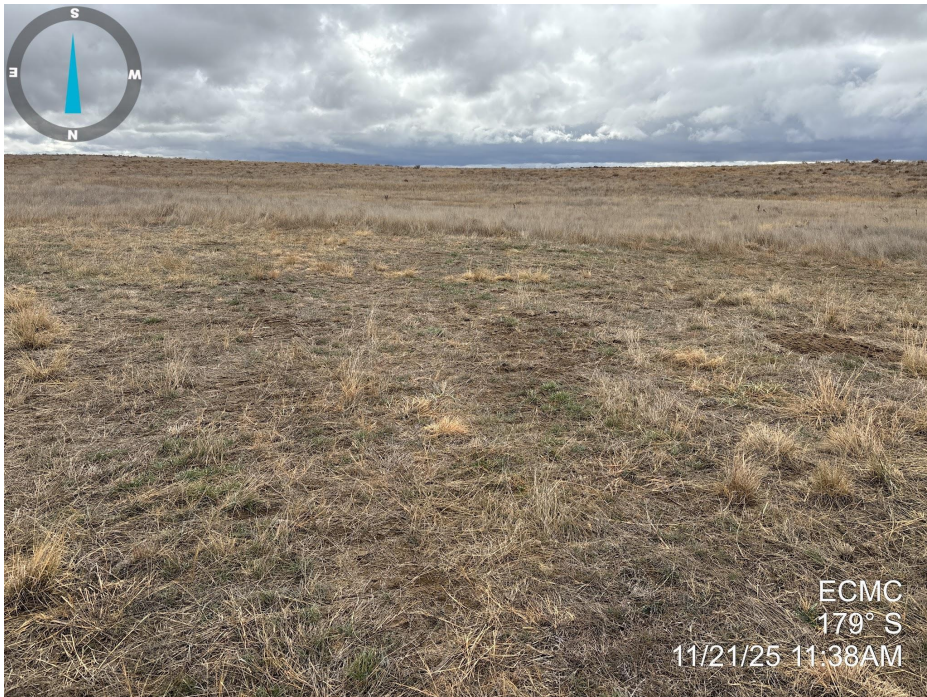
Photo 3. Photo taken of the well location, facing south. See comments under Photo 1.

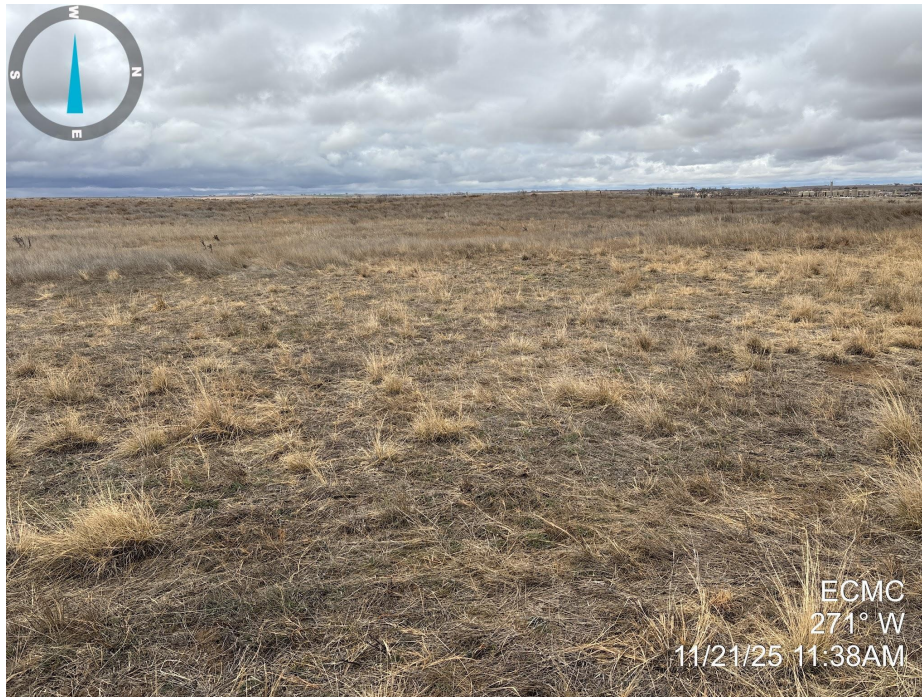
Photo 4. Photo taken of the well location, facing west. See comments under Photo 1.

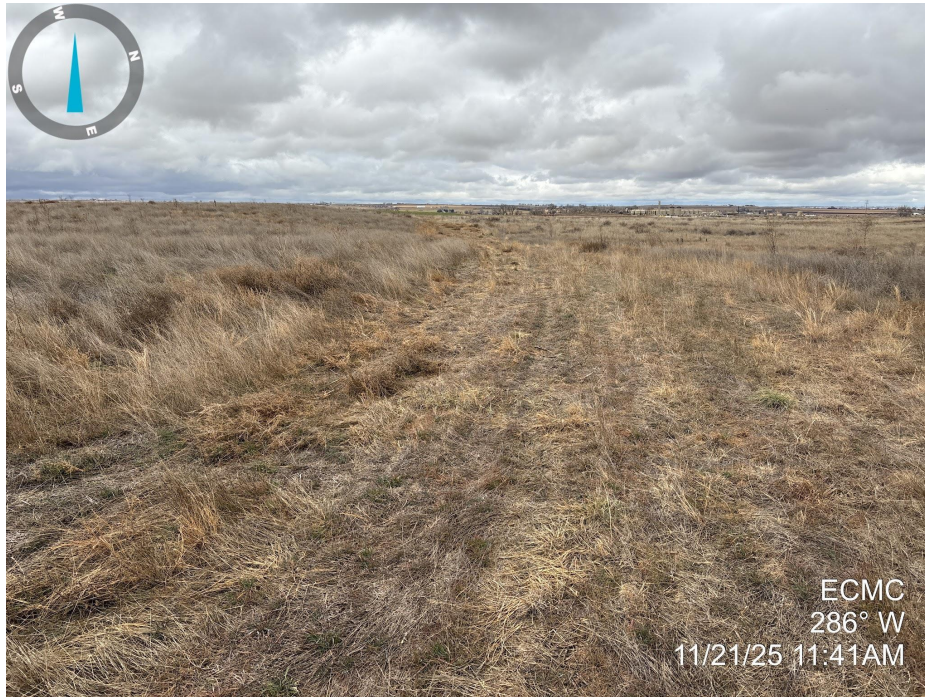
Photo 5. Photo taken of the access road to the location, facing south. Photo illustrates that final reclamation activities have taken place, but vegetation establishment does not meet Rule 1004 standards and weedy annual vegetation including cheatgrass (*Bromus tectorum*), a List C Noxious Weed species, was observed along the road.

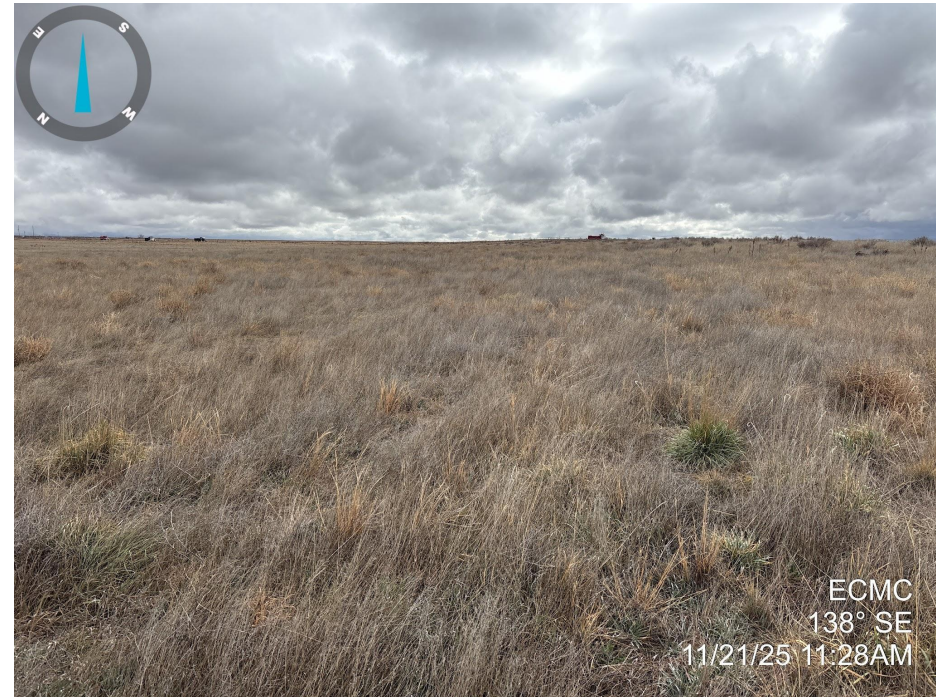
Photo 6. Photo taken of the reference area to the location, east of the location, facing southeast. Photo illustrates perennial grass and weedy annual vegetation.
