Inspection Photos

Operator: TEP Rocky Mountain LLC #96850

Location ID: 417777

Inspection Doc: 719200529

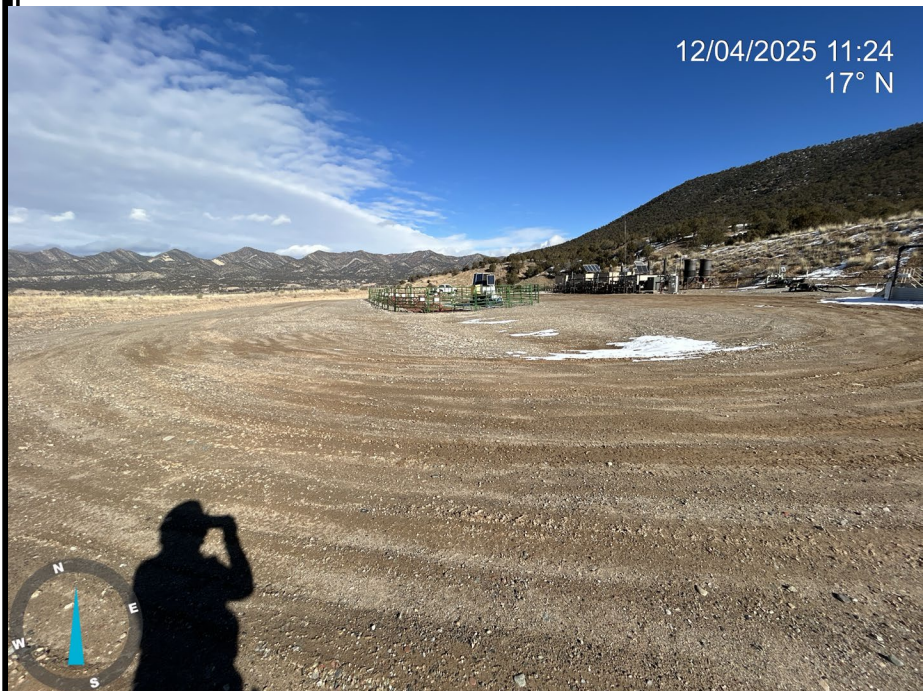
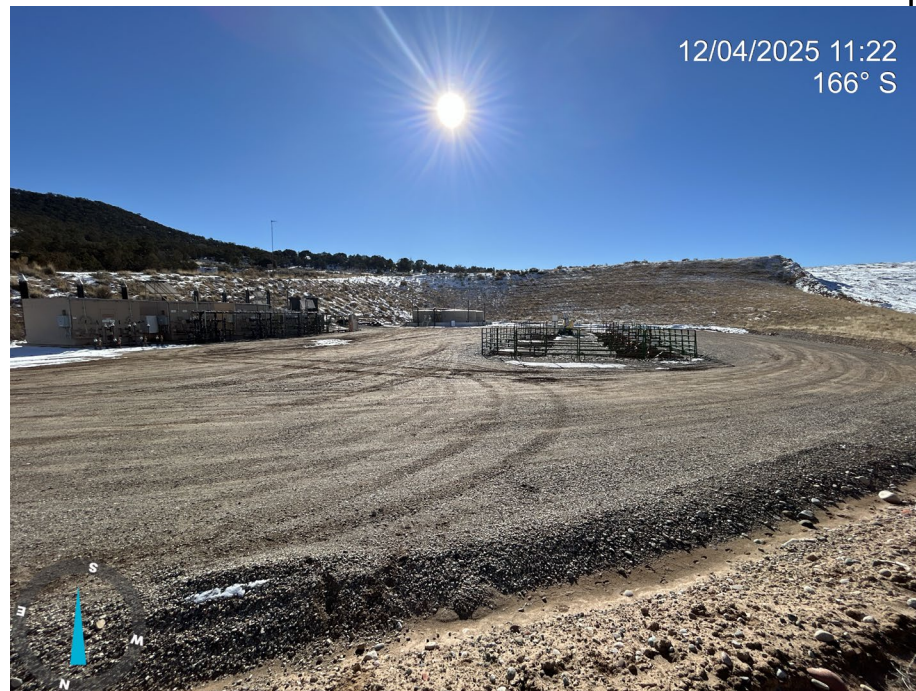
Photo 1: Photos showing an overview of the location looking north and south, respectively.

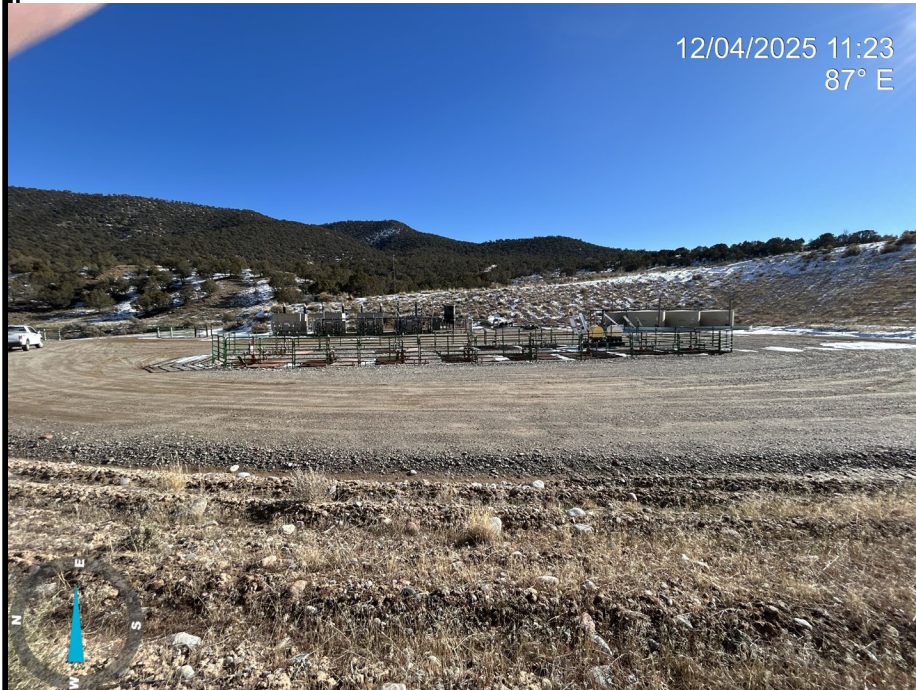
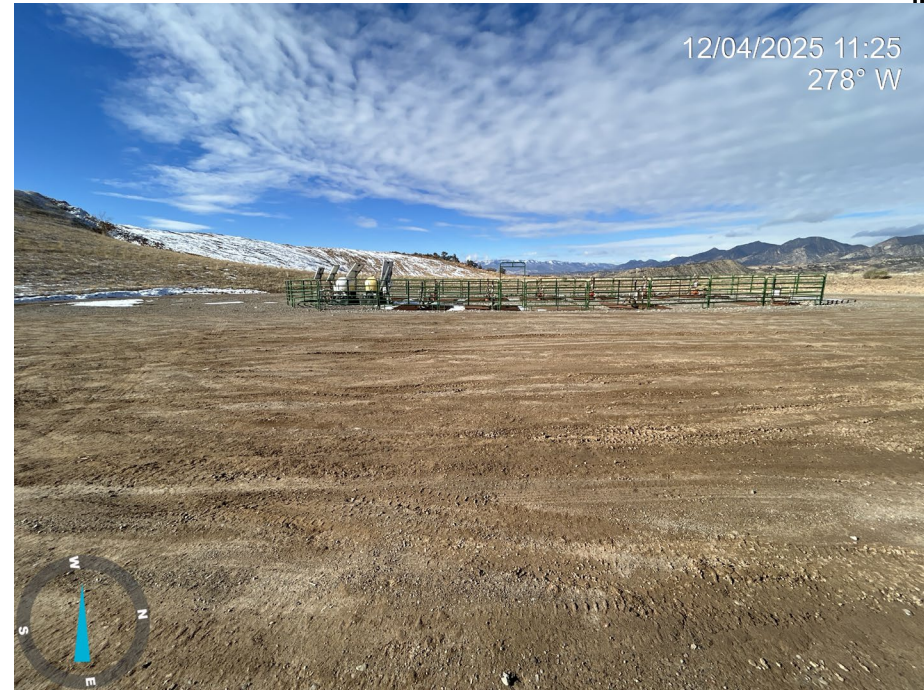
Photo 2: Photos showing an overview of the location looking north and south, respectively.

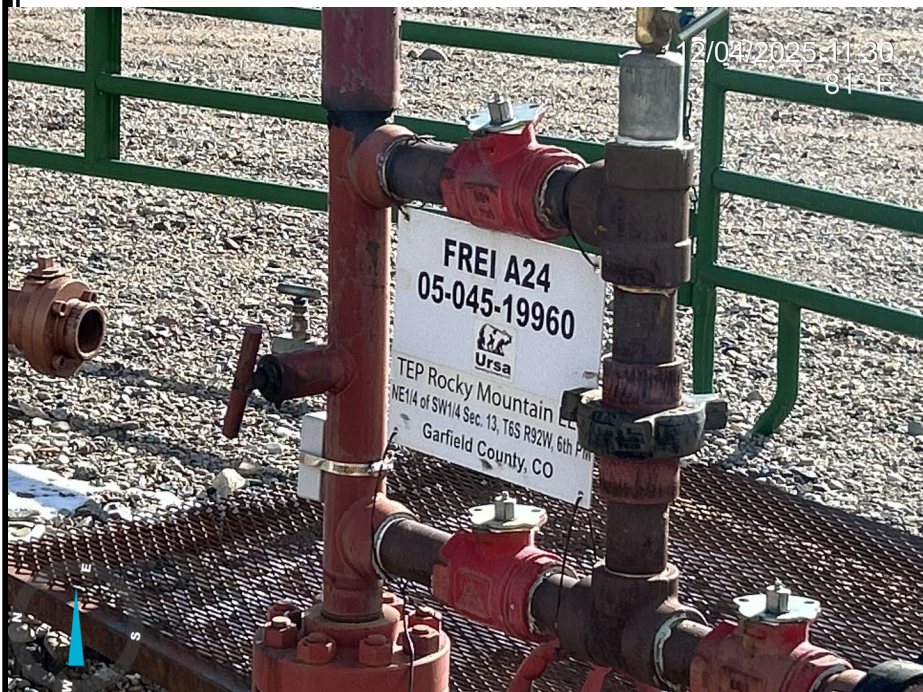
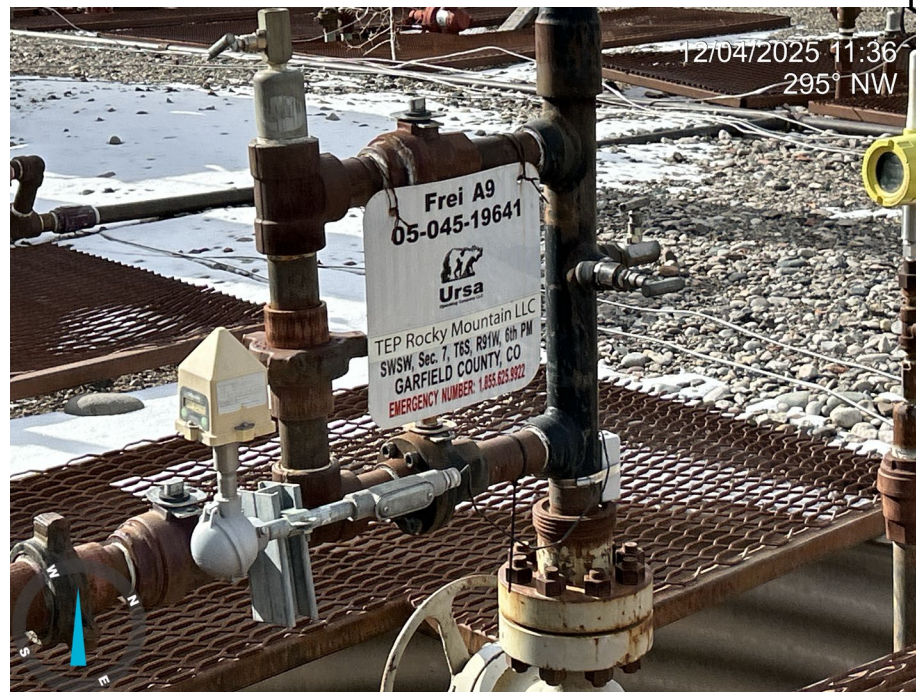
Photo 3: Photos showing an example of wellhead signage at the location with incorrect or unclear Operator information; comply with Rule 605.d.

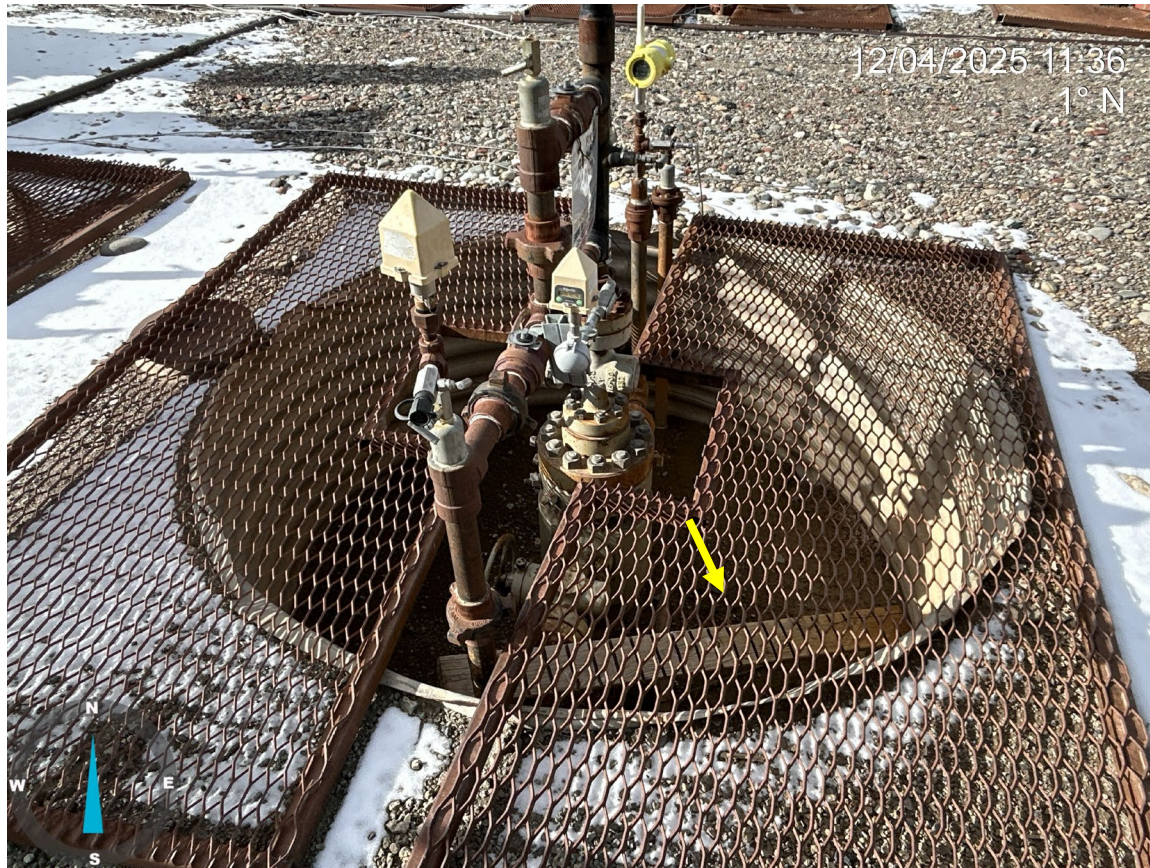
Photo 4: Photos showing a wellhead at the location with insufficient wildlife egress; the bunny board has fallen into the well cellar. Comply with Rule 902.b. and maintain wildlife protection BMPs.

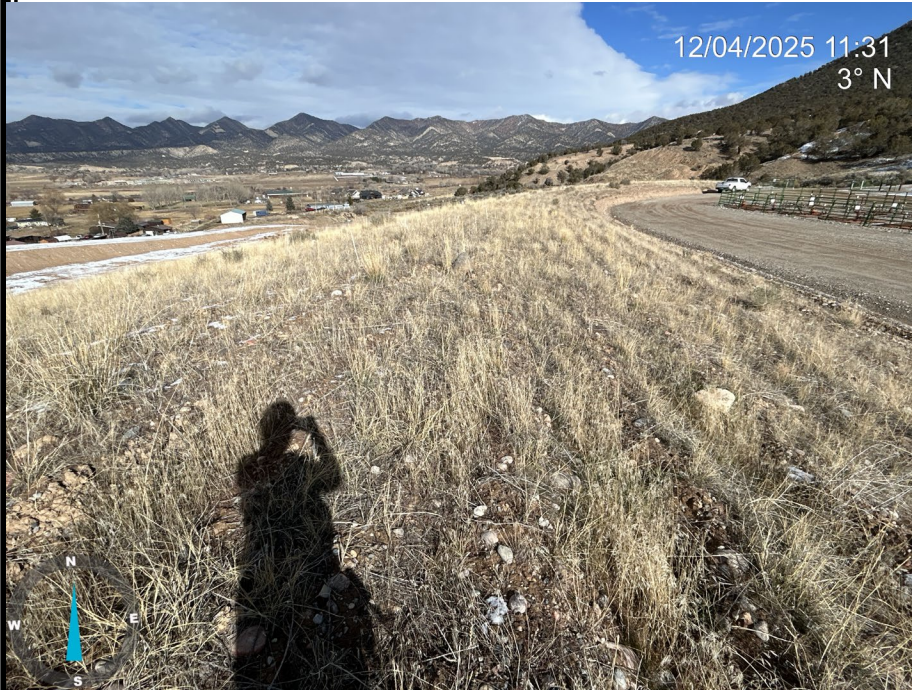
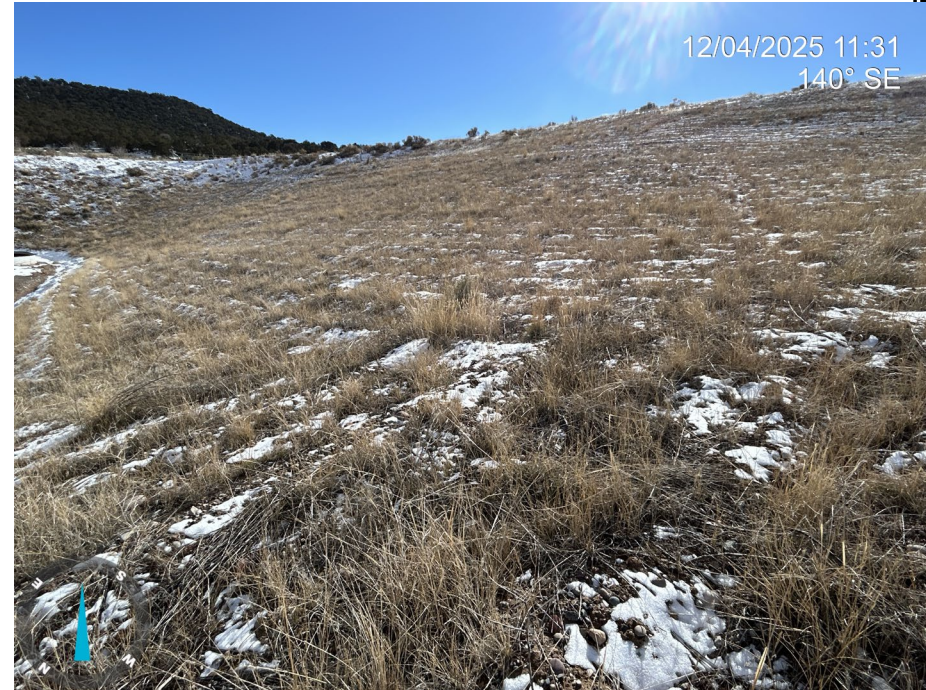
Photo 5: Photos showing an example of the western and southern interim areas, respectively. Interim areas are progressing towards 1003 requirements; weed control will likely be required in 2026.
