Inspection Photos

API: 009-06134

Operator: SAMSON OIL COMPANY

Inspection Date: 12/8/2025

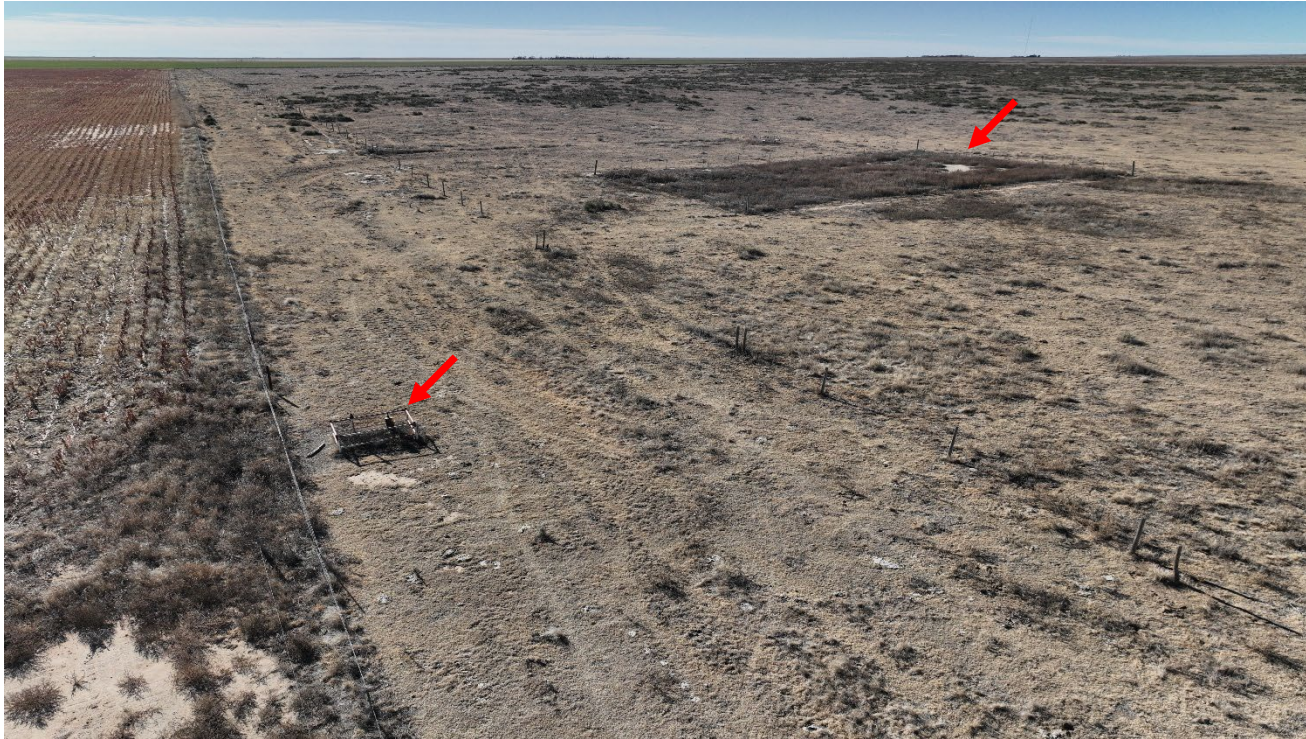
Photo 1. Drone aerial photo facing southwest. Red arrows points to the gathering risers and the former wellsite location.

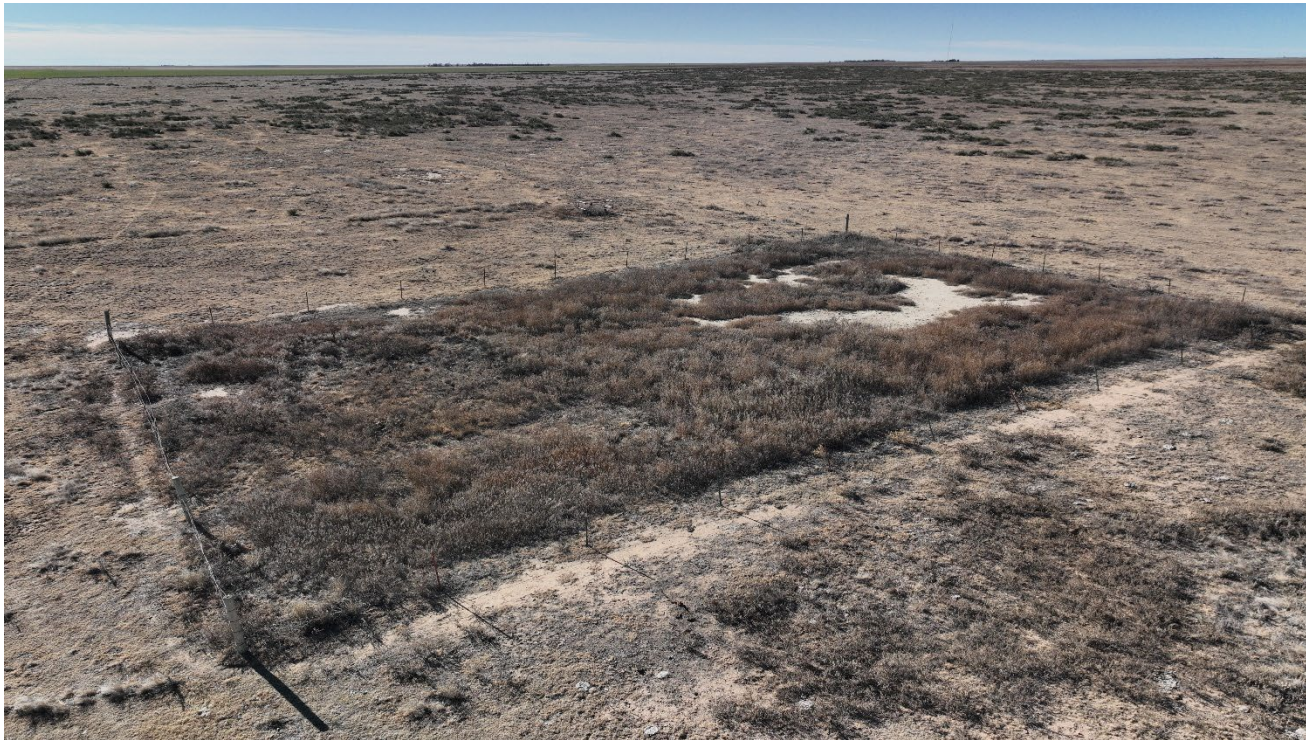
Photo 2. Drone aerial photo facing southwest toward the former wellsite location. The location is fenced but desirable vegetation has not established. The dark vegetation inside the fence is mostly undesirable weeds (Kochia?)

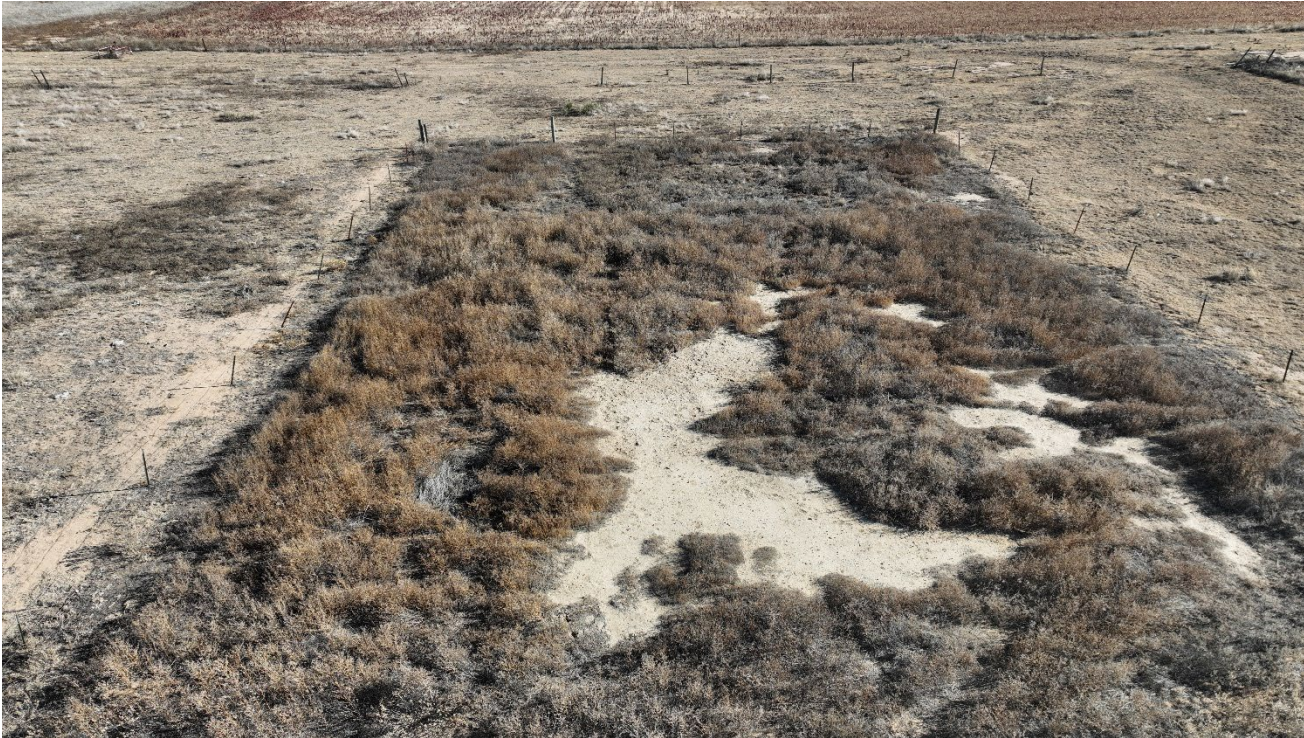
Photo 3. Drone aerial photo facing east at the former wellsite. The area is bare of vegetation and appears to be impacted from an historical spill from wellsite operations.

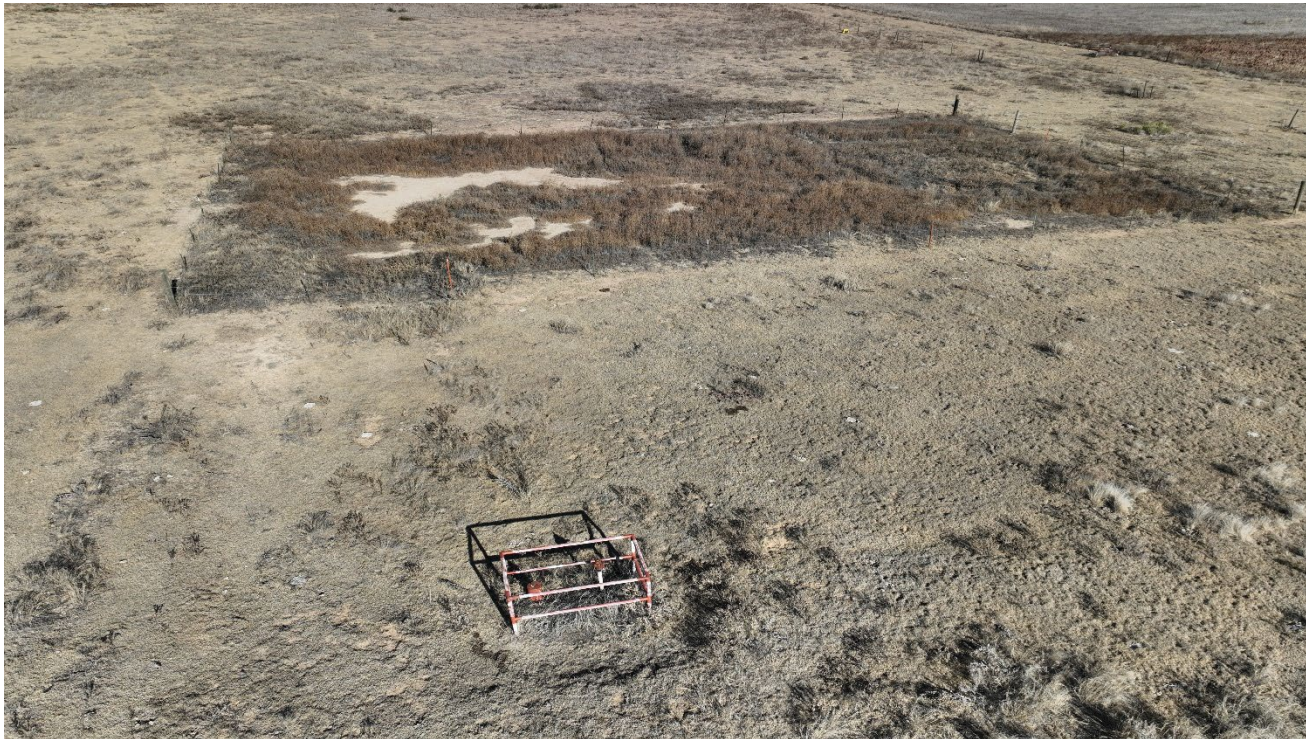
Photo 4. Drone aerial photo facing northeast at the former wellsite. Red arrow points to abandoned pipe risers that remain at the location.
