# Inspection Photos

**Operator:** TEP Rocky Mountain LLC #96850

**Location ID:** 420223

**Inspection Doc:** 719200535

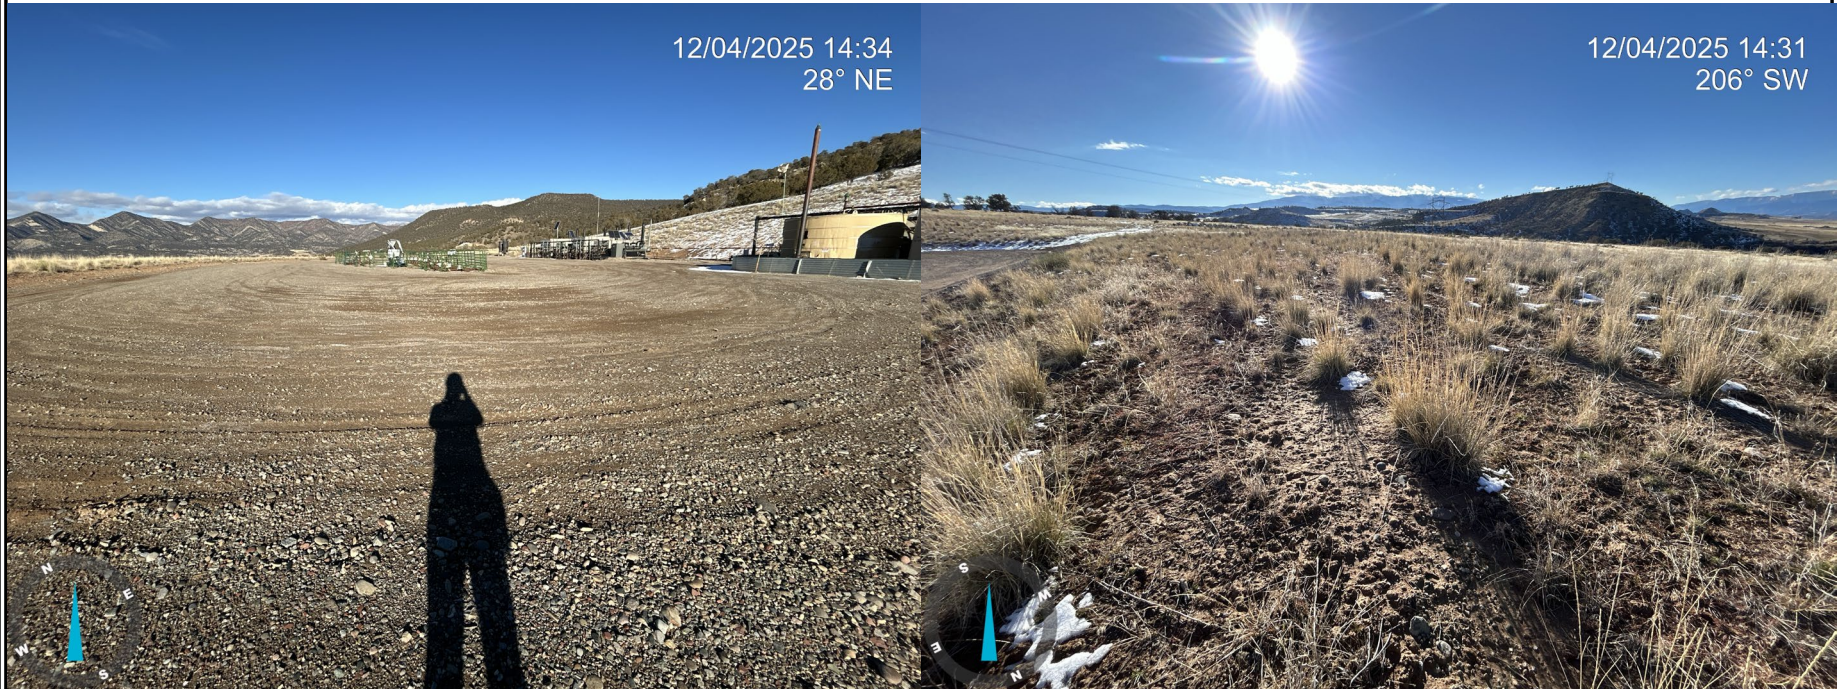
**Photo 1:** Photos showing an overview of the location looking northeast and southwest, respectively.

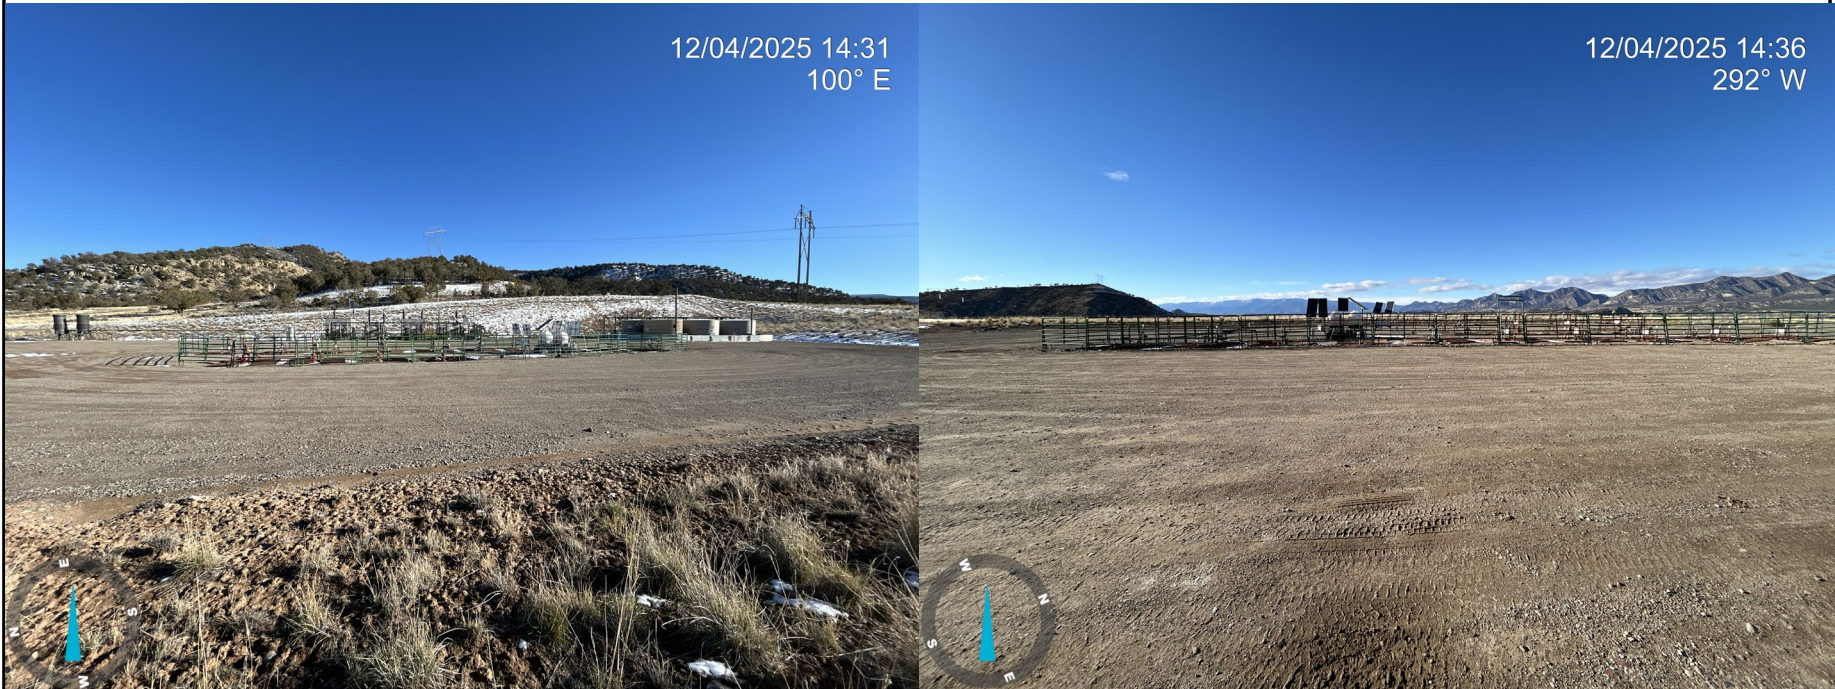
**Photo 2:** Photos showing an overview of the location looking east and west, respectively.

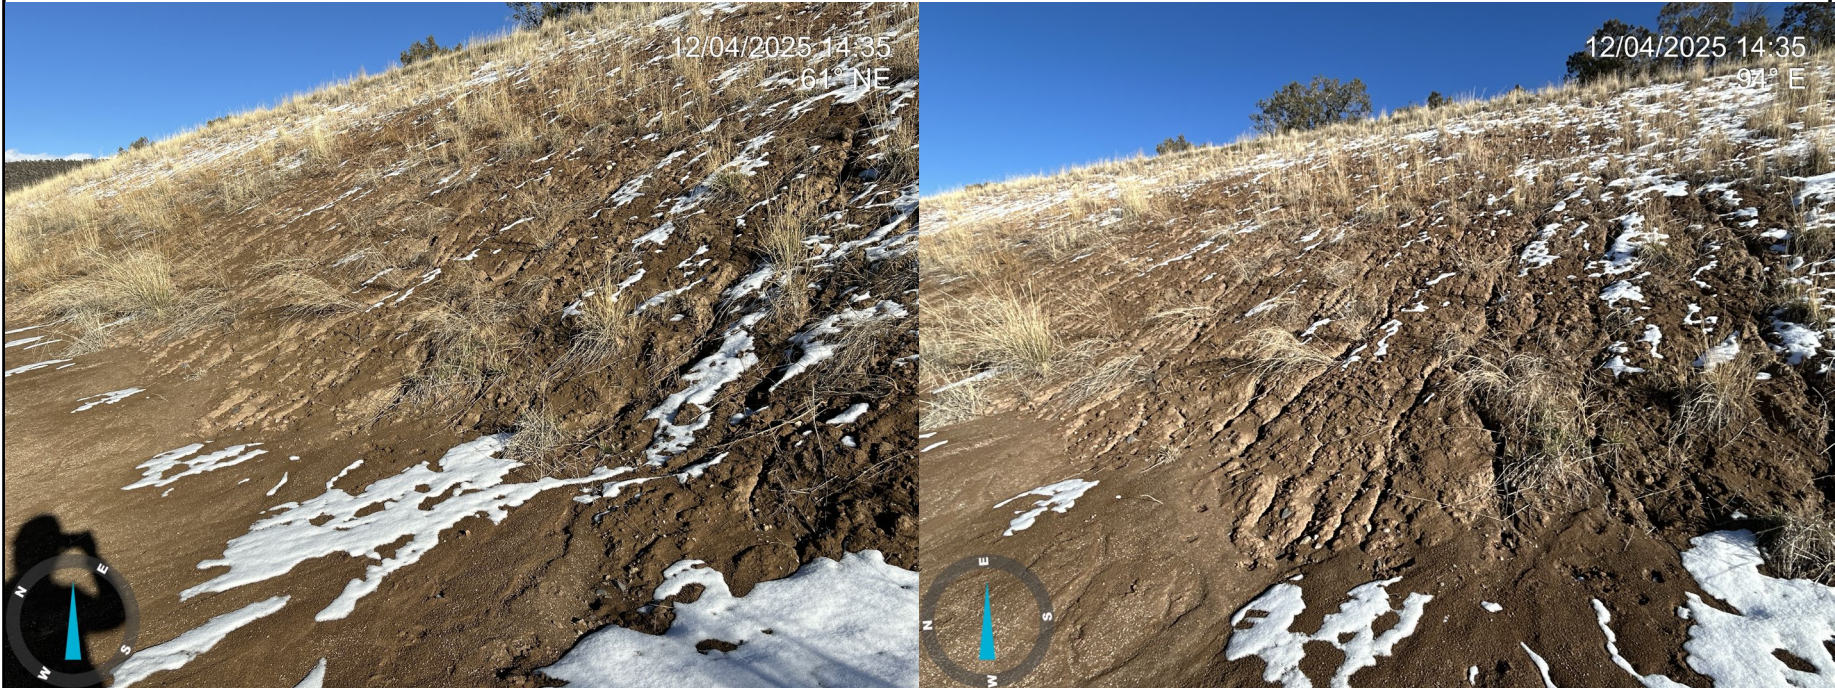
**Photo 3:** Photos showing erosion, rilling and sediment deposition occurring on cut slopes behind production equipment. Comply with 1002.f. and implement or maintain stormwater BMP's.

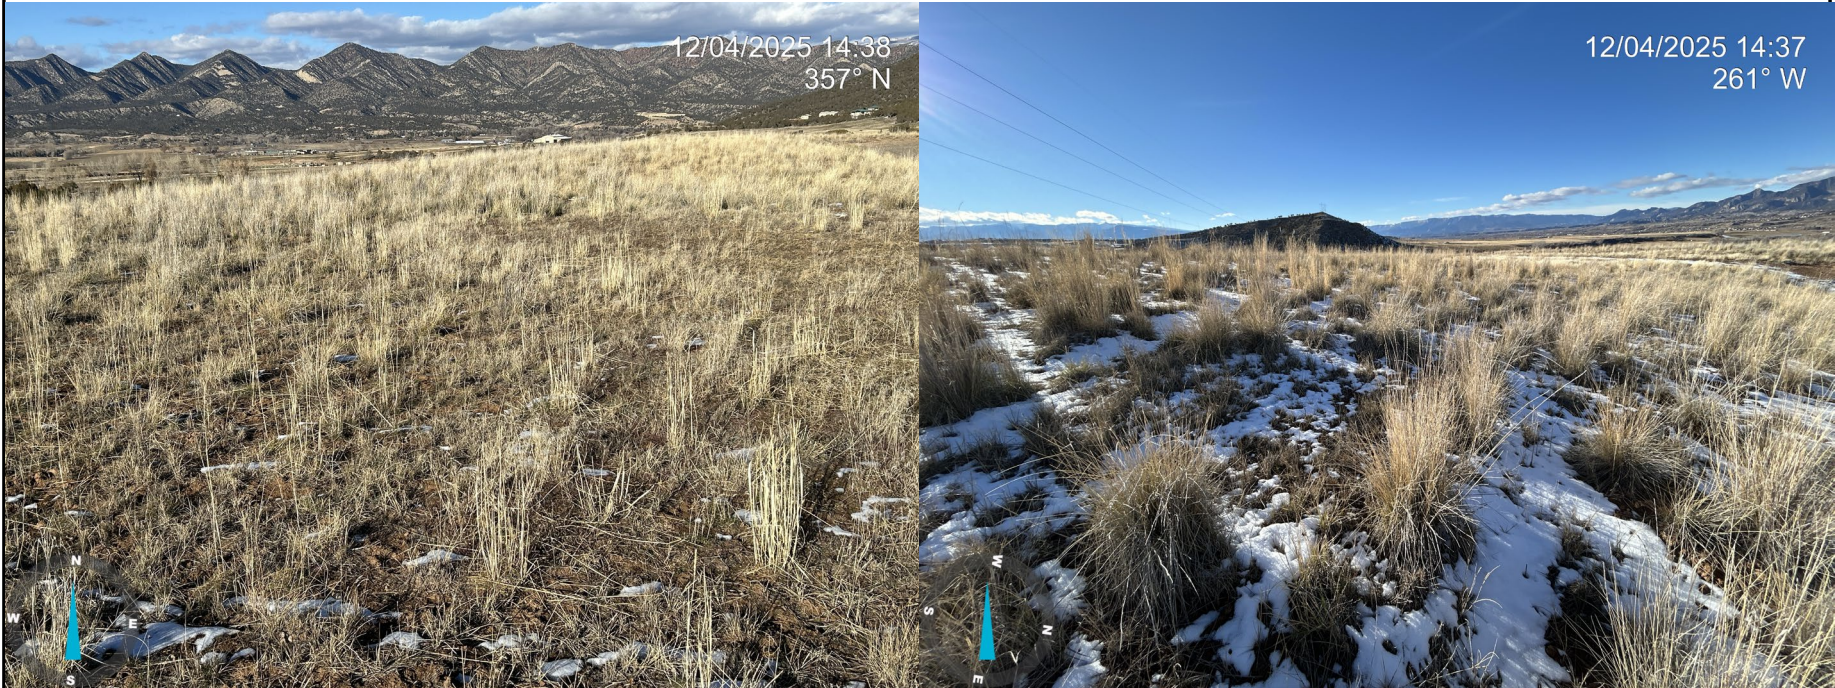
**Photo 4:** Photos showing the western and southern interim areas, respectively. Interim areas are progressing towards 1003 reclamation requirements.
