Frederick, CO, United States
Lat 40.100649, Long -104.954132
12/02/2025 14:37 GMT-07:00
ECMC : Environmental Inspection

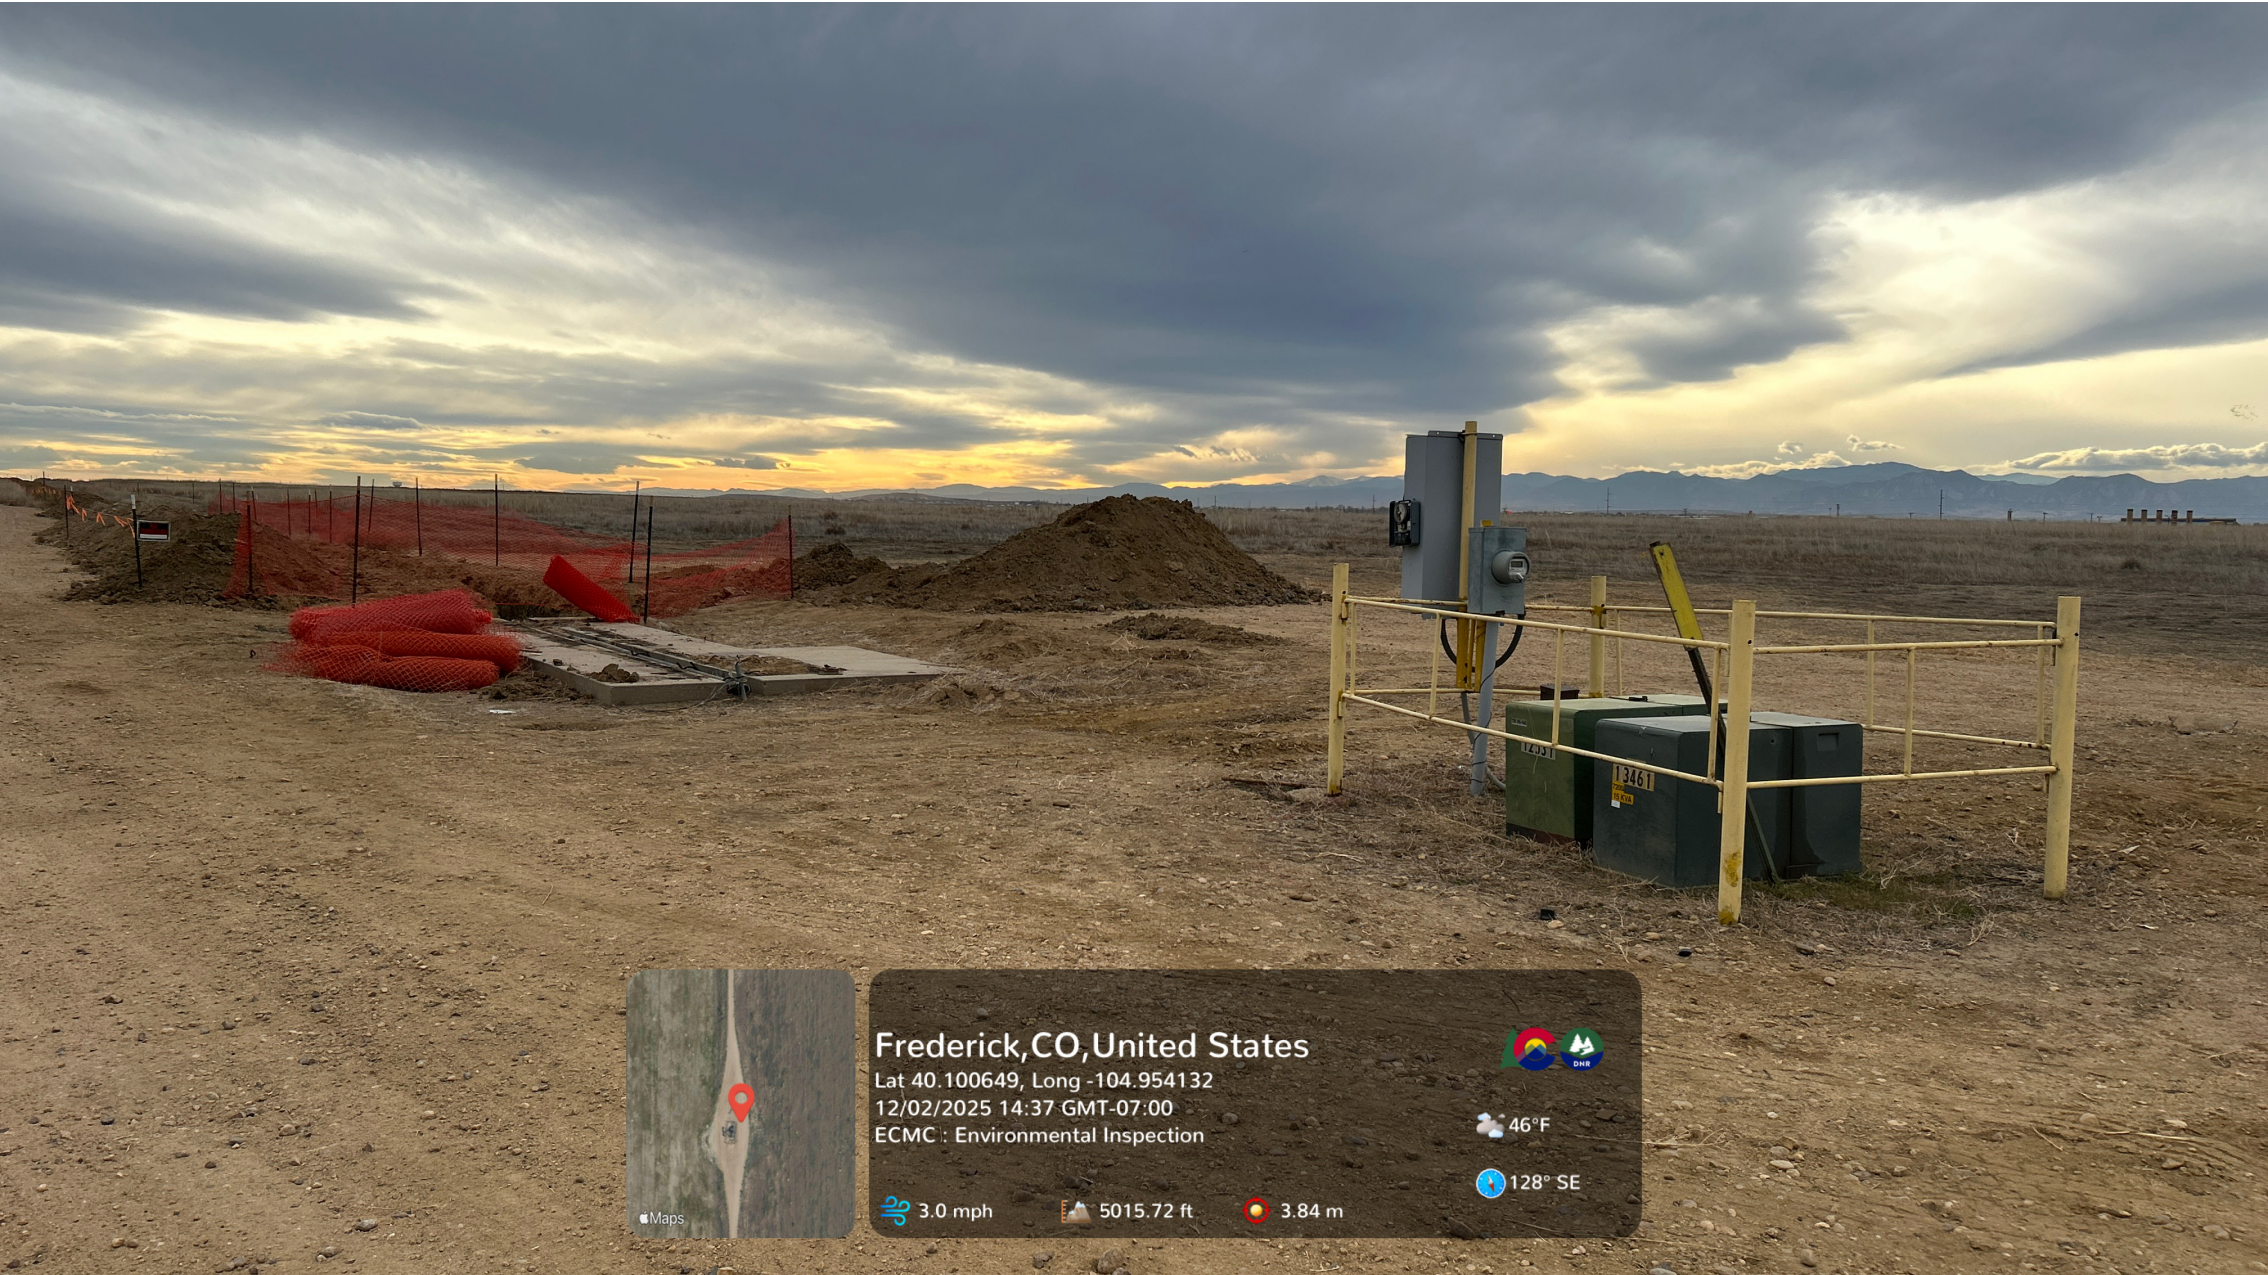
Looking at the former STATE #6 well. An open excavation is visible. Stockpiled soil is visible to the west of the former well. Orange construction fencing partially surrounds the excavation at the former well.

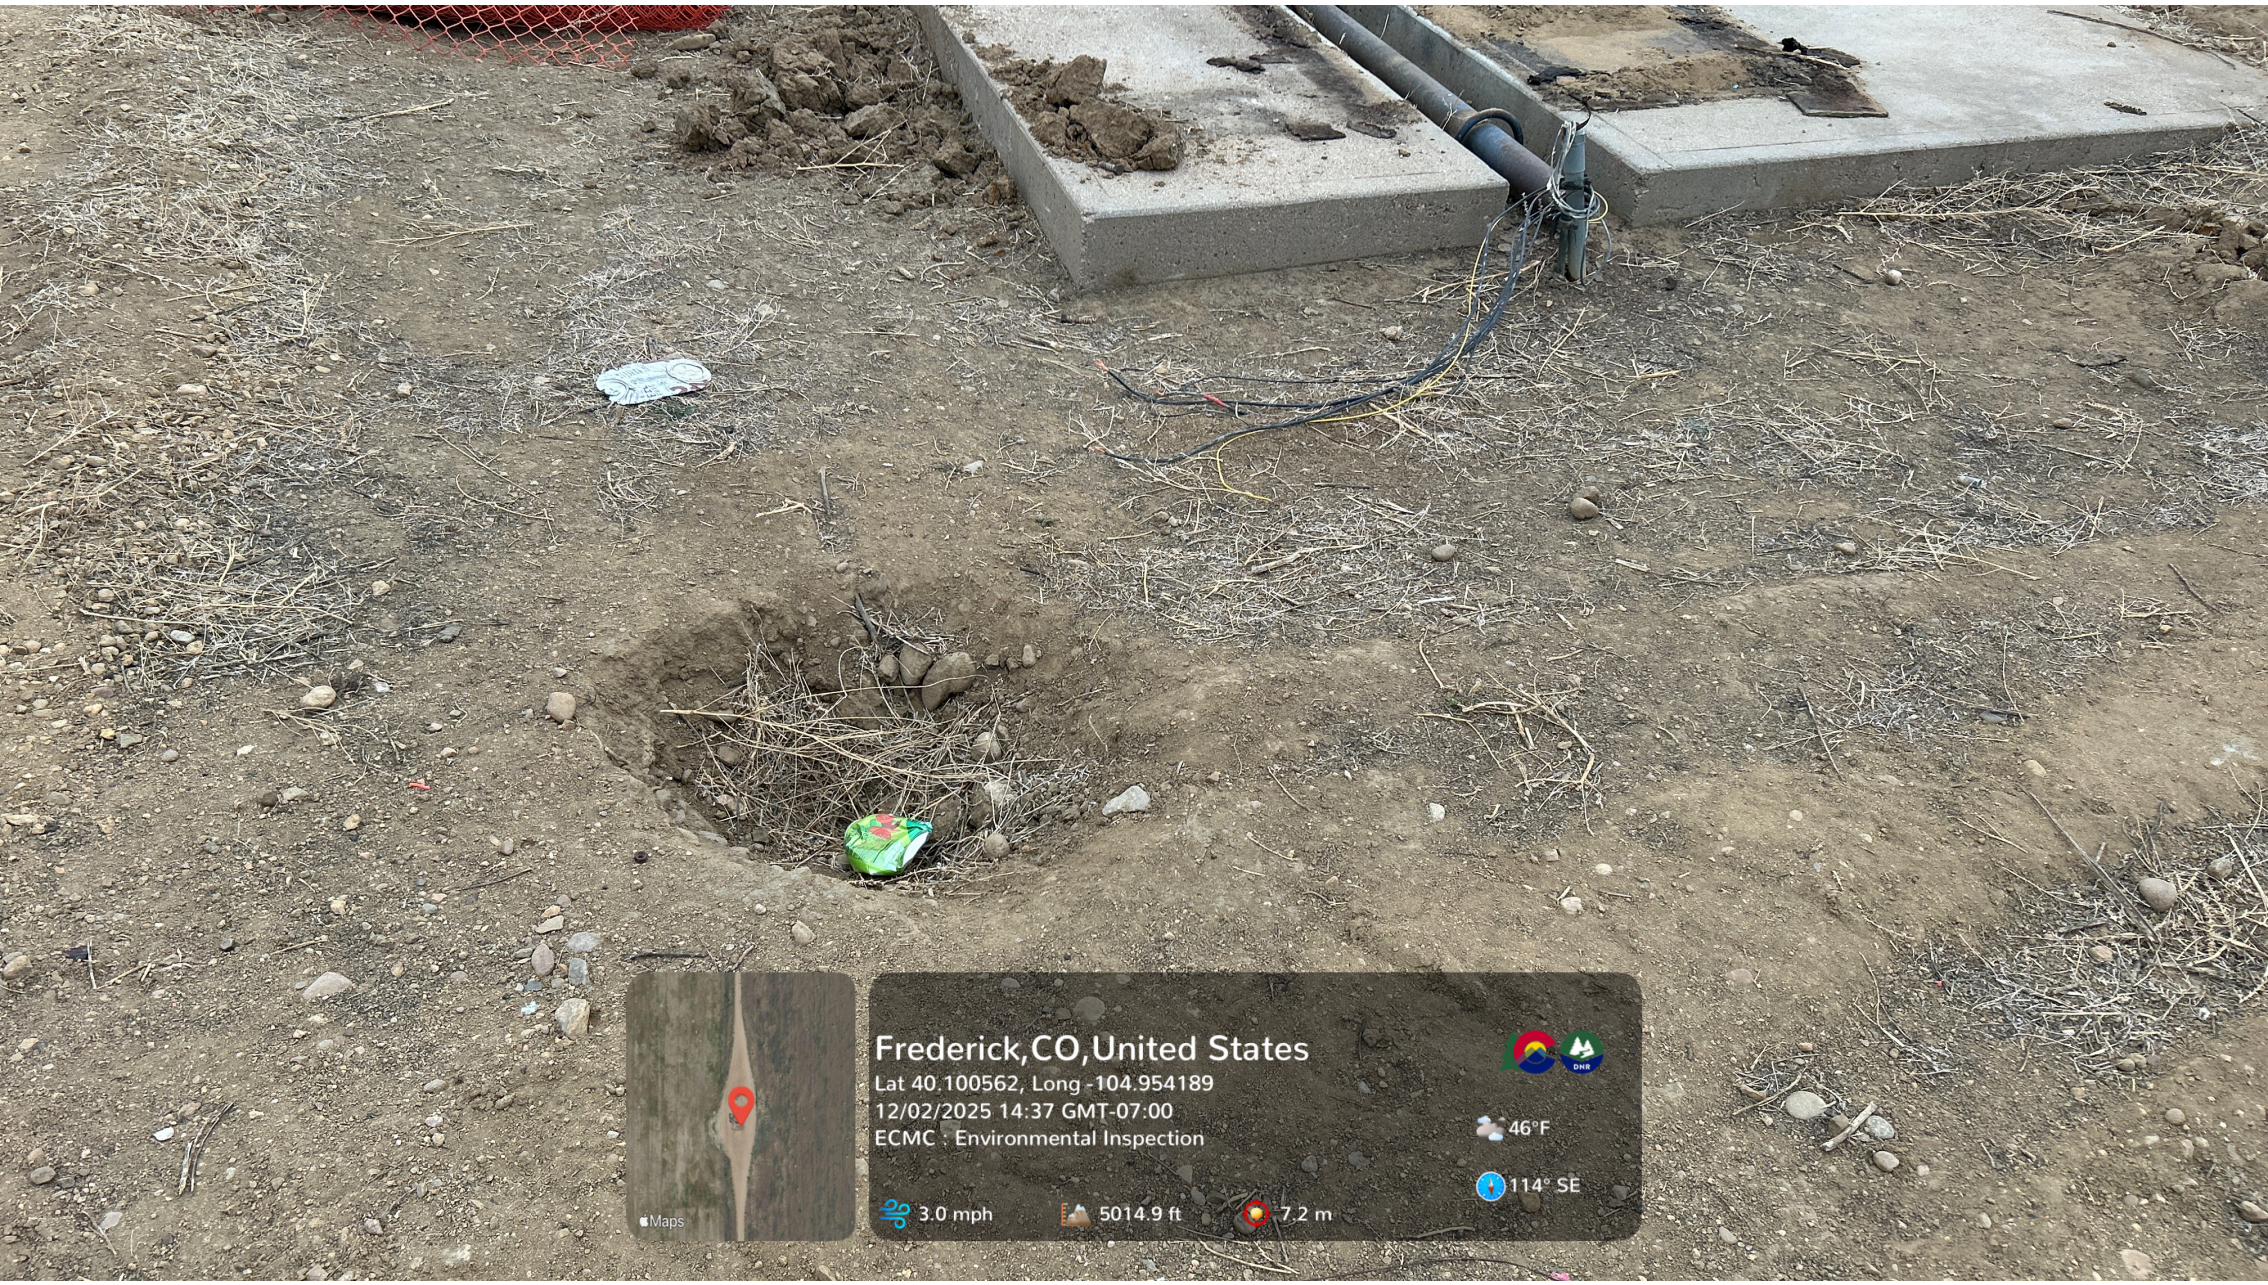
Trash is visible on location.

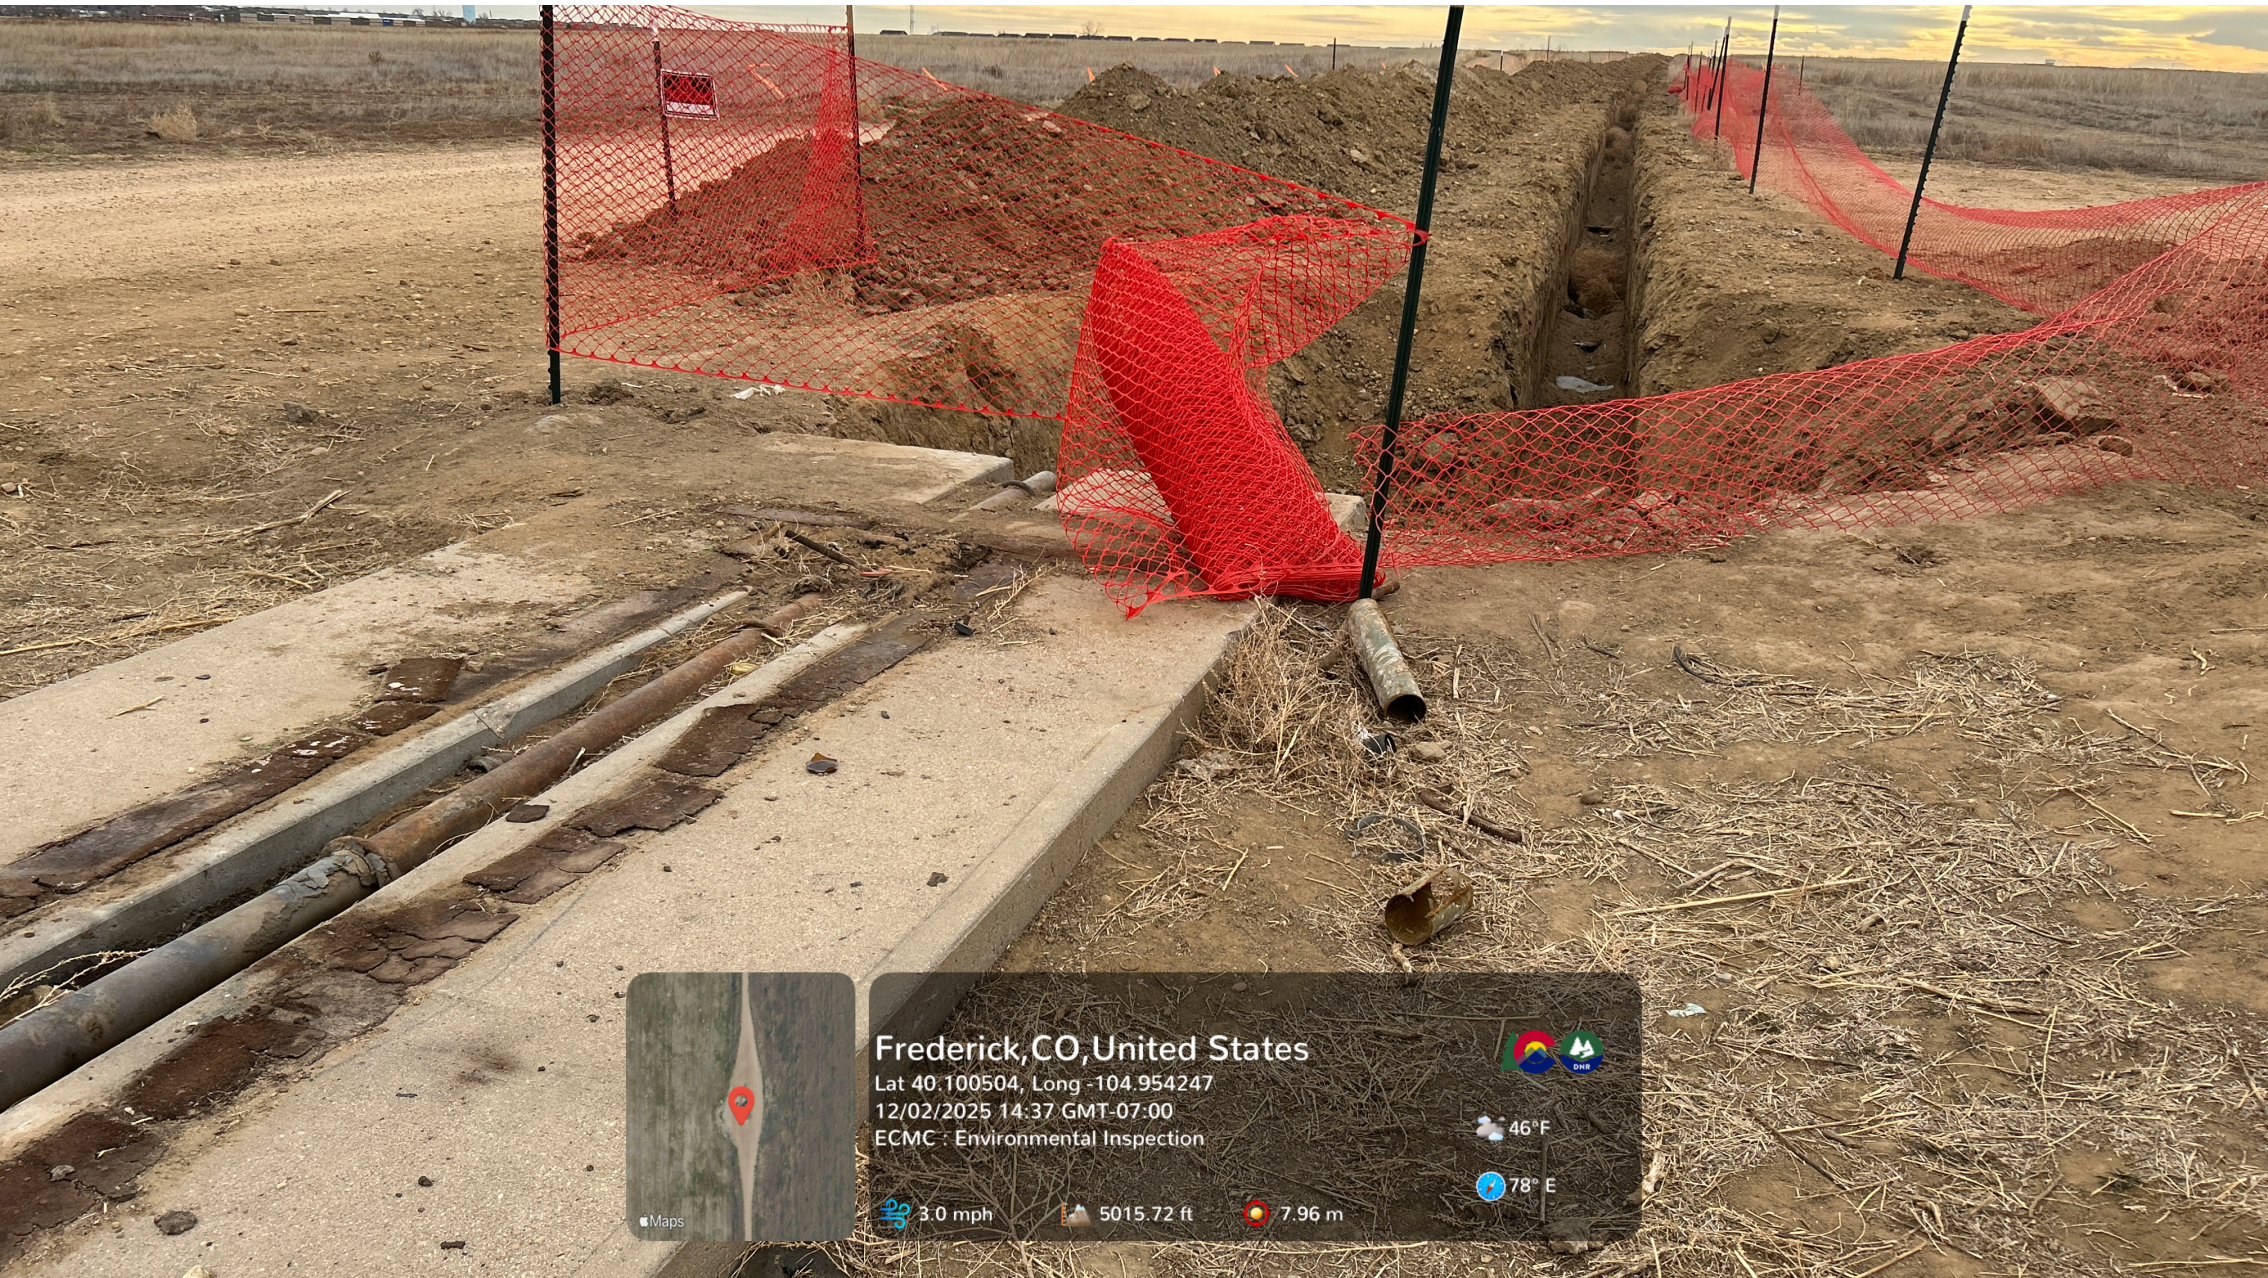
Orange construction fencing partially surrounds an open excavation. Pieces of flowline are visible adjacent to the former well. A trench associated with Flowline Facility ID 478291 is visible running south from the former well.

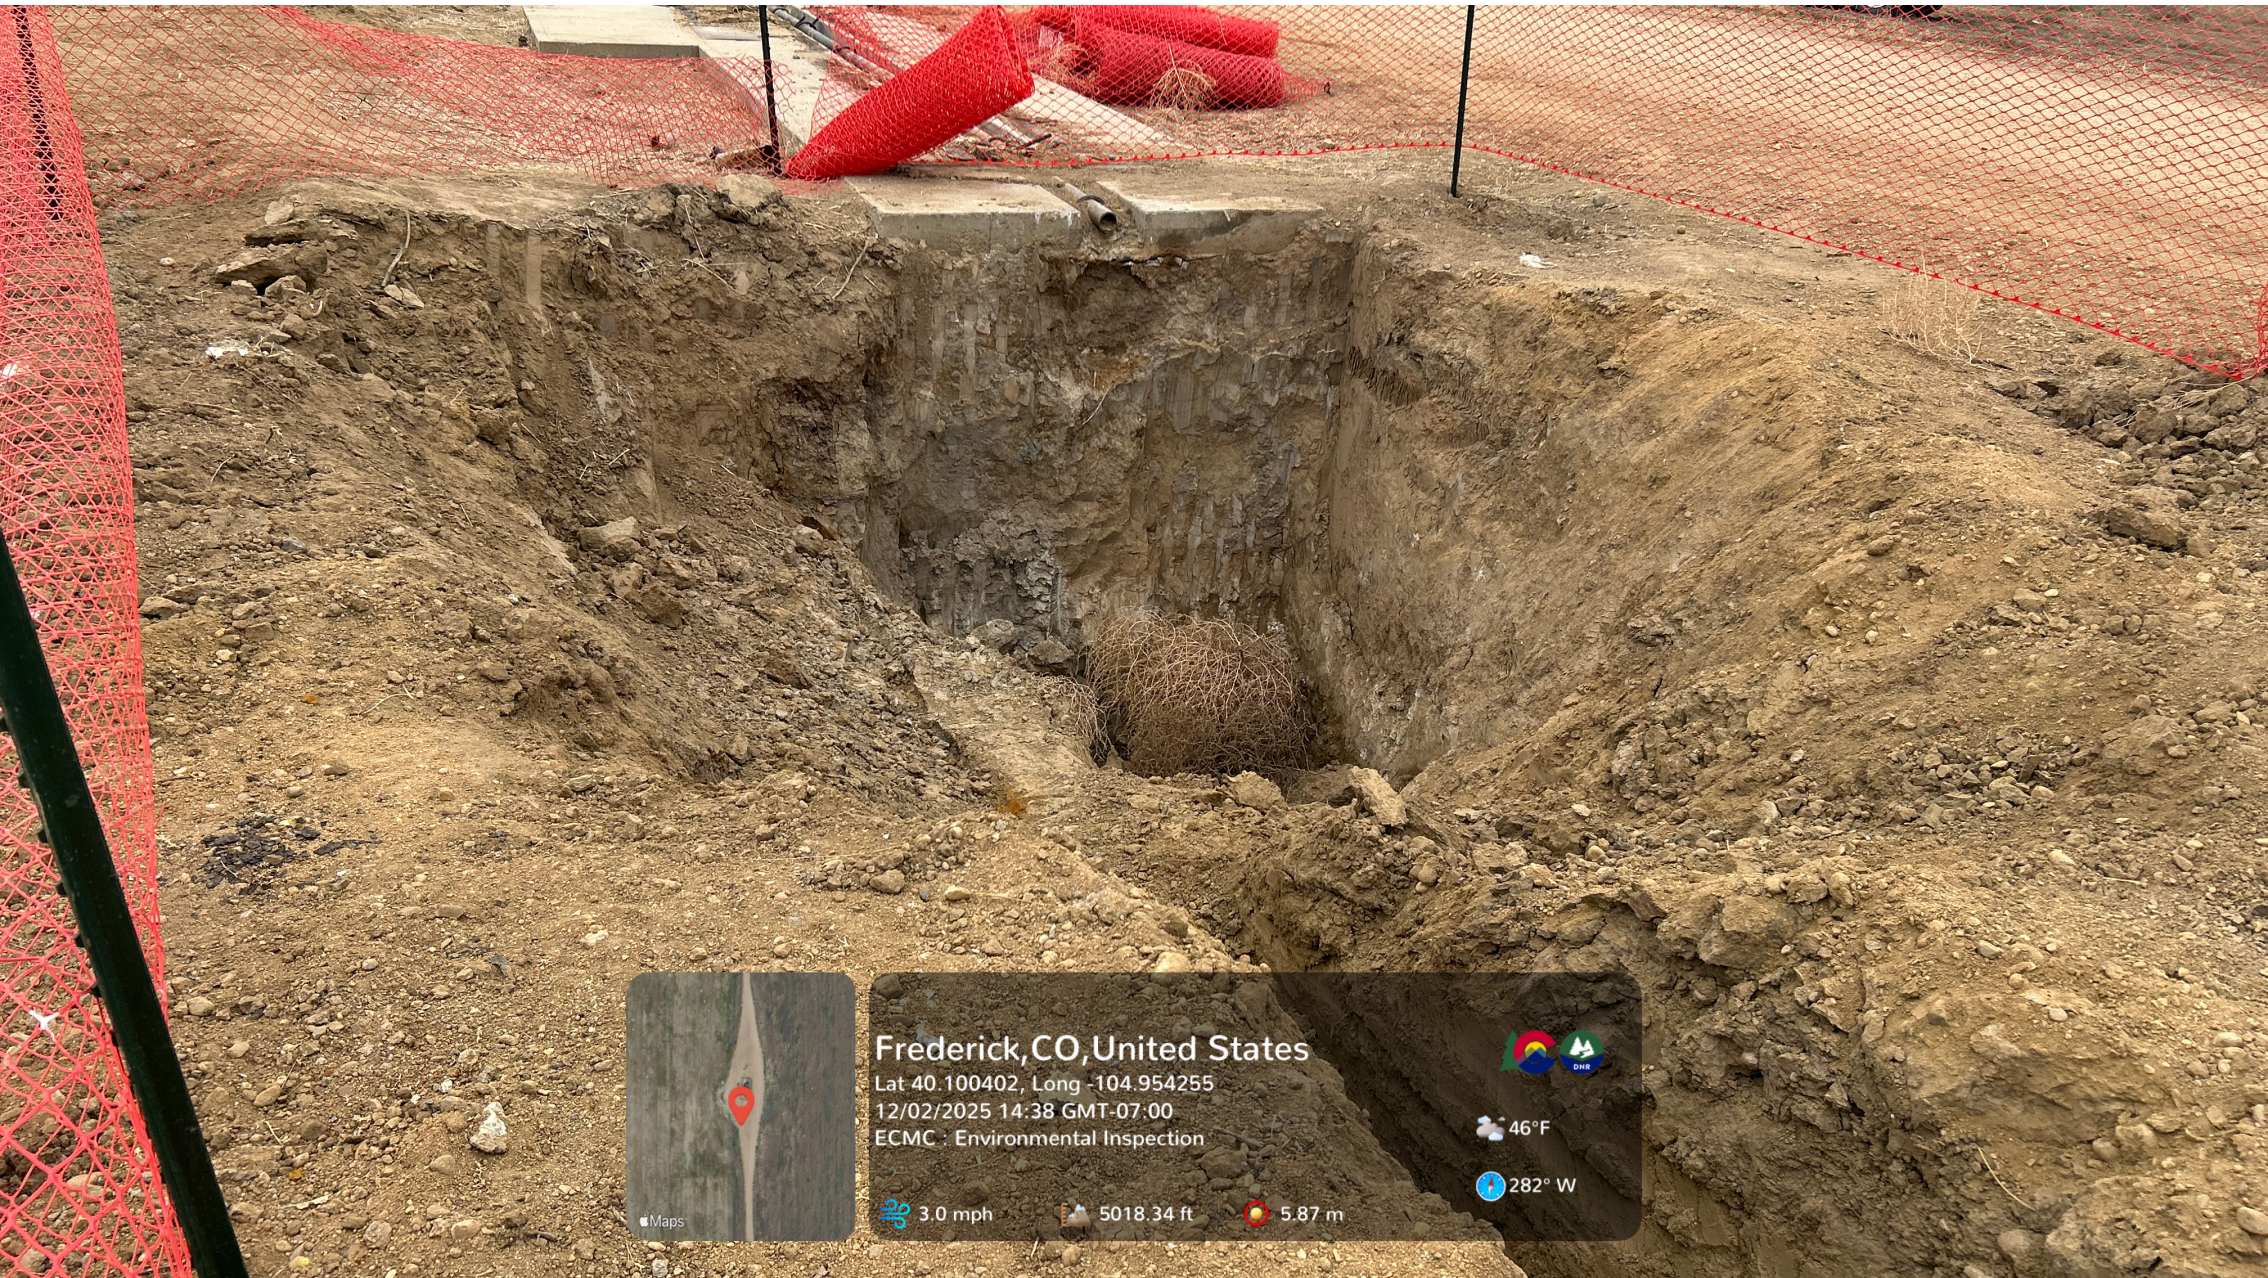
Looking at the excavation. Slight gray staining is visible within the excavation; debris obscures visibility of the base of the excavation.

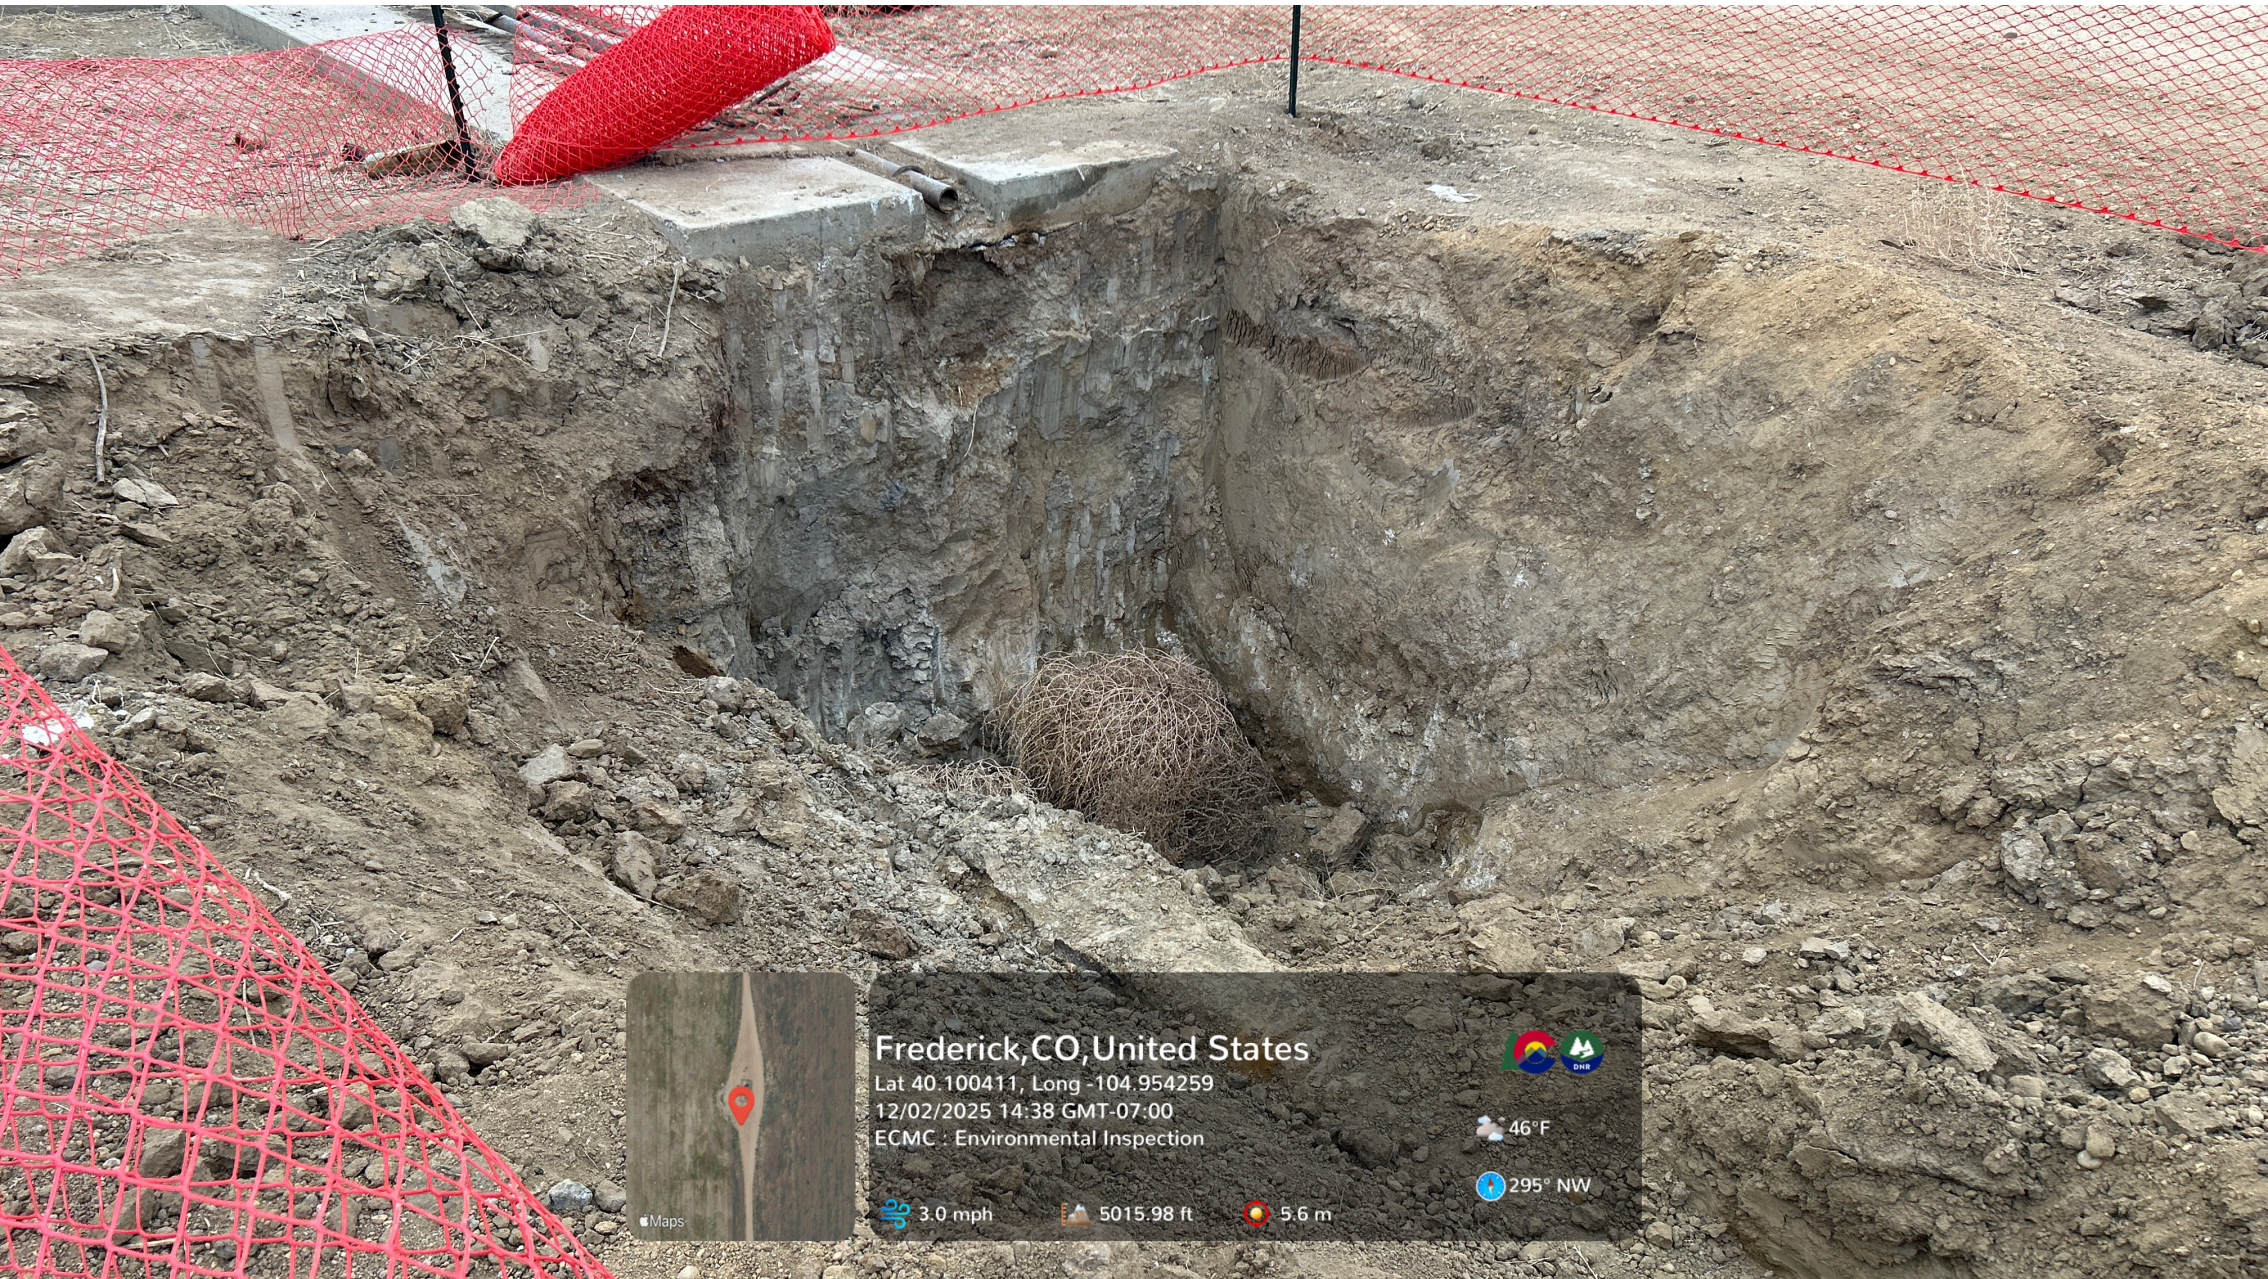
Looking at the excavation. Slight gray staining is visible within the excavation; debris obscures visibility of the base of the excavation.

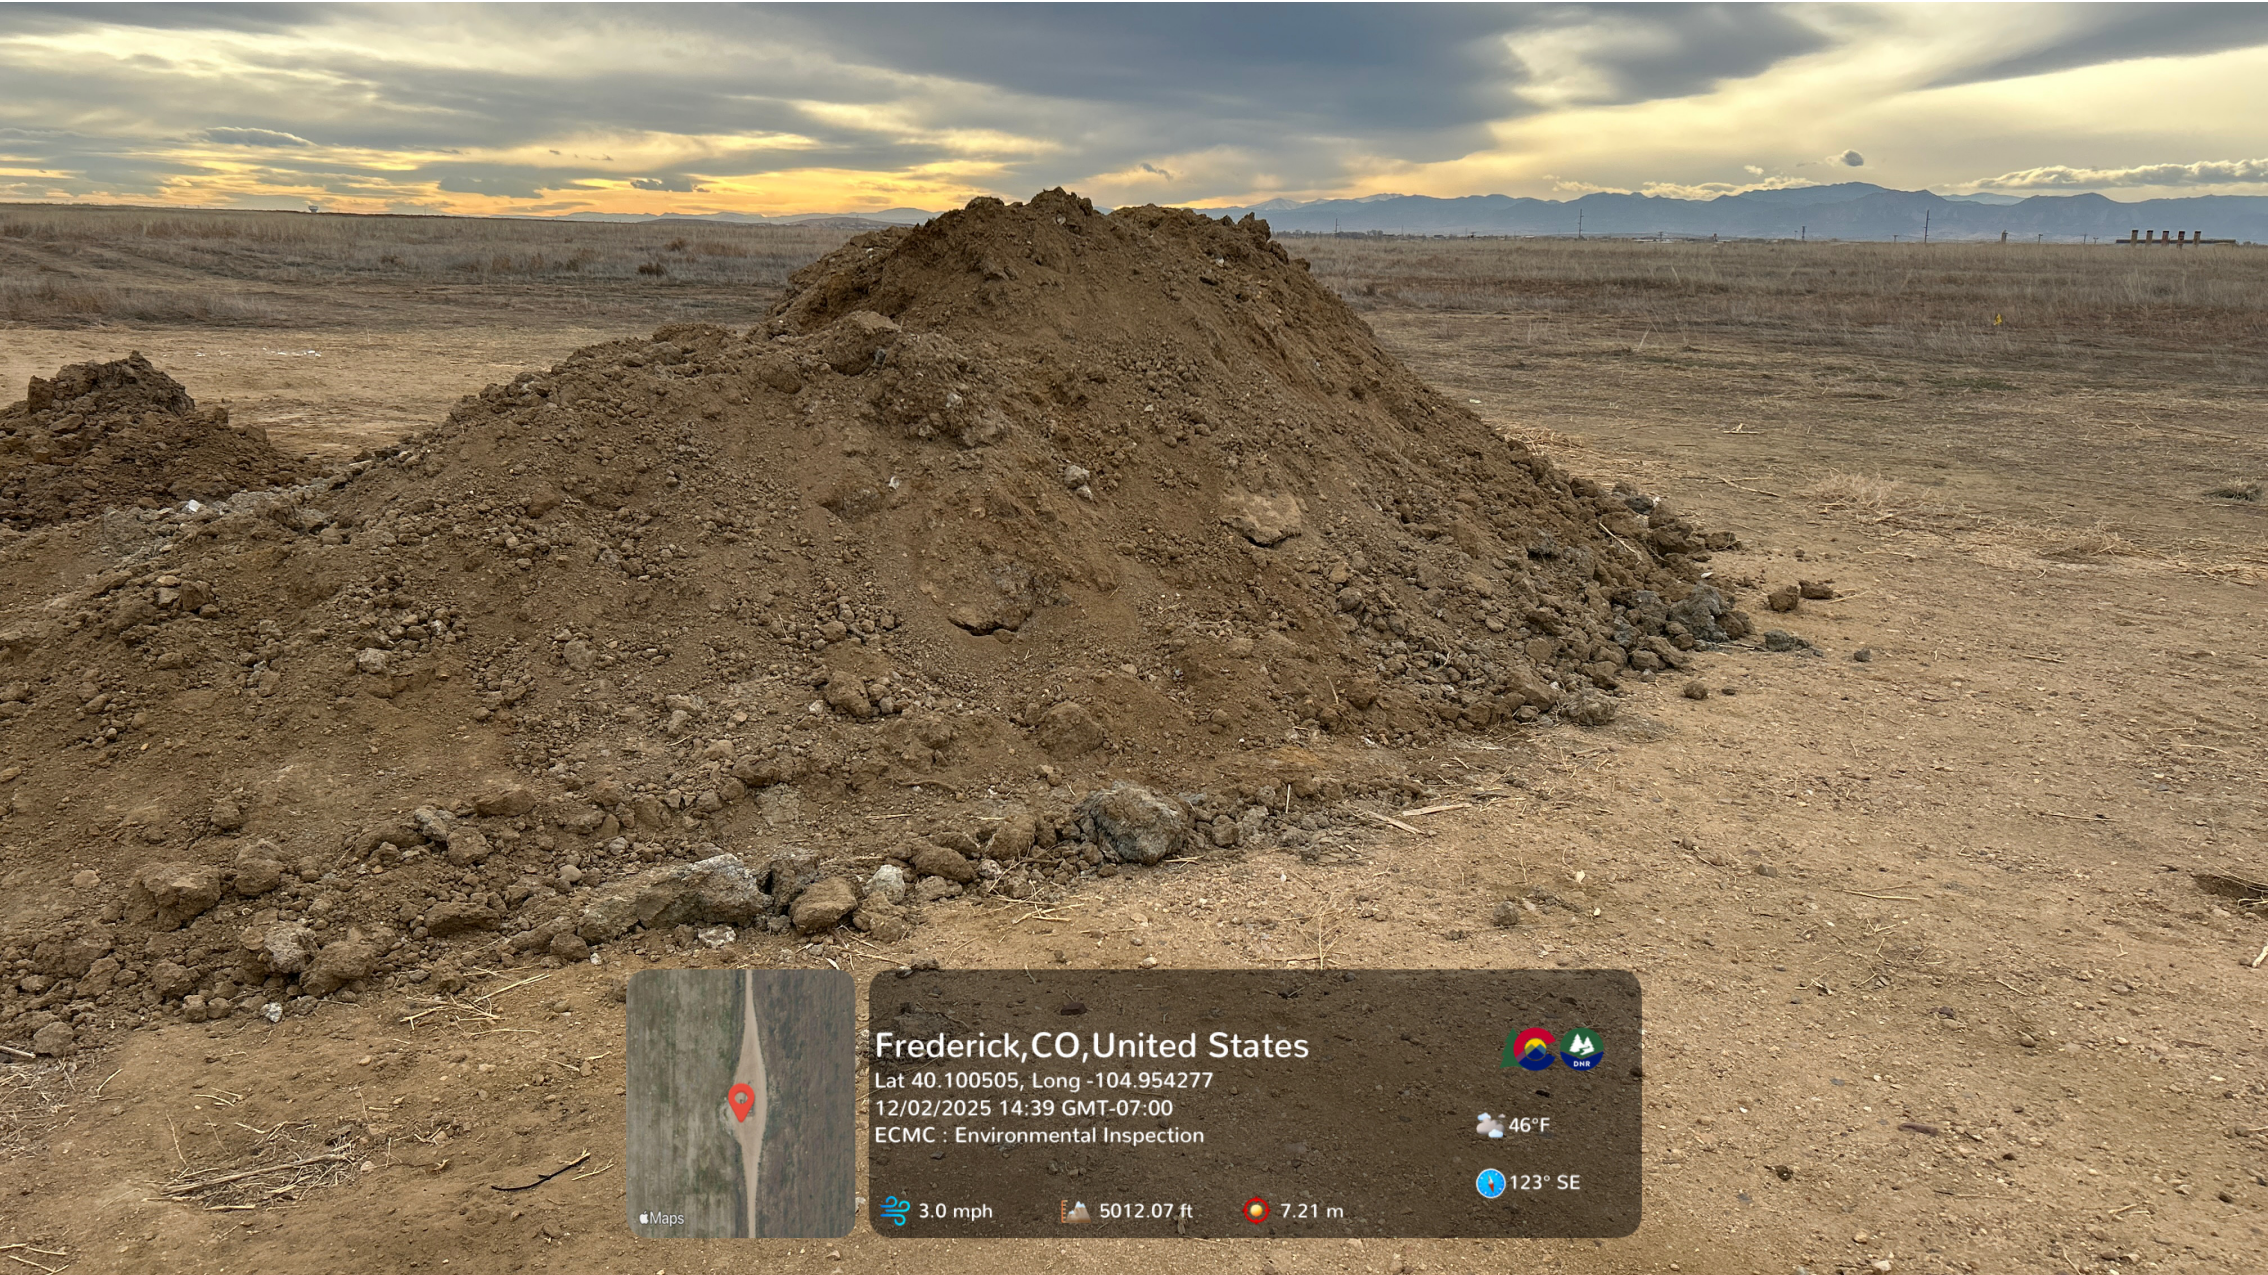
Looking at the soil stockpile adjacent to the former well. No liner or stormwater BMPs are visible. Gray staining is visible in areas of the stockpiled soil.

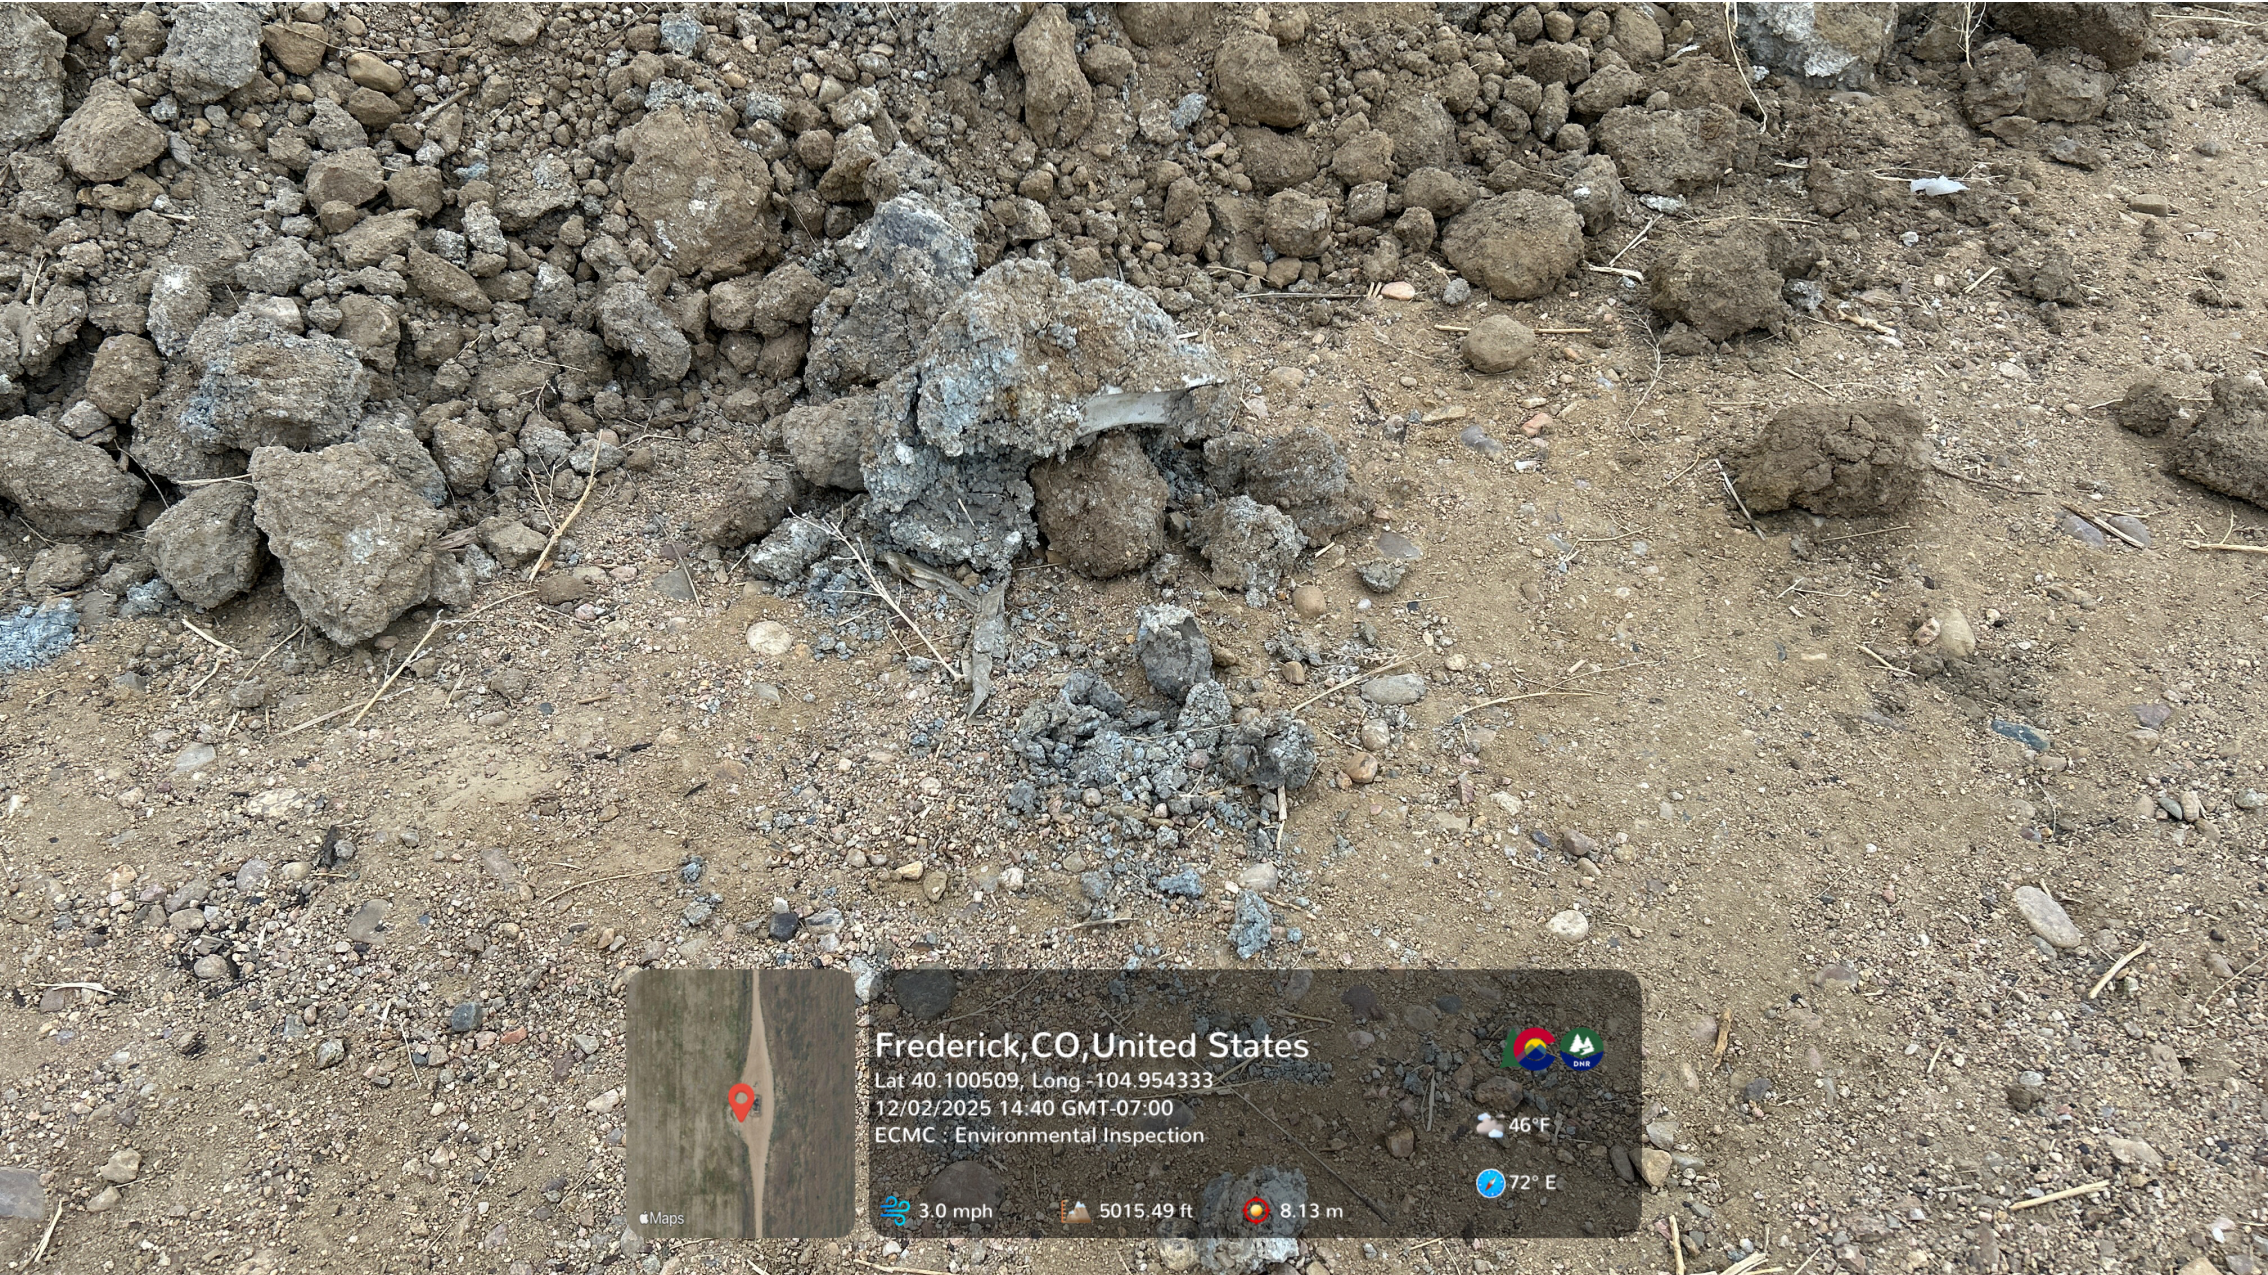
Looking at soil with gray staining in the stockpile. A petroleum hydrocarbon odor was observed when pieces of the stained soil were disturbed.
