Frederick, CO, United States
Lat 40.100649, Long -104.954132
12/02/2025 14:37 GMT-07:00
ECMC : Environmental Inspection

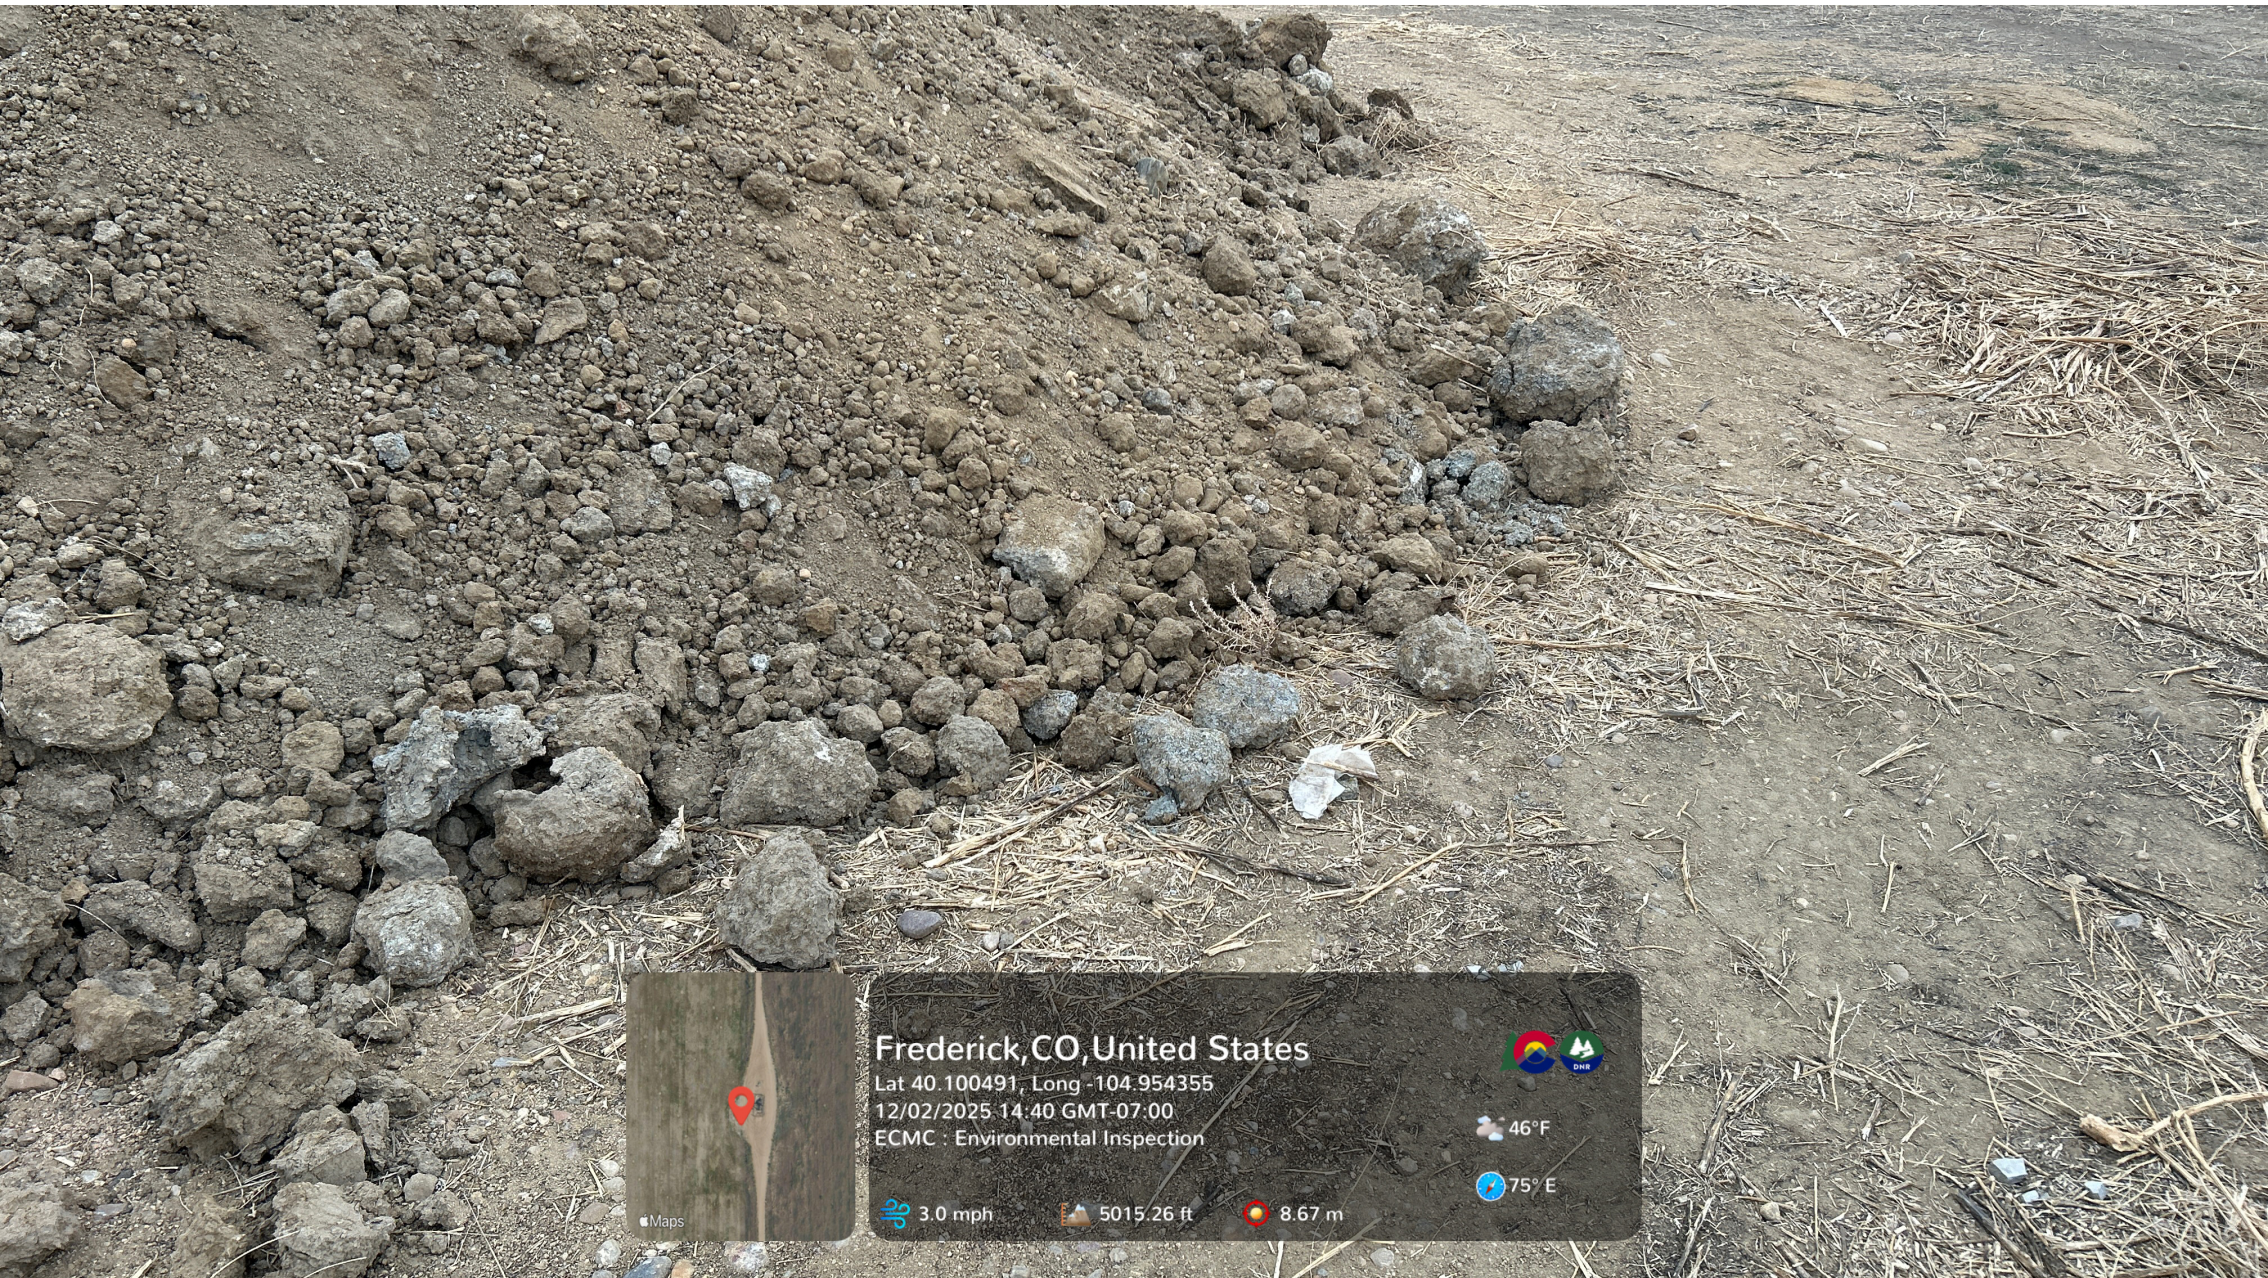
Looking at soil with gray staining in the stockpile. A petroleum hydrocarbon odor was observed when pieces of the stained soil were disturbed.
