Final Reclamation Inspection

November 25, 2025

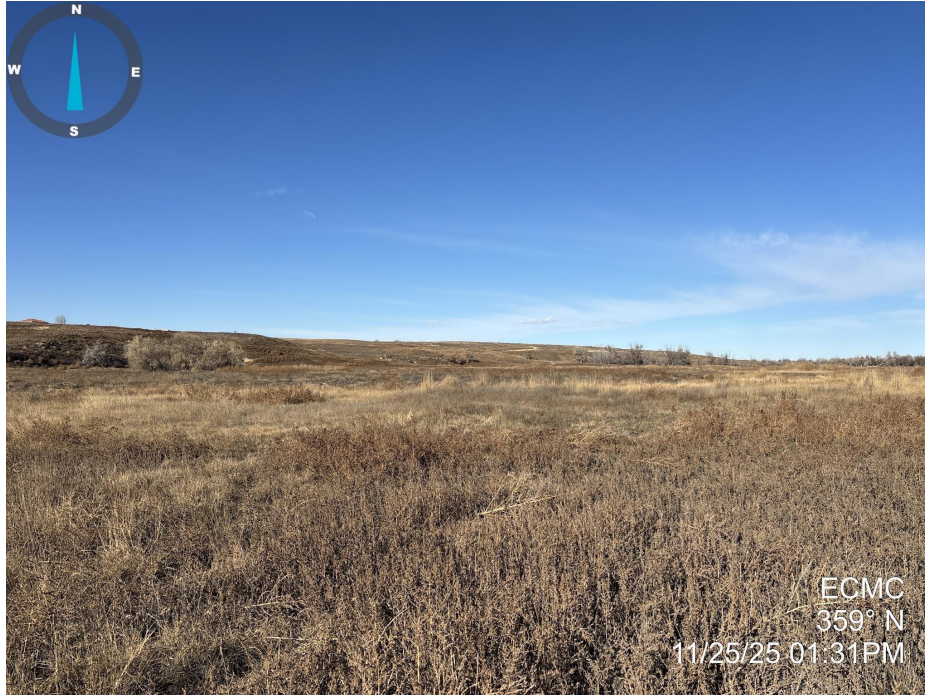
Photo 1. Photo taken of the well location, facing north. Photo illustrates that final reclamation activities have taken place, but vegetation establishment does not meet Rule 1004 standards and weedy annual vegetation including kochia (*Bassia scoparia*) was observed across the location.

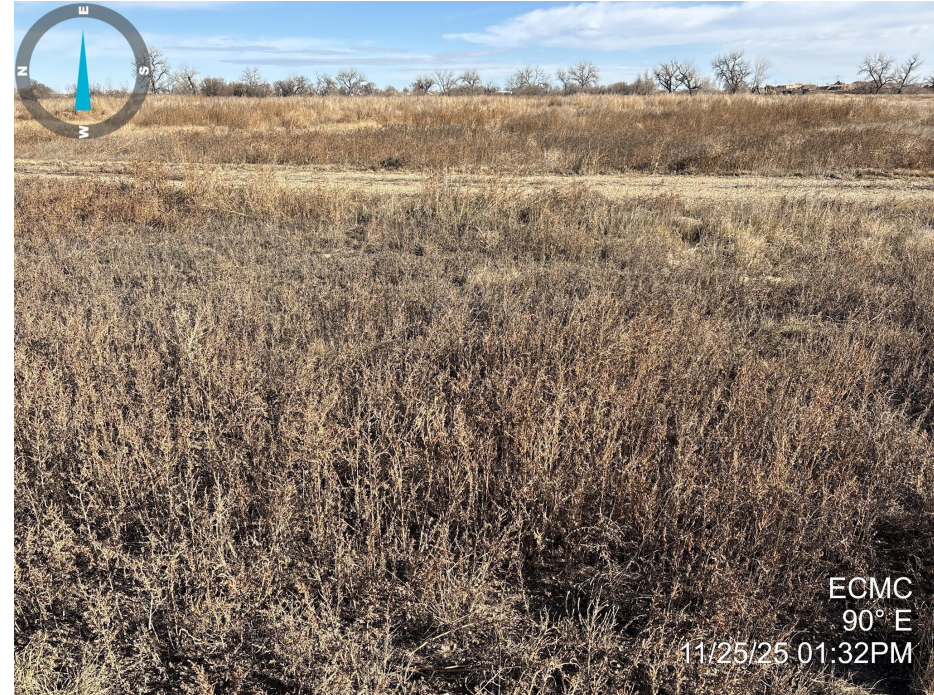
Photo 2. Photo taken of the well location, facing east. See comments under Photo 1.

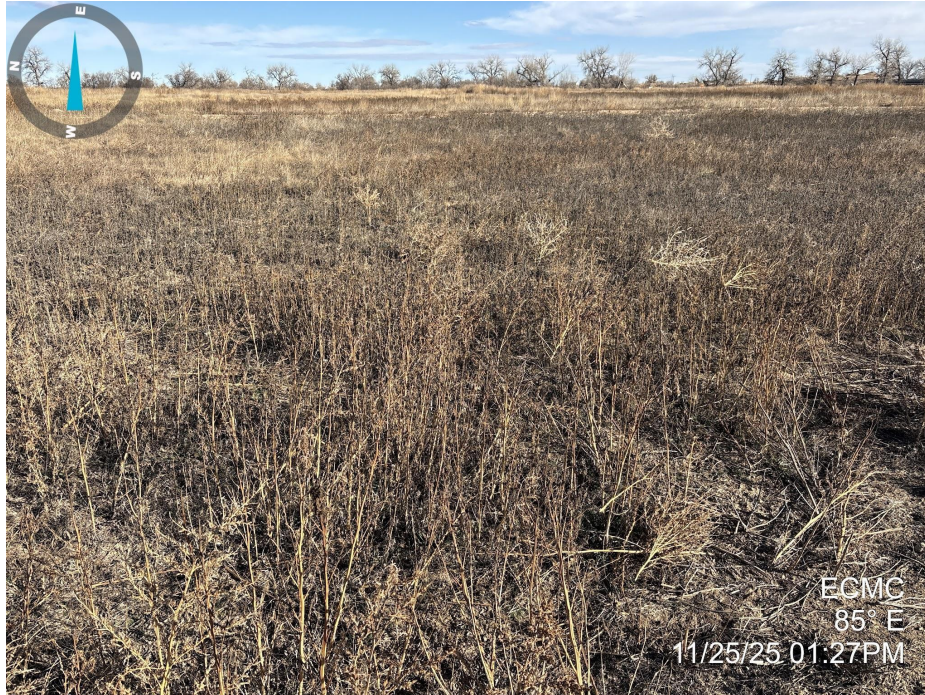
Photo 7. Photo taken of the tank battery location, facing east. Photo illustrates that final reclamation activities have taken place, but vegetation establishment does not meet Rule 1004 standards as gravel and weedy annual vegetation, including kochia (*Bassia scoparia*), were observed across the location.

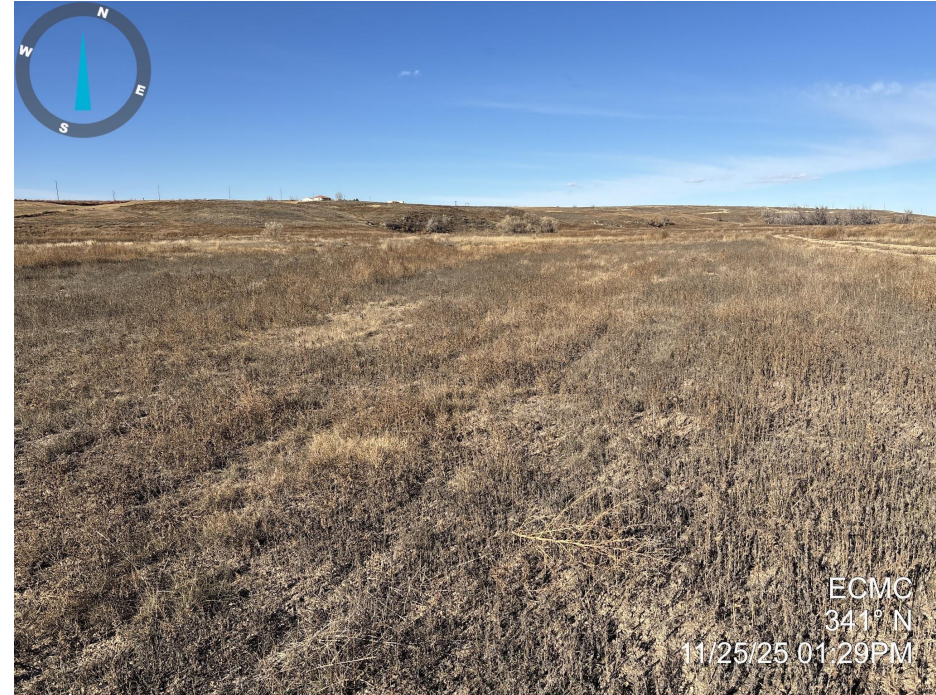
Photo 8. Photo taken of the tank battery location, facing north. See comments under Photo 7.
