# Final Reclamation Inspection

Operator: PDC ENERGY INC - 69175

Location ID: 323339

Inspection Photos  
Location Name: UCLI #6-3  
Location ID: 323339

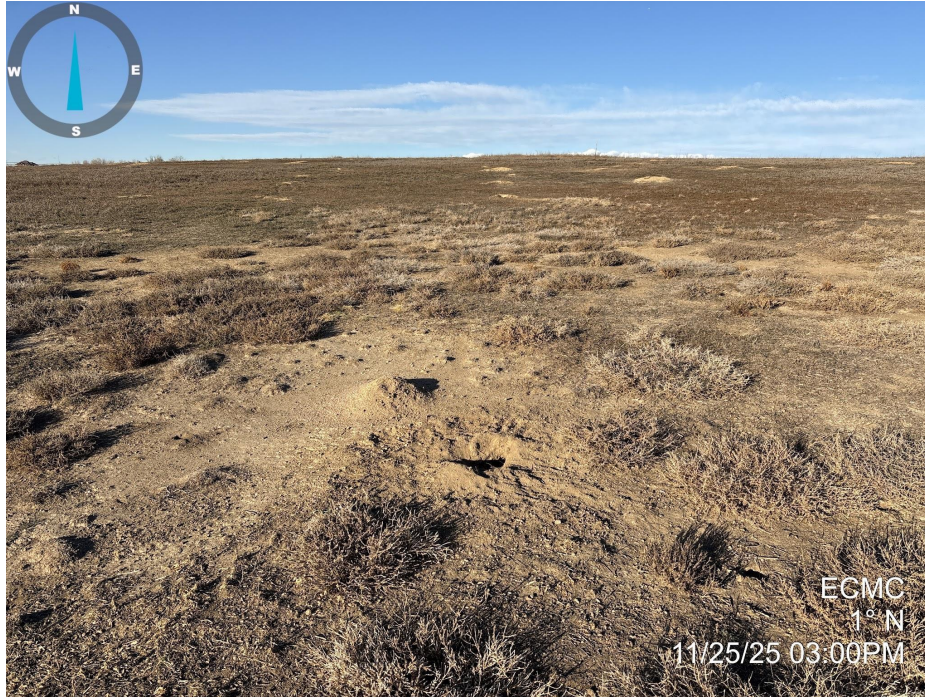
**Photo 1.** Photo taken of the well location, facing north. Photo illustrates that final reclamation activities have taken place, but vegetation establishment does not meet Rule 1004 standards and weedy annual vegetation including kochia (*Bassia scoparia*) was observed across the location.

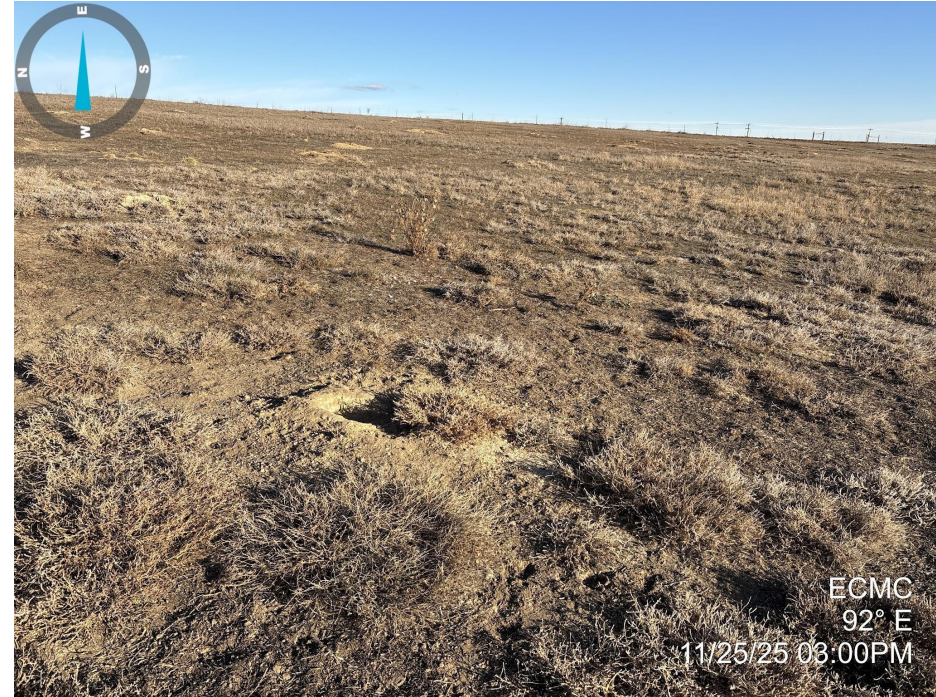
**Photo 2.** Photo taken of the well location, facing east. See comments under Photo 1.

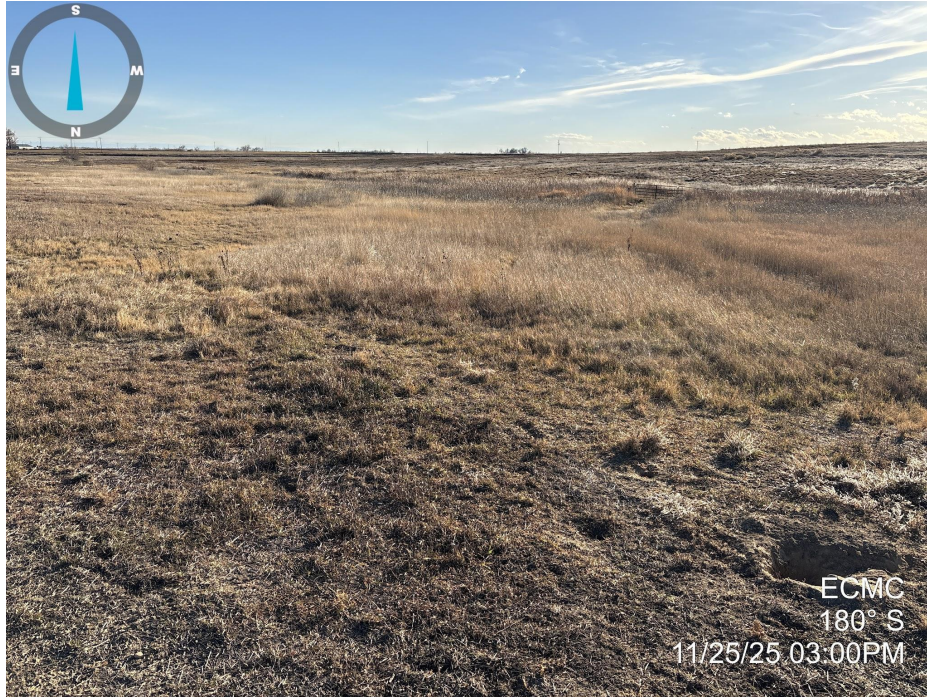
**Photo 3.** Photo taken of the well location, facing south. See comments under Photo 1.

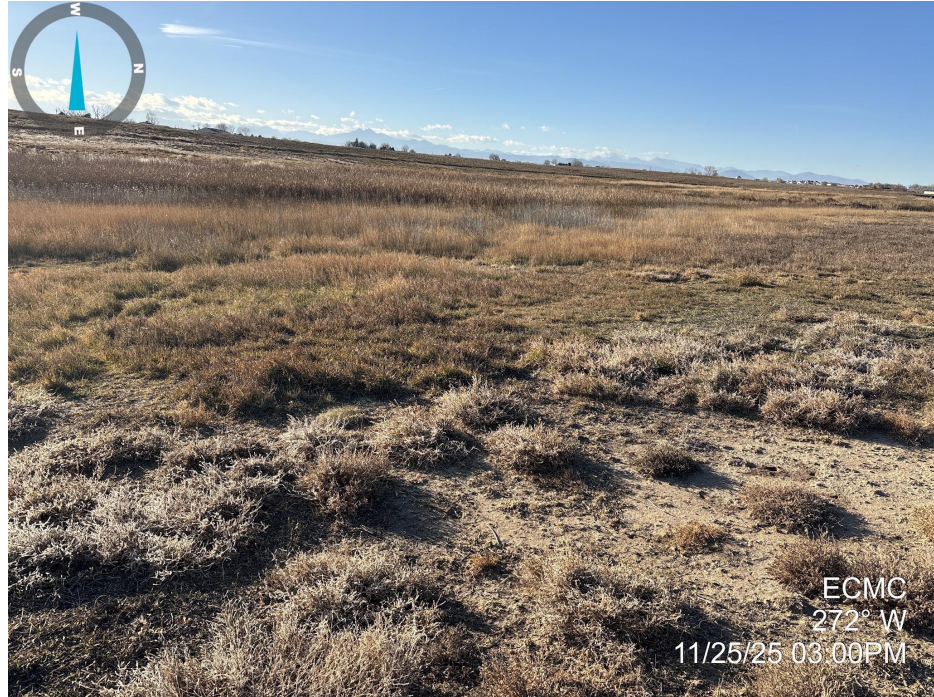
**Photo 4.** Photo taken of the well location, facing west. See comments under Photo 1.

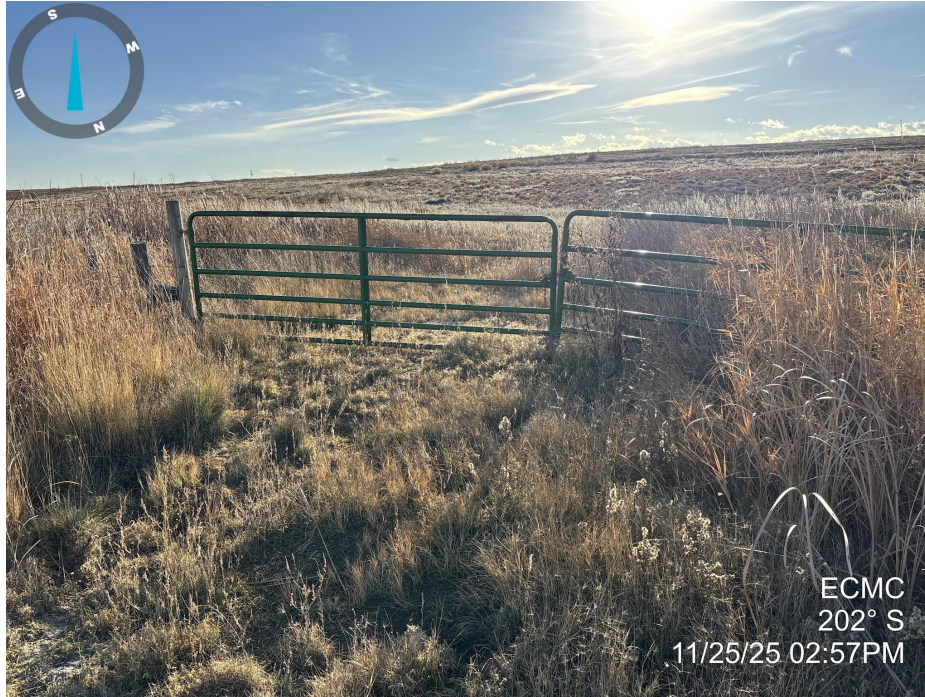
**Photo 5.** Photo taken of the access road to the location, facing south. Photo illustrates that a gate remains along the reclaimed access road.

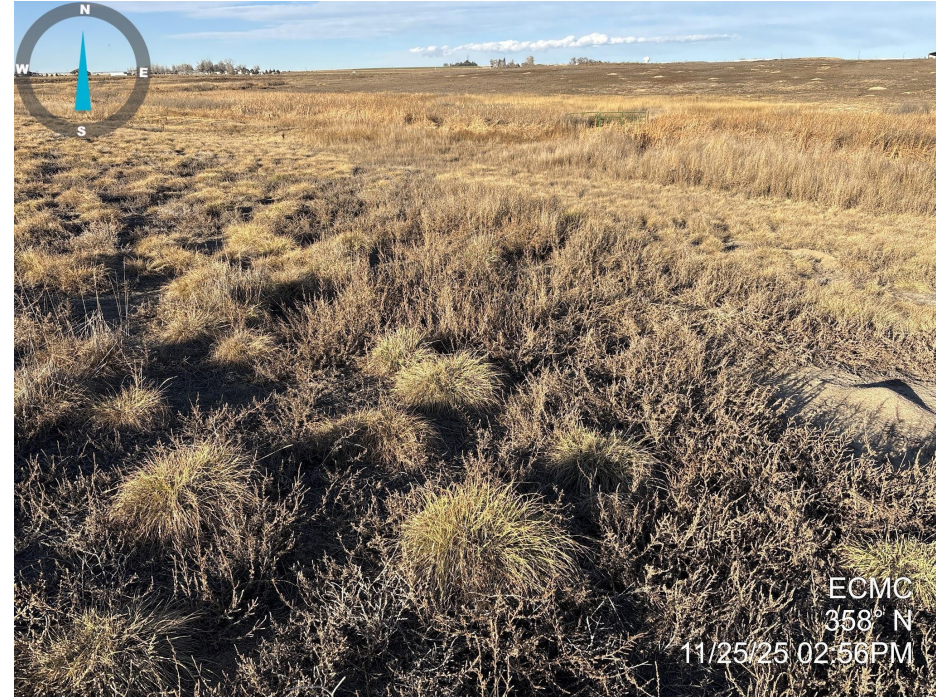
**Photo 6.** Photo taken of the access road to the location, facing north. Photo illustrates that final reclamation activities have taken place, but vegetation has not established to Rule 1004 standards along the access road and weedy annual vegetation including kochia (*Bassia scoparia*) was observed.

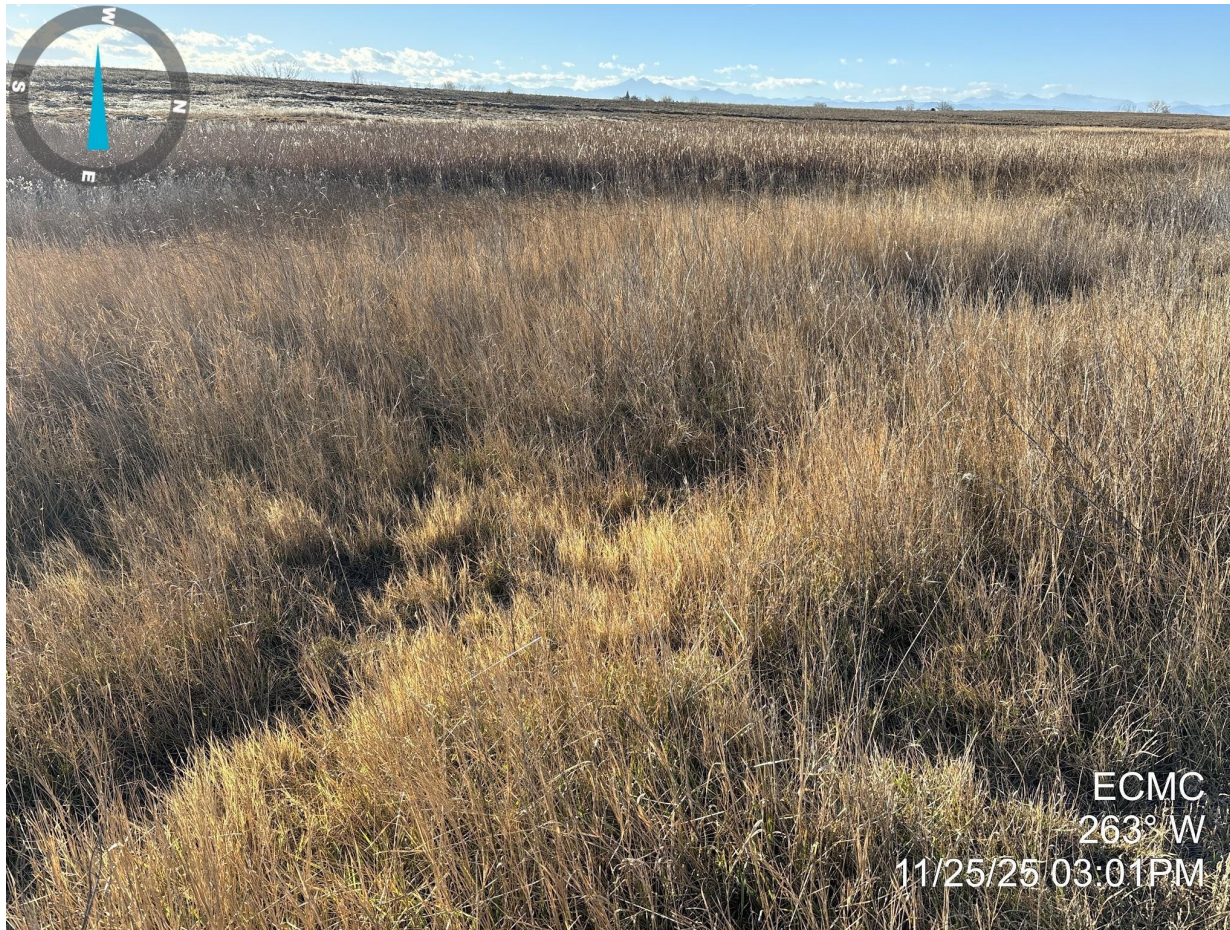
**Photo 7.** Photo taken of the reference area to the location, west of the location, facing west. Photo illustrates perennial grass vegetation.
