Interim Reclamation and Stormwater Inspection

Operator: KP KAUFFMAN COMPANY INC - 46290

Location ID: 336349

Well Name: WOOLEY #13-14

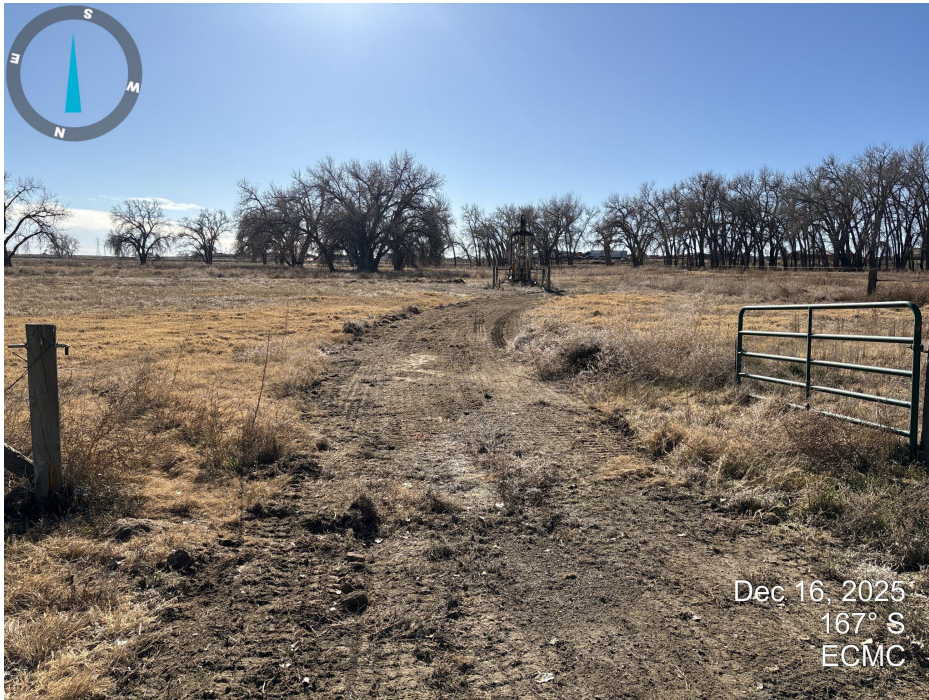
Photo 1. Looking south down the access road. Access road appears to have been recently graded.

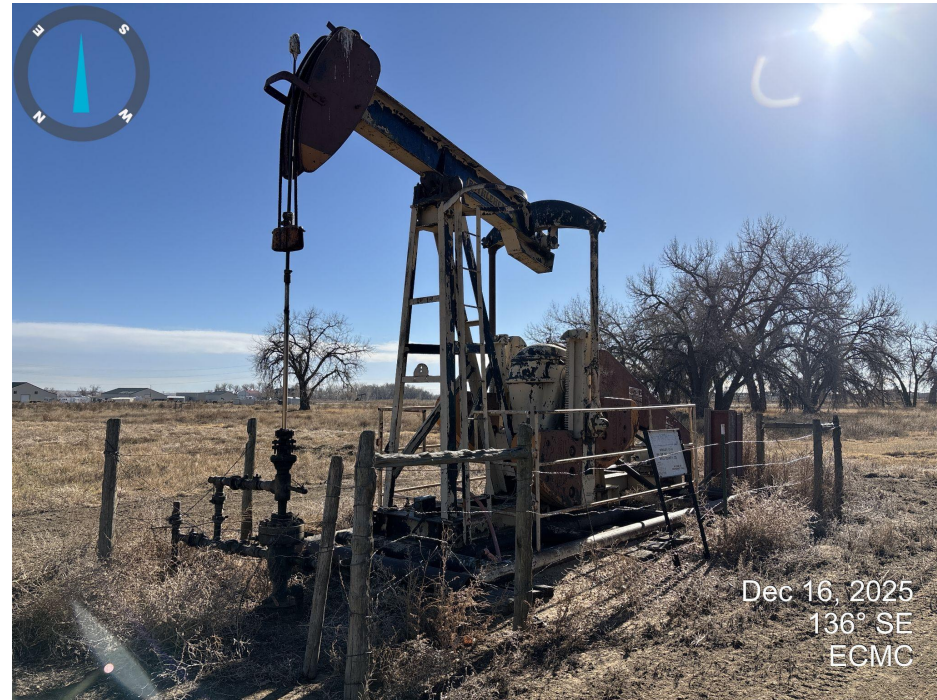
Photo 2. Looking at the pump jack. Undesirable weeds such as kochia are present on the location.

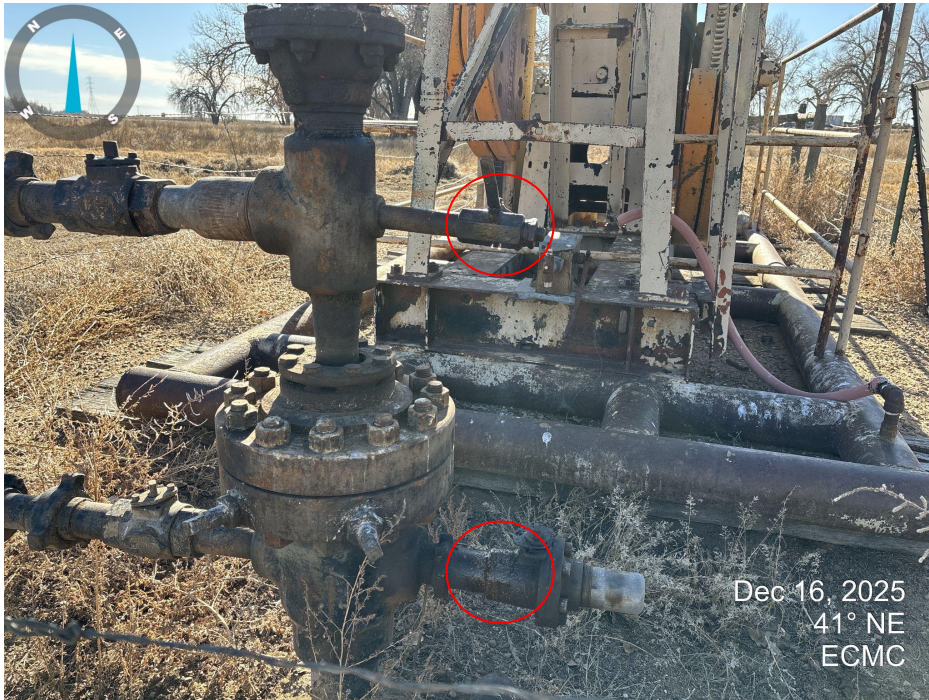
Dec 16, 2025
41° NE
ECMC

Photo 3. Picture taken at the wellhead. Fluid was visible on the upper valve and beneath the valve.

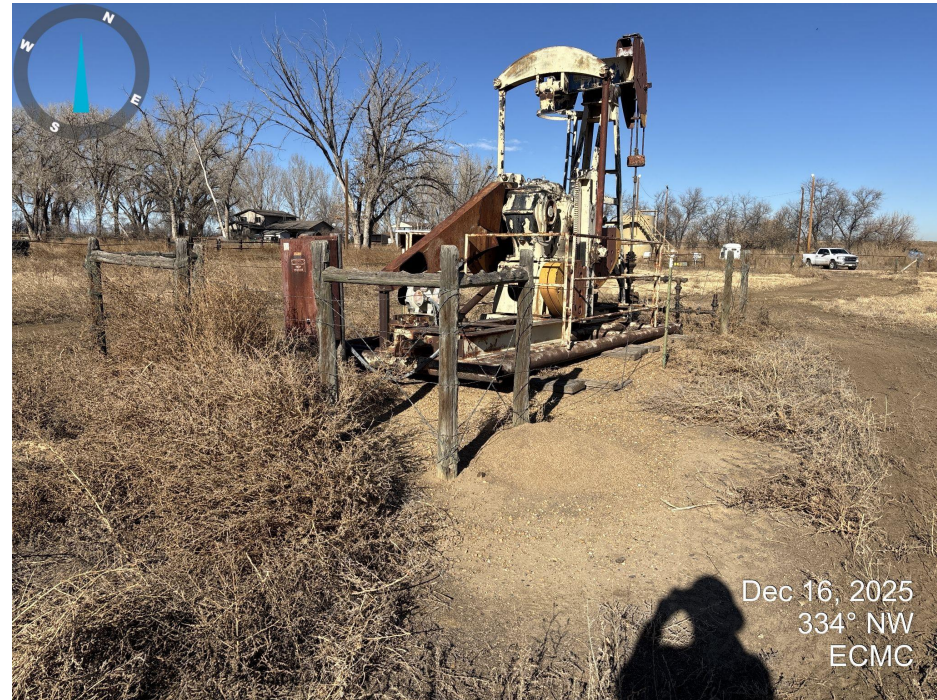
Dec 16, 2025
334° NW
ECMC

Photo 4. Looking north across the location. Weeds are present on location. The location size has been reduced and desirable perennial vegetation appears to be progressing in the interim area.
