Final Reclamation and Stormwater Inspection

Location ID: 319865

Well Name: AYLOR #2

Inspection Document #: 718601266

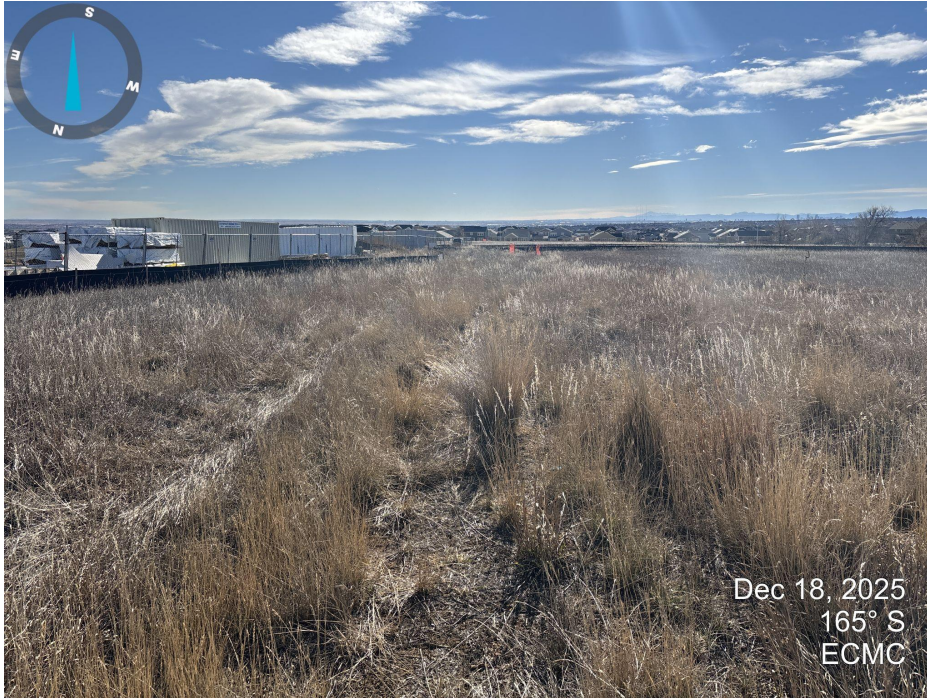
Photo 1. Looking south down the two track from the main access road irrigation ditch crossing. Vegetation appears to be reflective of the surrounding area. Nearby construction has disturbed a portion of this section of access road.

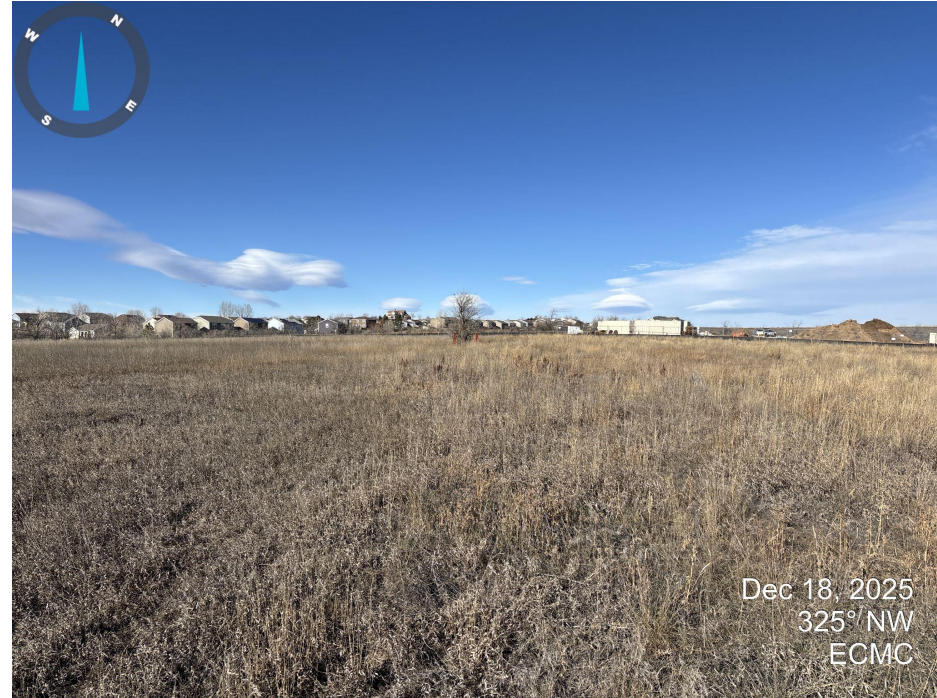
Photo 2. Looking north from the location along the northern access road. Vegetation on the access road appears to be reflective of the surrounding reference area.

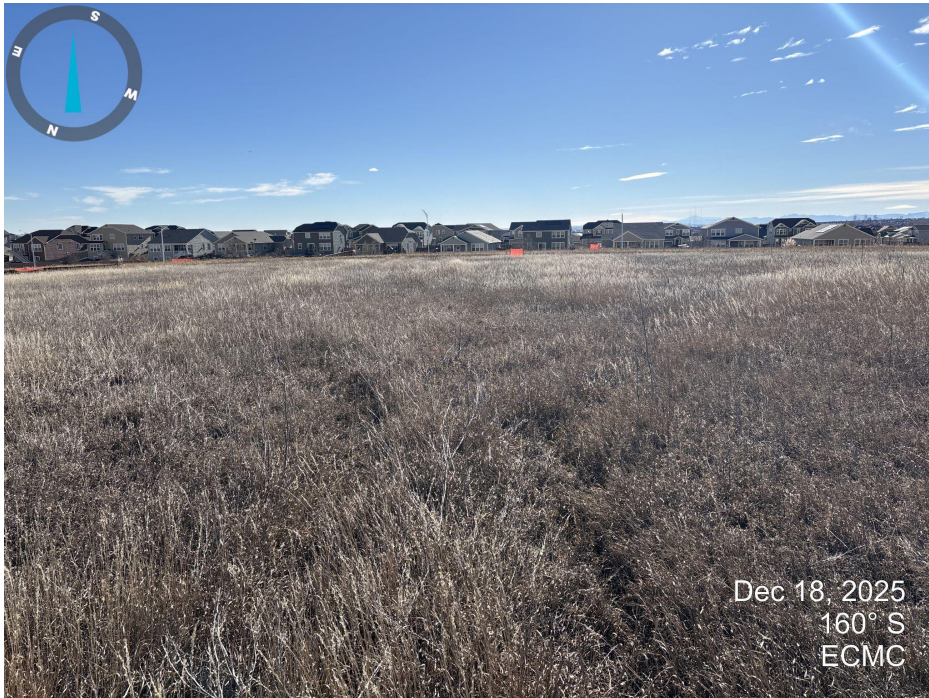
Photo 3. Picture taken from access road junction to the west of the well location. This portion of the access road appears to have been used for well access around 2014. This section of the access road appears reflective of the surrounding reference vegetation.

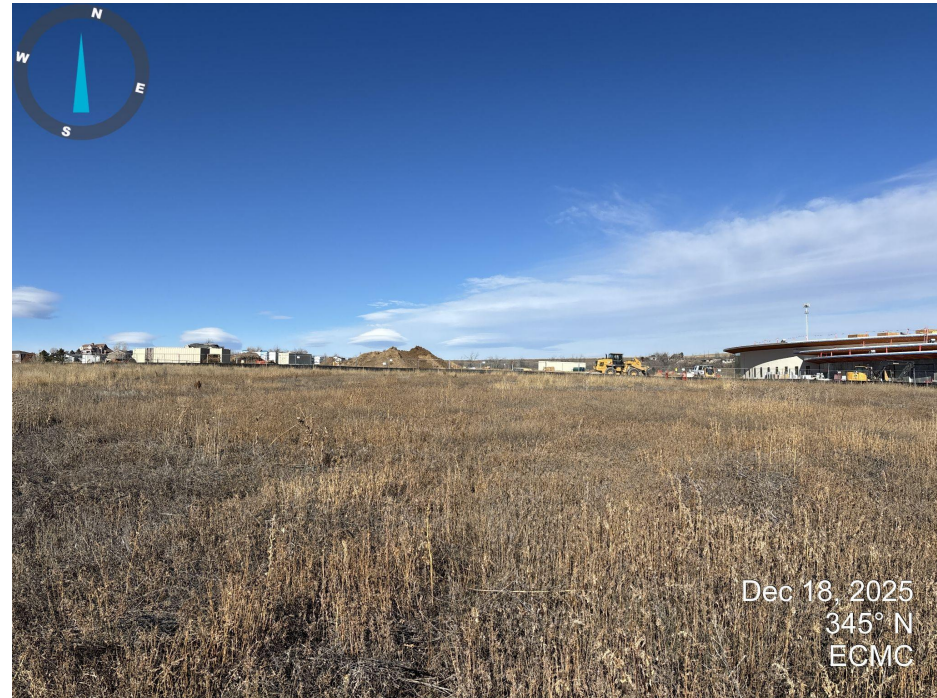
Photo 4. Looking across the well location disturbance from the south edge. Vegetation on location consists primarily of undesirable weeds such as ragweed and kochia. All oil and gas equipment has been removed from the location.

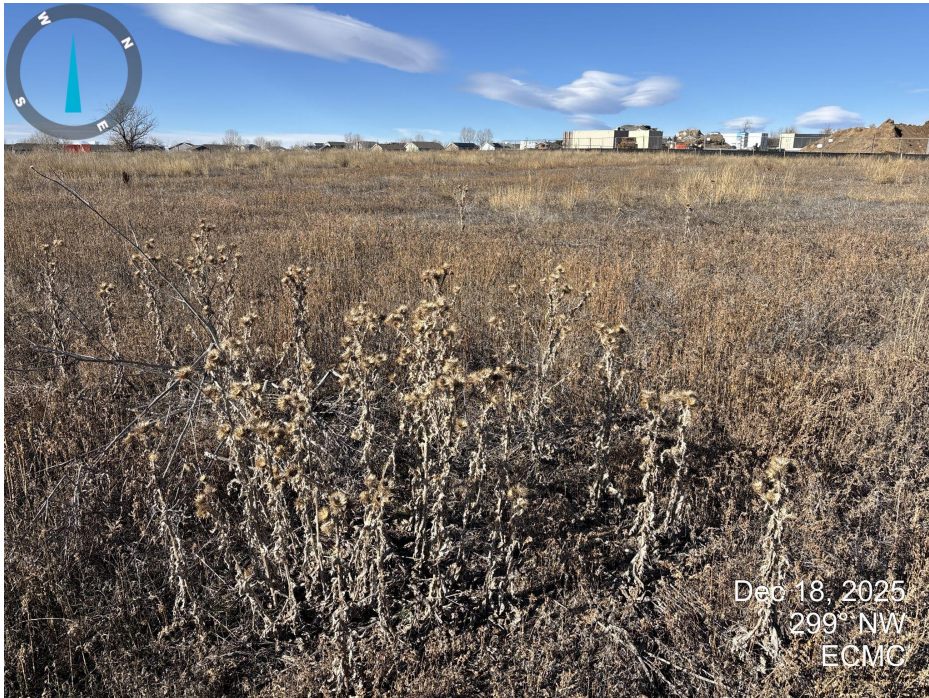
Photo 5. List B noxious weed scotch thistle is present on the location

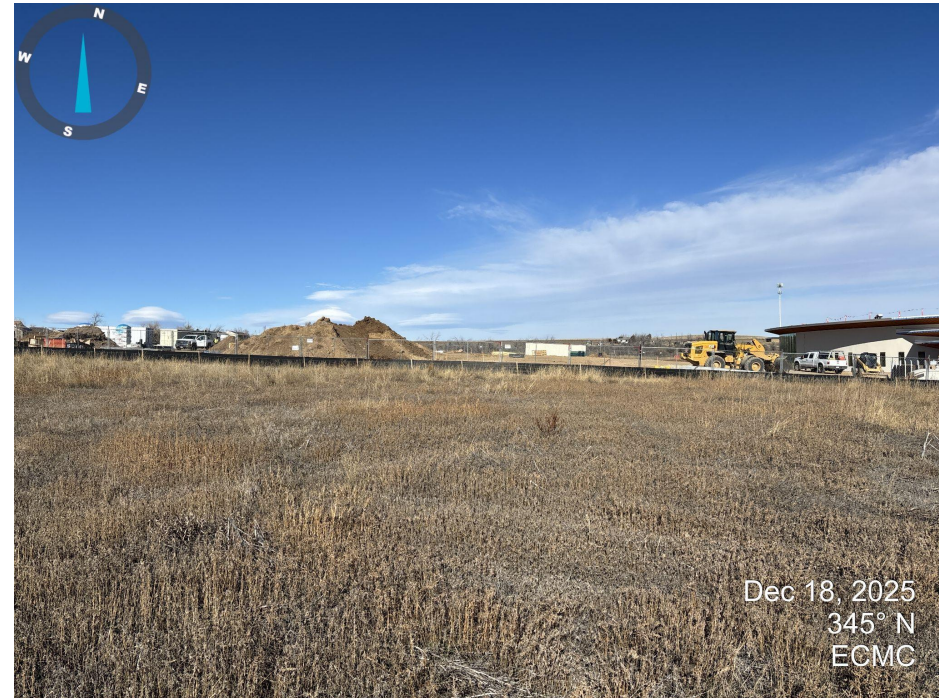
Photo 6. Looking north from the well location. Vegetation on location consists primarily of undesirable weeds such as ragweed and kochia. Limited desirable perennial vegetation is present on location but the location is not reflective of the reference area. A portion of the location is within an active construction zone.

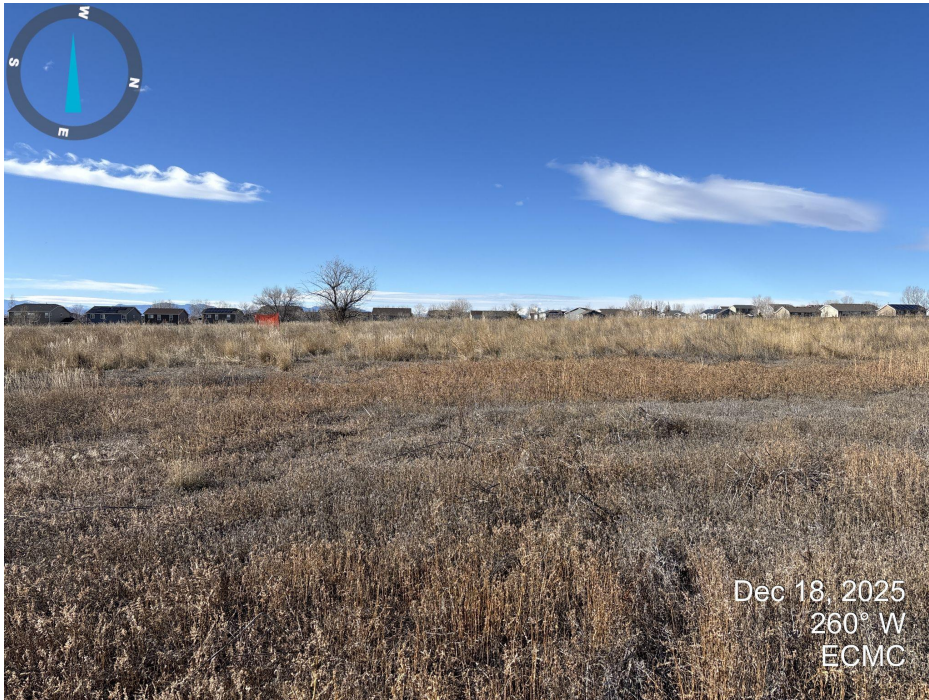
Photo 7. Looking west from the well location. See photo 6 comments.

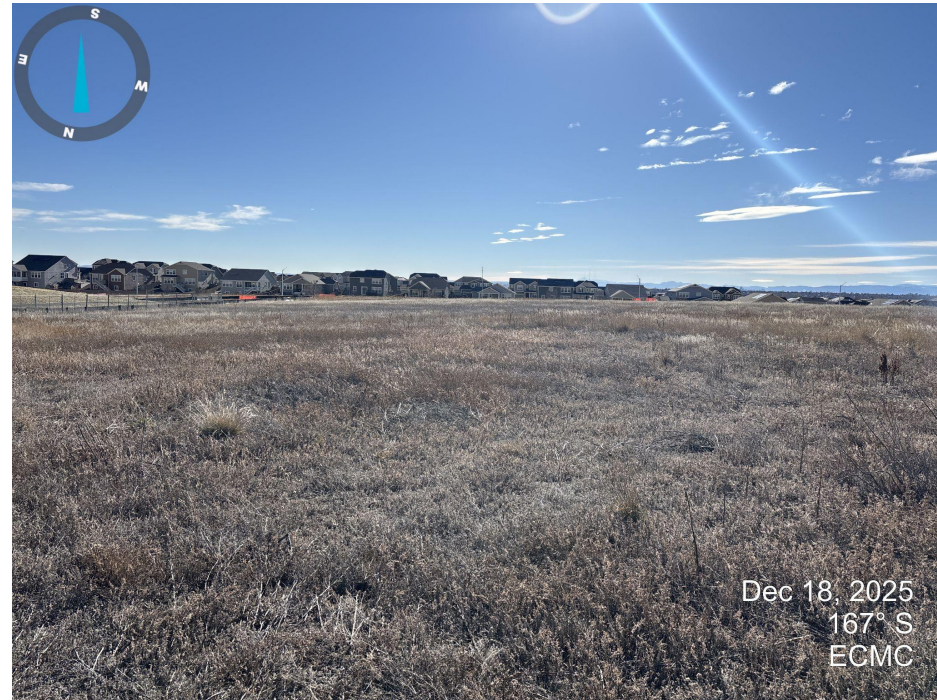
Photo 8. Looking south from the well location. See photo 6 comments.

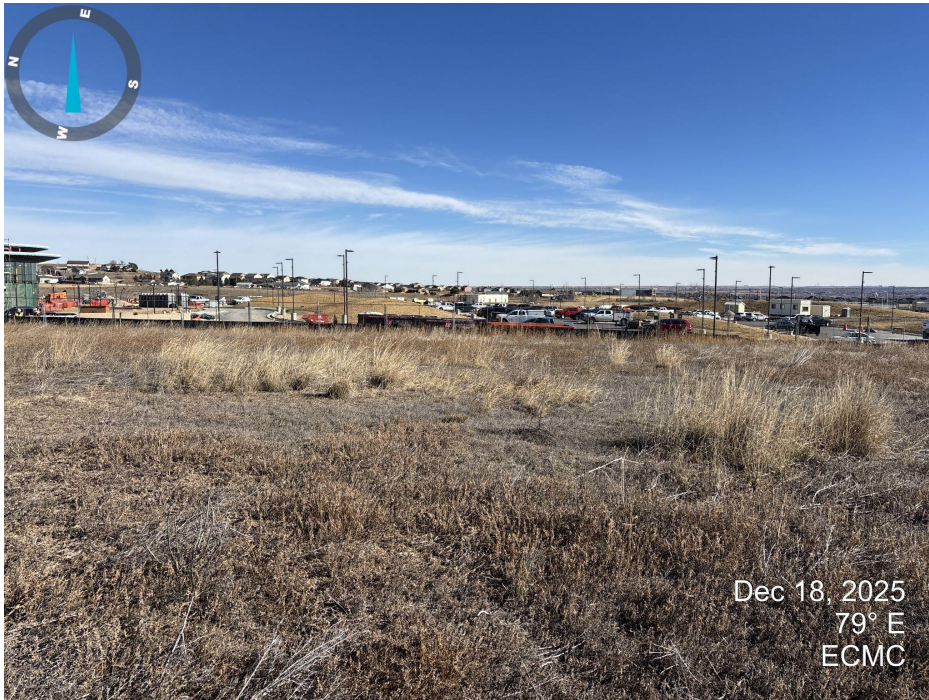
Photo 9. Looking east from the well location. See photo 6 comments.

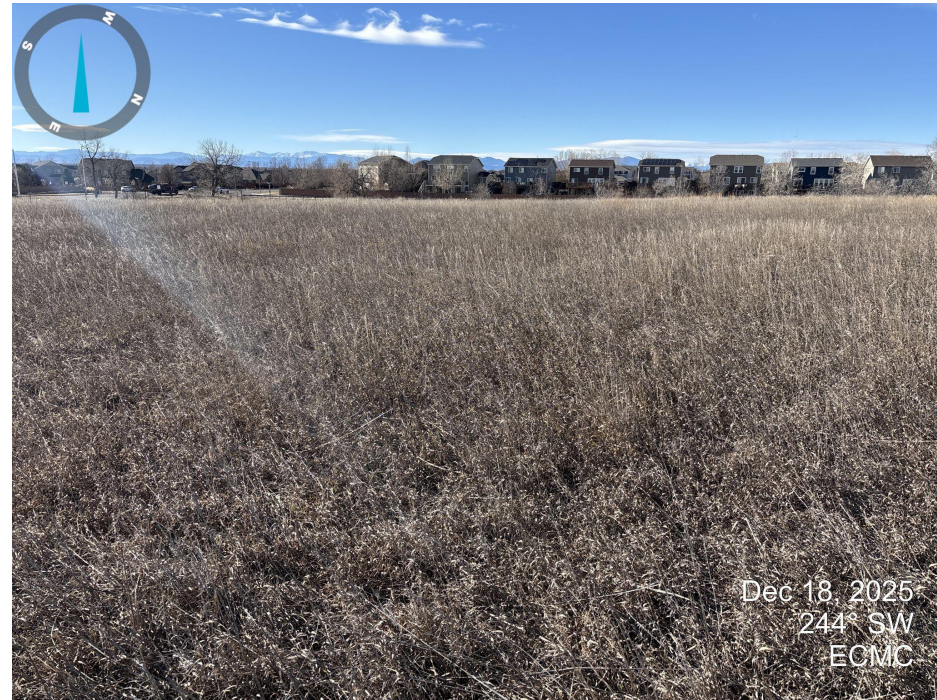
Photo 10. Reference vegetation to the west of the location.

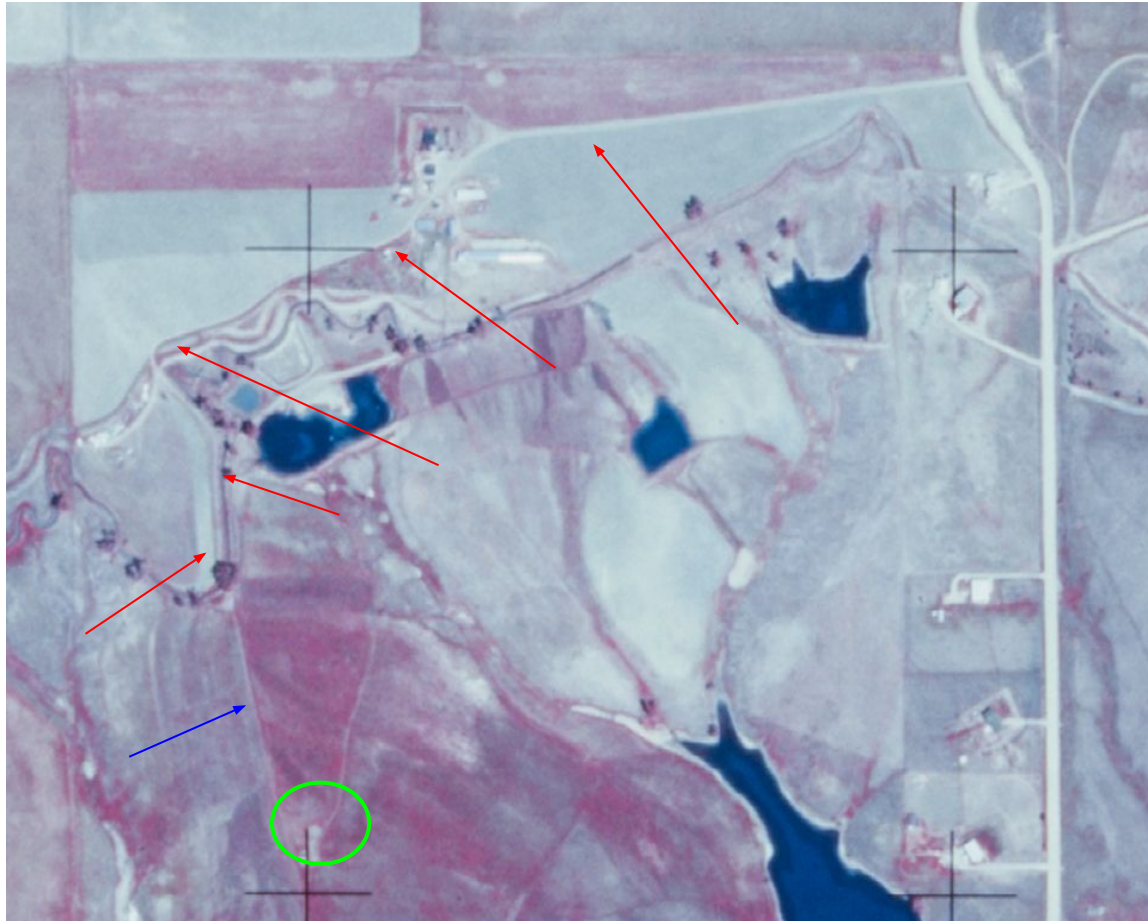
Photo 11. Aerial photograph taken 06-02-1972. The main access road appears to be preexisting to oil and gas development (red arrows). A two track (blue arrow) appears to exist after the irrigation ditch crossing, possibly along flood irrigation channels. Approximate location is displayed in green.

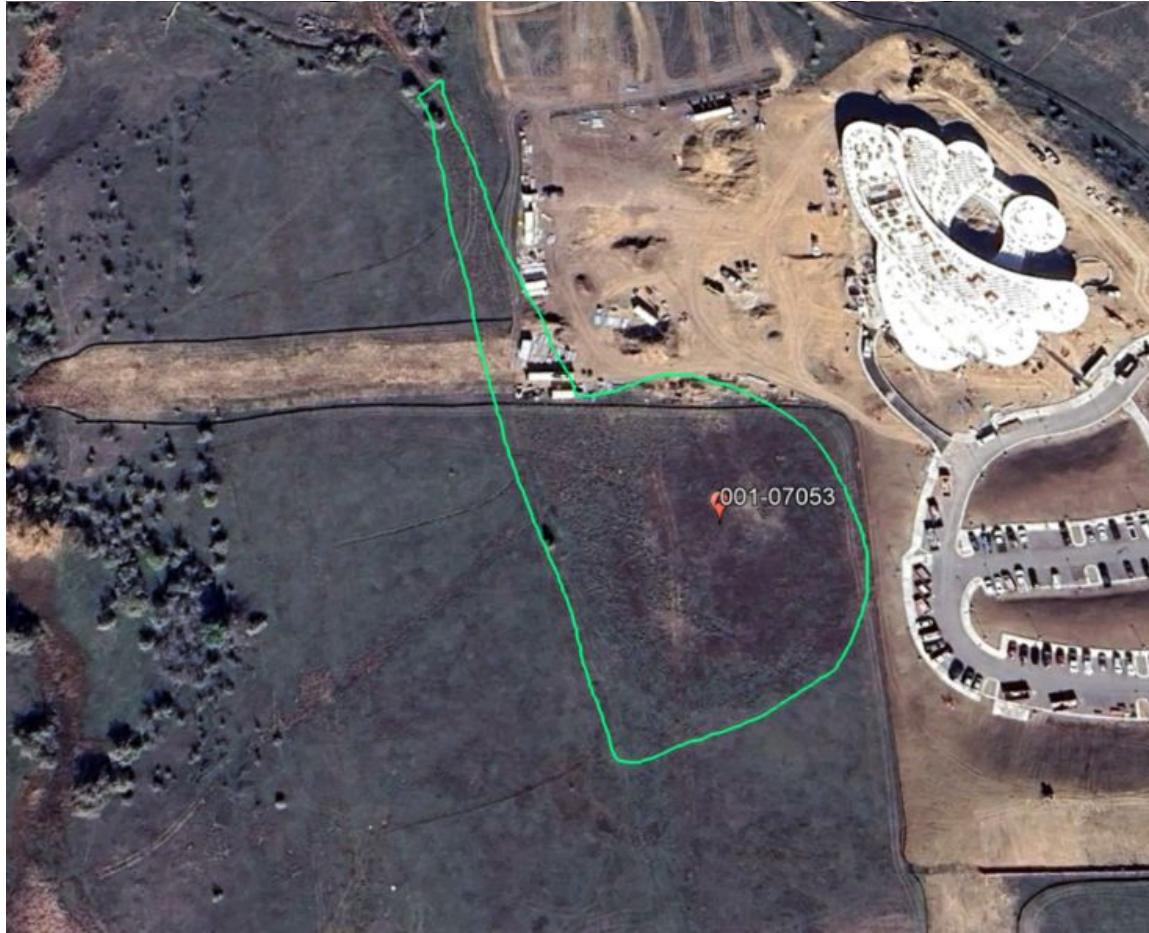
Photo 12. Google earth aerial imagery taken 10/2025. A portion of the disturbance area (green circle) for this location is in an active construction area.
