Final Reclamation and Stormwater Inspection

Location ID: 462729

Location Name: AYLOR-61S67W/20NWSE

Inspection Document #: 718601263

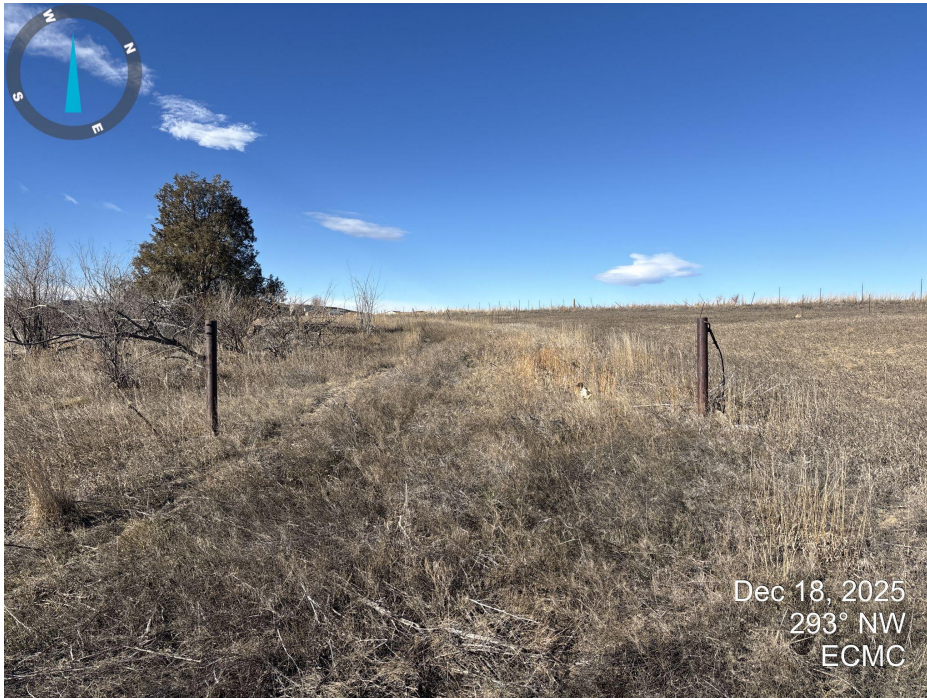
Photo 1. Looking northwest down the tank battery access road from the main access road. Wire gate and posts remain. Vegetation on the access road is primarily undesirable weeds such as kochia and ragweed as well as list C noxious weed downy brome.

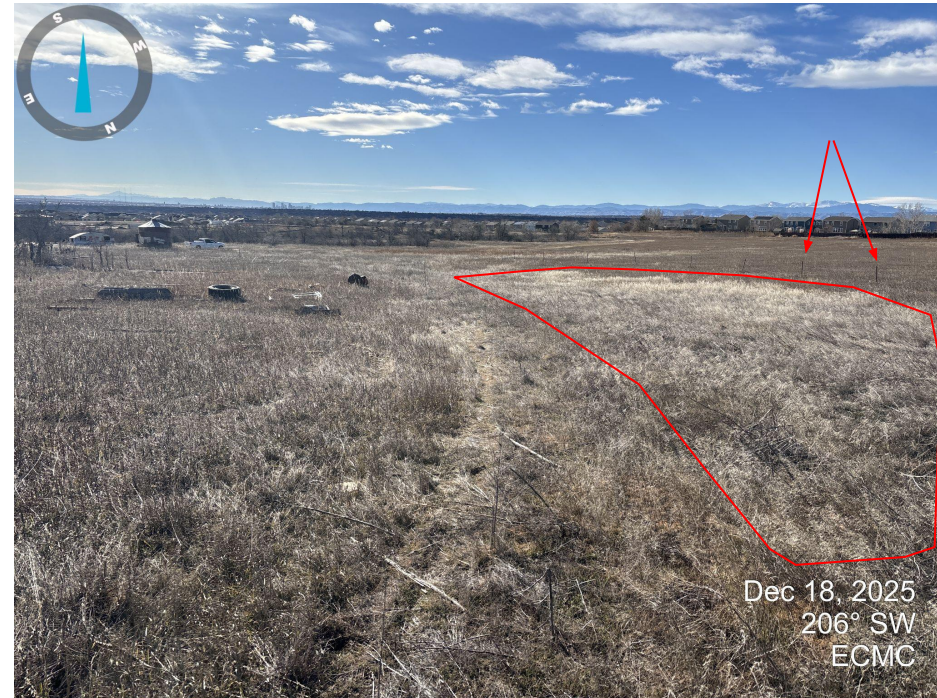
Photo 2. The tank battery access road travels north around nearby building. Photo taken looking south down the access road towards the tank battery location. An area that appears to have been disturbed by oil and gas is present to the west of the access road (red circle). A single wire fence borders this area (red arrow). This area contains list C noxious weed downy brome.

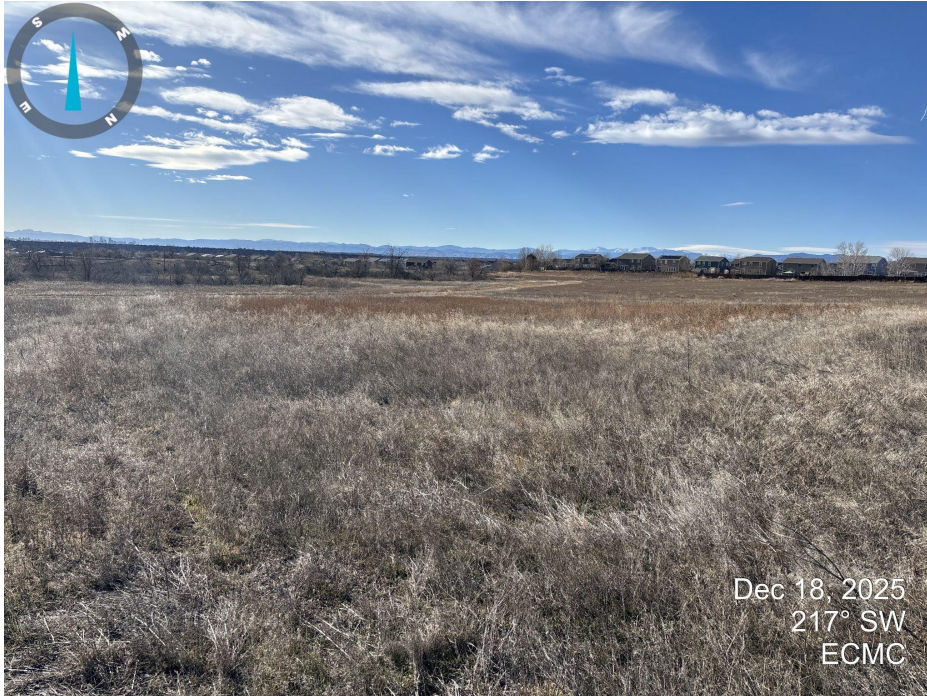
Photo 3. Picture Looking south west across the tank battery location. No production equipment remains on the tank battery.

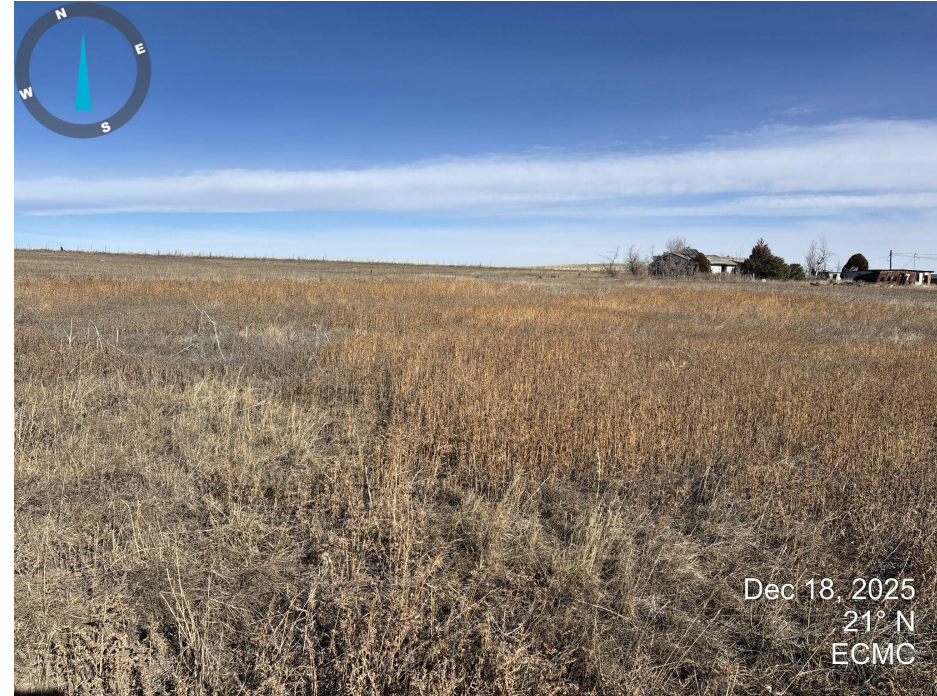
Photo 4. Looking north from the center of the location. Vegetation on the location is primarily undesirable vegetation such as ragweed kochia and list C noxious weed downy brome. Limited amounts of desirable perennial vegetation are present on and around the edges of the location but does not appear to be progressing towards 80% coverage of the reference area.

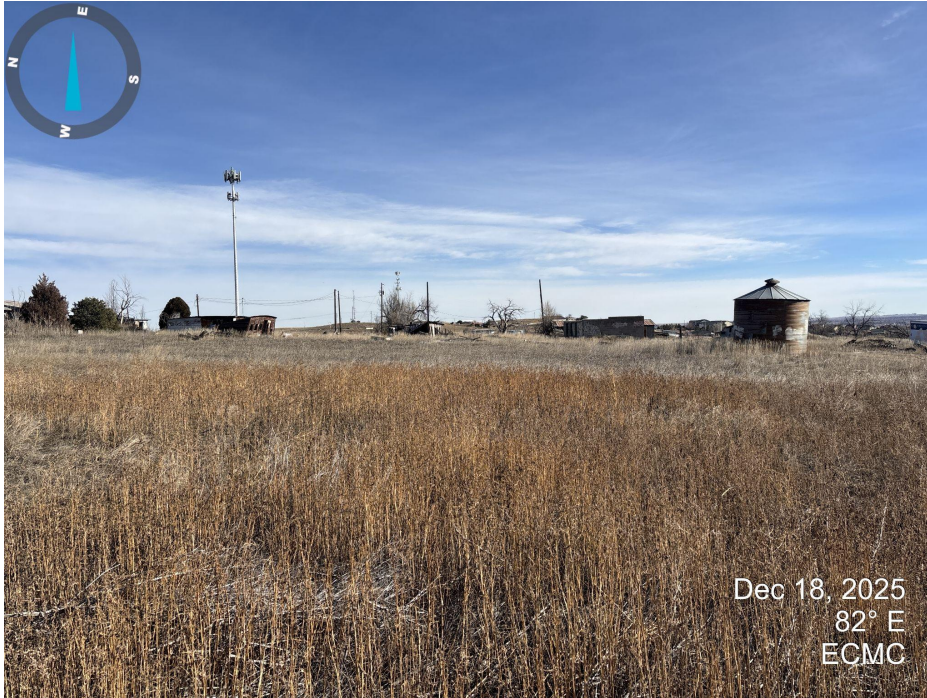
Dec 18, 2025
82° E
ECMC

Photo 5. Looking east from the center of the tank battery. See photo 4 comments.

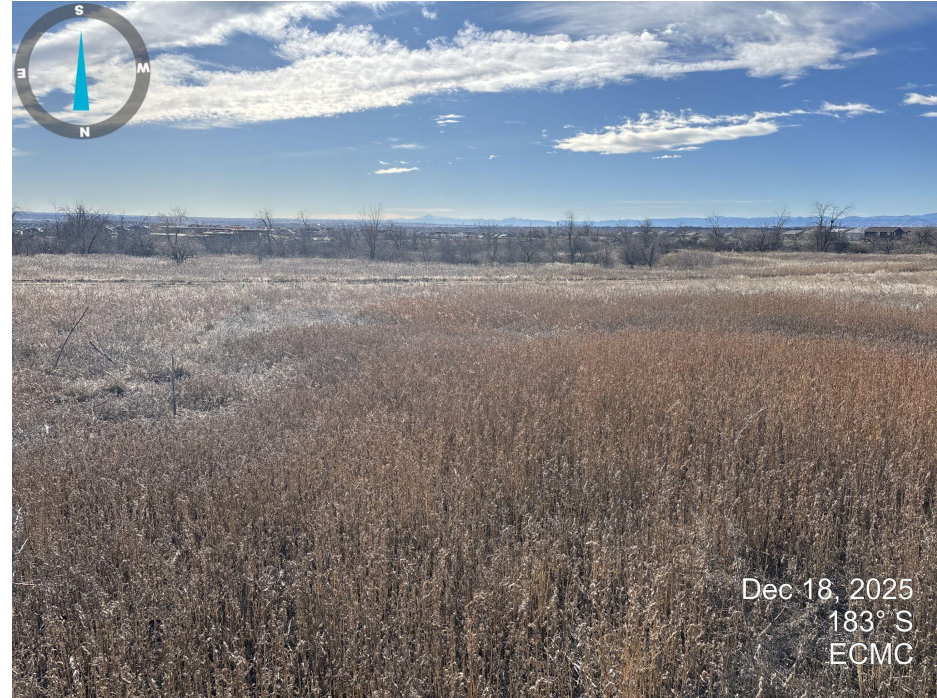
Dec 18, 2025
183° S
ECMC

Photo 6. Looking south from the center of the tank battery. See photo 4 comments.

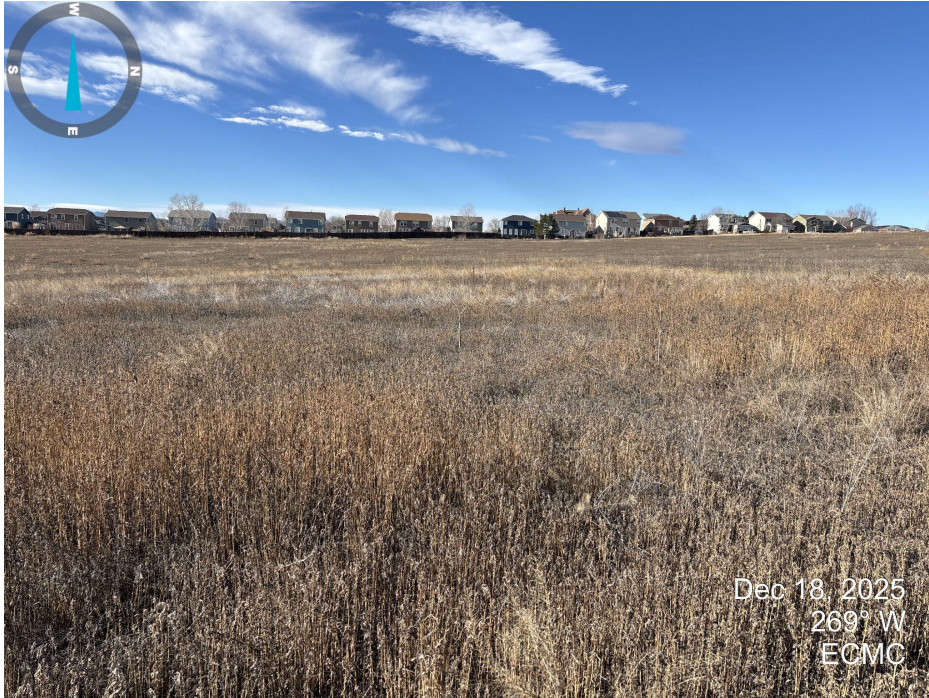
Photo 7. Looking west from the center of the tank battery. See photo 4 comments.

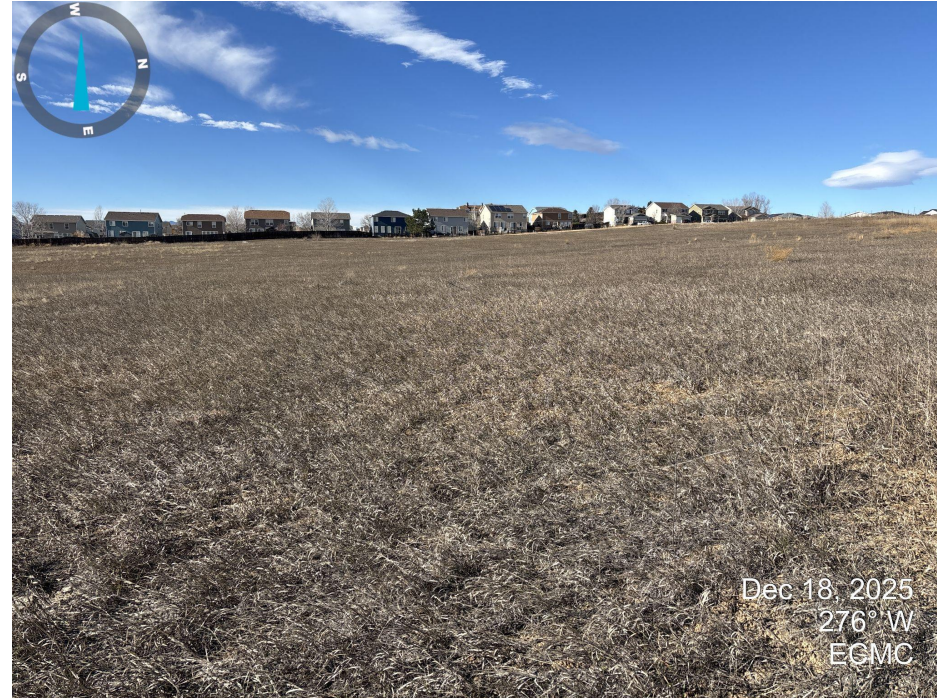
Photo 8. Reference vegetation to the west of the tank battery location.

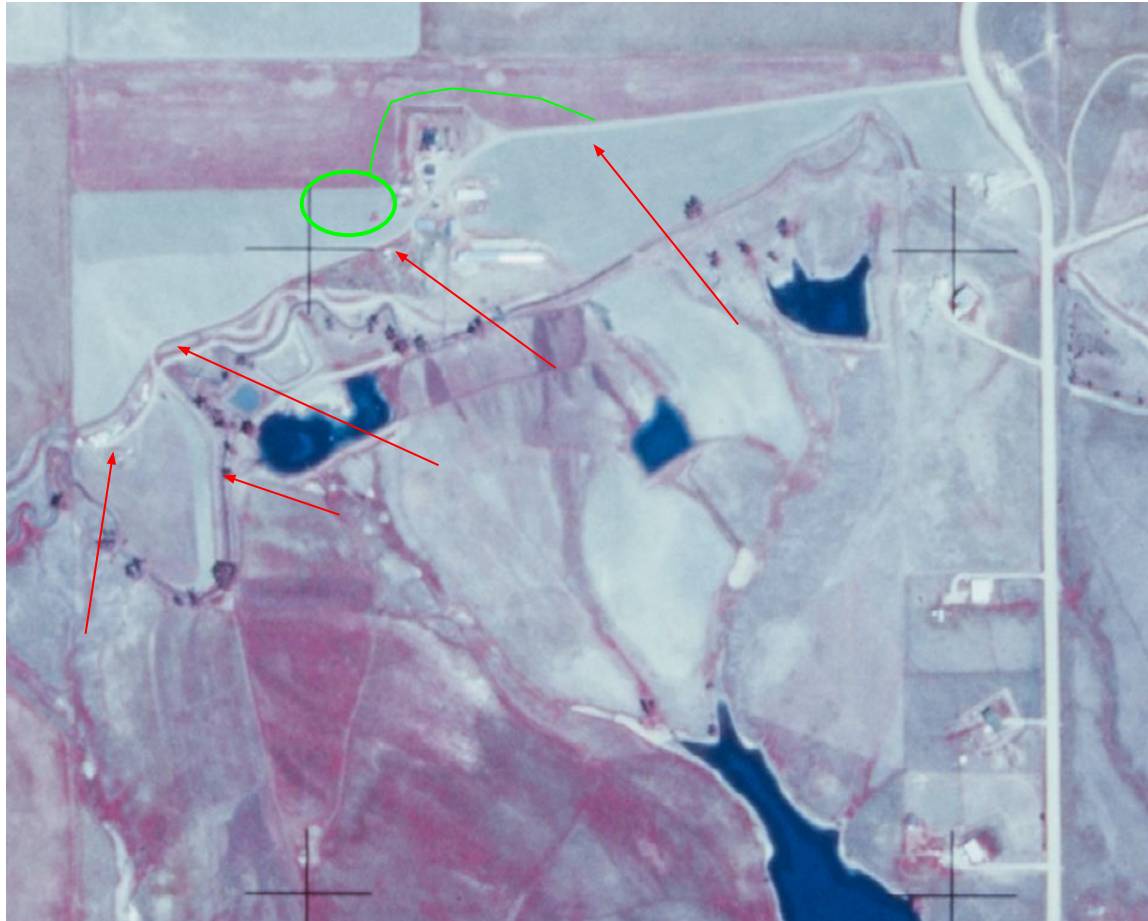
Photo 9. Aerial photograph taken 06-02-1972. The main access road appears to be preexisting to oil and gas development (red arrows). Approximate tank battery access road and location are displayed in green.
