# Chevron Rockies Business Unit

## Field Qualitative Criteria for ECMC Reporting Associated with the Discovery of Potentially Impacted Material

Location name: Weidenkeller 64N65W 1NWNW

**Potential Release Locations (12/30/2025)**  
Weidenkeller 64N65W 1NWNW

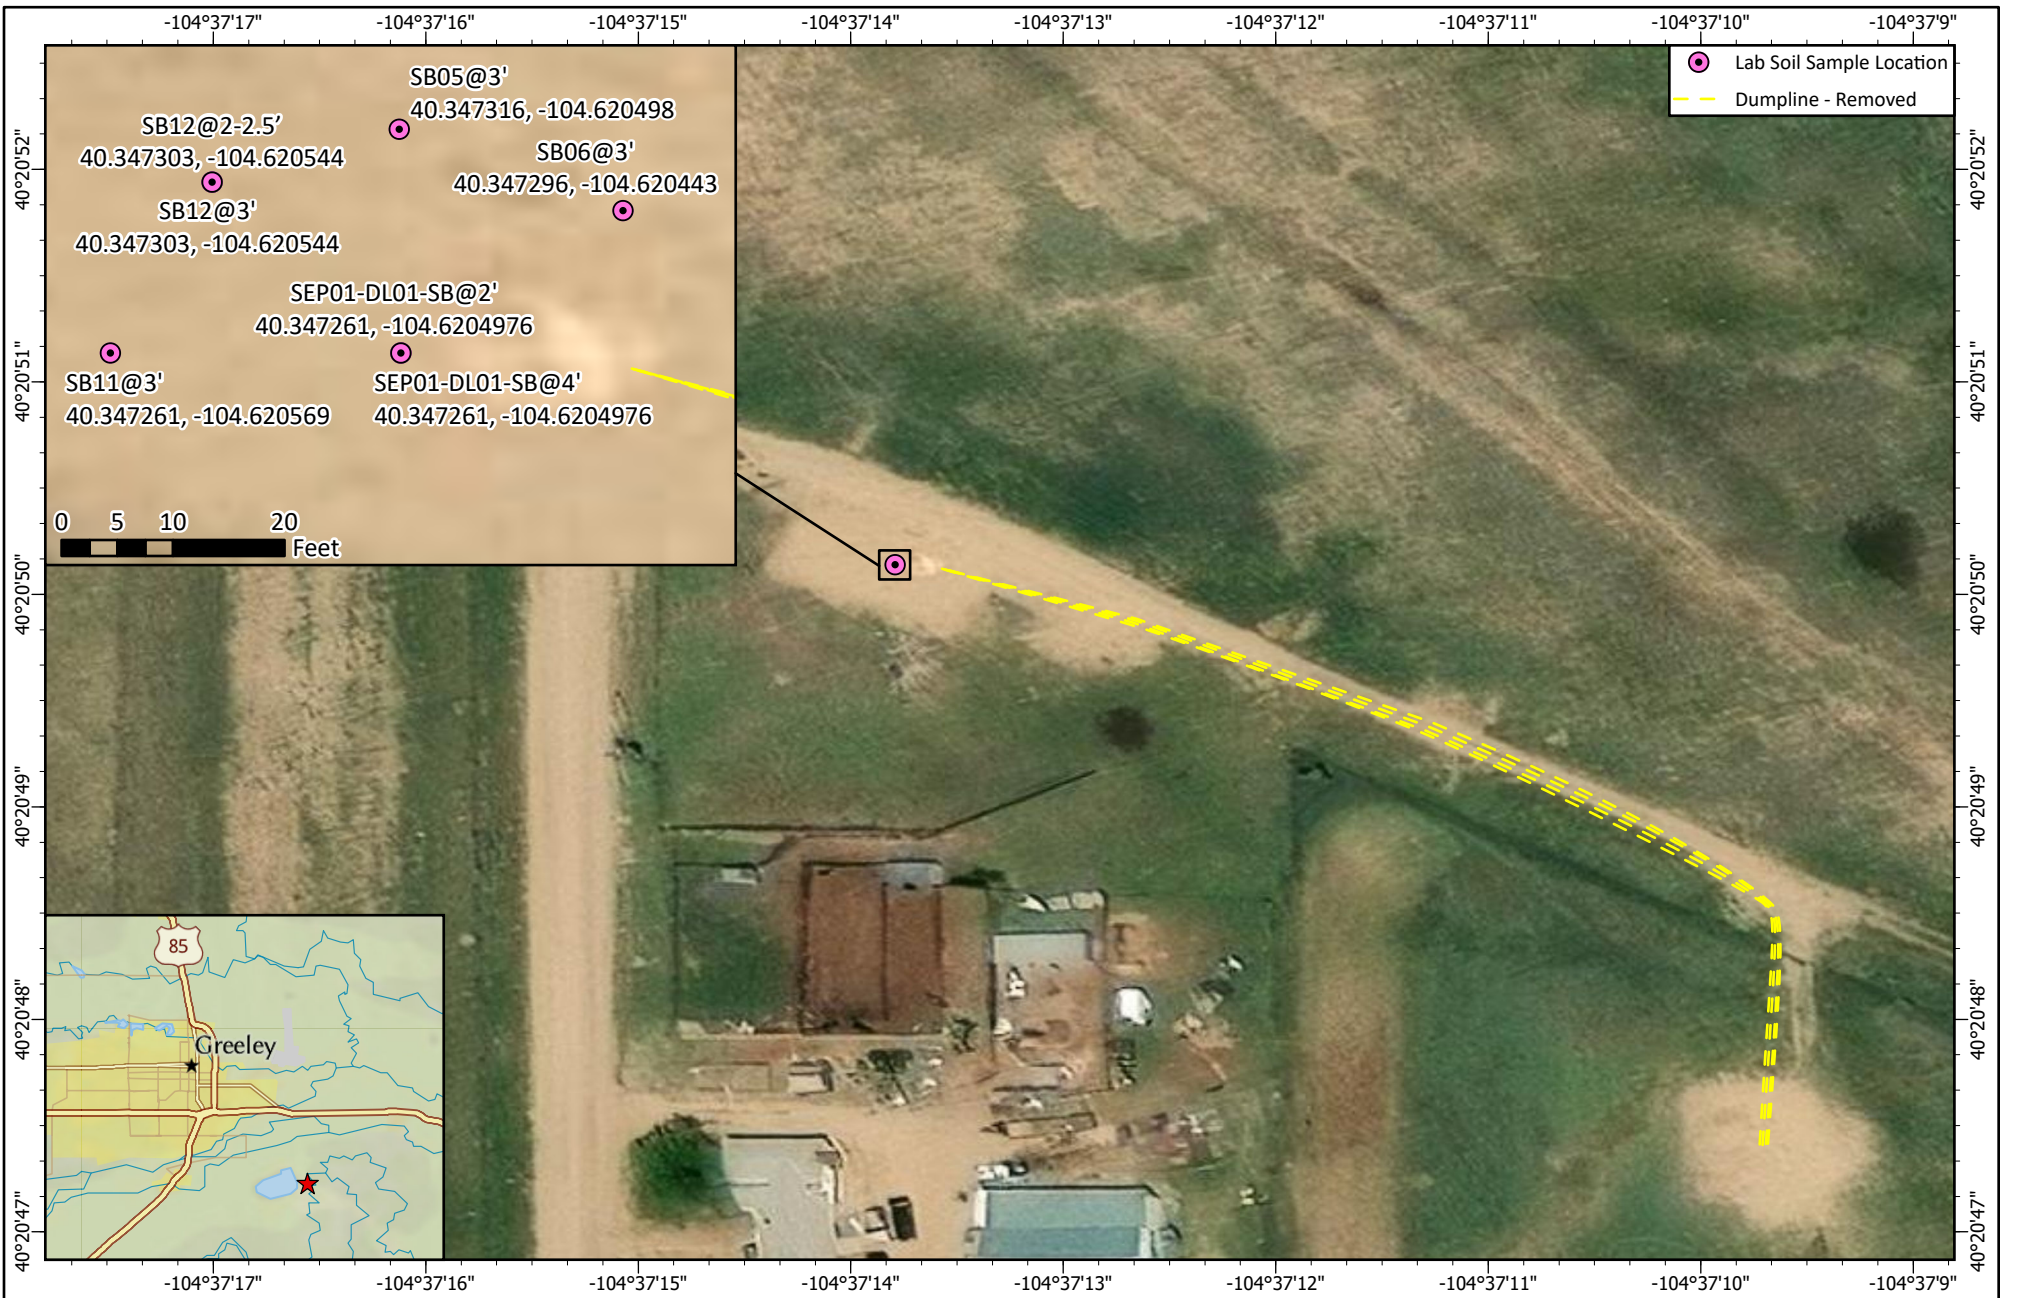
Figure 2

Visibly stained soils were encountered during the SSI sampling activities completed on December 30, 2025. Visibly stained soil was observed at sampling location SEP01-DL01-SB (40.347261, -104.620498) from approximately 1.5 to four (4) feet below ground surface (bgs); at sampling location SB05 (40.347316, -104.620498) from approximately one (1) to three (3) feet bgs; at sampling location SB06 (40.347296, -104.620443) at approximately three (3) feet bgs; at sampling location SB11 (40.347261, -104.620569) from approximately 2.5 to three (3) feet bgs; and at sampling location SB12 (40.347303, -104.620544) from approximately 0.5 to three (3) feet bgs. The stained soils encountered at sampling locations SEP01-DL01-SB, SB05, SB06, and SB12 also exhibited petroleum odors.

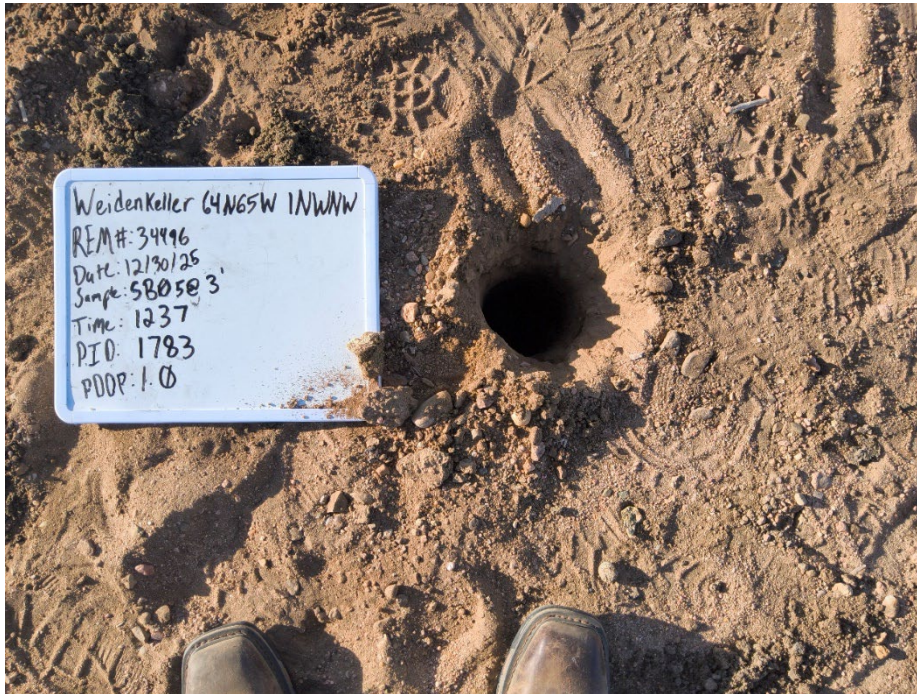
<b>Photo:</b> 1	<b>Date:</b> 12/30/2025	<b>Description:</b> Representative picture of general conditions at soil sampling location SB05 (soil boring; 40.347316, -104.620498) in well graded sand (SW) at a depth of approximately three (3) feet below ground surface (bgs) (PID: 1,783 ppm). Soil staining and petroleum odors were observed.
--------------------	----------------------------	---

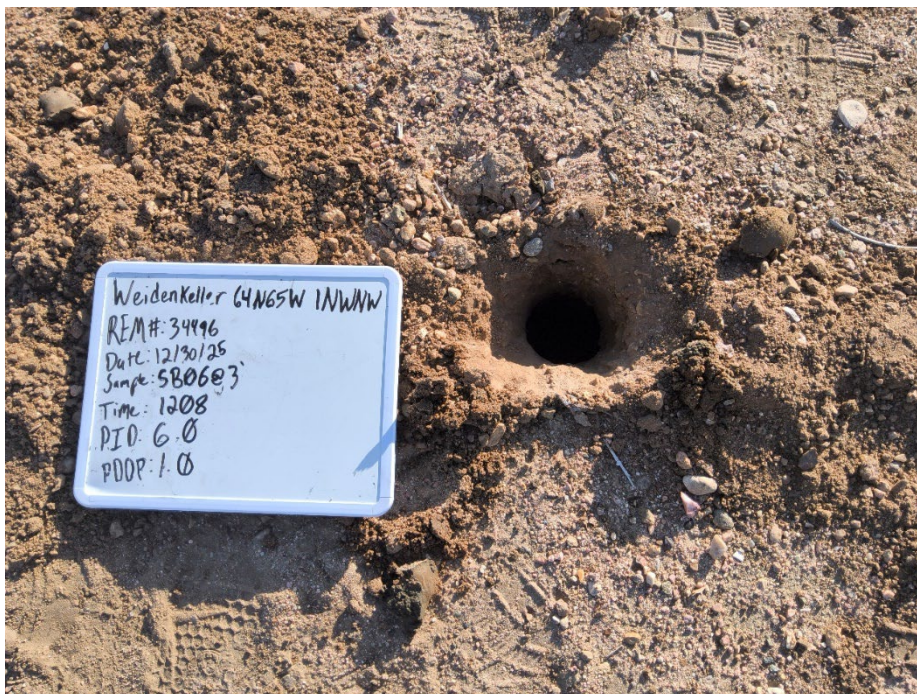
<b>Photo:</b> 2	<b>Date:</b> 12/30/2025	<b>Description:</b> Representative picture of general conditions at soil sampling location SB06 (40.347296, -104.620443) in well graded sand (SW) at a depth of approximately three (3) feet bgs (PID: 6.0 ppm). Soil staining and petroleum odors were observed.
--------------------	----------------------------	---

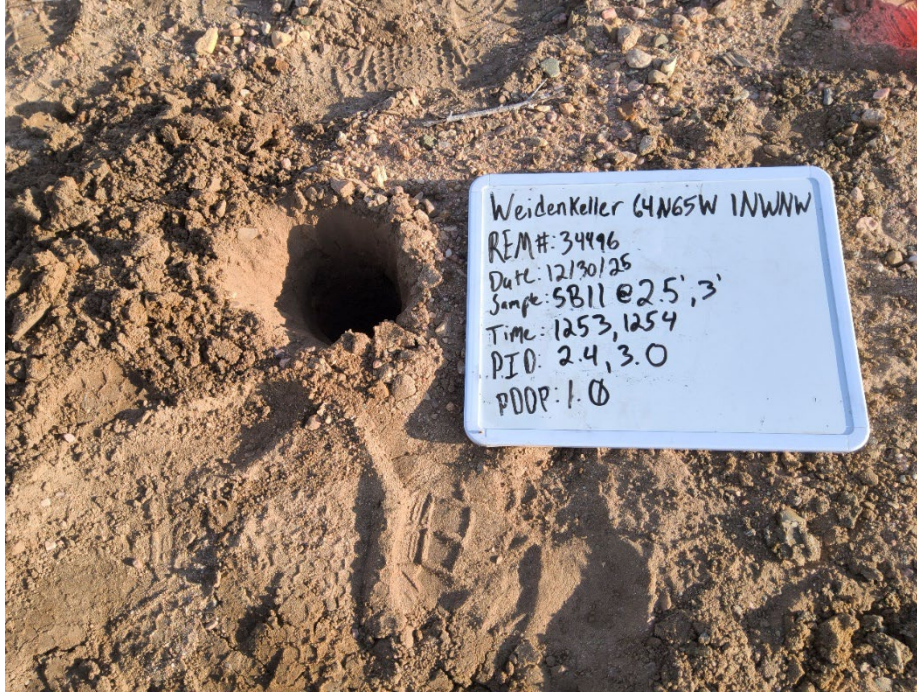
<b>Photo:</b> 3	<b>Date:</b> 12/30/2025	<b>Description:</b> Representative picture of general conditions at soil sampling location SB11 (40.347261, -104.620569) in well graded sand (SW) at a depth of approximately three (3) bgs (PID: 3.0 ppm). Soil staining observed.
--------------------	----------------------------	---

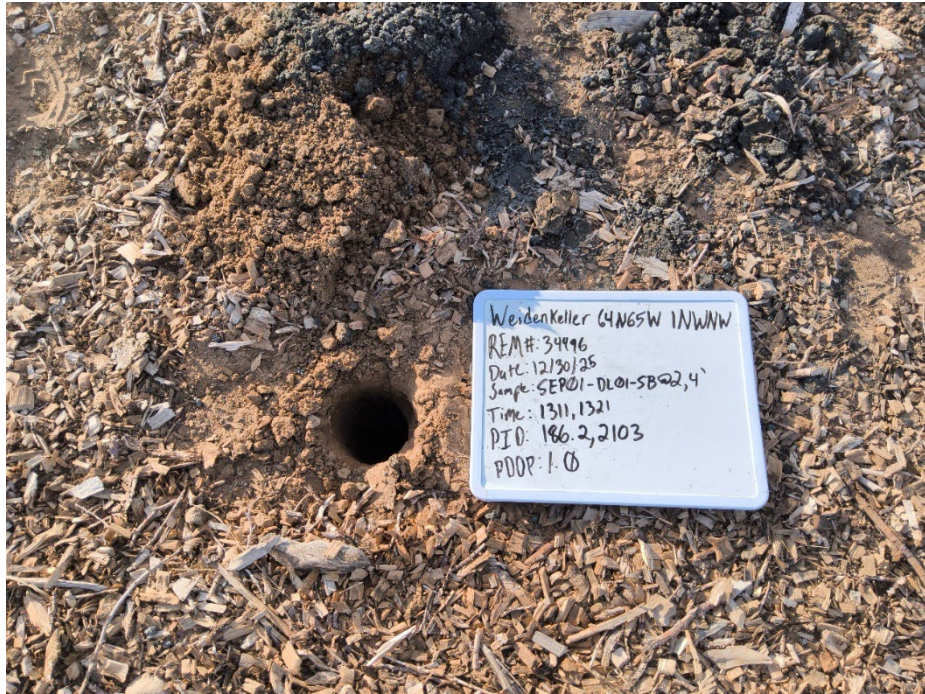
<b>Photo:</b> 5	<b>Date:</b> 12/30/2025	<b>Description:</b> Representative picture of general conditions at soil sampling location SEP01-DL01-SB (40.347261, -104.620498) in well graded sand (SW) at a depth of approximately two (2) and four (4) feet bgs (PID: 186.2 and 2103 ppm). Soil staining and petroleum odors were observed.
--------------------	----------------------------	--
