# Inspection Photos

Operator: Hilcorp Energy

Location ID: 385910

Inspection Photos  
Location Name: Kaime 2-12 U-R  
Location ID: 385910

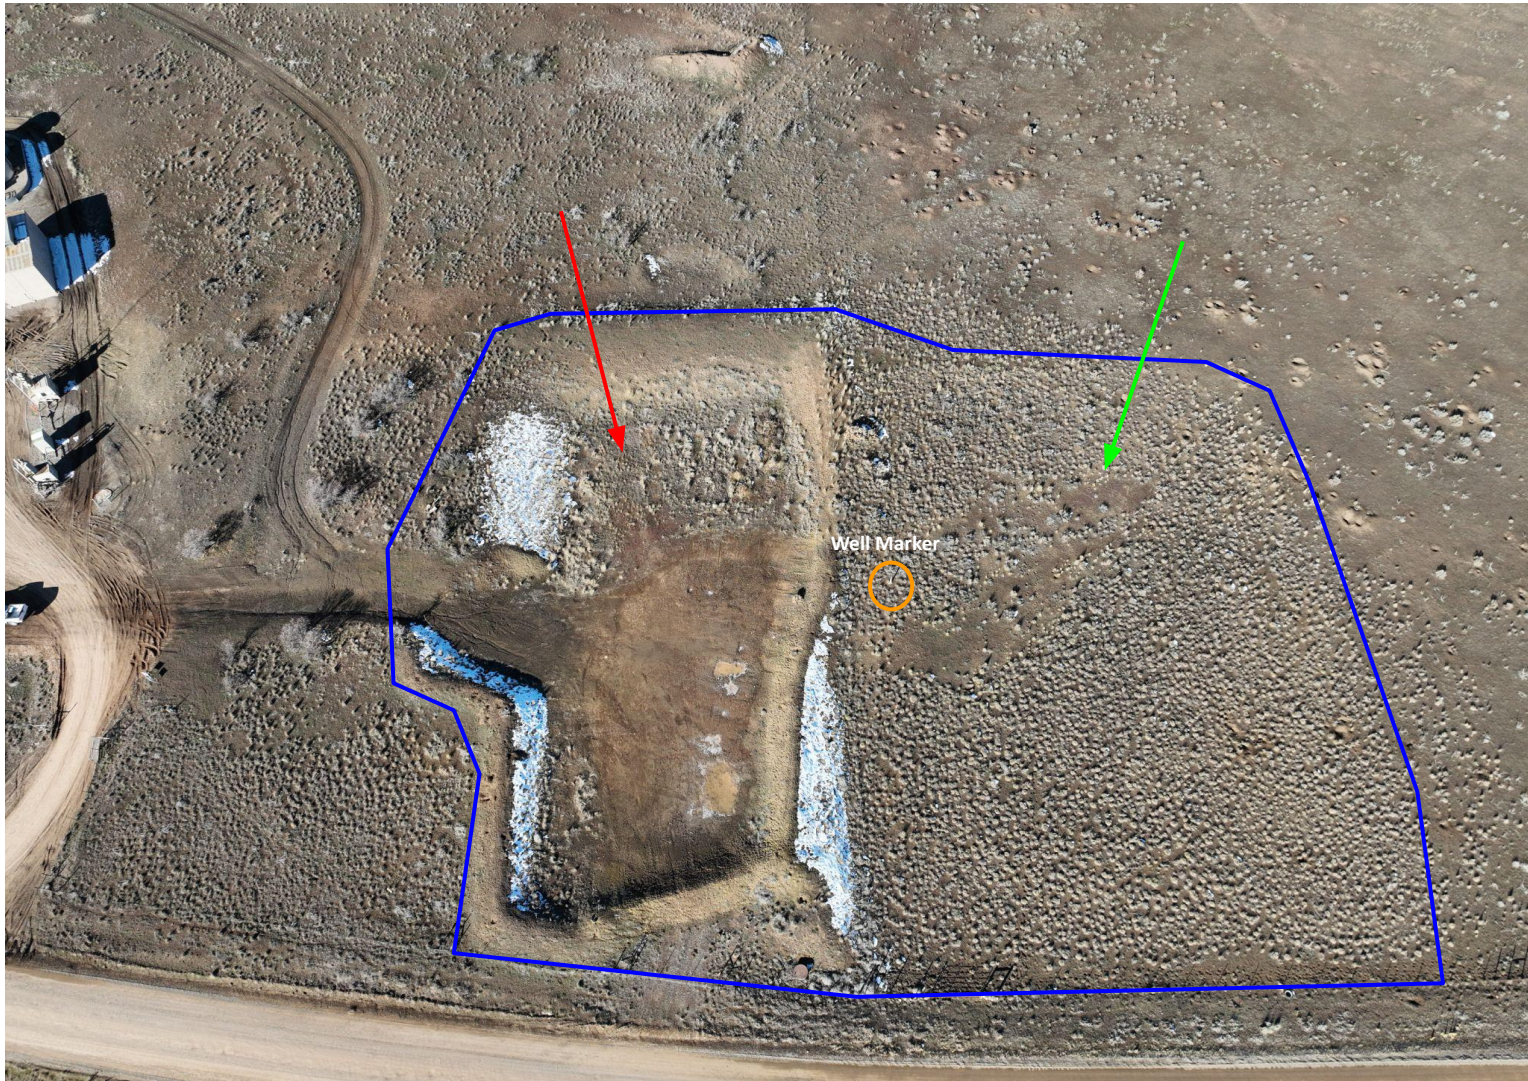
**Photo 1.** Aerial photo of the location taken with a drone during the time of the inspection from directly above the project area. Note: Entire project area has been outlined in blue. western portion which has not been reclaimed (indicated by red arrow) and Eastern portion of project area which appears to have been reclaimed per 1004 rules and standards (indicated by green arrow).

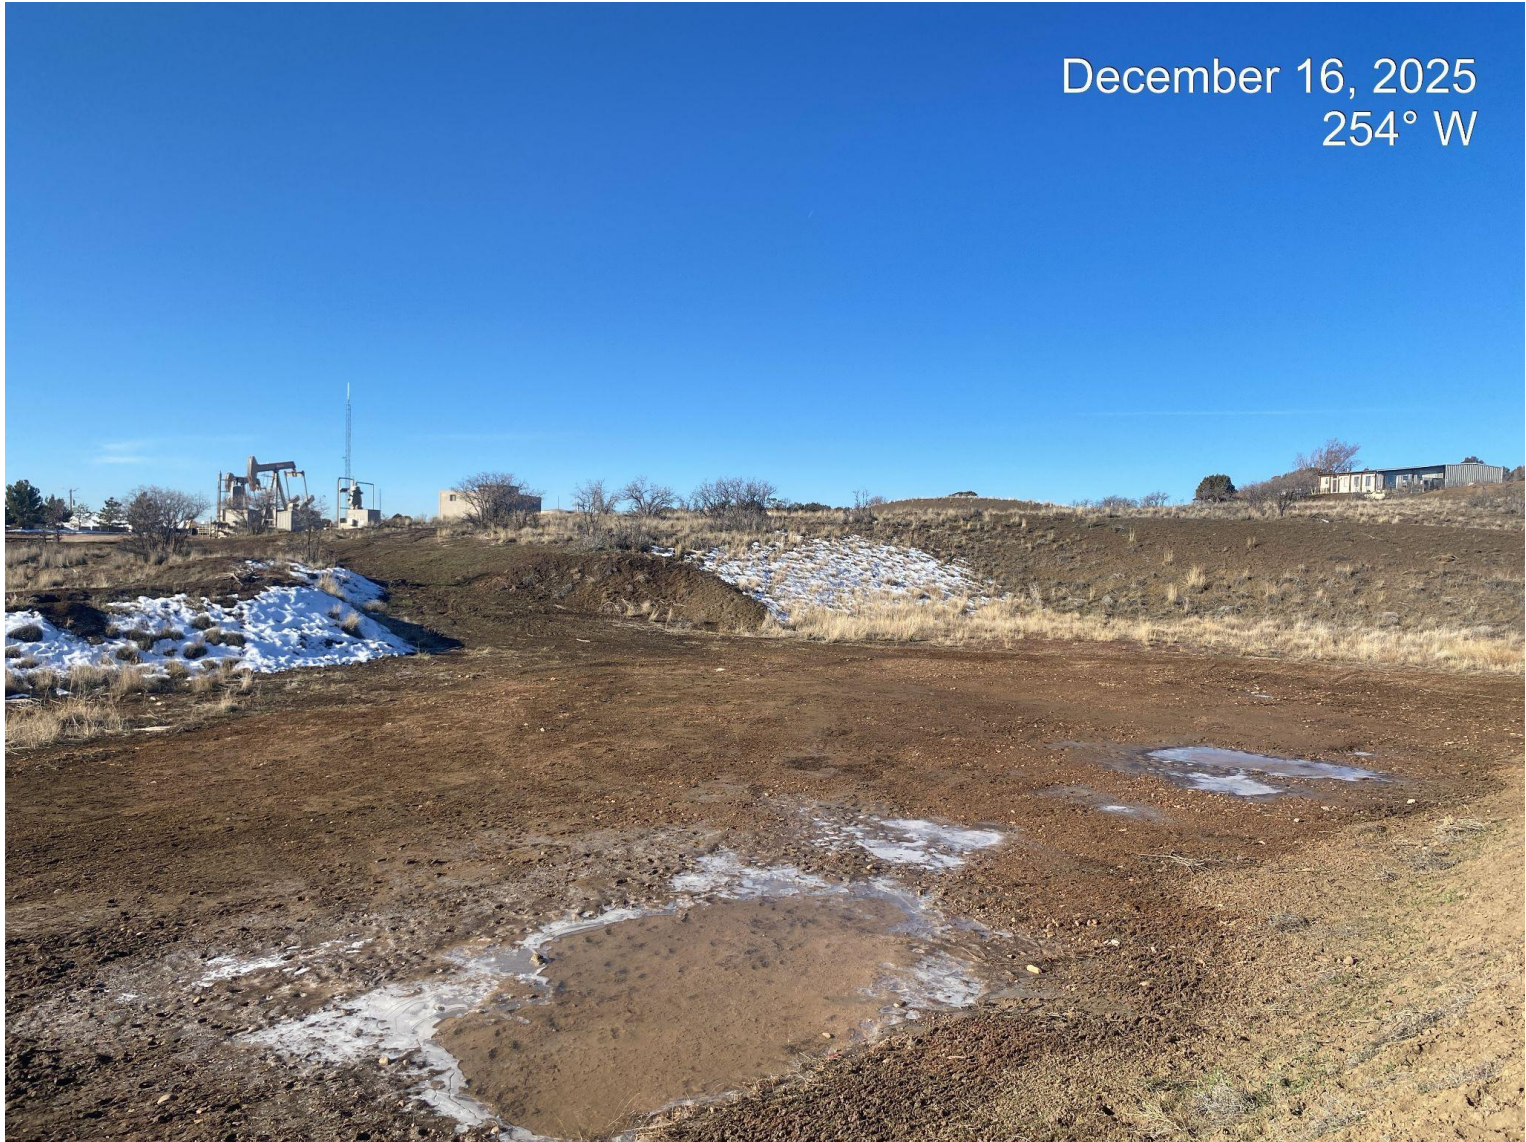
December 16, 2025  
254° W

**Photo 2.** View of the western portion of the project area taken at ground level from the southern edge facing west.

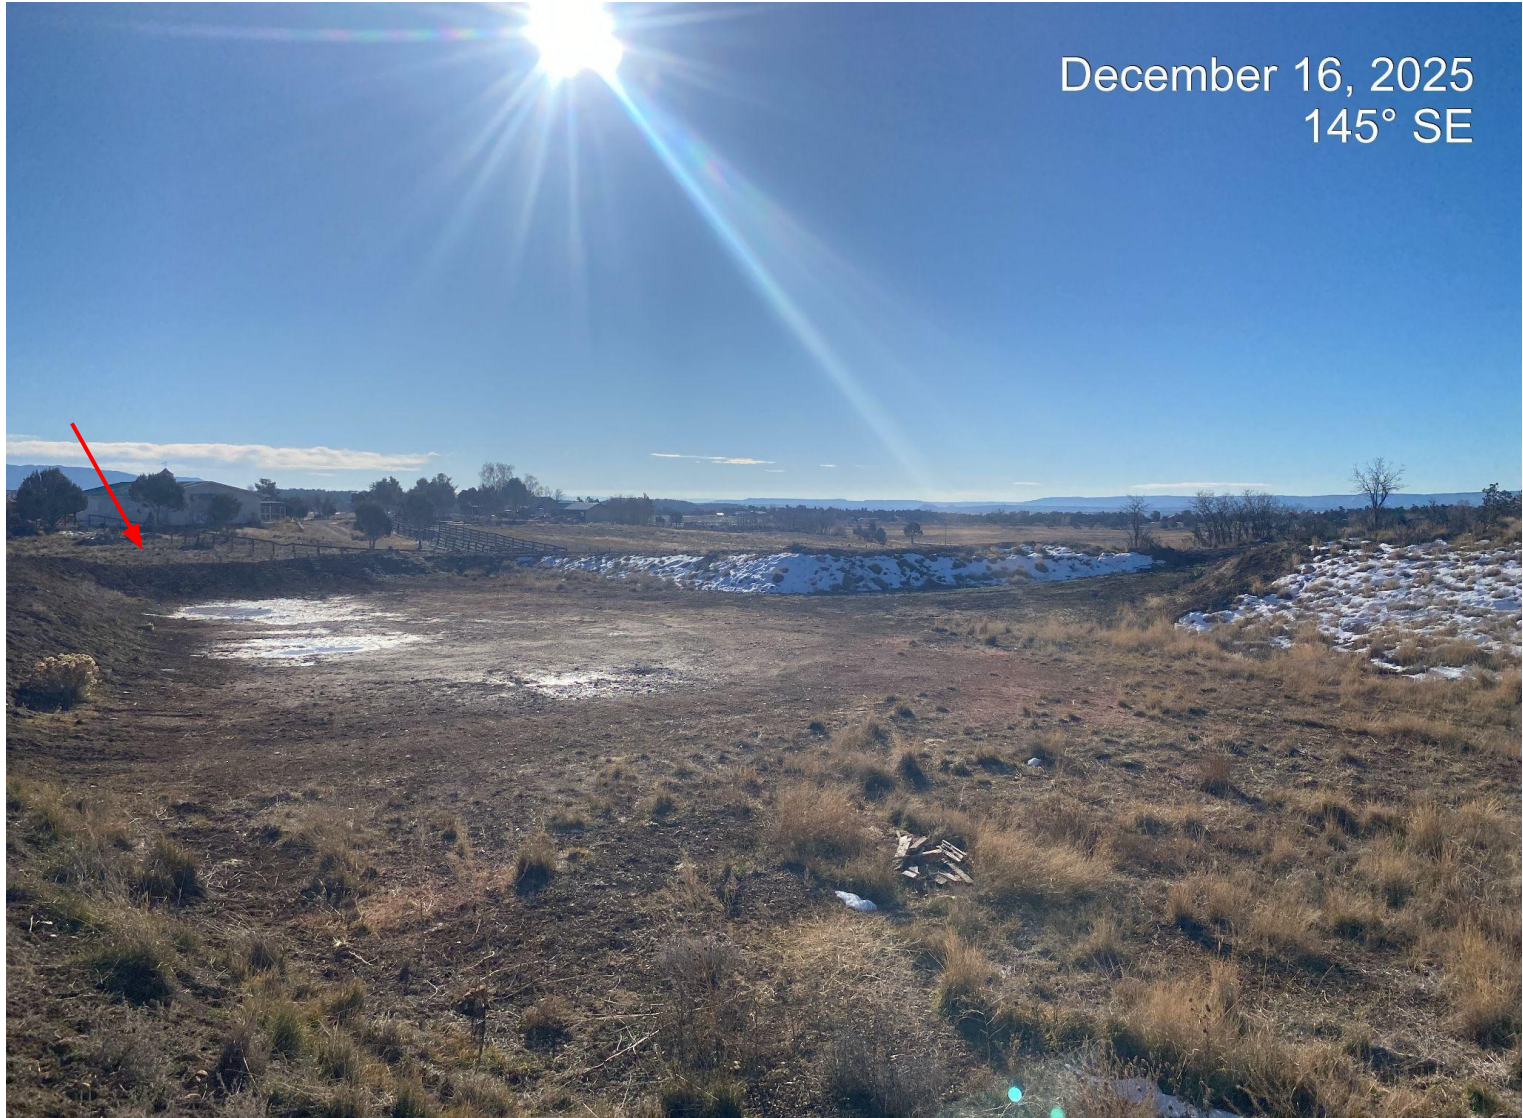
December 16, 2025  
145° SE

**Photo 3.** View of the the western portion of the project area taken from the northern edge facing south east. Note: Additional berm has been constructed on the southern edge of the western project area (indicated by red arrow). It was noted that surface owner equipment has been removed but western portion of the project area still remains unreclaimed per 1004 rules.

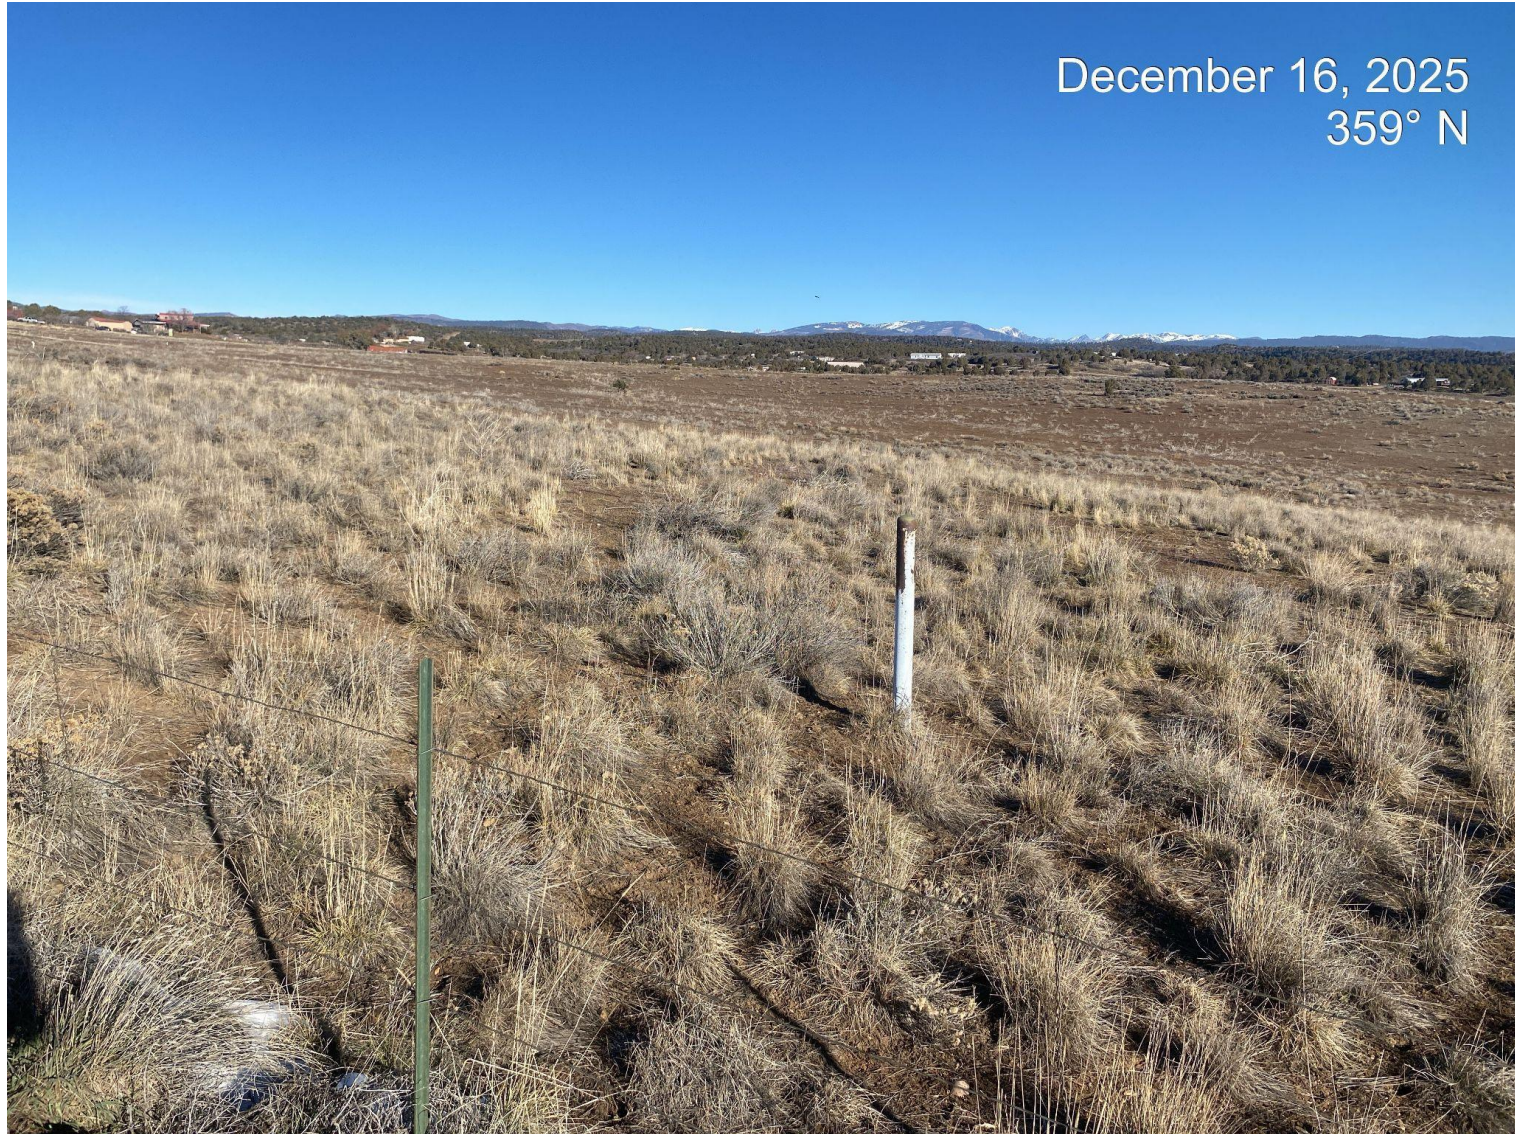
December 16, 2025  
359° N

**Photo 4.** View of well marker on the eastern side of the project area. This portion of the project area has been reclaimed and appears consistent with adjacent reference areas.

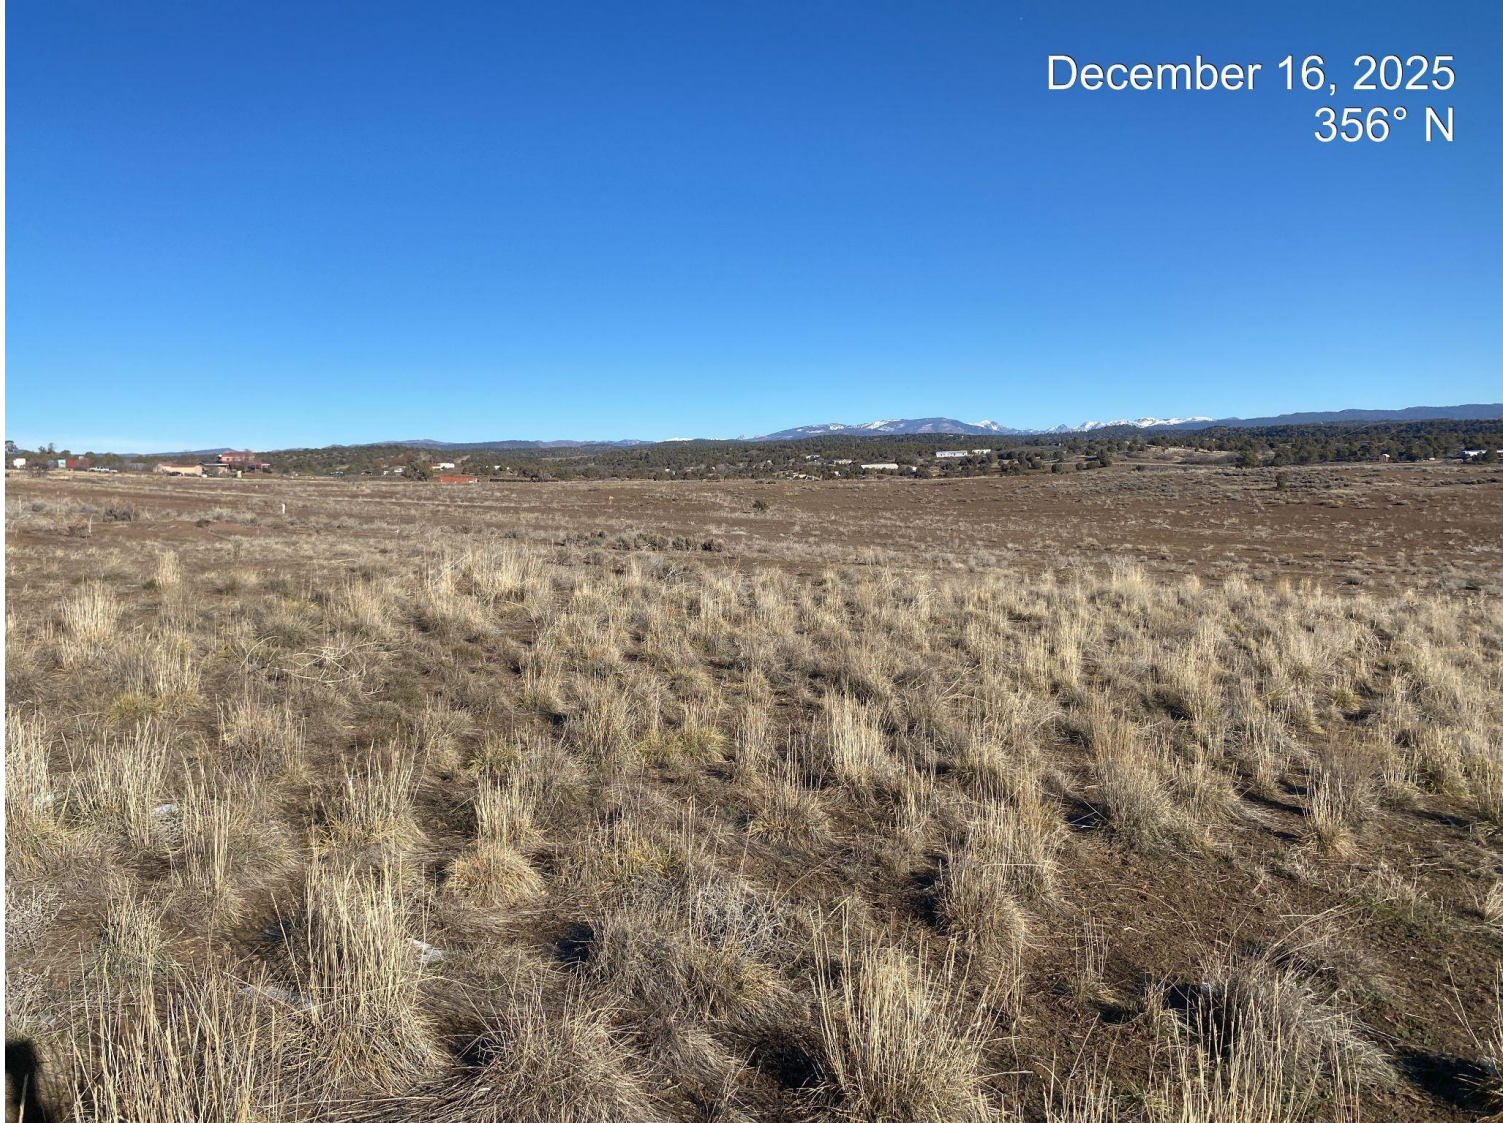
December 16, 2025  
356° N

**Photo 5.** View of adjacent reference area.
