# INSPECTION PHOTOS

Well: ANTONIO 23-29

API #: 05-071-06802

INSPECTION DOC #: 716301912

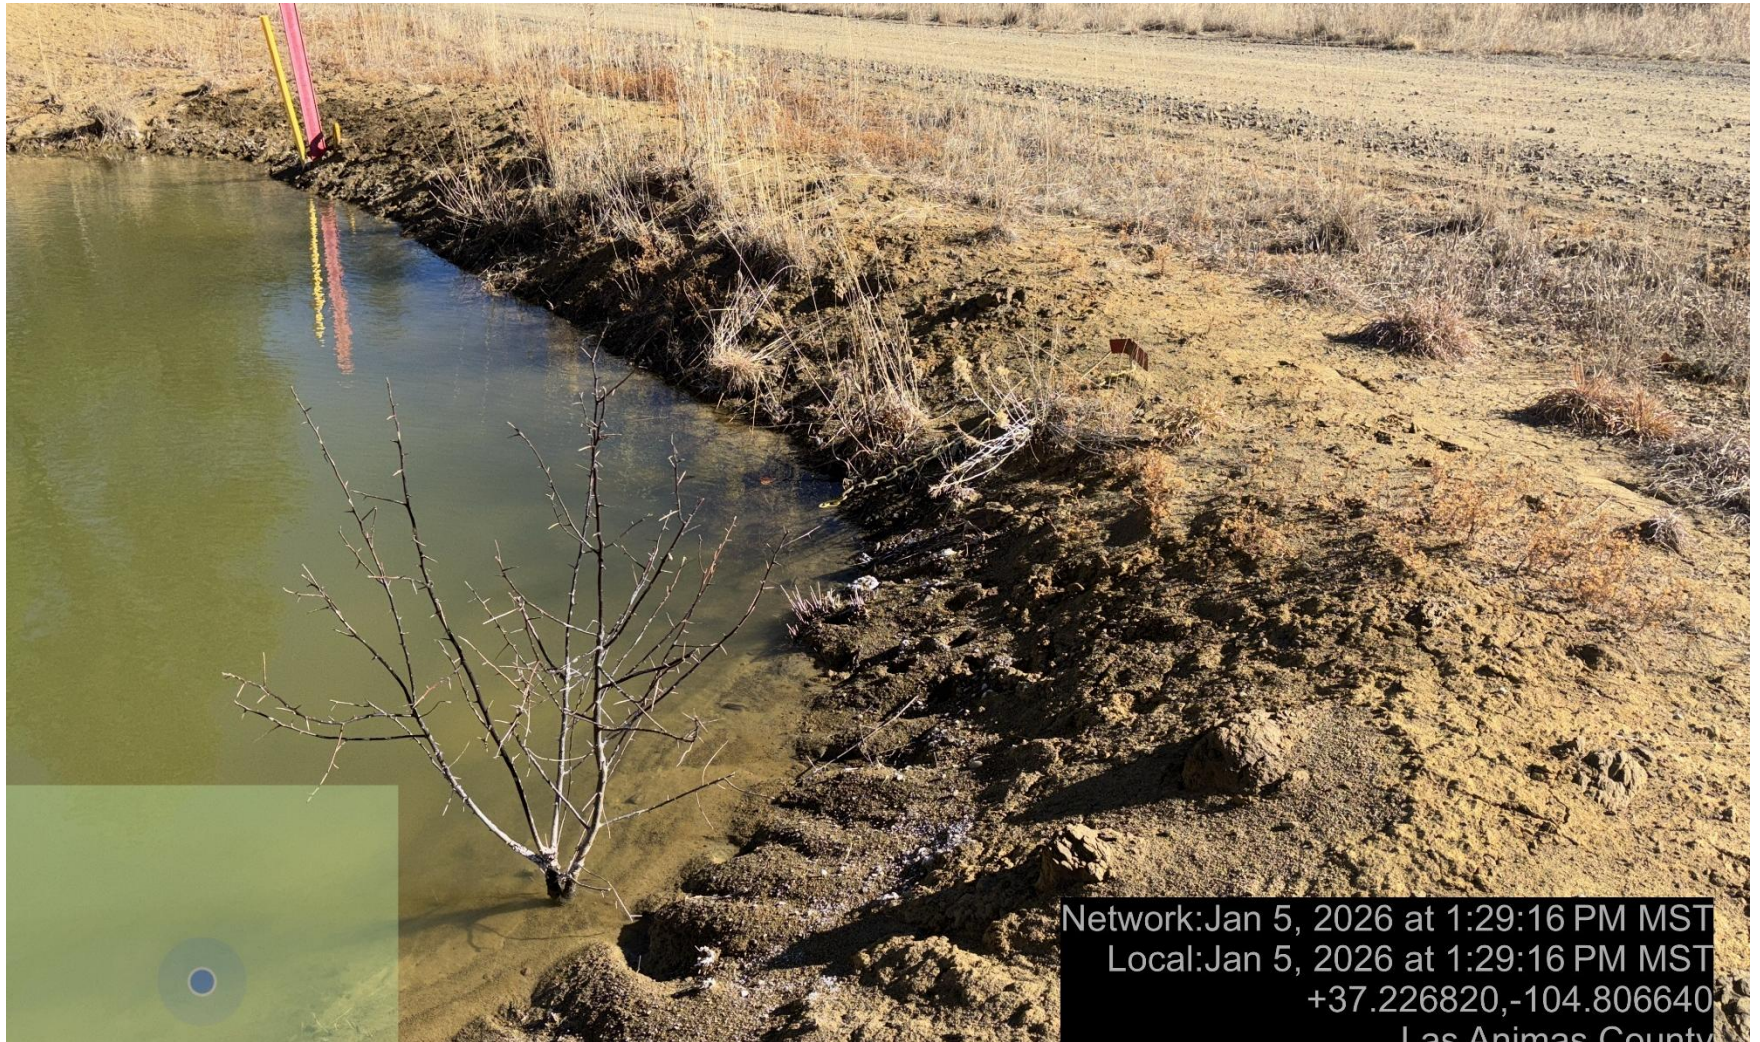
**PHOTO 6: LESS THAN 2" OF FREEBOARD IN TR WELLS PIT. Lower fluid level so at least two feet of freeboard exists per Rule 909.c. CA DATE 1/6/2025.**
