Inspection/Audit Photos

Location Name: QB ENERGY OPERATING LLC PUCKETT 31-36 Pad

Location #: 324208

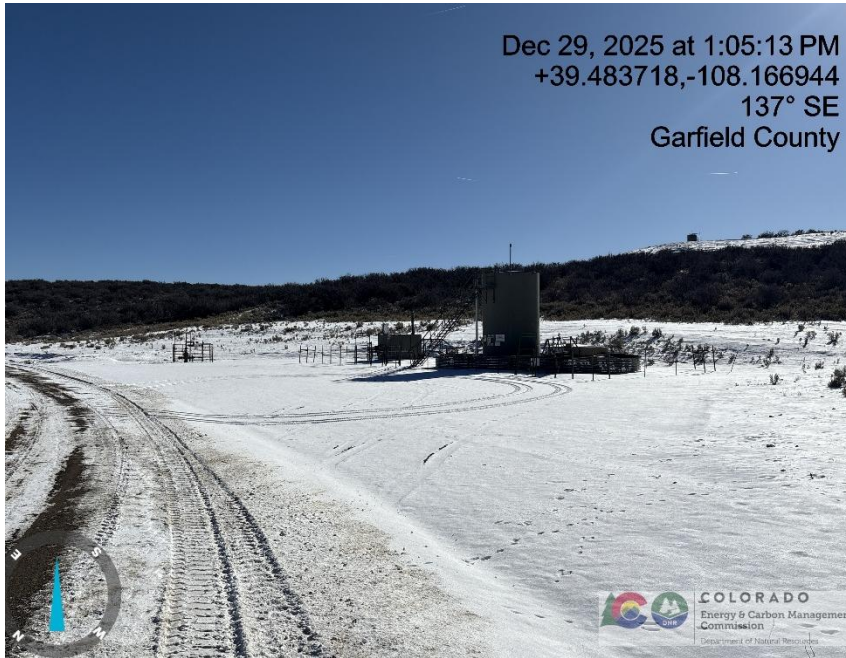
Photo # 5964 From entrance to location

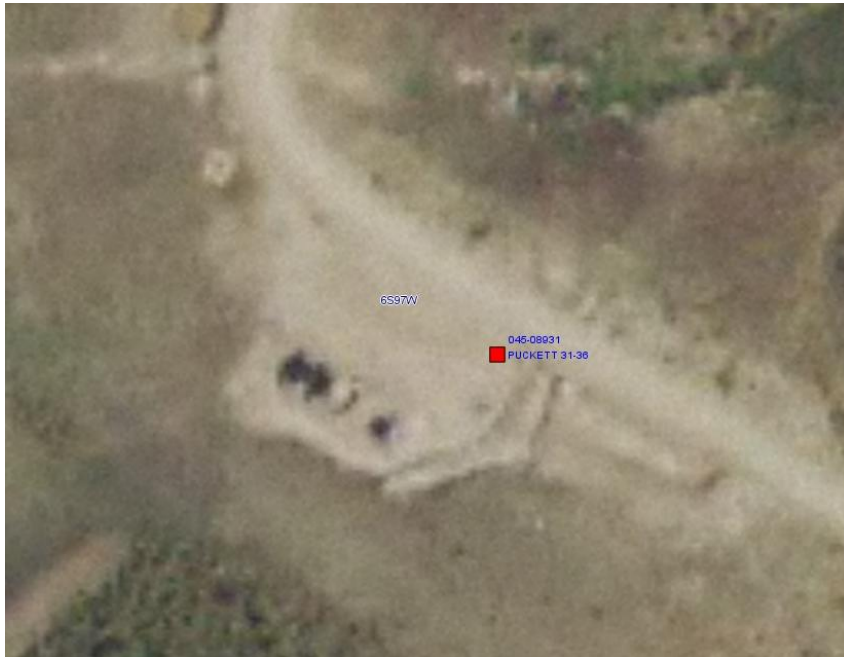
Photo # 5970 Scout Card record “as drilled” coordinates for the PUCKETT 31-36 well - Coordinates appear to be off by approximately 25 ft (coordinates incorrect/not in compliance with CECMC Rules 216 & 414 – records require updating)

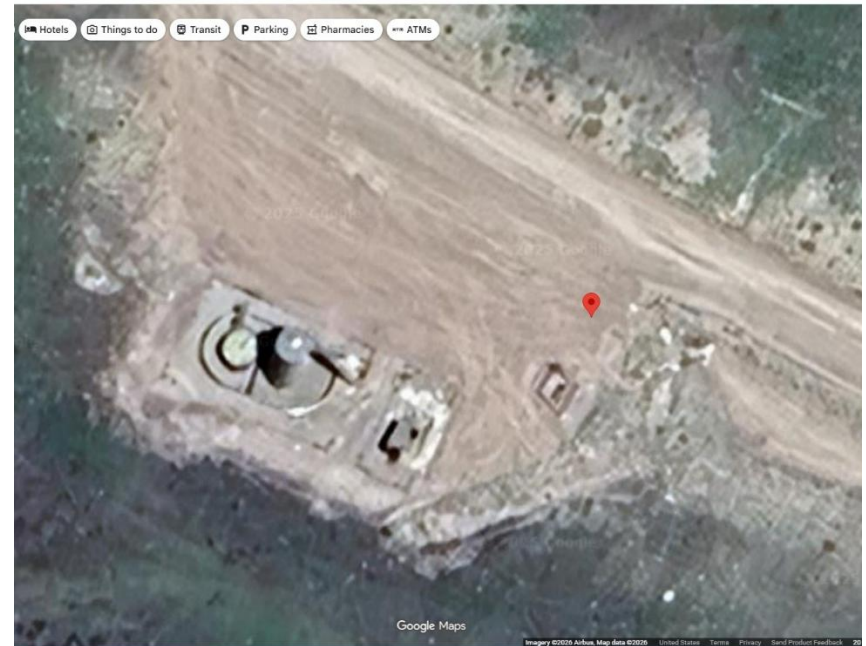
Photo # 5971 Scout Card record “as drilled” coordinates for the PUCKETT 31-36 well - Coordinates appear to be off by approximately 25 ft (coordinates incorrect/not in compliance with CECMC Rules 216 & 414 – records require updating)
