Inspection Photos

Operator: QB Energy Operating LLC #10844

Location ID: 311615

Inspection Doc: 719200622

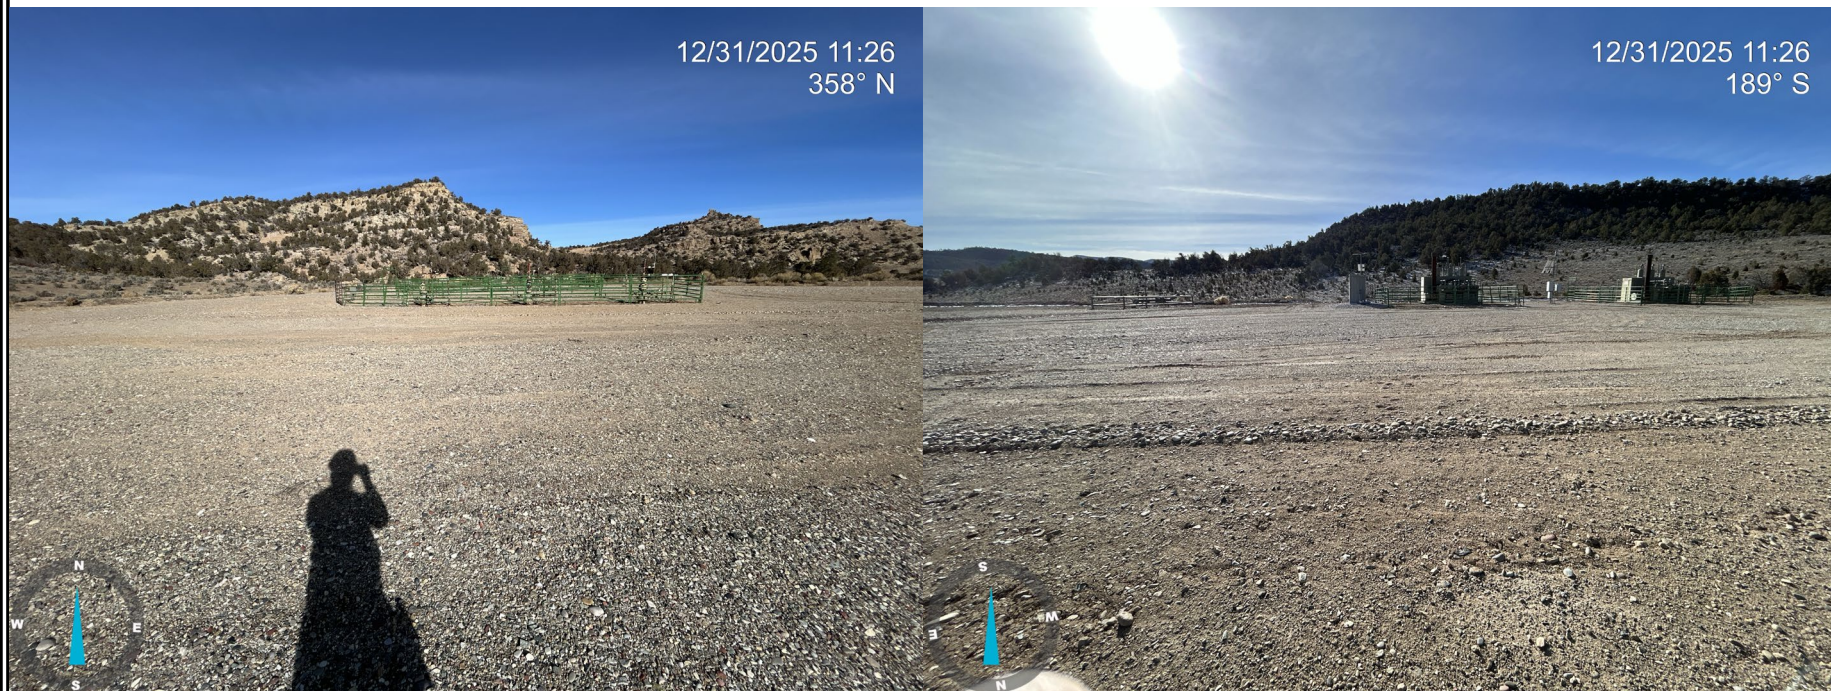
Photo 1: Photos showing an overview of the location looking north and south, respectively.

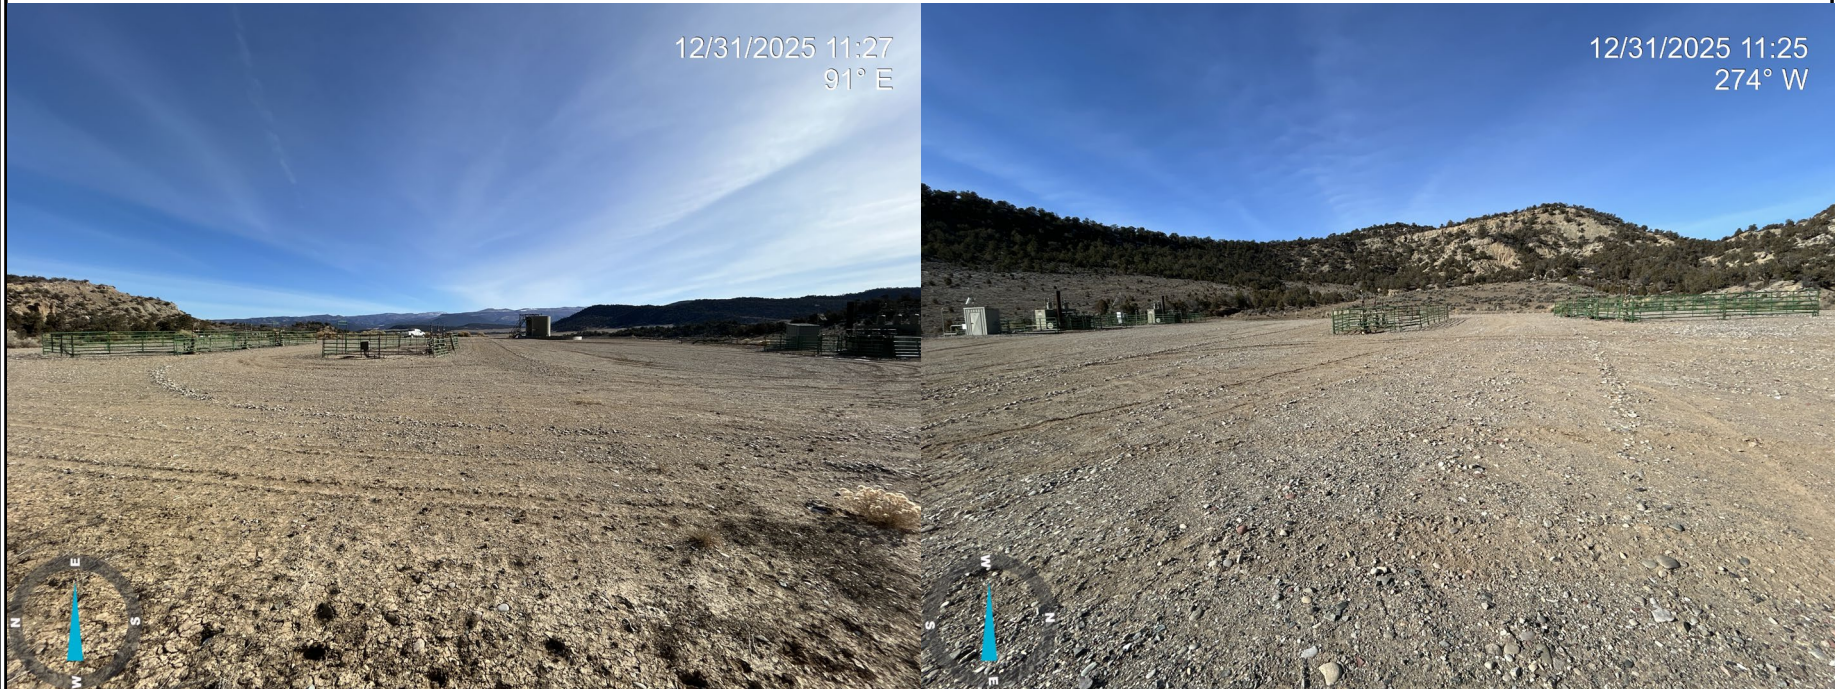
Photo 2: Photos showing an overview of the location looking east and west, respectively.

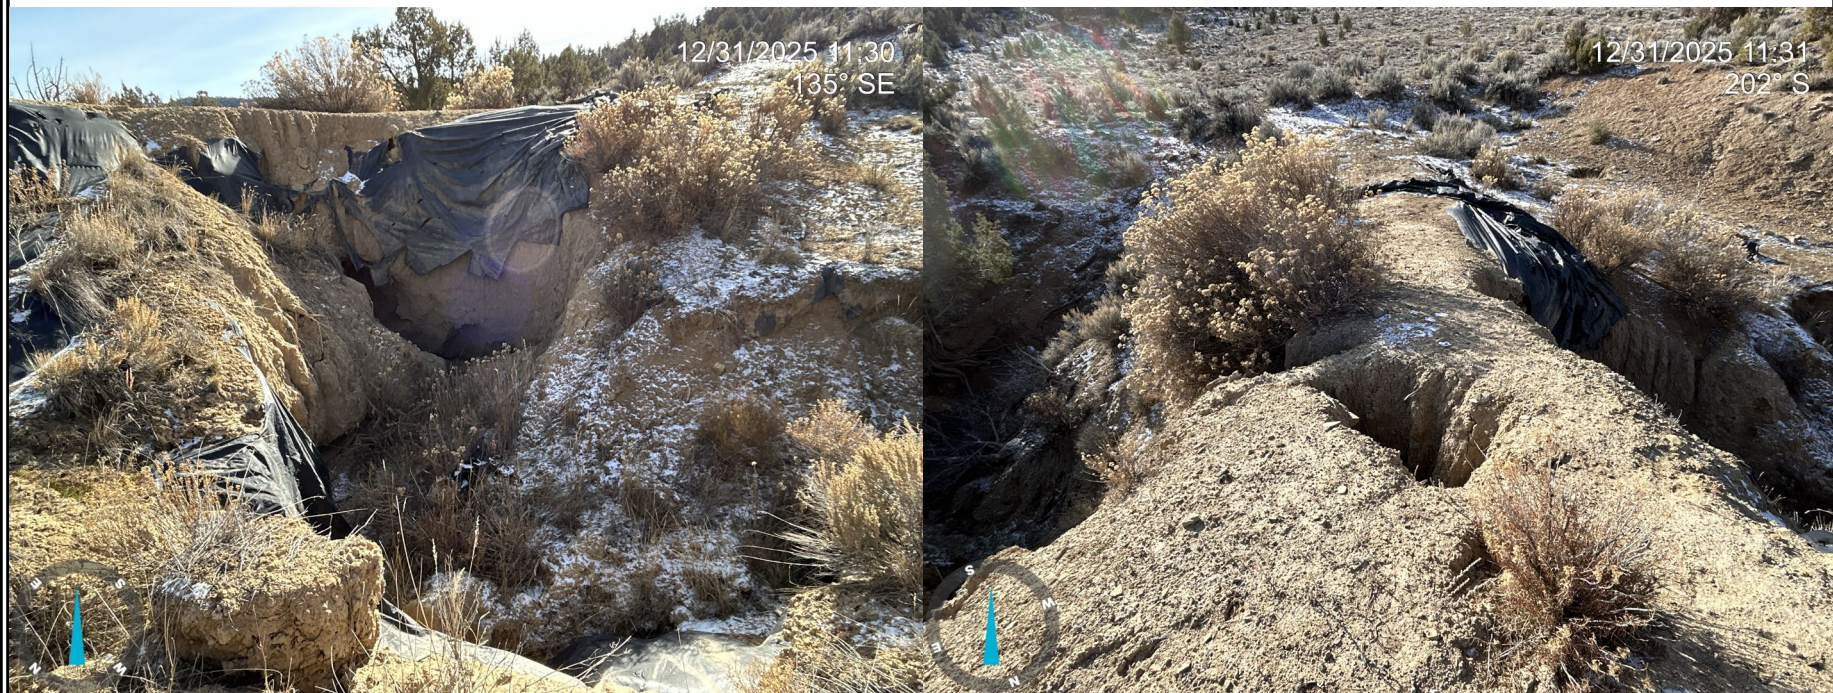
Photo 3: Photos showing examples of the sloughing land bridge to the southwest of the location. This feature does not appear to be associated with Oil and Gas activities.

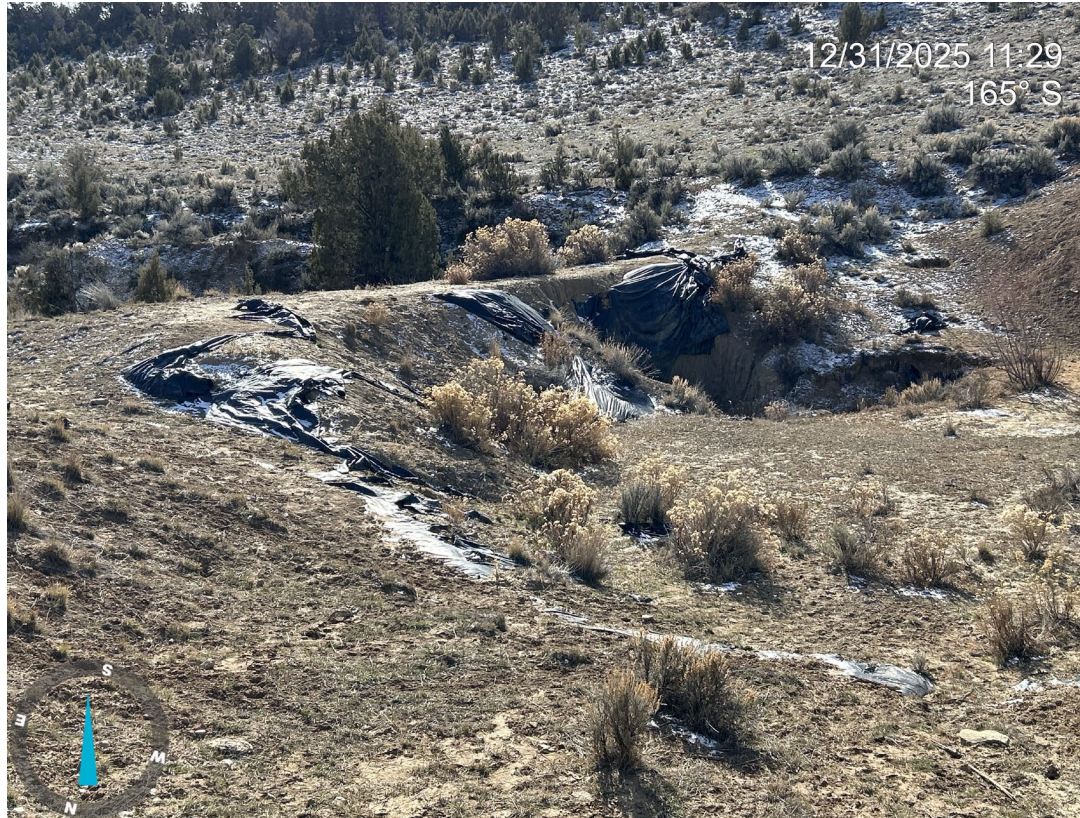
Photo 4: Photos showing examples of the sloughing land bridge to the southwest of the location. This feature does not appear to be associated with Oil and Gas activities.

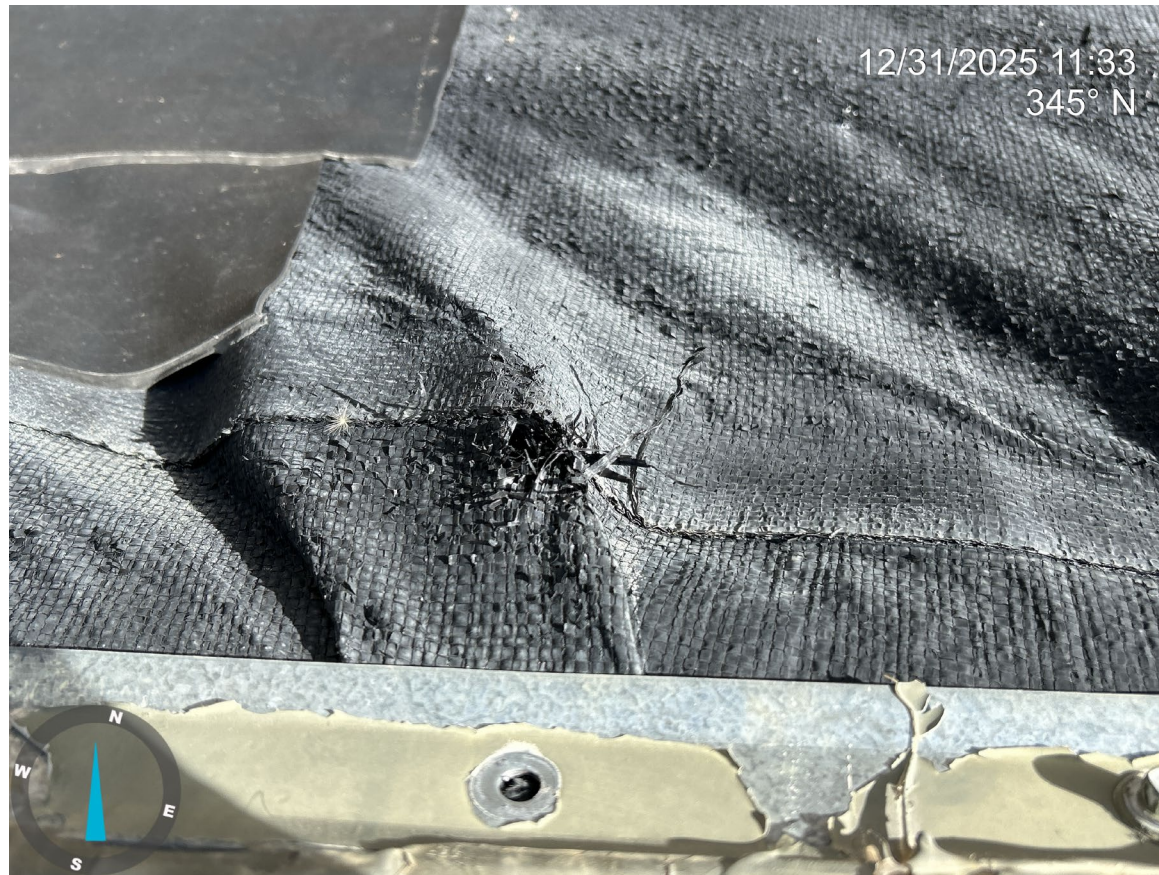
Photo 5: Photos showing a small tear in the black geotextile liner of the tank's secondary containment system. Comply with Rule 603.o.

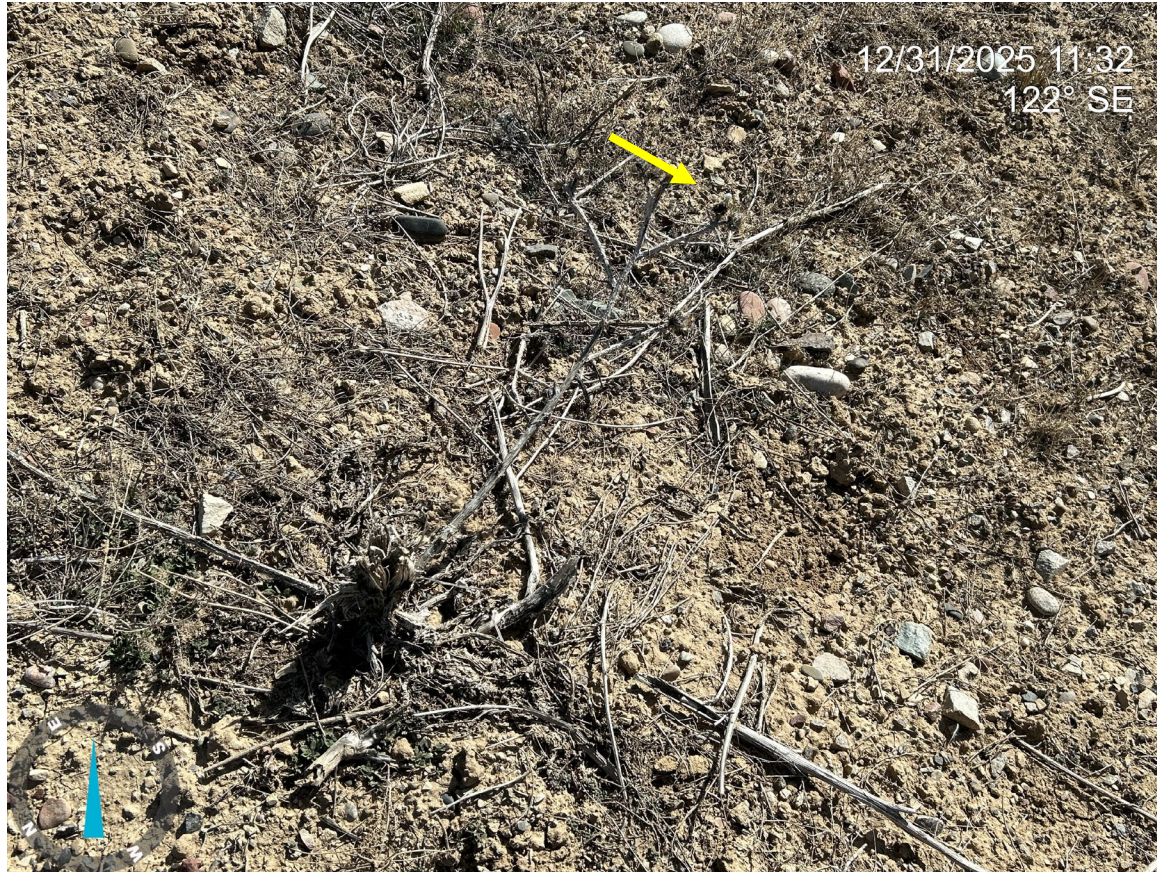
Photo 6: Photo showing a thistle skeleton, likely Canadian or Scotch thistle, that is present in trace amounts at the location. Ongoing weed monitoring and maintenance is necessary.

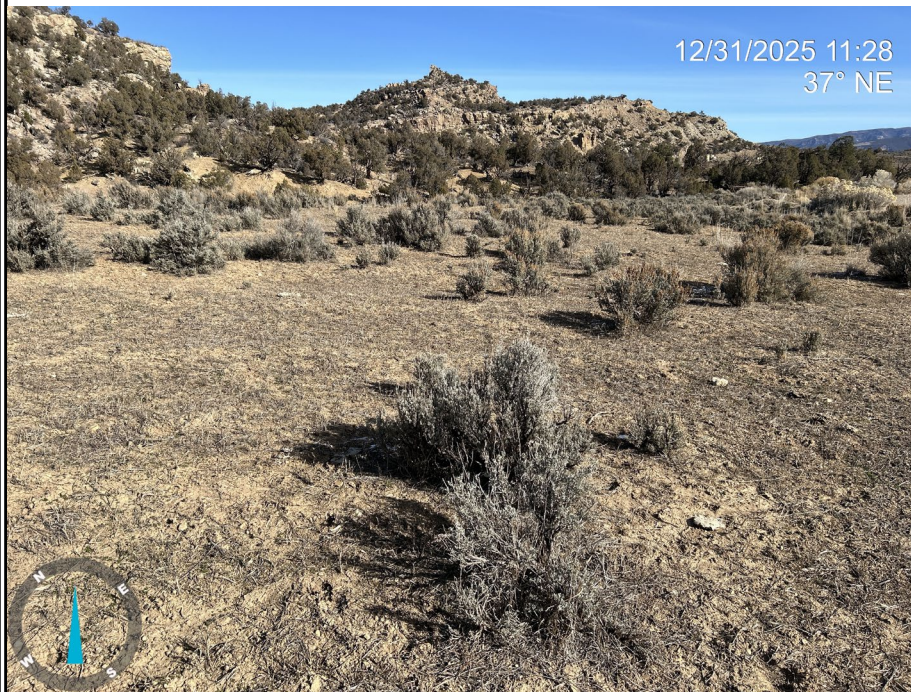
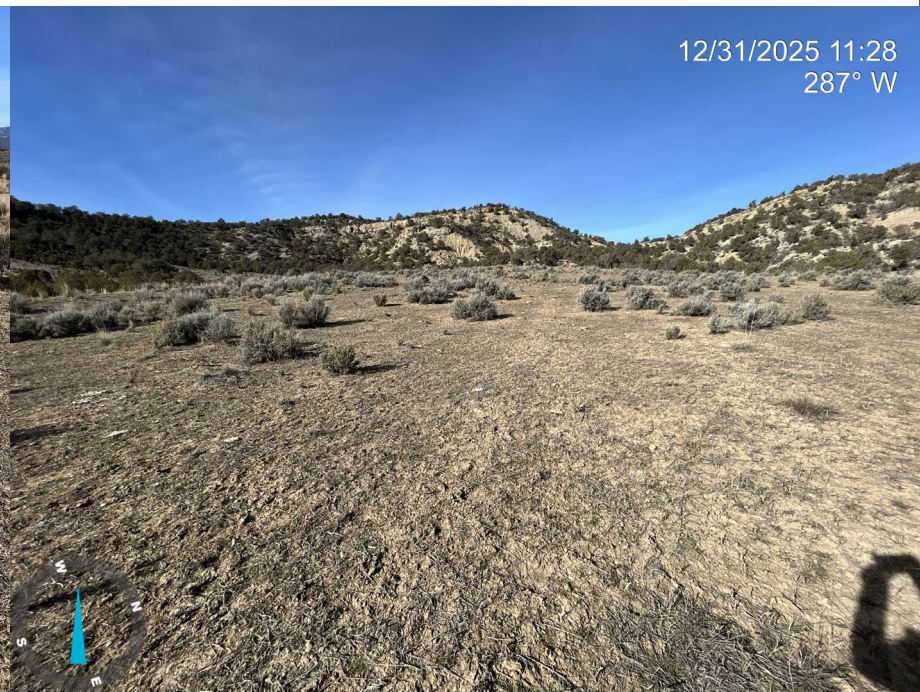
Photo 7: Photos showing the northern and western interim areas, respectively. Interim areas are progressing towards 1003 reclamation requirements.
