# Final Reclamation Inspection

Operator: PDC ENERGY INC - 69175

Location ID: 309694

Inspection Photos  
Location Name: STROH #5  
Location ID: 309694

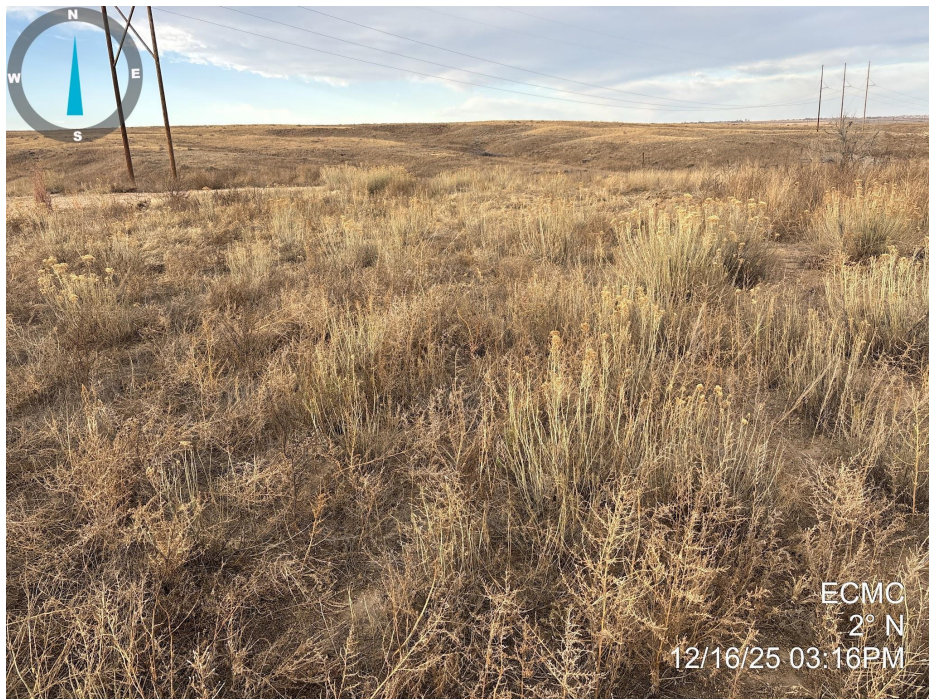
**Photo 1.** Photo taken of the well location, facing north. Photo illustrates that final reclamation activities appear to have taken place, with evidence of drill row seeding, but vegetation establishment does not meet Rule 1004 standards.

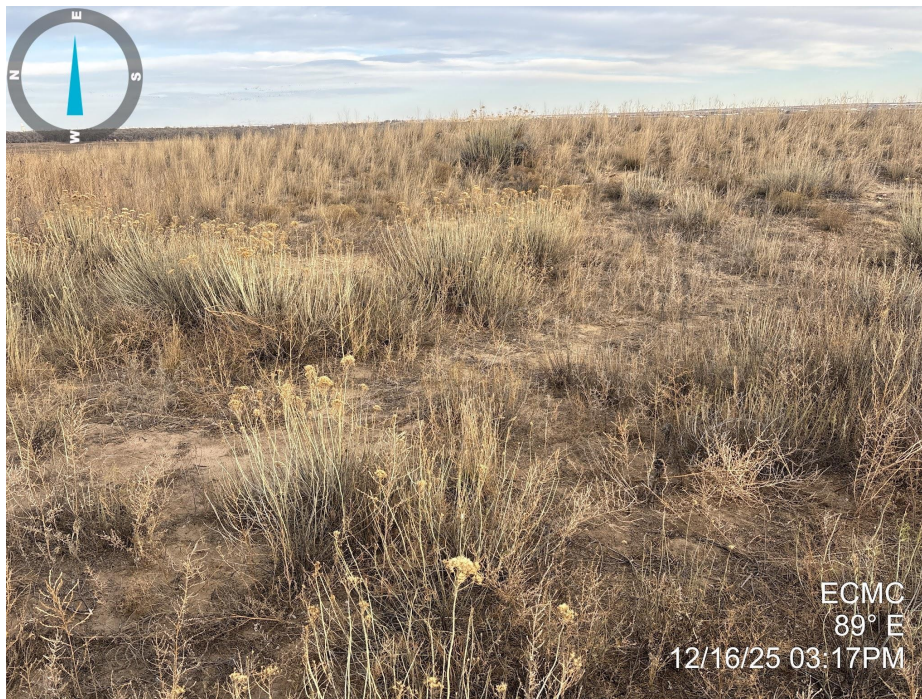
**Photo 2.** Photo taken of the well location, facing east. See comments under Photo 1.

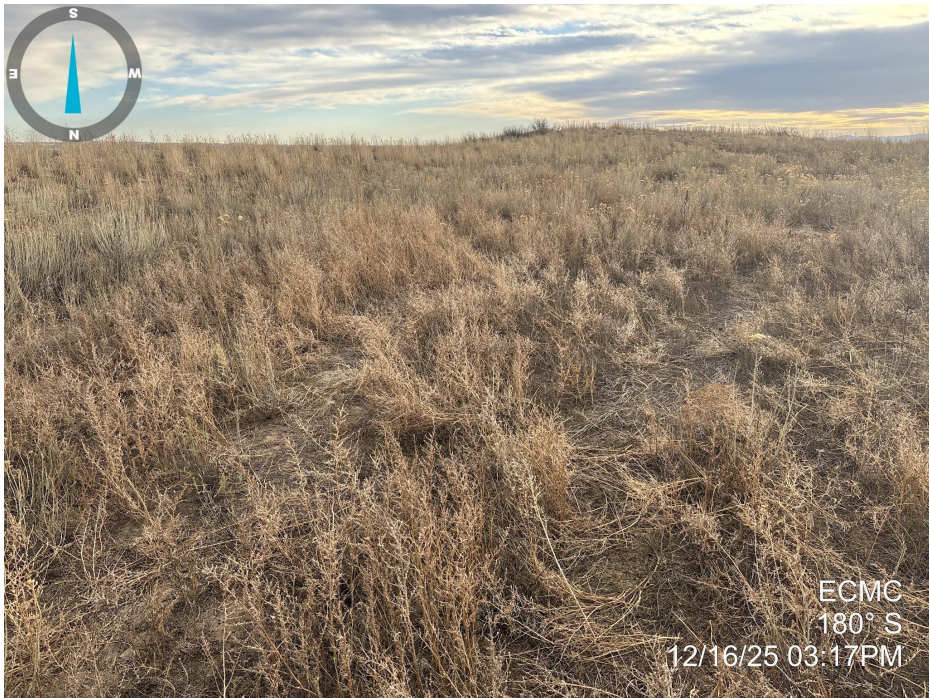
**Photo 3.** Photo taken of the well location, facing south. See comments under Photo 1.

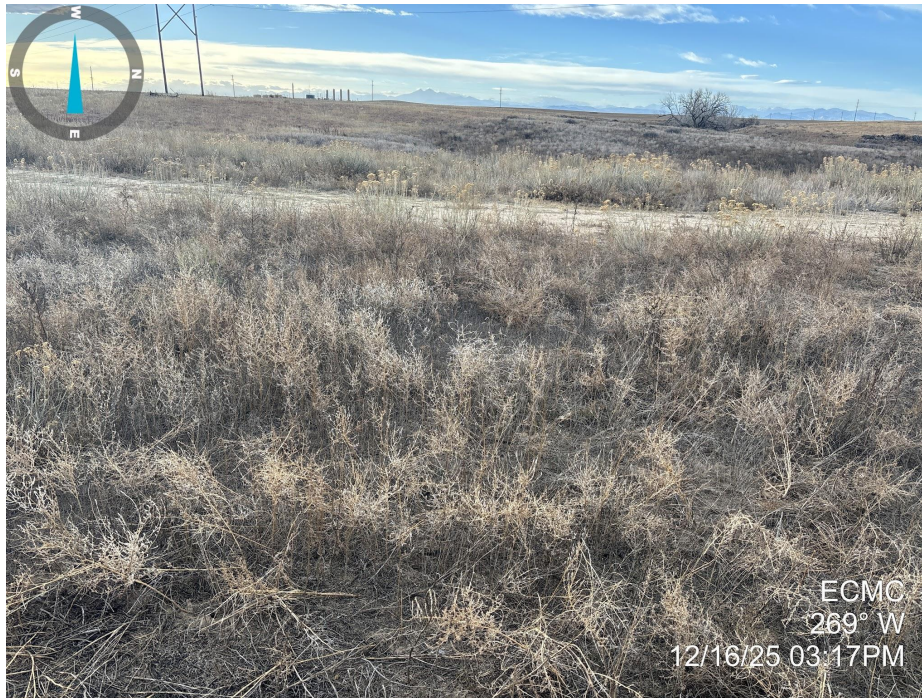
**Photo 4.** Photo taken of the well location, facing west. See comments under Photo 1.

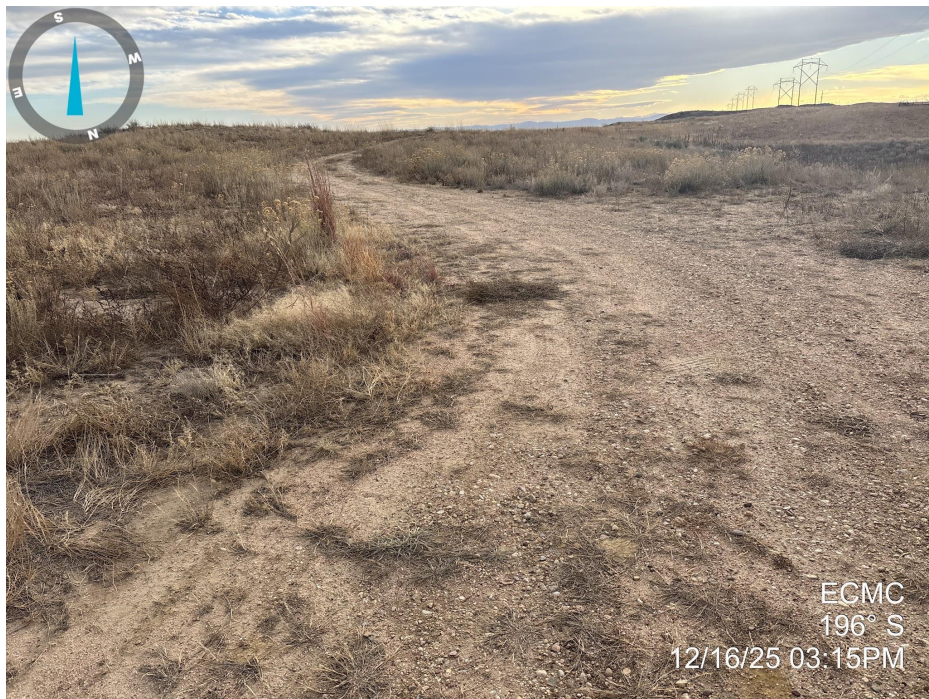
**Photo 5.** Photo taken of the access road to the location, facing south, towards the location. Photo illustrates that final reclamation activities have not taken place and gravel and bare ground remain across the road.

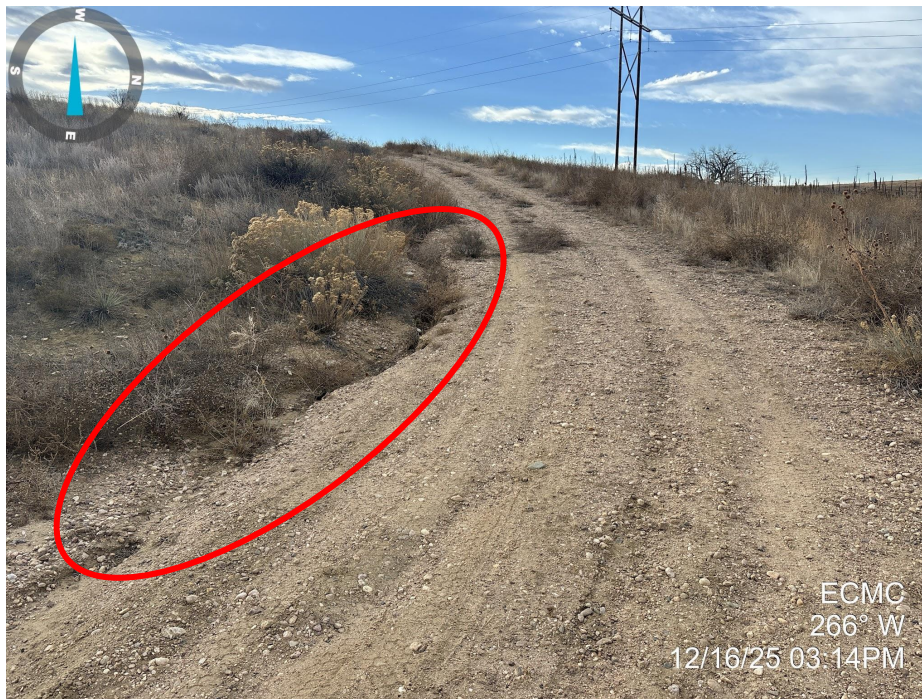
**Photo 6.** Photo taken of the access road to the location, facing west, towards the location. Stormwater erosion was observed along the edge of the road (highlighted in red).

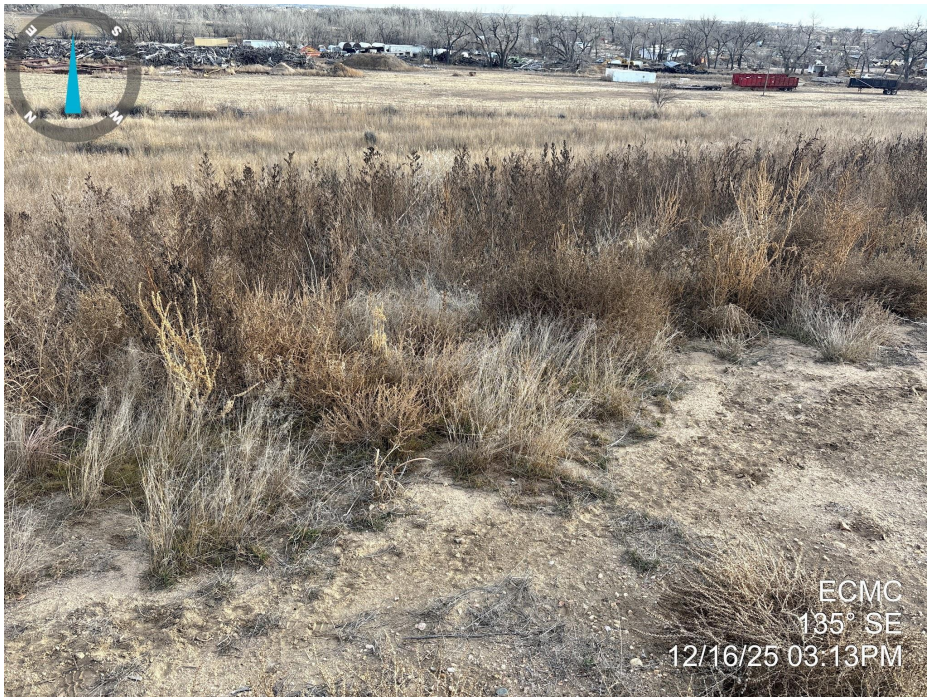
**Photo 7.** Photo taken of the tank battery location, facing southeast. Photo illustrates that final reclamation activities appear to have taken place, but the location does not meet Rule 1004 standards as weedy annual vegetation was observed across the location.

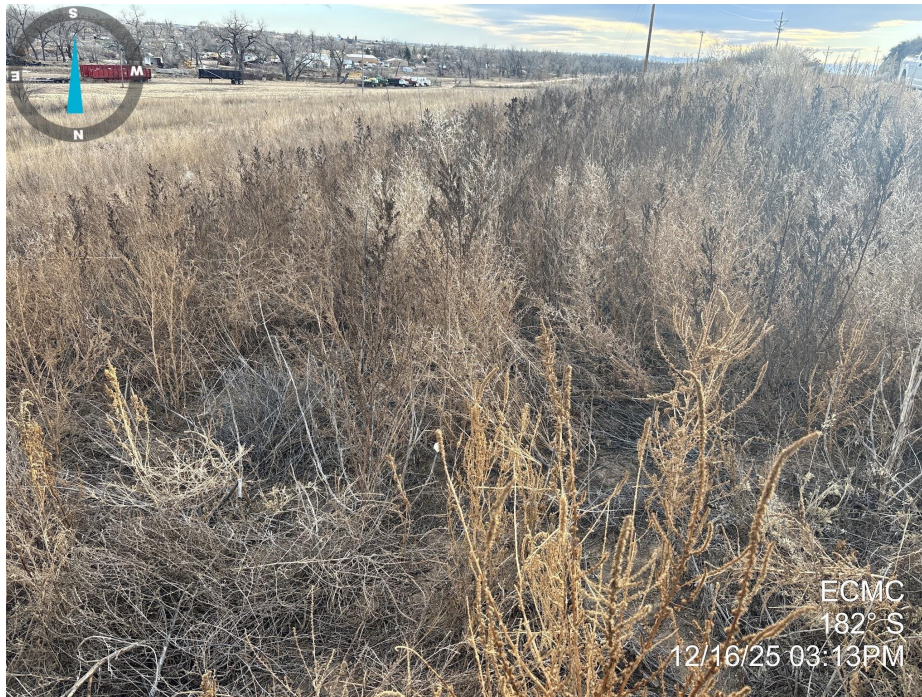
**Photo 8.** Photo taken of the tank battery location, facing south. See comments under Photo 7.

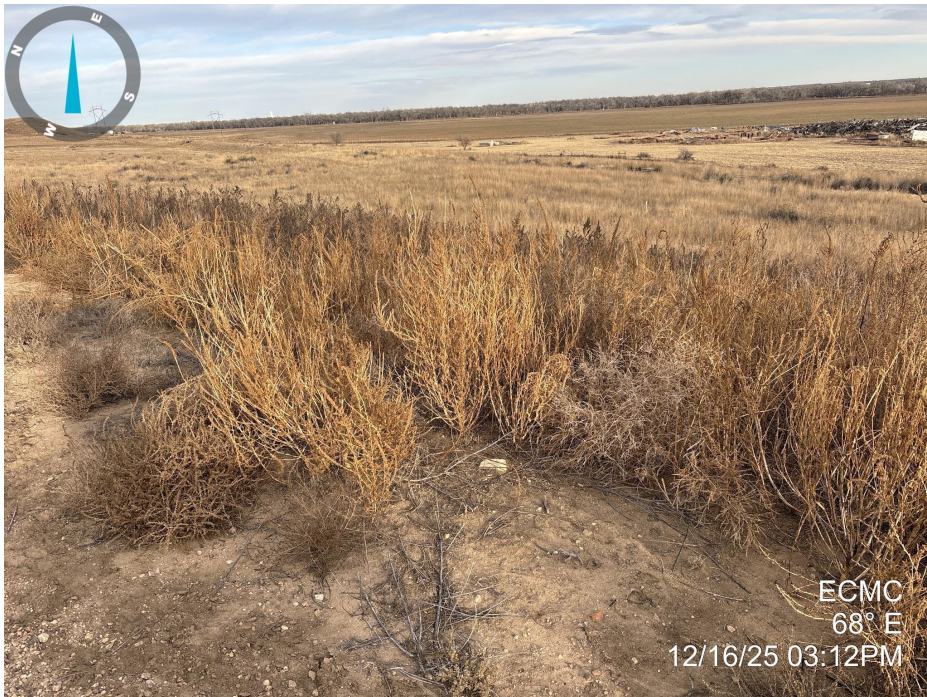
**Photo 9.** Photo taken of the tank battery location, facing east. See comments under Photo 7.

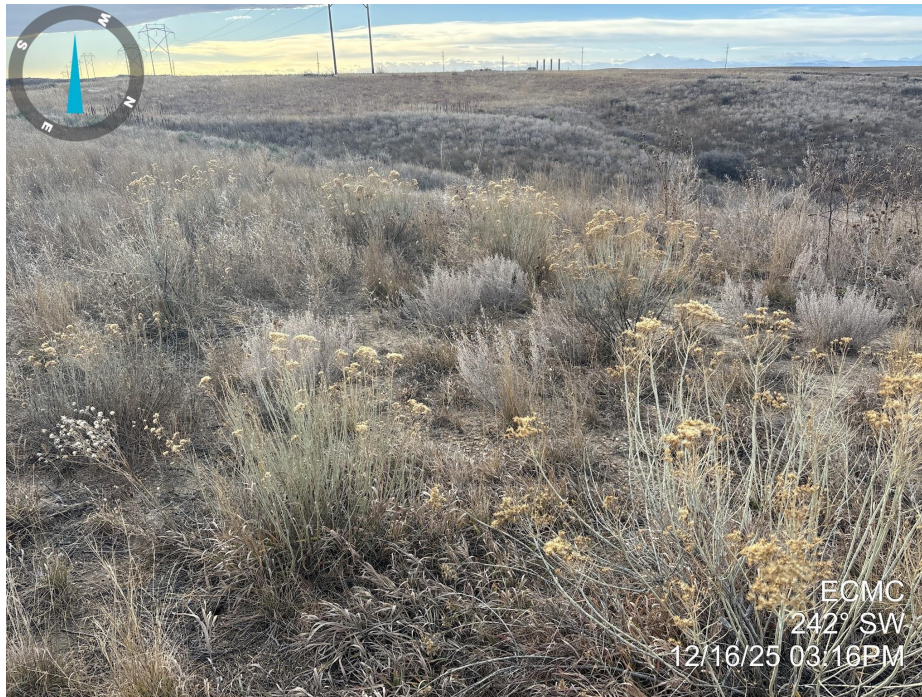
**Photo 10.** Photo taken of the reference area to the location, west of the location, facing southwest. Photo illustrates perennial grass and shrub vegetation.
