Final Reclamation Inspection

Operator: PDC ENERGY INC - 69175

Location ID: 332487

Inspection Photos
Location Name: STROH #24-12
Location ID: 332487

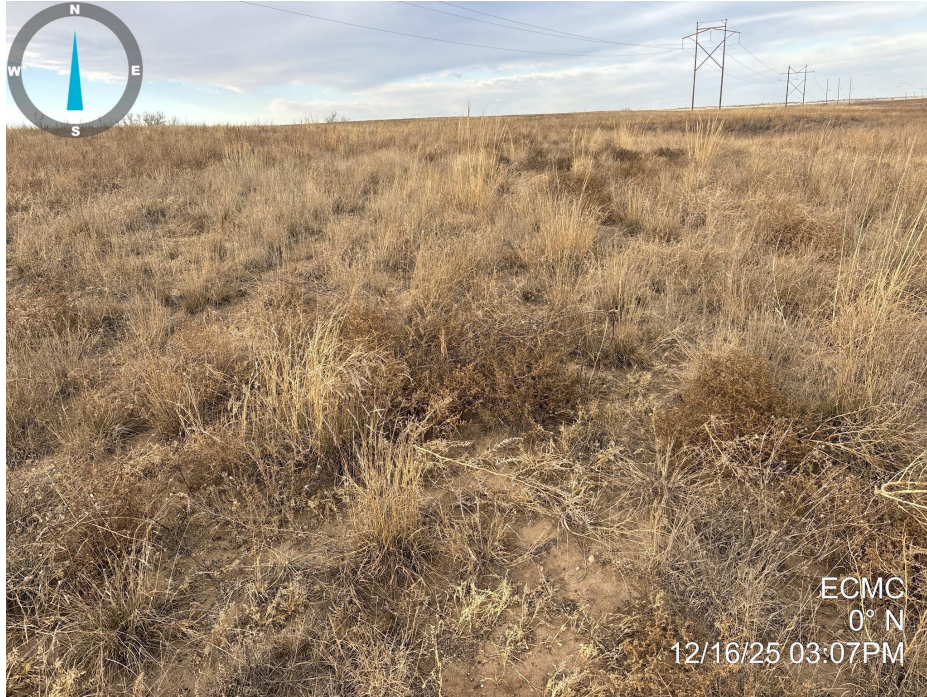
Photo 1. Photo taken of the well location, facing north. Photo illustrates that final reclamation activities appear to have taken place, with evidence of drill row seeding, but vegetation establishment does not meet Rule 1004 standards.

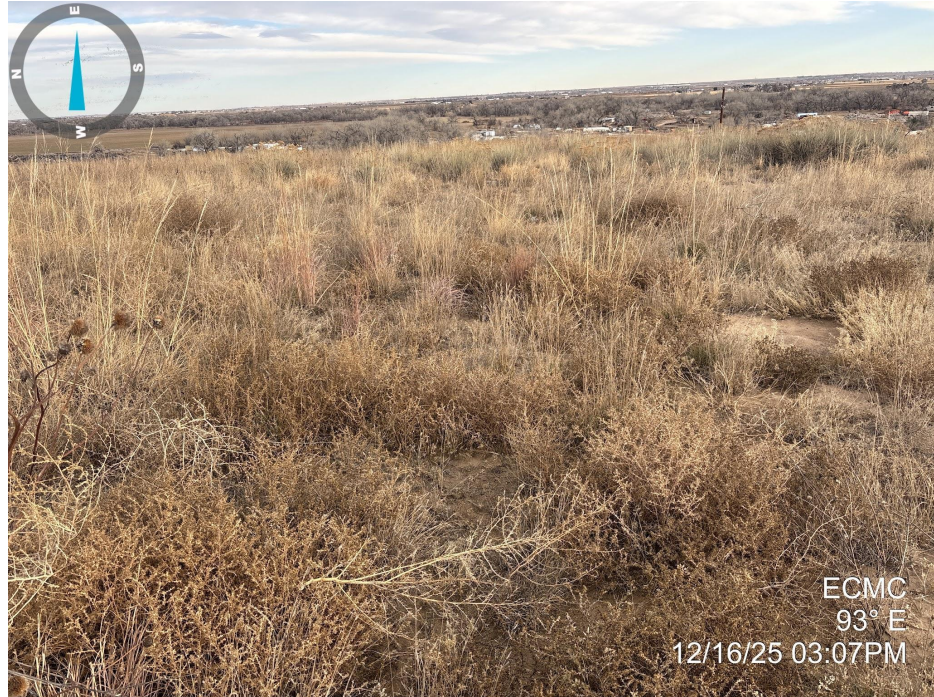
Photo 2. Photo taken of the well location, facing east. See comments under Photo 1.

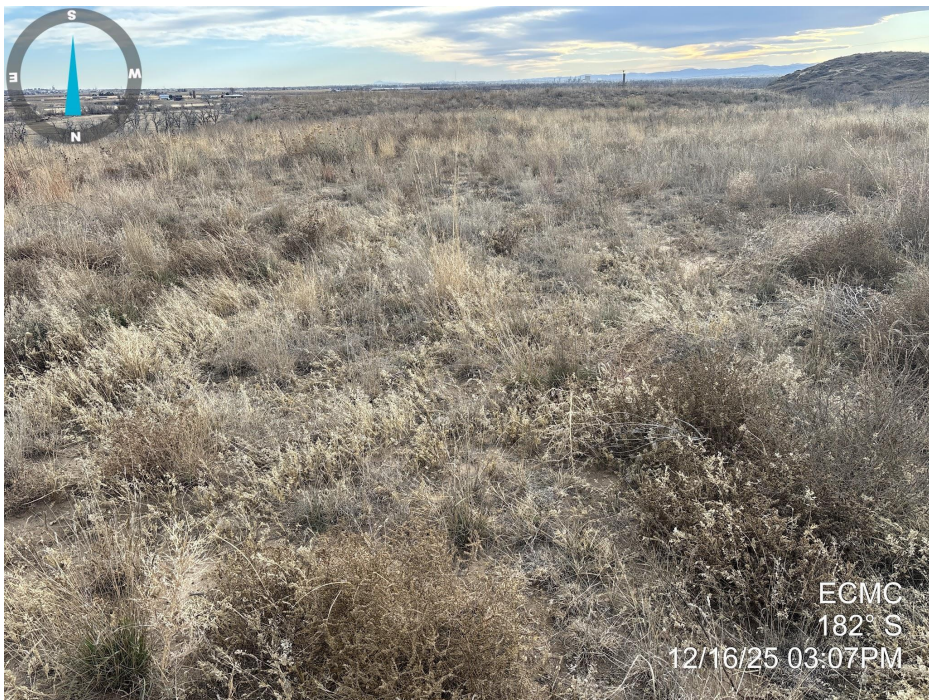
Photo 3. Photo taken of the well location, facing south. See comments under Photo 1.

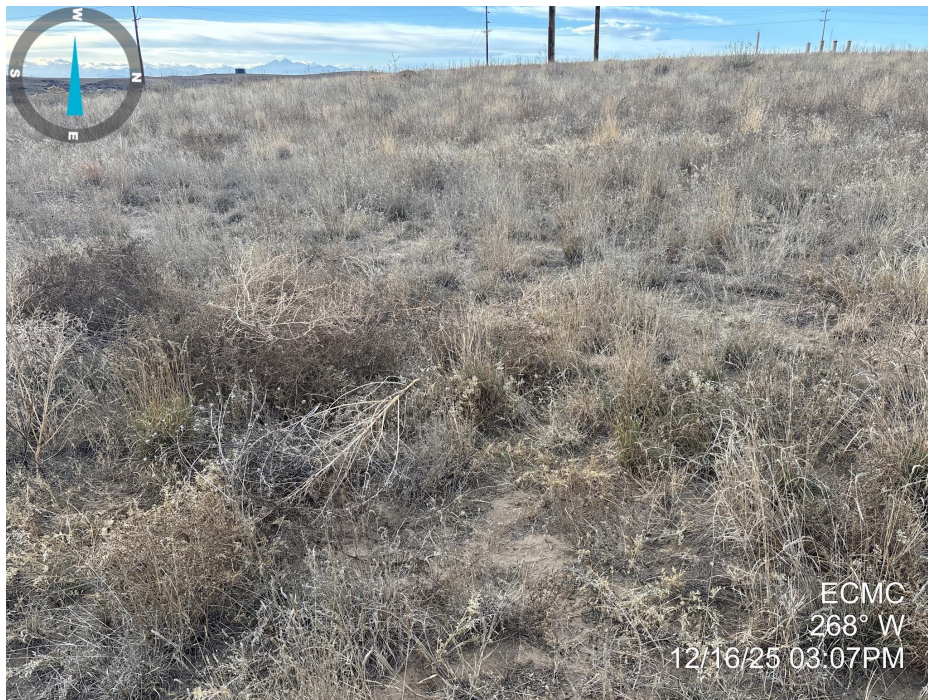
Photo 4. Photo taken of the well location, facing west. See comments under Photo 1.

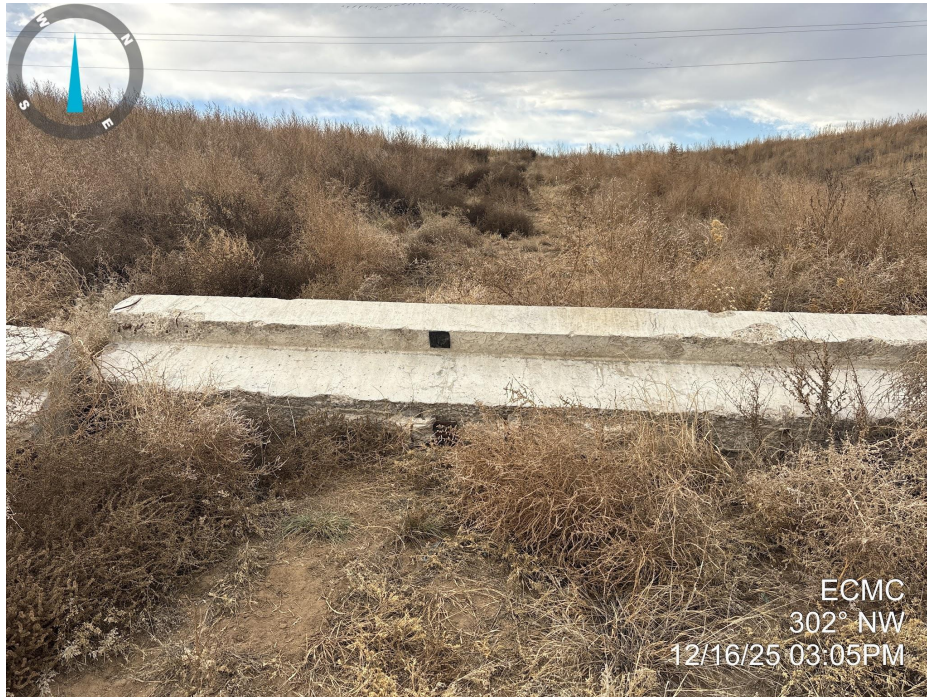
Photo 5. Photo taken of the access road to the location, facing northwest, towards the location. Photo illustrates that final reclamation activities have taken place, but vegetation has not established to Rule 1004 standards. A concrete barrier has been implemented along the access road.

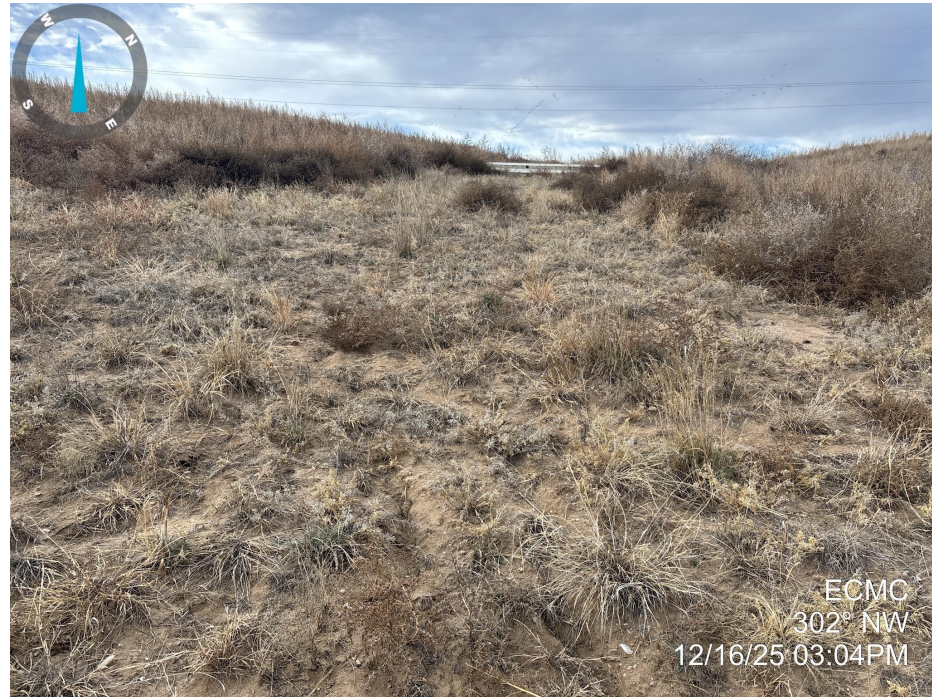
Photo 6. Photo taken of the access road to the location, facing northwest, towards the location. Stormwater erosion was observed along the southeastern portion of the road.

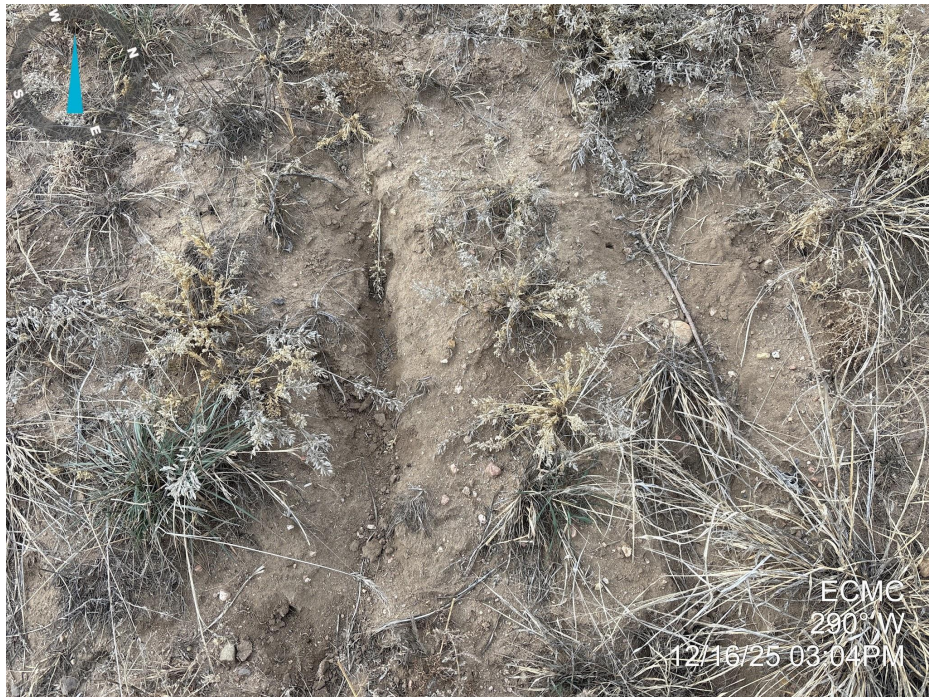
Photo 7. Photo taken of ground cover at the access road. Photo illustrates stormwater erosion.

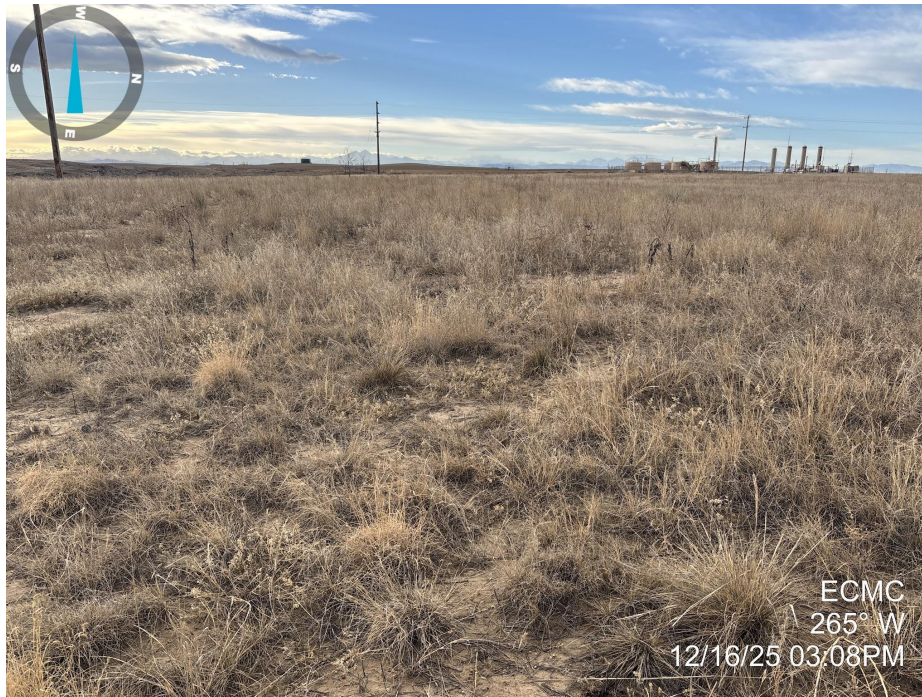
Photo 8. Photo taken of the reference area to the location, west of the location, facing west. Photo illustrates perennial grass and weedy annual vegetation.
