Final Reclamation Inspection

Operator: PDC ENERGY INC - 69175

Location ID: 472039

Inspection Photos
Location Name: Stroh #24-12
Location ID: 472039

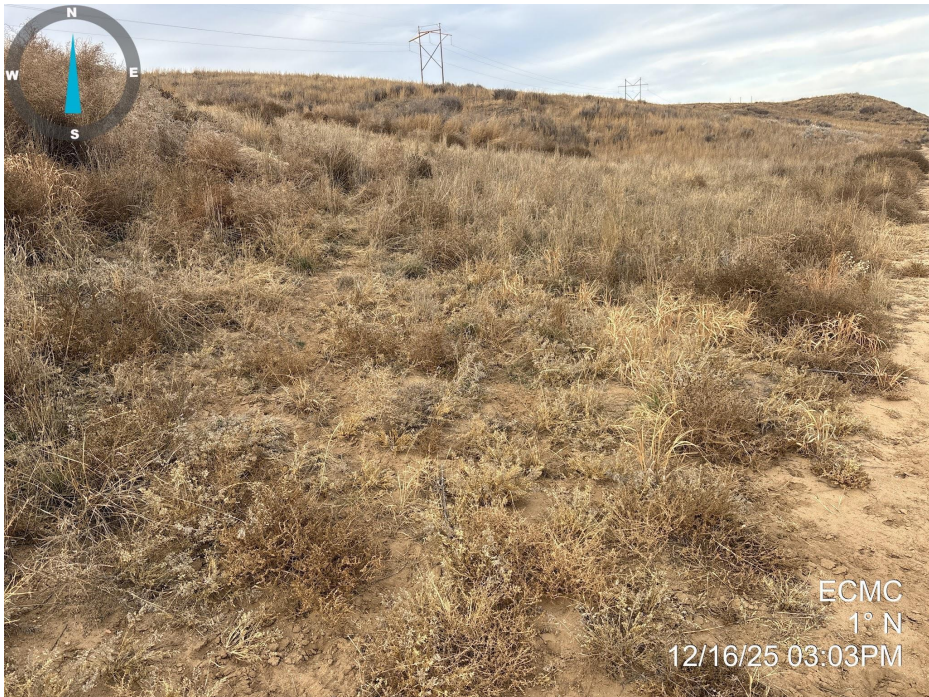
Photo 1. Photo taken of the tank battery location, facing north. Photo illustrates that final reclamation activities appear to have taken place, but vegetation establishment does not meet Rule 1004 standards. Weedy annual vegetation including kochia (*Bassia scoparia*) and russian thistle (*Salsola tragus*) were observed across the location.

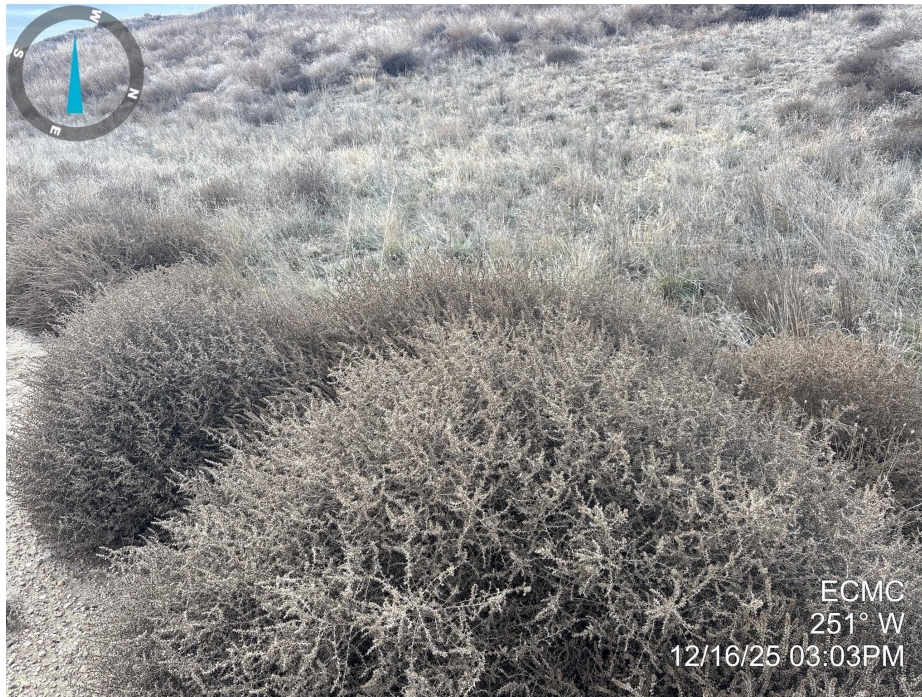
Photo 2. Photo taken of the tank battery location, facing west. See comments under Photo 1.

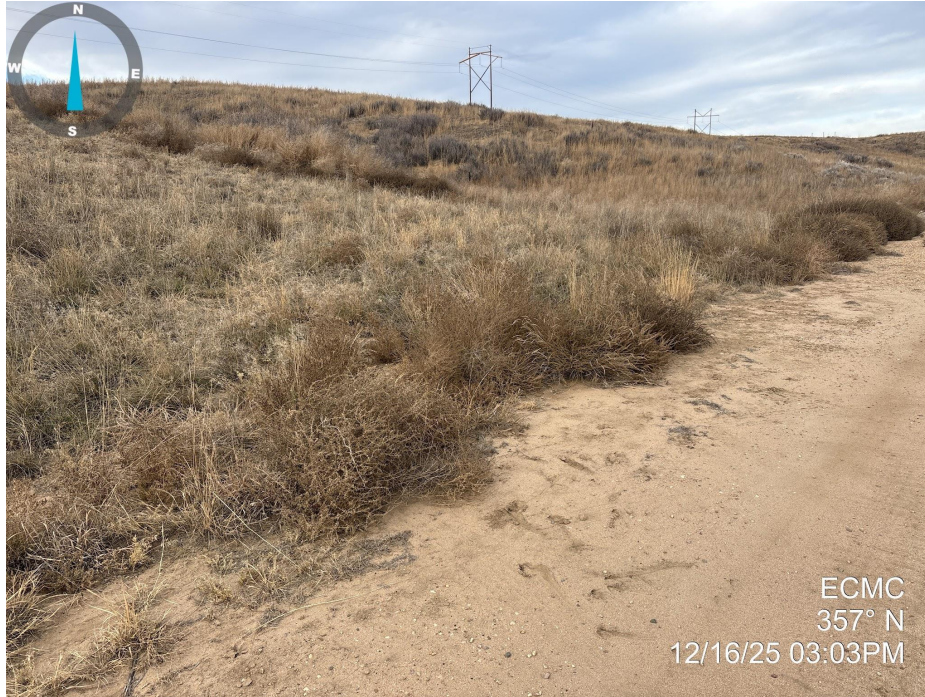
Photo 3. Photo taken of the tank battery location, from the adjacent road, facing north. See comments under Photo 1.

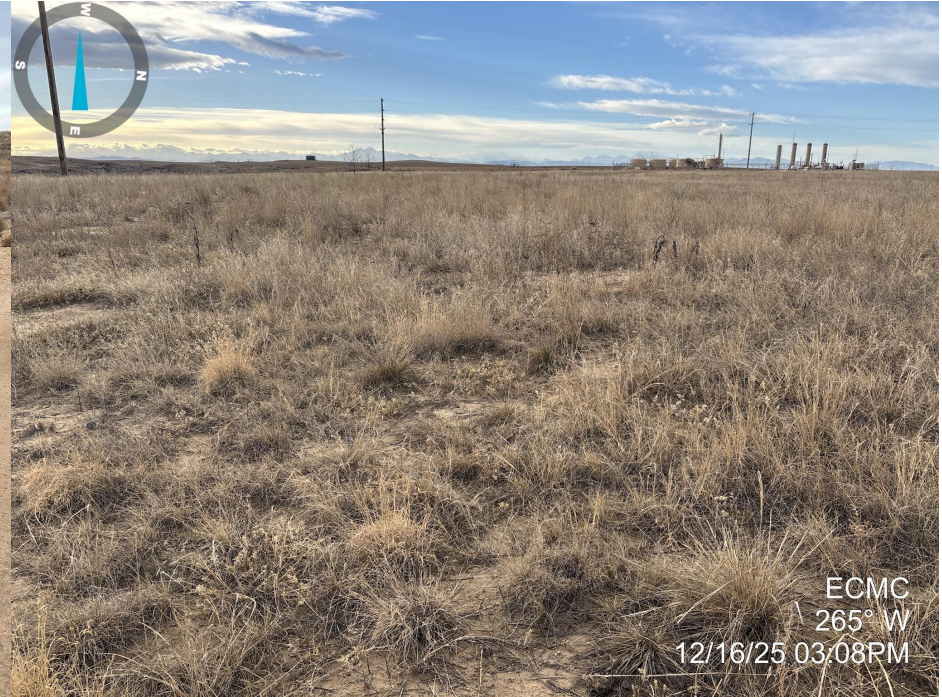
Photo 4. Photo taken of the reference area to the location, northwest of the location, facing west. Photo illustrates perennial grass and weedy annual vegetation.
