# Final Reclamation Inspection

Operator: PDC ENERGY INC - 69175

Location ID: 447144

Inspection Photos  
Location Name: Orr #33-24  
Location ID: 447144

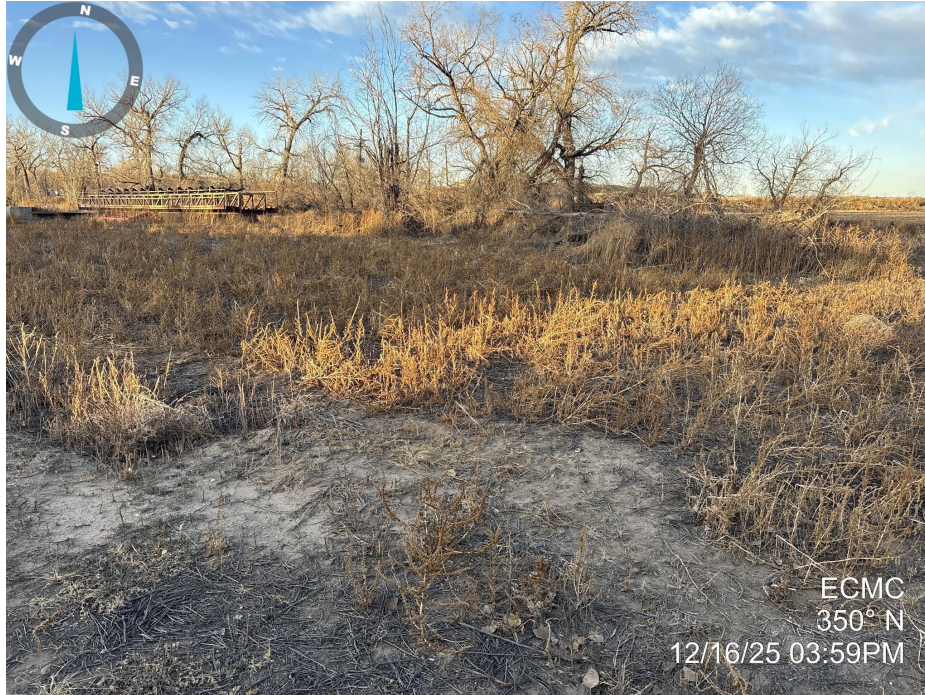
**Photo 1.** Photo taken of the tank battery location, facing north. Photo illustrates that final reclamation activities appear to have taken place, but vegetation establishment does not meet Rule 1004 standards.

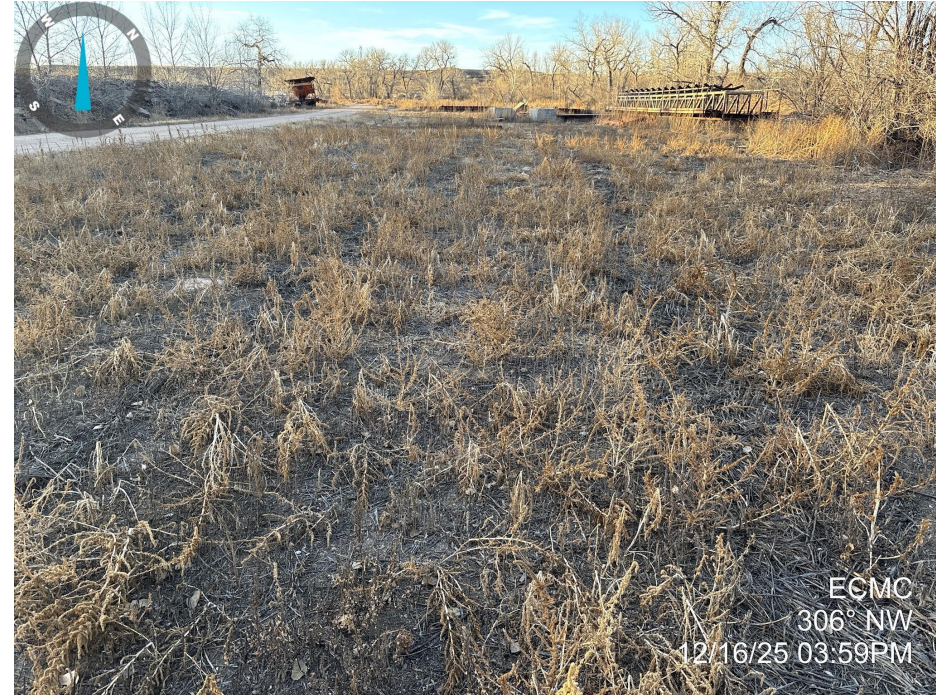
**Photo 2.** Photo taken of the tank battery location, facing northwest. See comments under Photo 1.

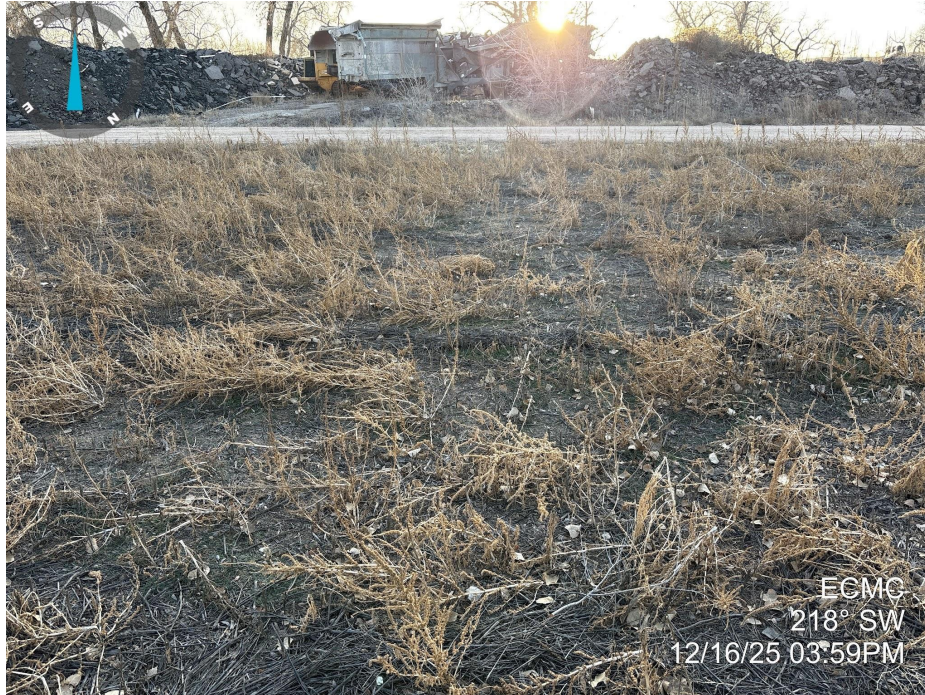
**Photo 3.** Photo taken of the tank battery location, facing southwest. See comments under Photo 1.

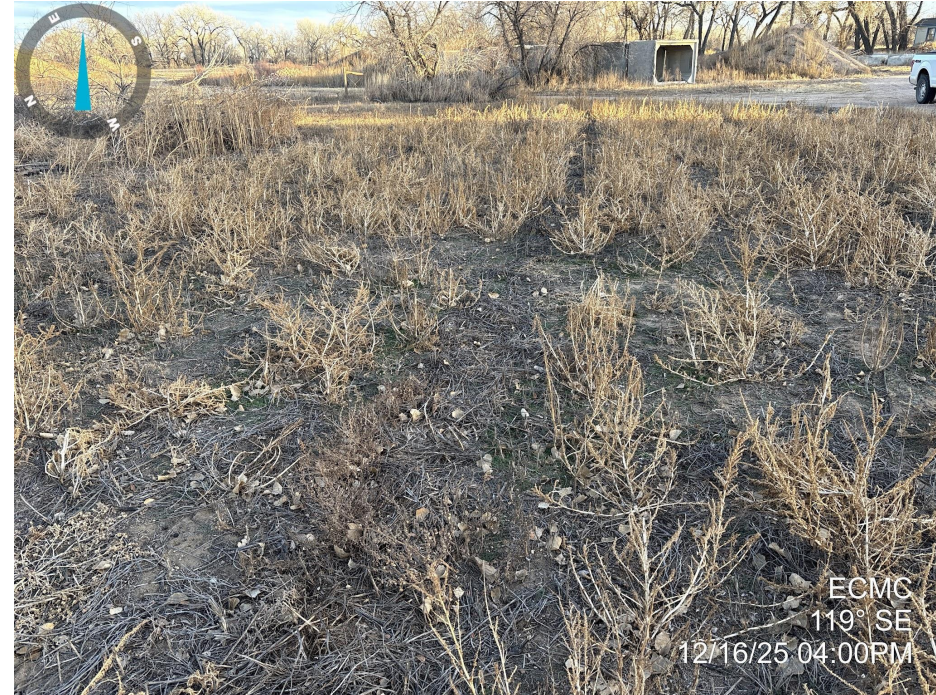
**Photo 4.** Photo taken of the tank battery location, facing southeast. See comments under Photo 1.

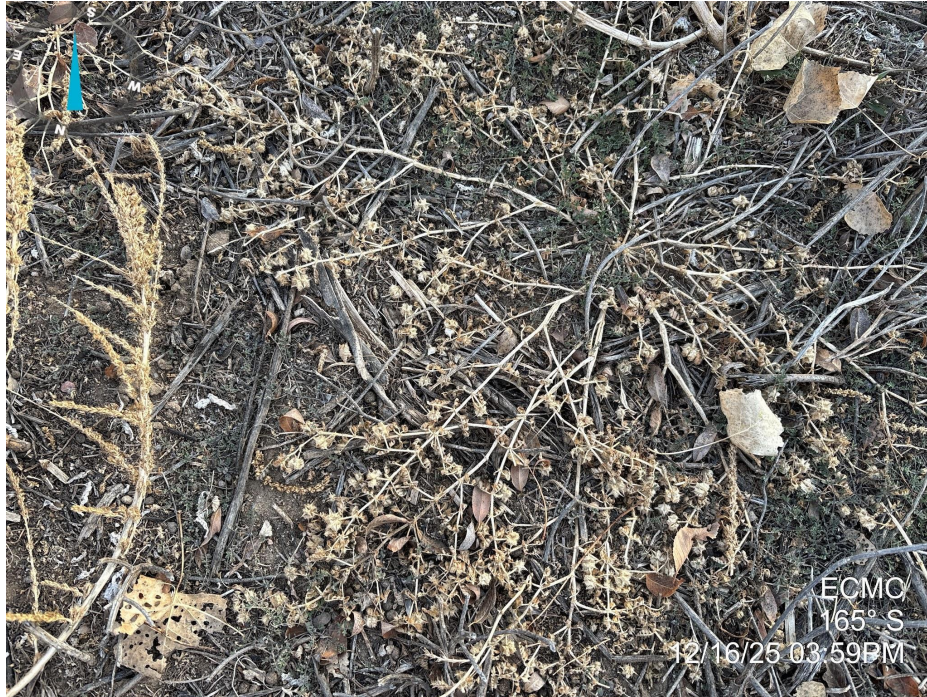
**Photo 5.** Photo taken of ground cover at the tank battery location. Photo illustrates weedy annual vegetation including puncture vine (*Tribulus terrestris*), a List C Noxious Weed species.

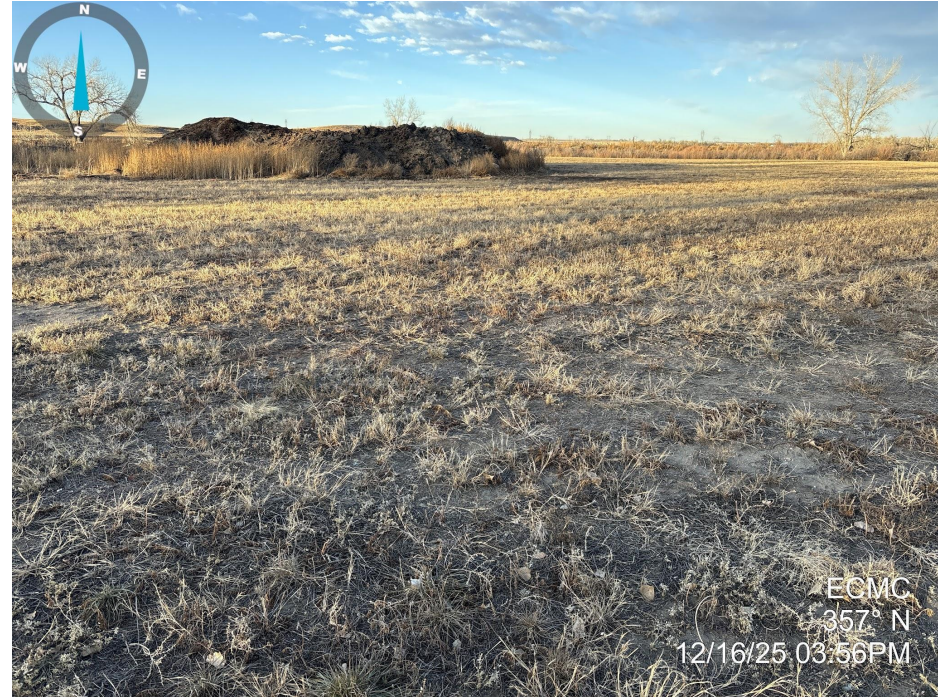
**Photo 6.** Photo taken of the reference area to the location, east of the location, facing north. Photo illustrates perennial grass that has been mowed.

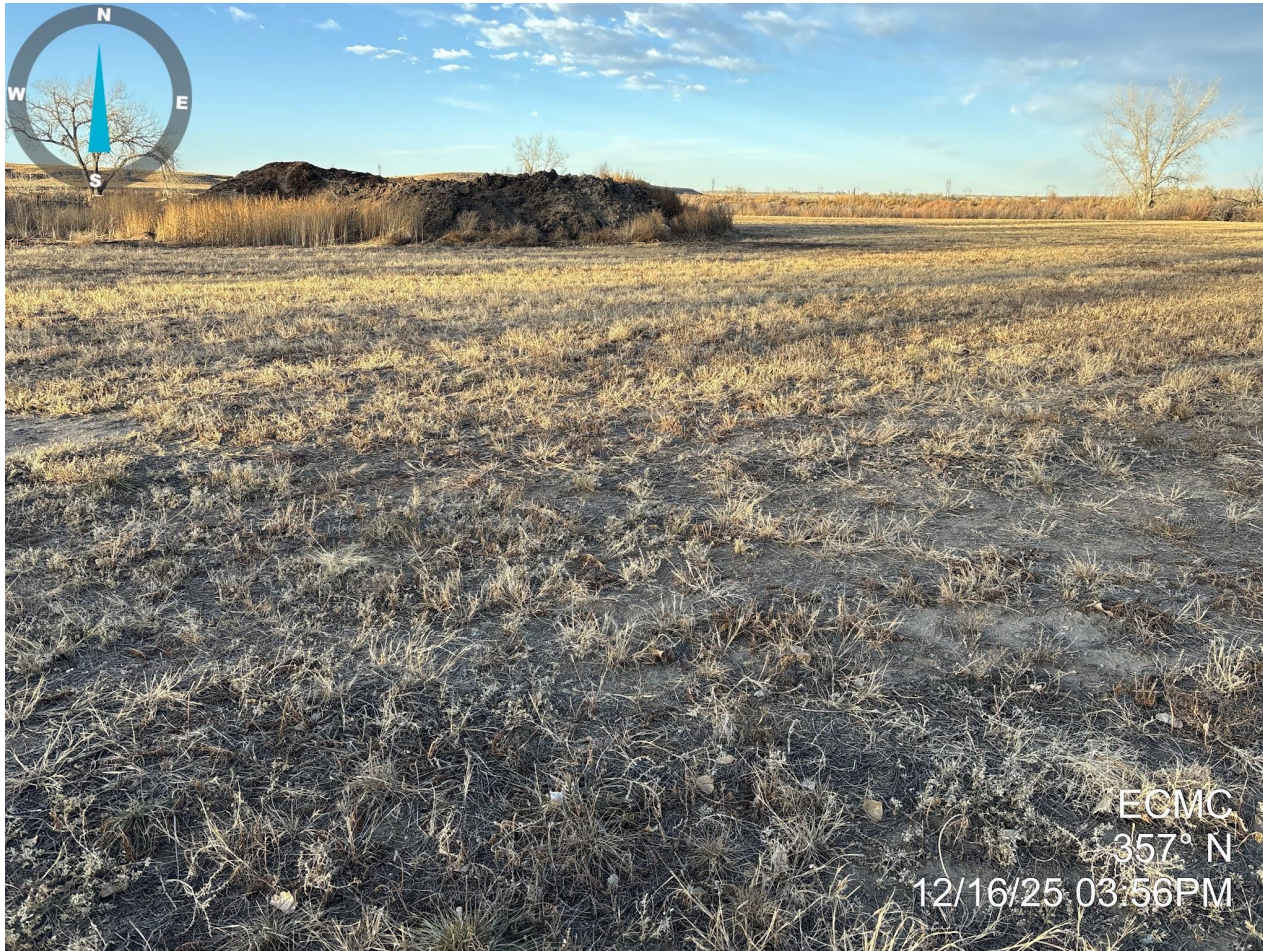
**Photo 7.** Photo taken of the reference area to the location, east of the location, facing north. Photo illustrates perennial grass that has been mowed.
