# INSPECTION PHOTOS

**Well: GOLDEN EAGLE 21-10**

**INSPECTION DOC #: 716301926**

**Operator: OGRIS OPERATING LLC 10758**

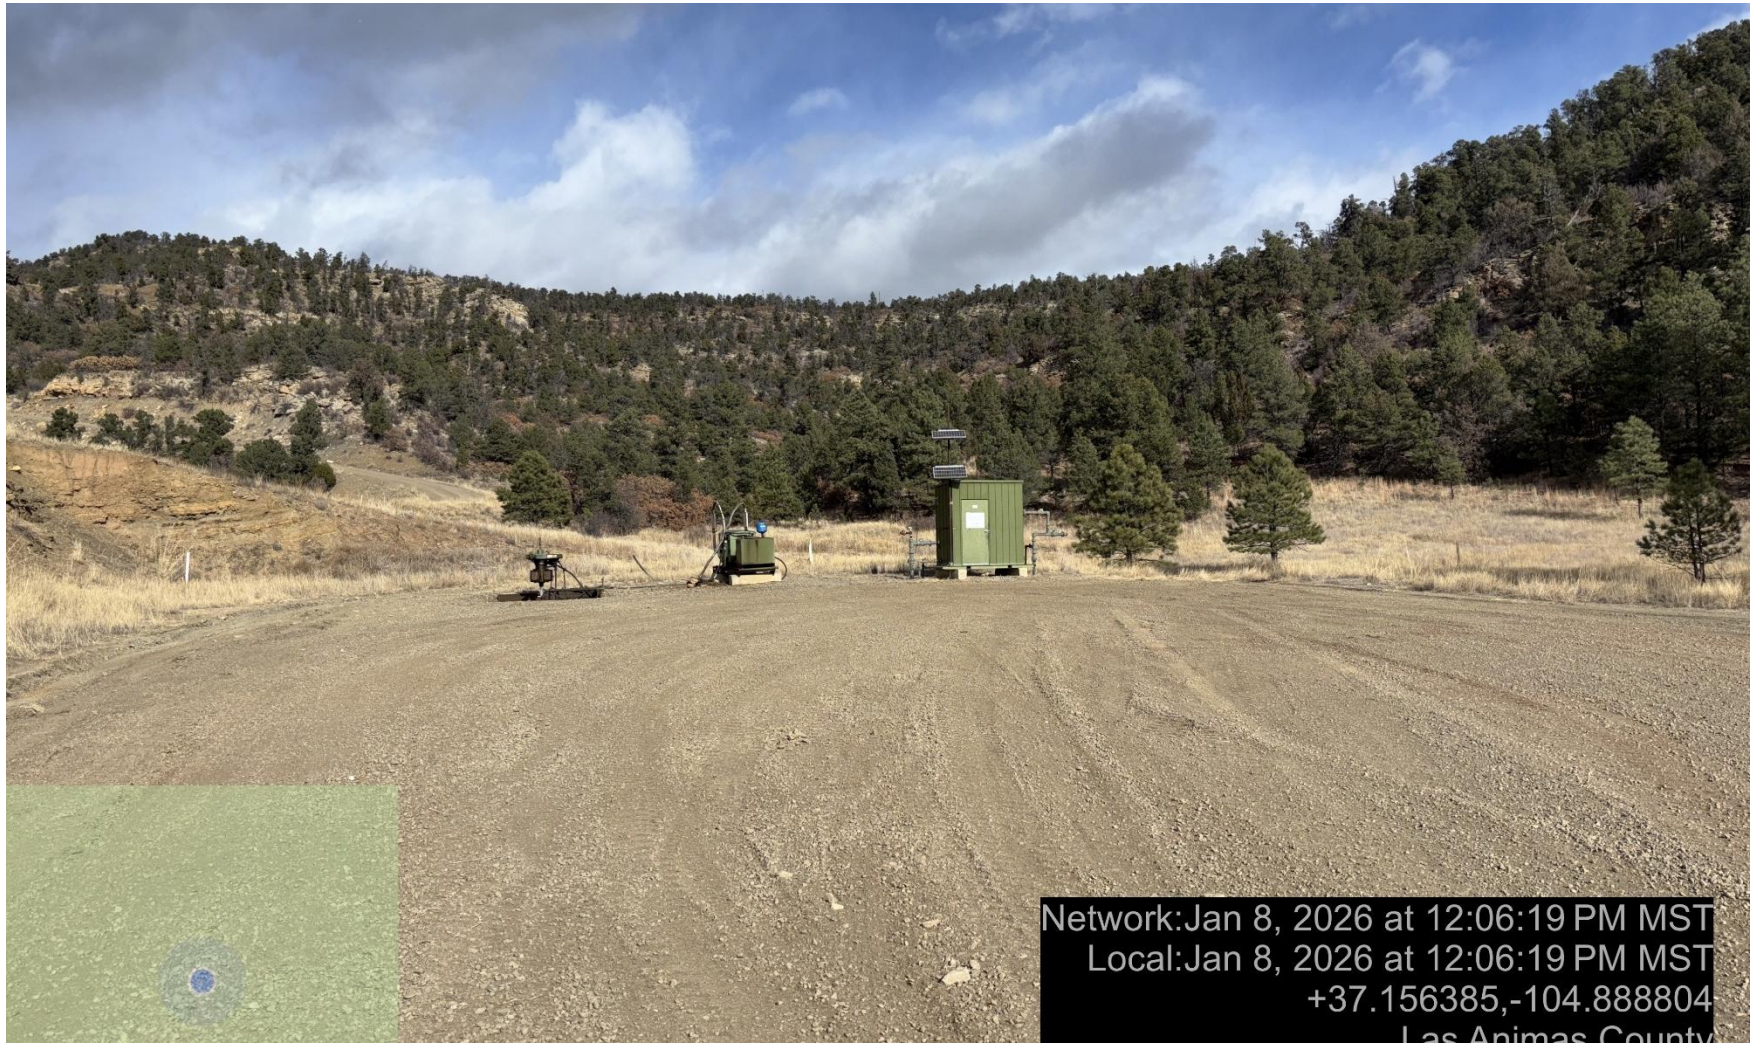
PHOTO 2: API # IS NOT POSTED ON WELL SIGN AND CONTACT PHONE NUMBER IS FADED AND NOT LEGIBLE. **POST SIGN PER RULE 605. CA DATE 2/8/2026.**

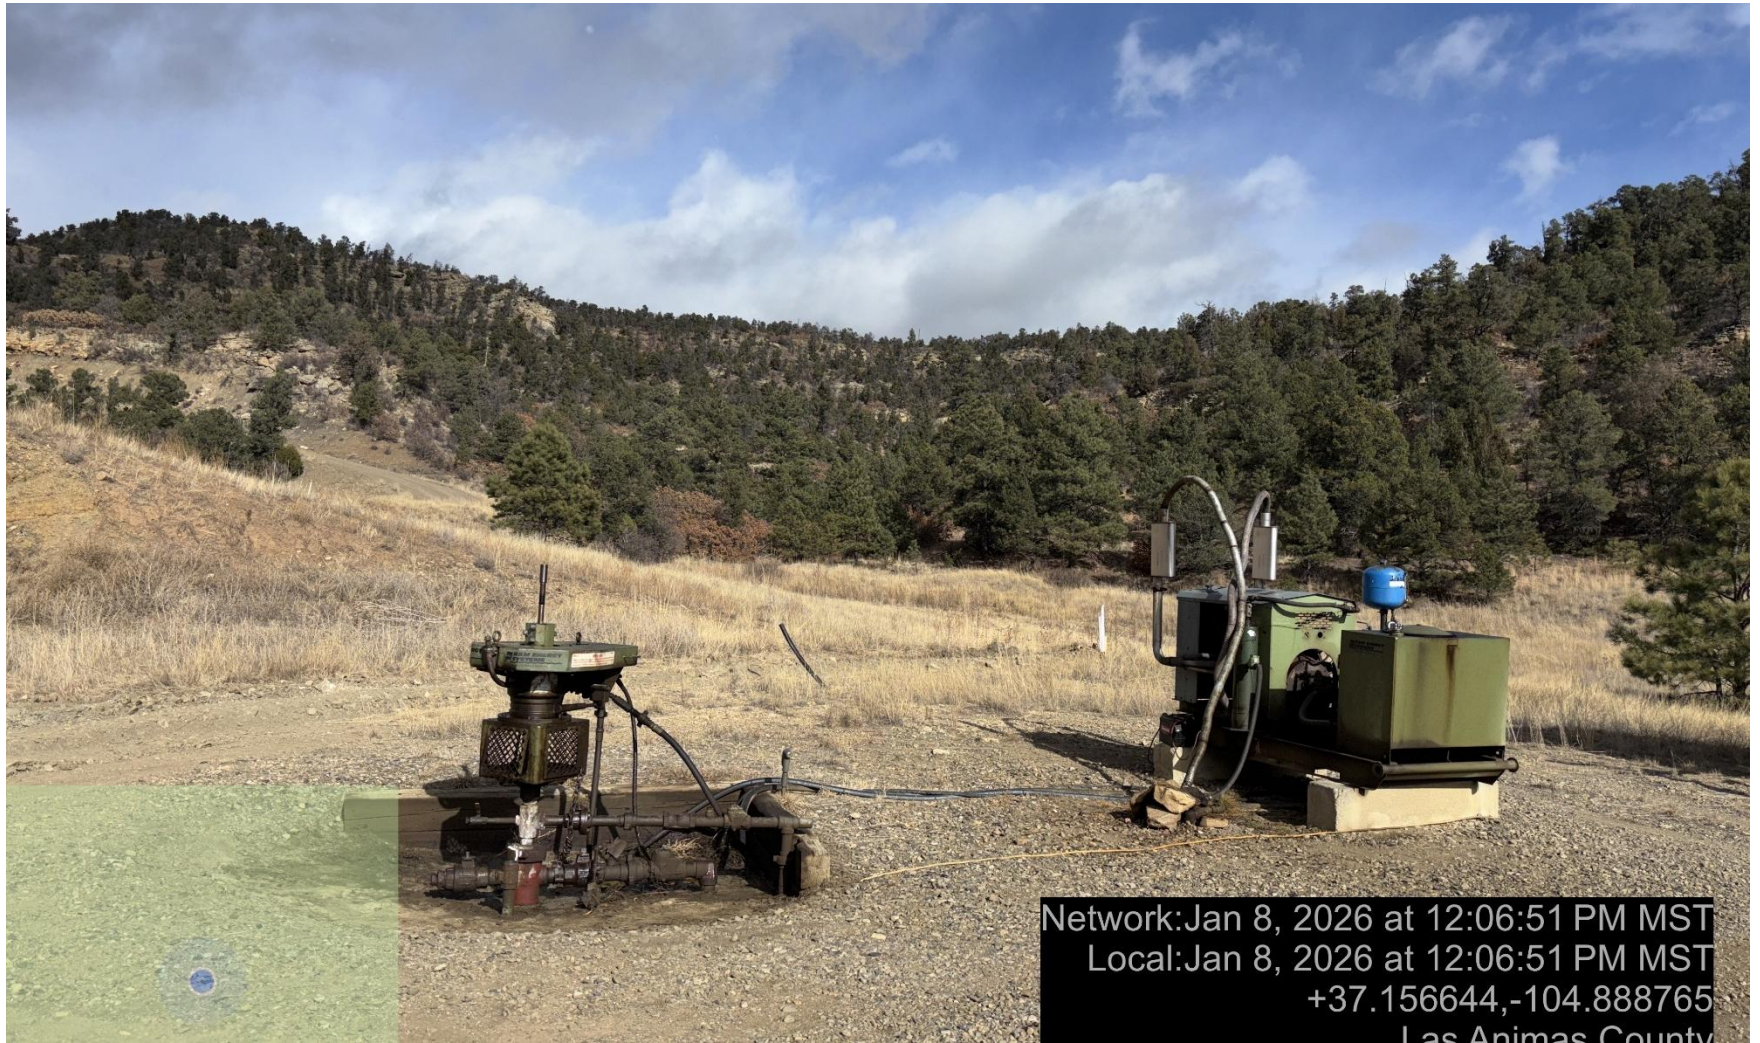
PHOTO 3: LOCATION.

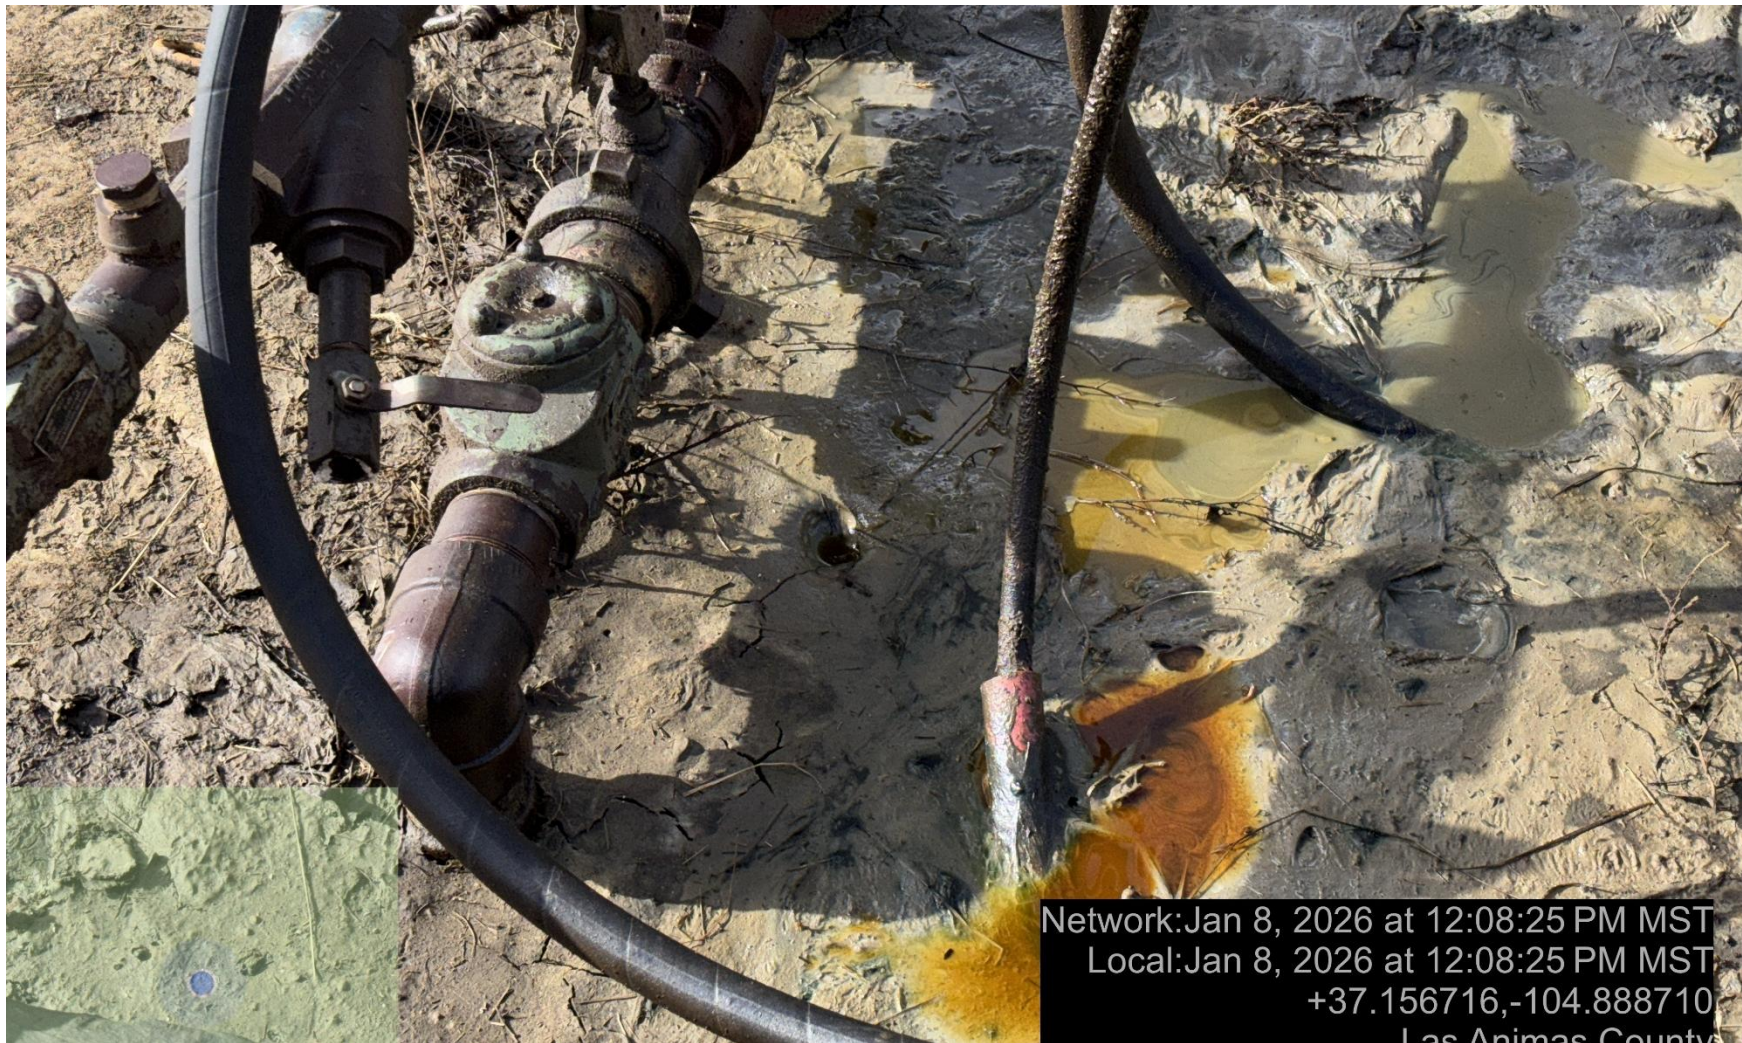
PHOTO 4: WELLHEAD AND EQUIPMENT.

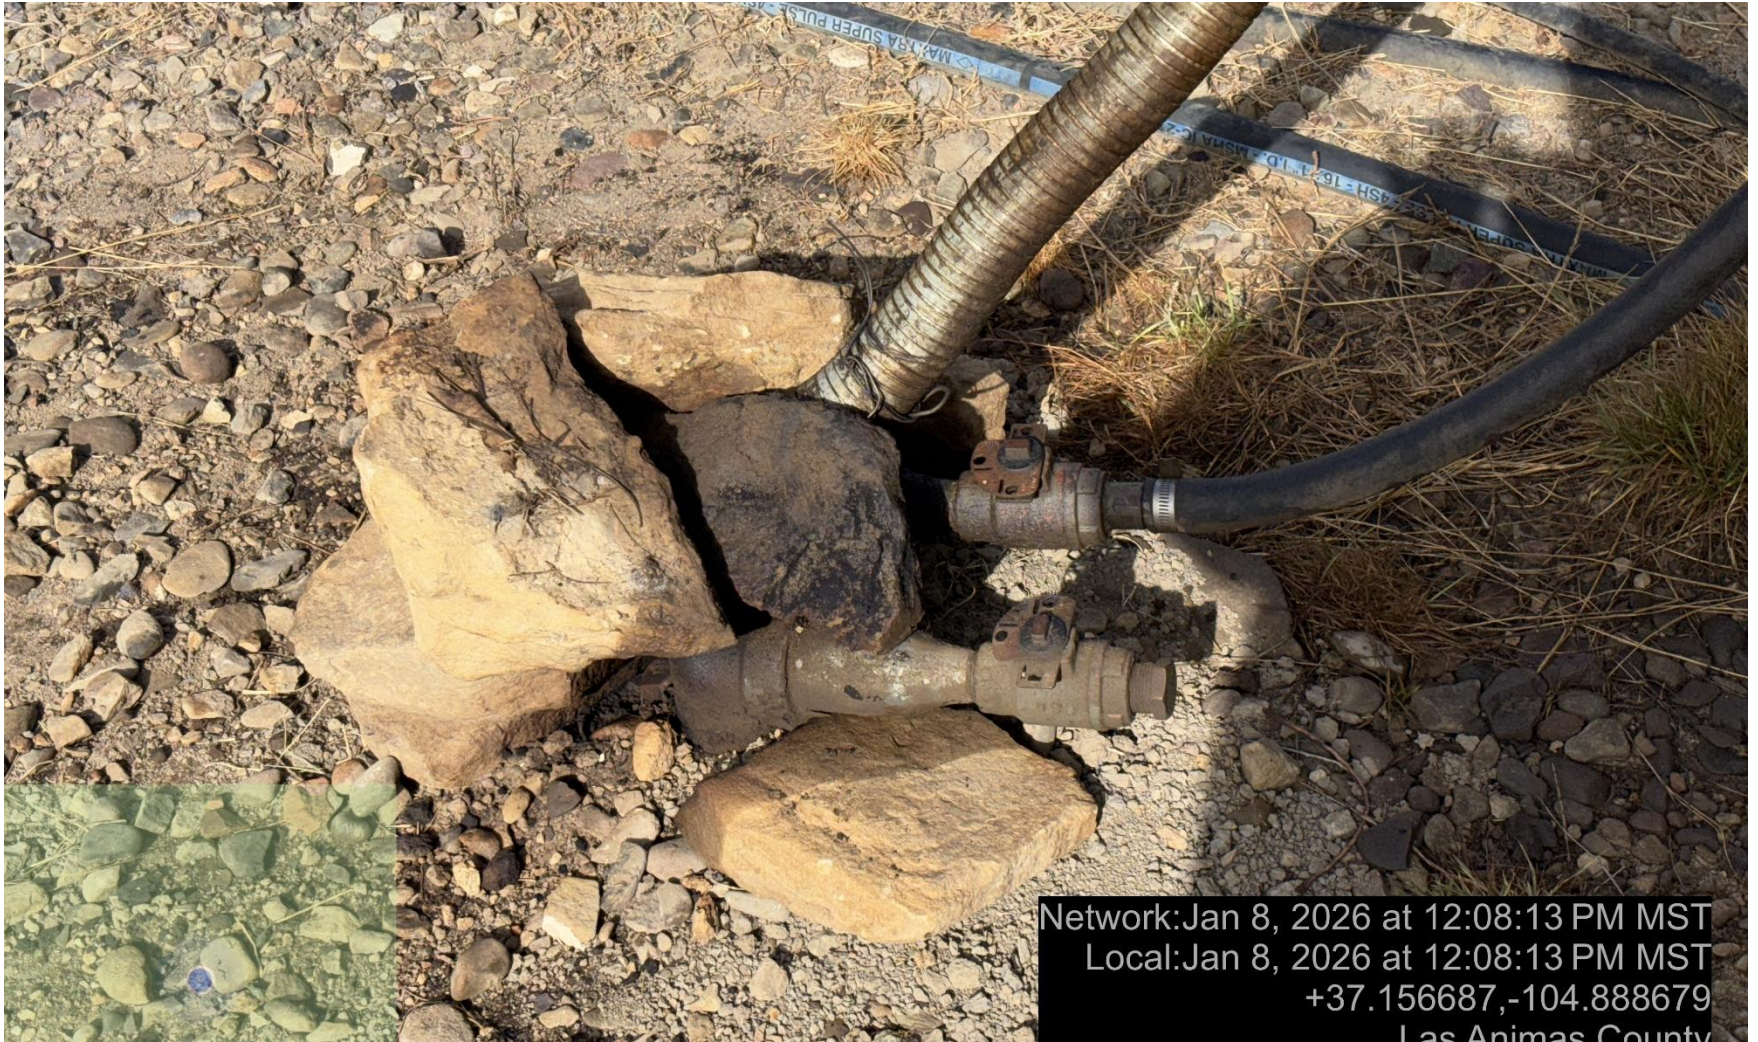
PHOTO 5: There is a dripping leak at the wellhead and a pool of water at wellhead with an oily sheen. **Control and contain spills/releases and clean up per Rule 912.a. THIS IS THE SECOND NOTICE FOR THIS CA IMMEDIATE ACTION IS REQUIRED.**

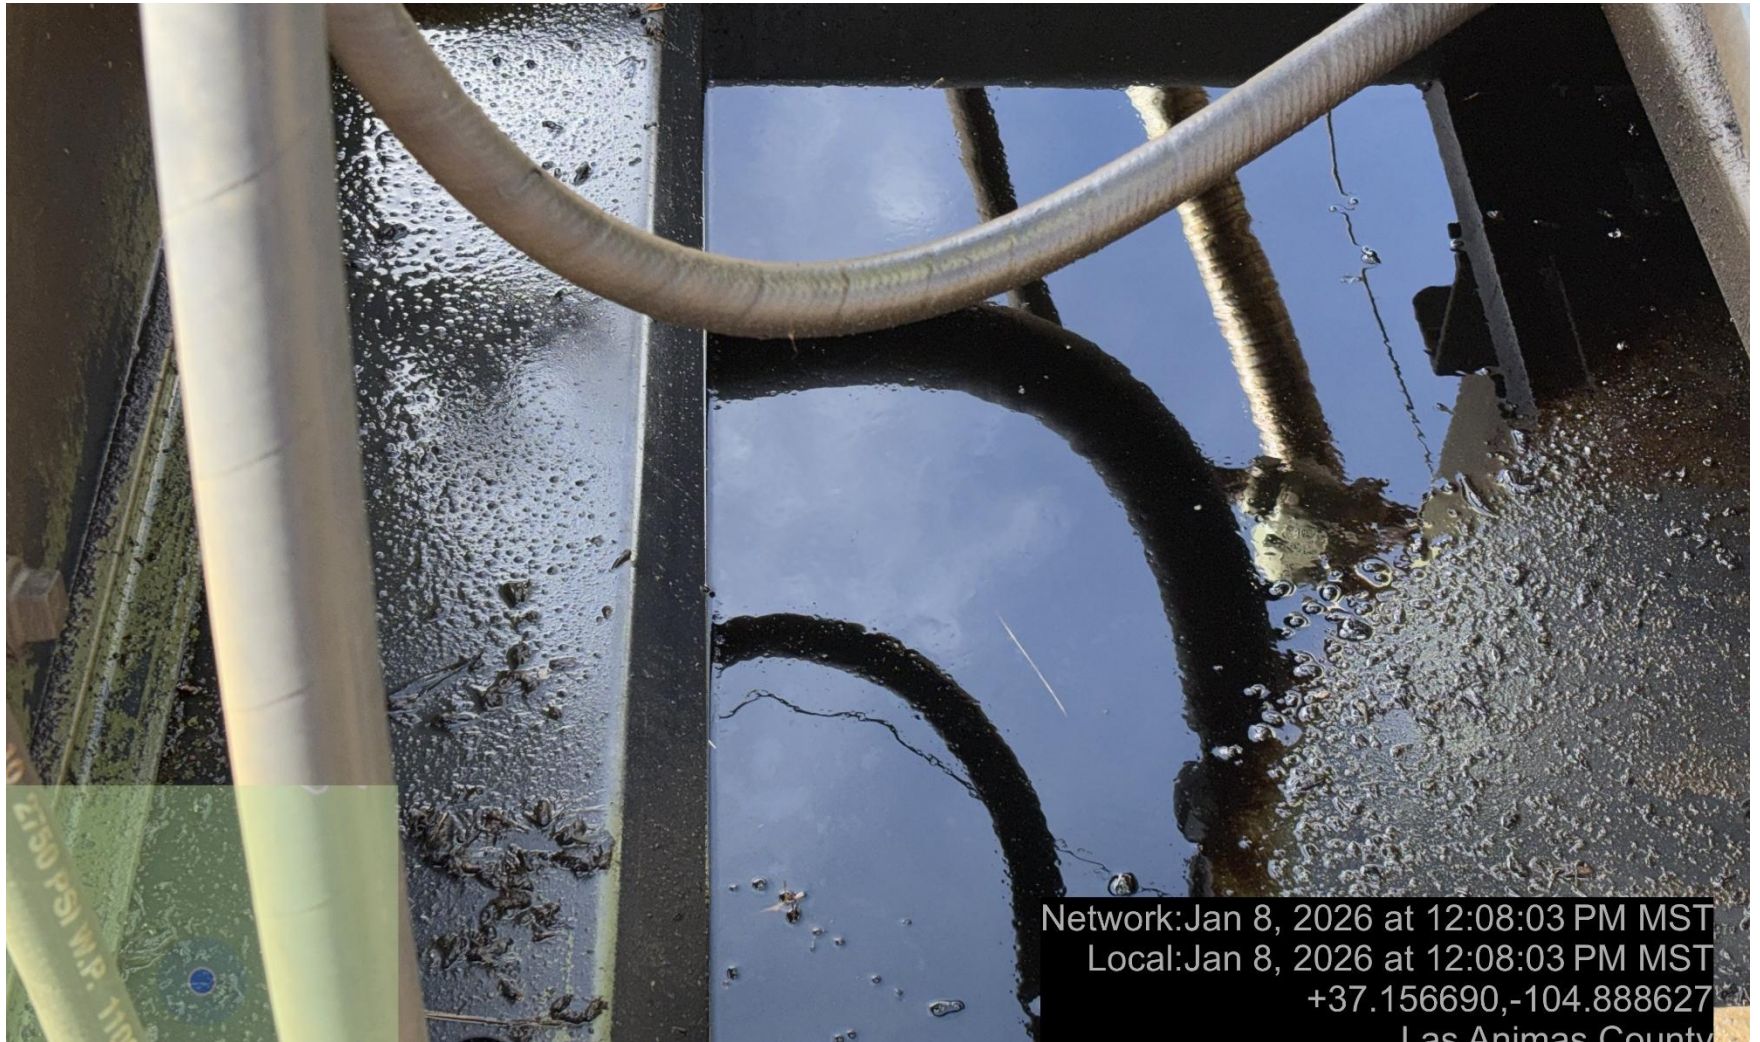
**PHOTO 6: There is oily fluids in the engine skid and stained material at the engine exhaust pipe. Conduct maintenance on equipment, cleanup stained material and review self inspection processes. THIS IS THE SECOND NOTICE FOR THIS CA IMMEDIATE ACTION IS REQUIRED.**
