**Form 27-S
Site Investigation Plan
Travis 1-10**

This Site Investigation Plan supports Form 27-S site decommissioning for the Travis 1-10 location (ID 483129). The location is operated by Navex Resources, LLC. The status of the Travis 1-10 location in the Energy & Carbon Management Commission (ECMC) COGIS database is closed (CL). The well is plugged and abandoned (PA).

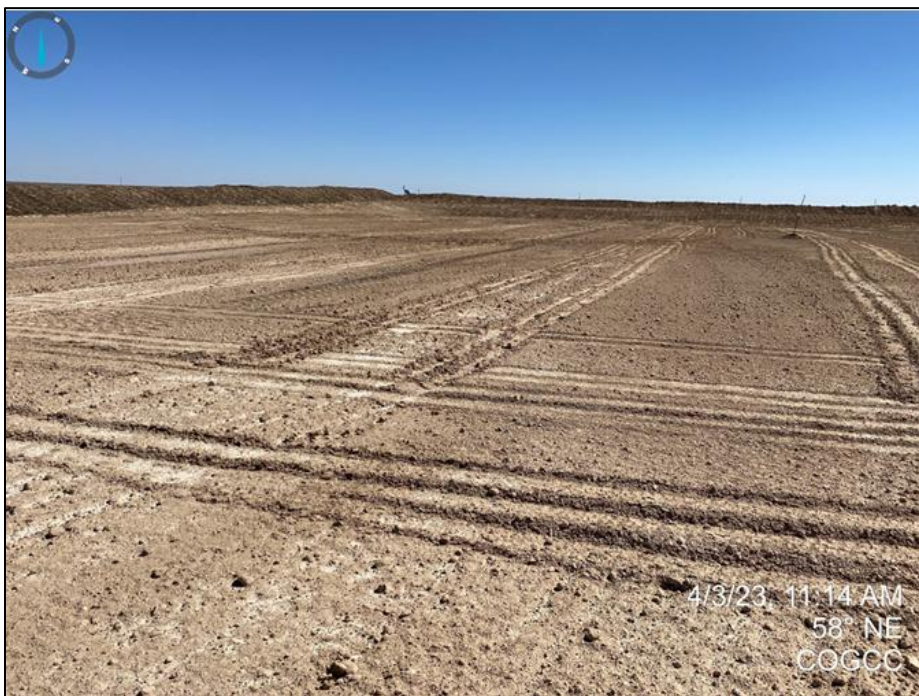
Figure 1. ECMC 4/3/23 inspection showed and reported no surface indication of a pit

However, Navex never buried drill cuttings on site. Instead, Navex reported in a 10/17/25 Form 27-S that drill cuttings were hauled off site for disposal to the Kit Carson County landfill. Figure 1 shows that the Travis 1-10 location never had a drill cuttings pit or trench. Likewise, ECMC's 4/3/23 inspection report stated that there was no surface indication of a pit. During the time that drill cuttings were temporarily stored on site, they were managed using the following controls:

- ECMC: Provide photo evidence to show the presence or absence of a drill cuttings trench on the location.
[Response: Photo 1 shows the absence of a drill cuttings trench, together with ECMC's corroboration during its 4/3/23 inspection of the location that there was no surface indication of a pit.](#)
- ECMC: Provide photos showing the location where exploration waste was stored.
[Response: Photos 2 through 4 show that dewatered and dried drill cuttings were stored on a liner on the well pad before the drill cuttings were hauled to the Kit Carson County landfill for disposal.](#)

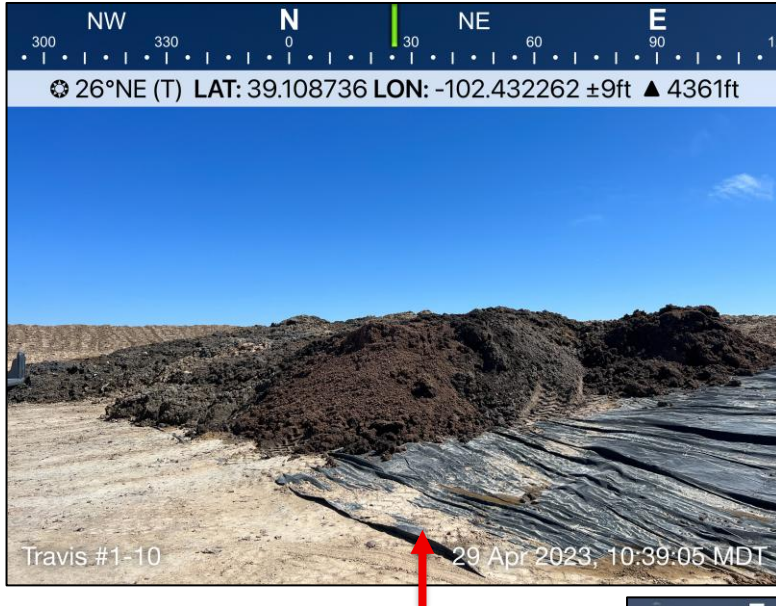
Figure 2. Demonstrates dried drill cuttings on liner (4/29/23)

1. Drill cuttings were dewatered and dried to contain less than 5% moisture content.
2. Dewatering was performed with a Mammoth 2276 centrifuge.
3. Drying was further performed with shakers and double drying.
4. Dried cuttings were then contained on a liner. The lined area is shown in Figures 2 through 4.
