Inspection Photos

Operator: QB Energy Operating LLC #10844

Location ID: 324267

Inspection Doc: 719200643

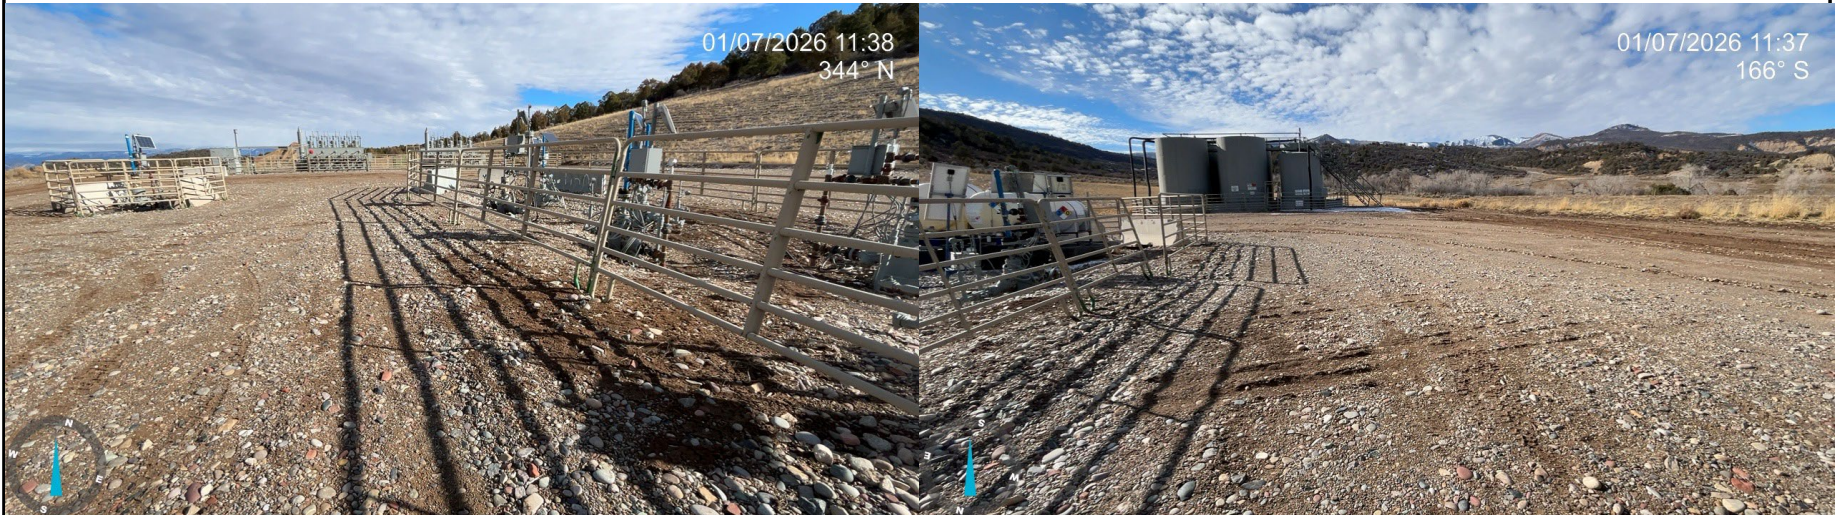
Photo 1: Photos showing an overview of the location looking north and south, respectively.

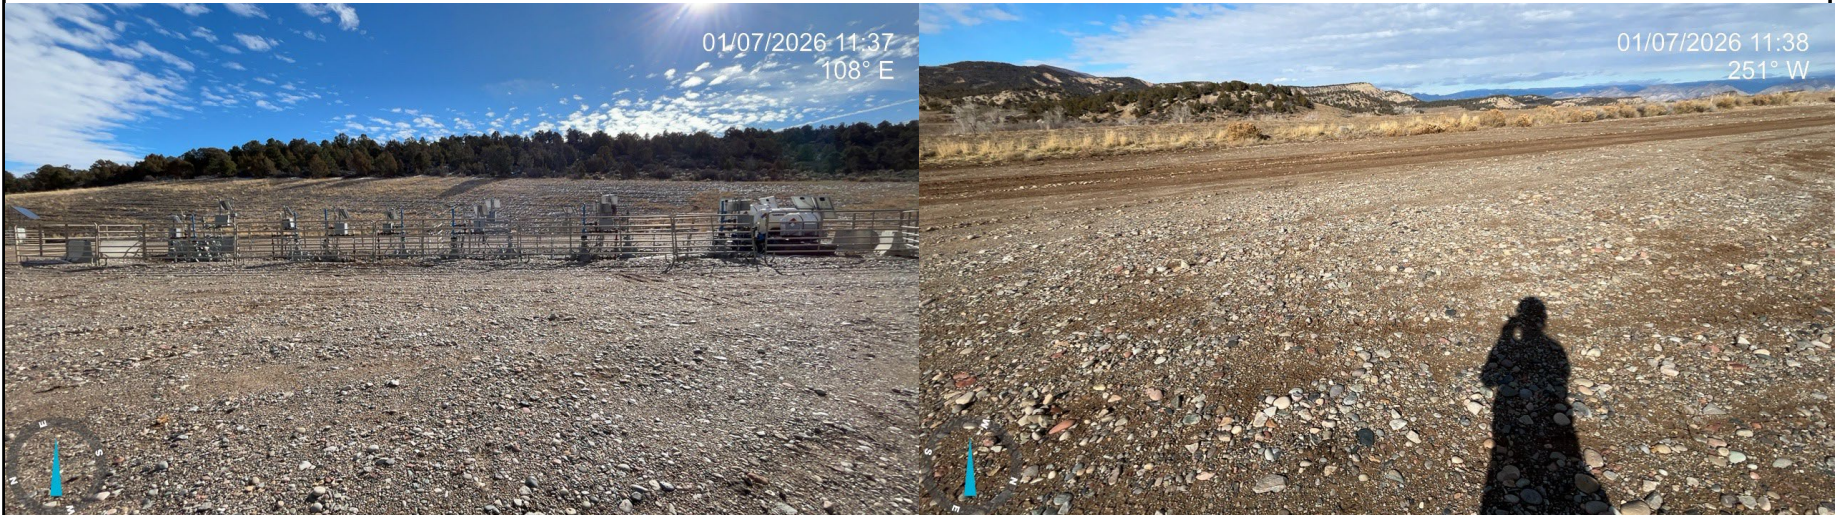
Photo 2: Photos showing an overview of the location looking east and west, respectively.

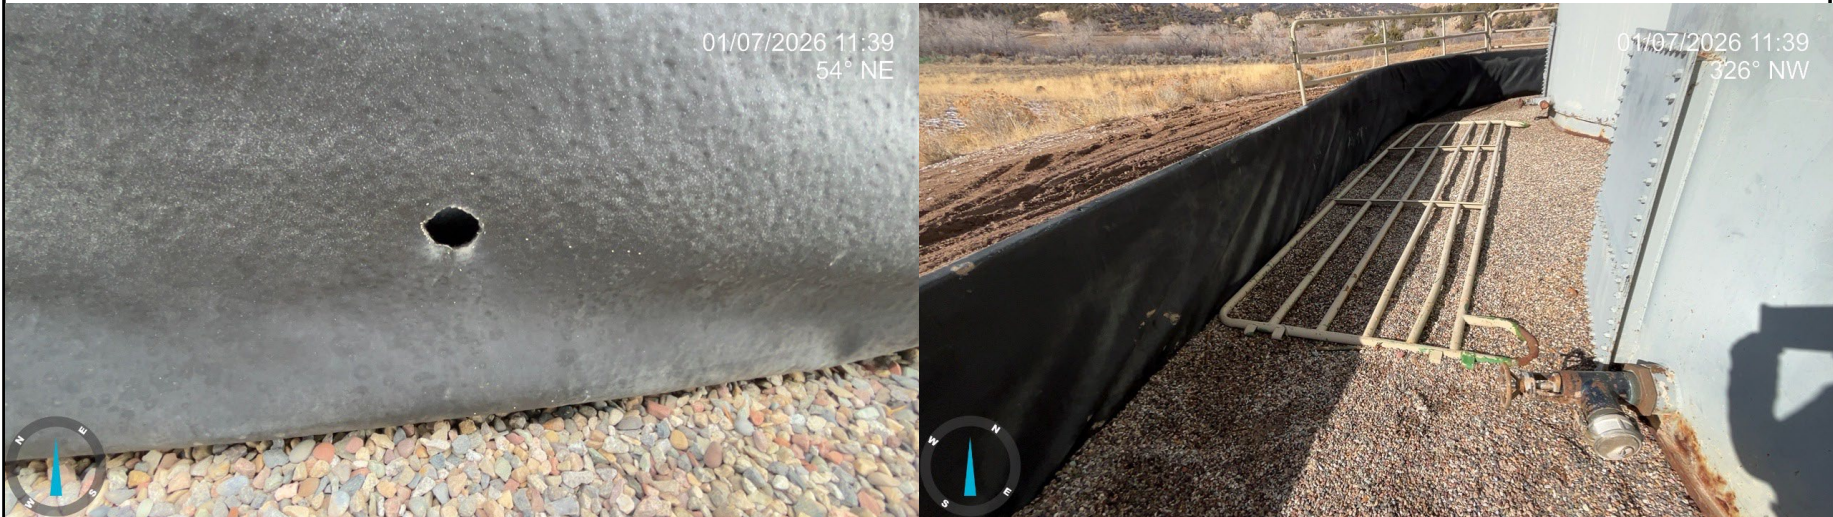
Photo 3: Photos showing a hole at the base of the black geotextile liner and an unused cattle fencing panel within the secondary containment system. Comply with Rules 603.o. and 606.a.

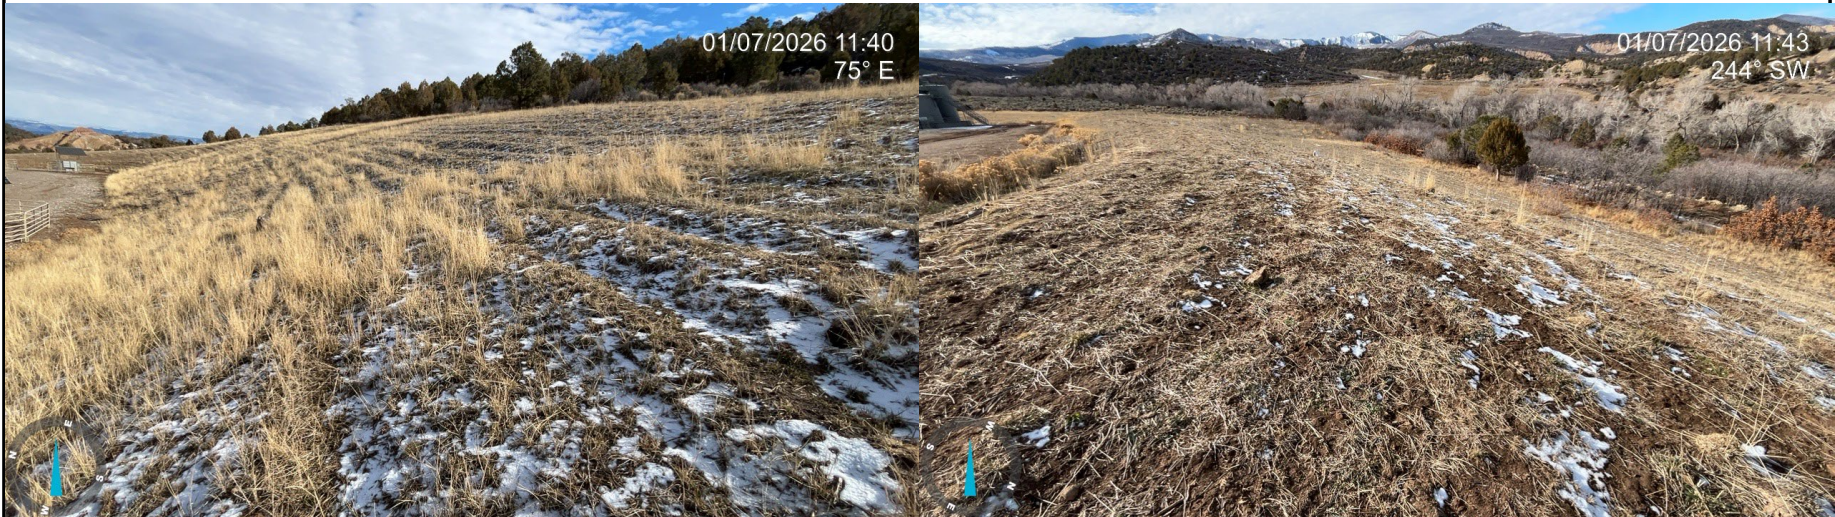
Photo 4: Photos showing an overview of the southern and northwestern interim areas, respectively. Interim areas are progressing towards 1003 reclamation requirements.
