Inspection Photos

Operator: QB Energy Operating LLC #10844

Location ID: 334821

Inspection Doc: 719200657

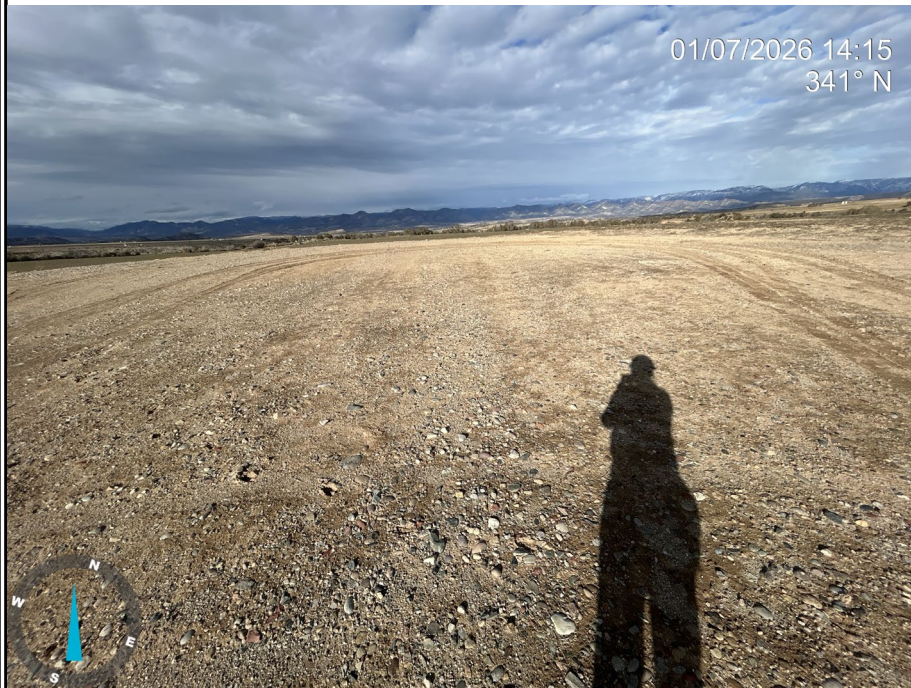
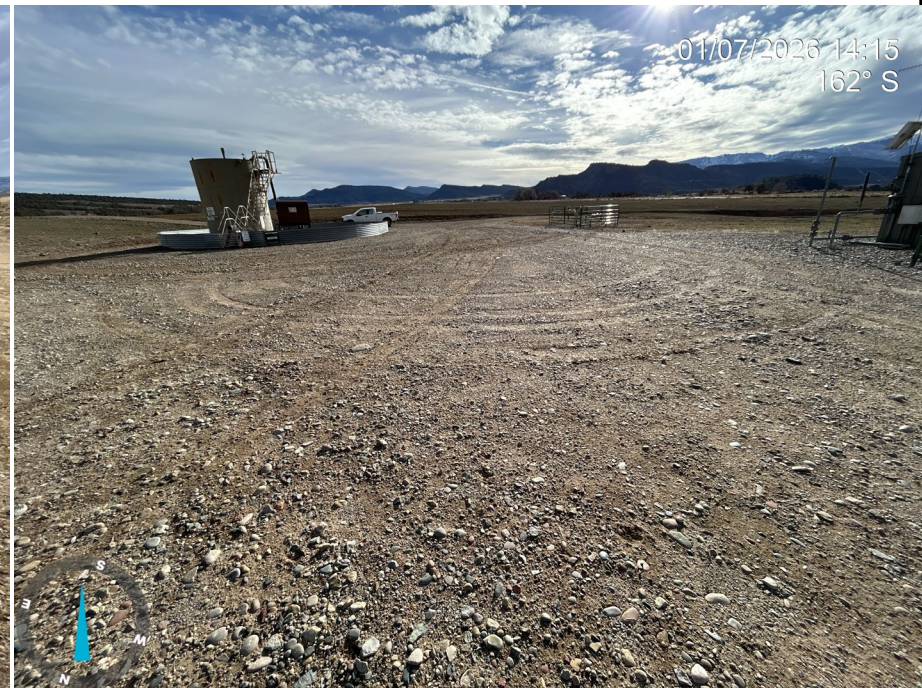
Photo 1: Photos showing an overview of the location looking north and south, respectively.

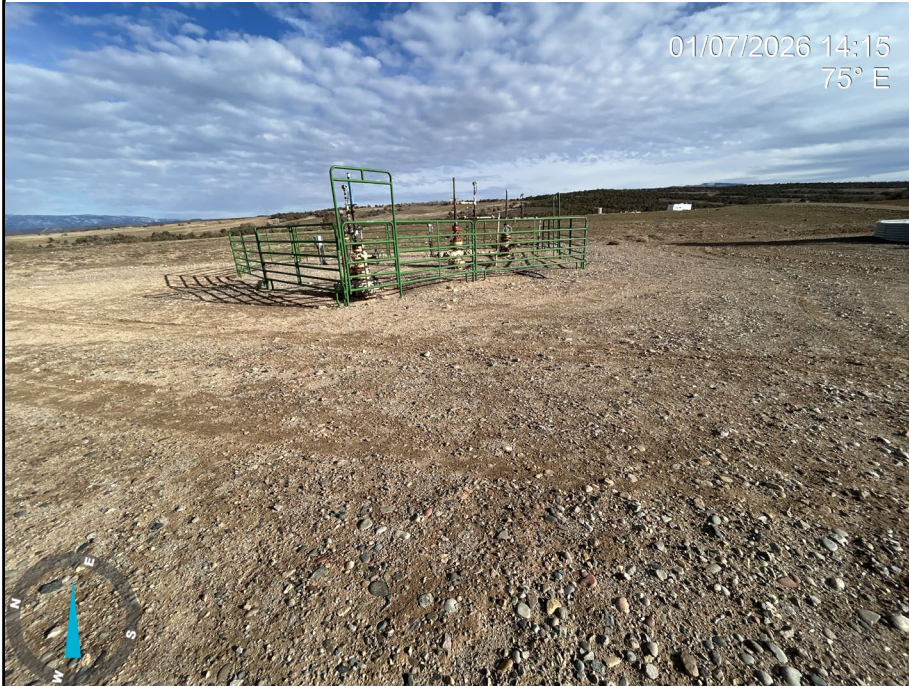
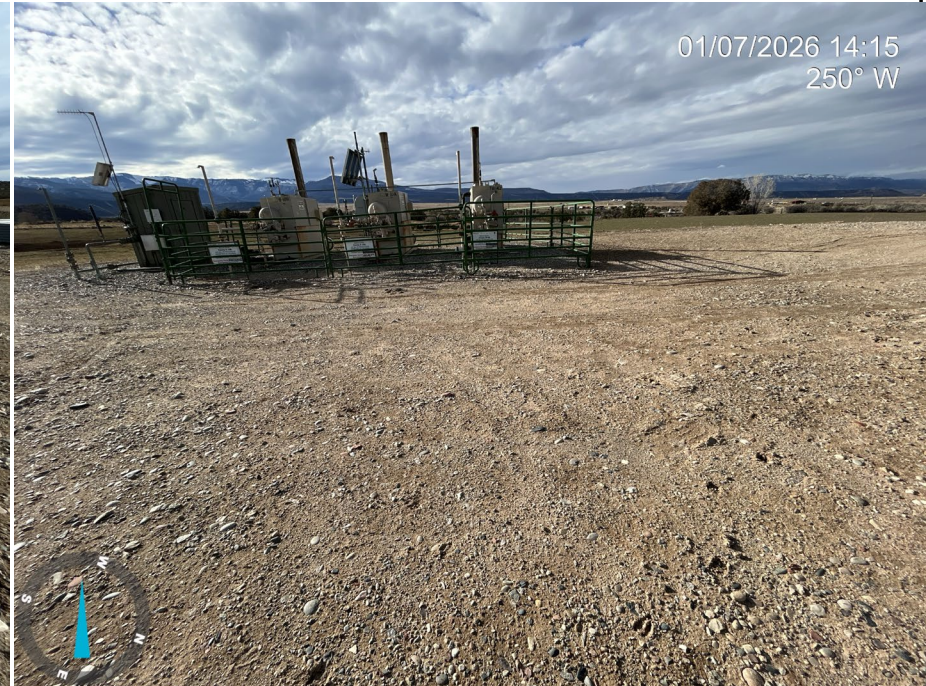
Photo 2: Photos showing an overview of the location looking east and west, respectively.

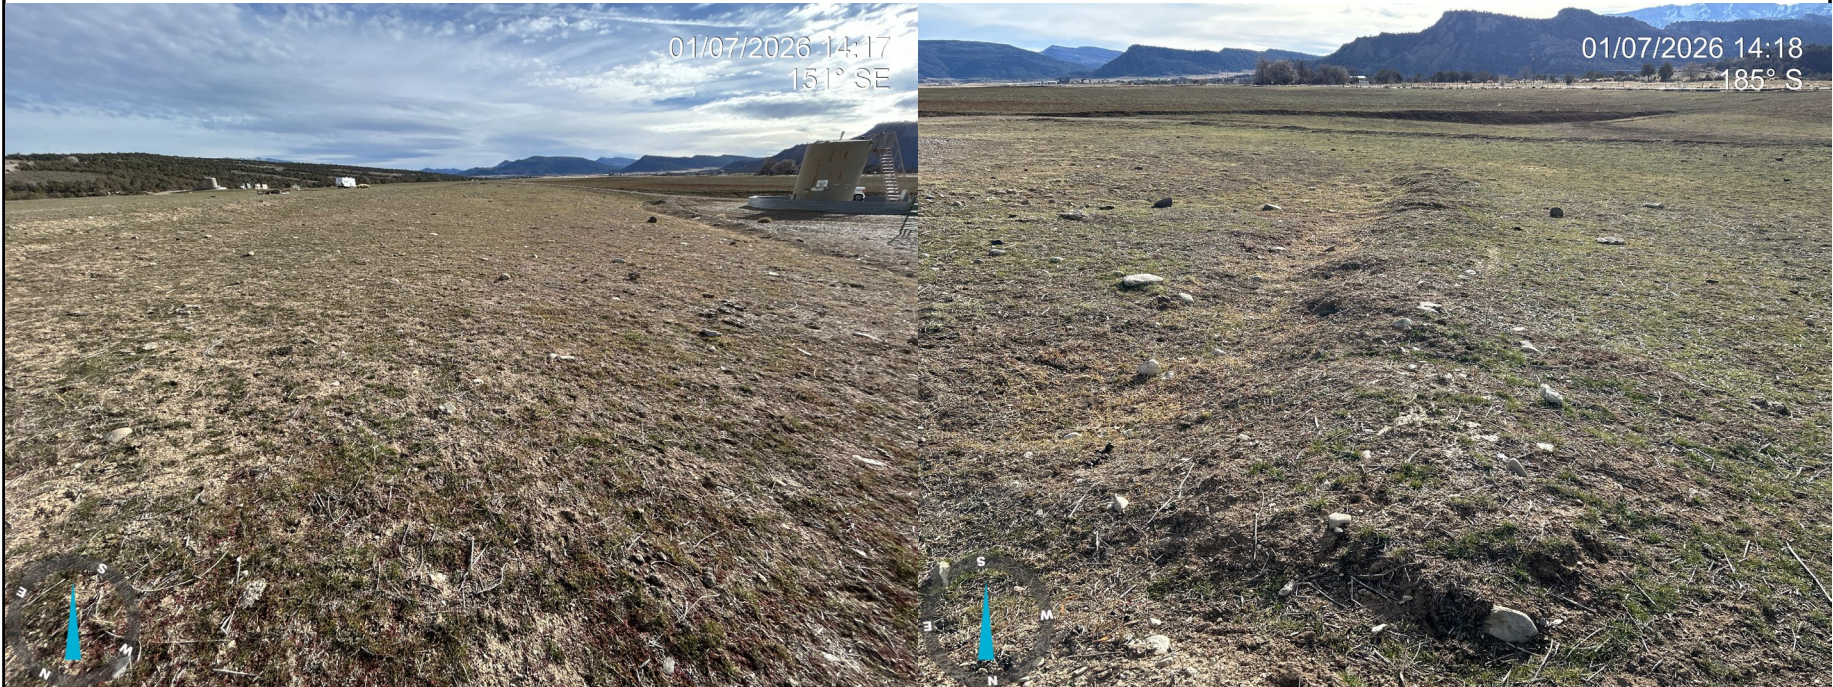
Photo 3: Photos showing an overview of the eastern and western interim areas, respectively. Perennial grasses are present; a follow-up inspection will be conducted during future growing seasons to determine 1003 compliance.

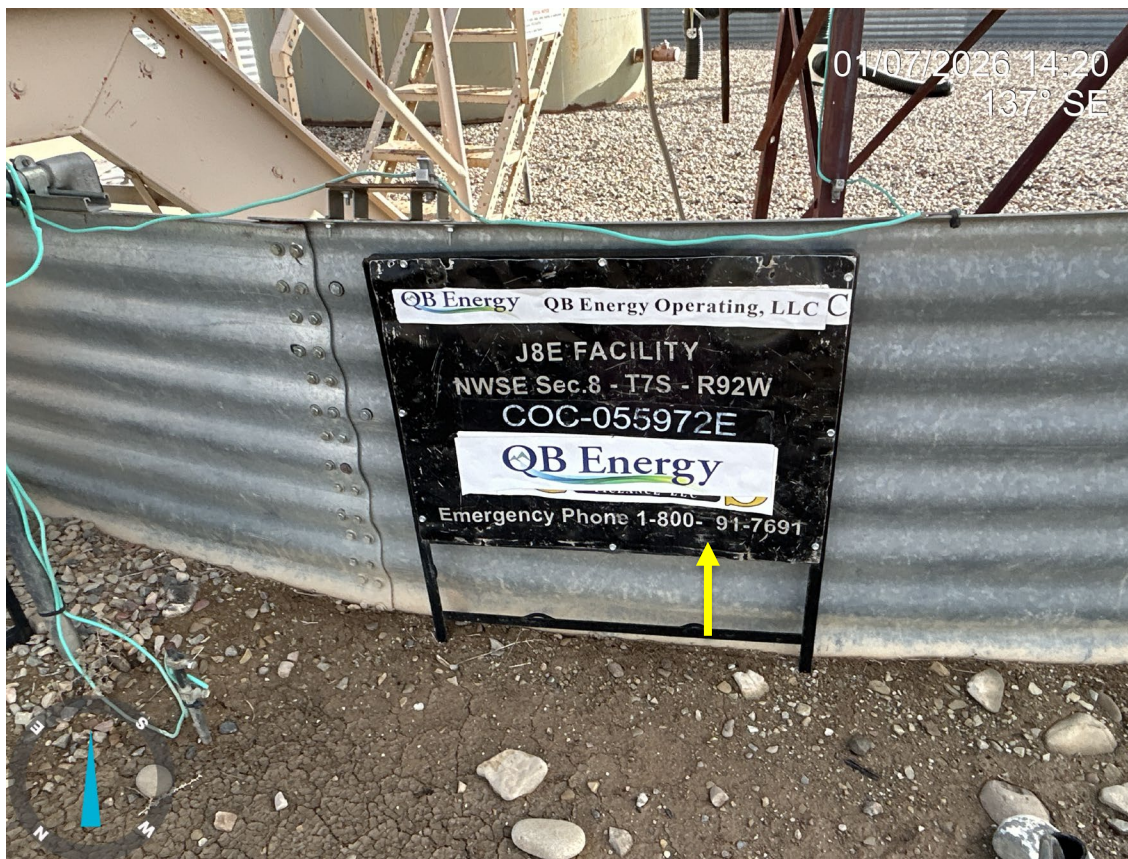
Photo 4: Photo showing the emergency phone number on tank battery signage is missing a numeral and appears to be incomplete; comply with Rule 605.e.
