Date of Inspection	12/30/2025
Inspector Name	Tyson Dilka, Stelbar
Location Name	State B 1
API	05-121-09383
COGCC Loc ID	317155
County	Washington
Location Directions	CR TT & 25, E to end, then NE into
Lat/Long	39.942185, -102.854175
Area Inspected	Former well & tank battery
Equipment on Site	No
Livestock Grazing	Yes
Fences	No
Weeds or Debris	No
Visual of Vegetative Cover	Location is visually observed at 80% overall
Stormwater	No stormwater issues observed, cattle and burrowing animals have created minor disturbance
Recommendations	Final Reclamation Release
Photos	See below 1-8.

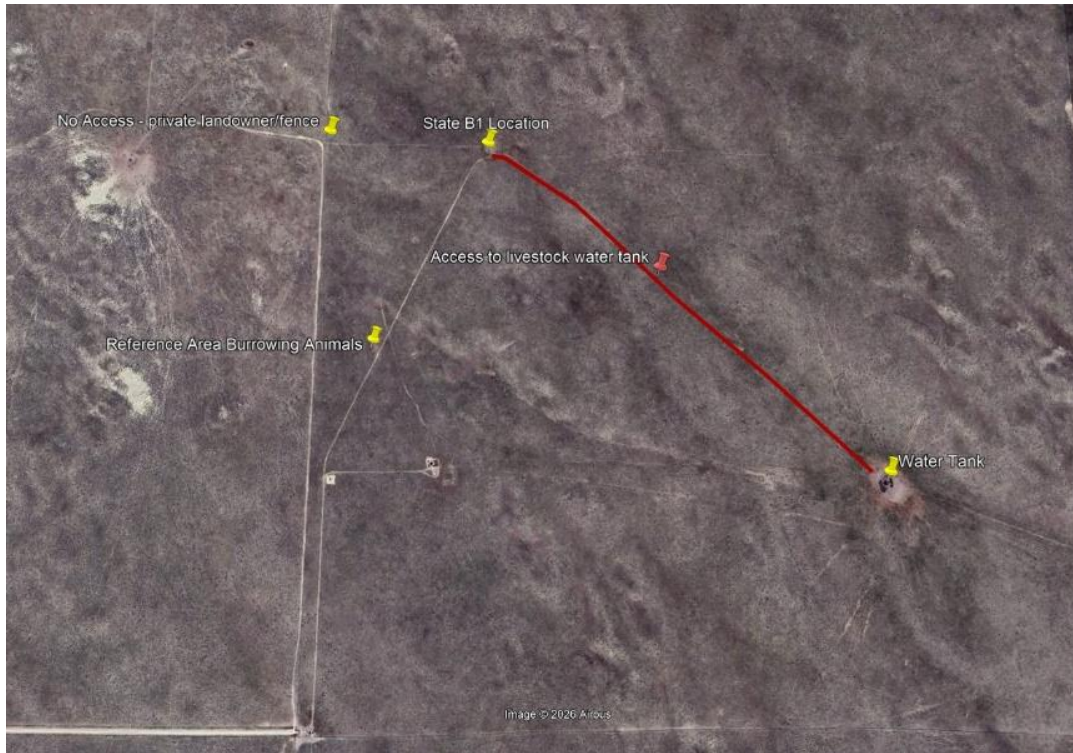
Photo 1. Map showing extended access road to water tank and no access from adjacent property to the west.

Response to Inspection	<p>The access road does not require reclamation, as it serves as access to a livestock water tank approximately 3500 ft to the SW of the location. The road was extended by the landowner (State of CO) at an unknown date after spud of the well. There is no access to the water tank from the property to the west as there is a fenceline and there is a private landowner (Rogers). Please reference photos 1 and 2 below.</p> <p>Photo 8 in document 708201895 indicates bare soil at the former well location. This is due to burrowing animals and livestock disturbance, not due to lack of progression of vegetation establishment. There are other areas in adjacent reference areas that also have bare soil due to burrowing animals. Please reference photo 3 below.</p>

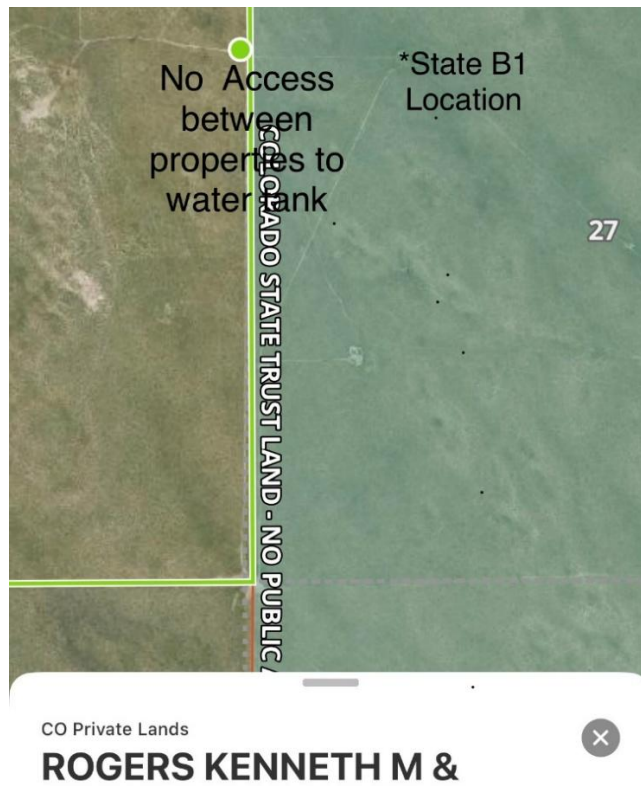
Photo 2. Map showing property line and no access to water tank between State of CO and Rogers properties.

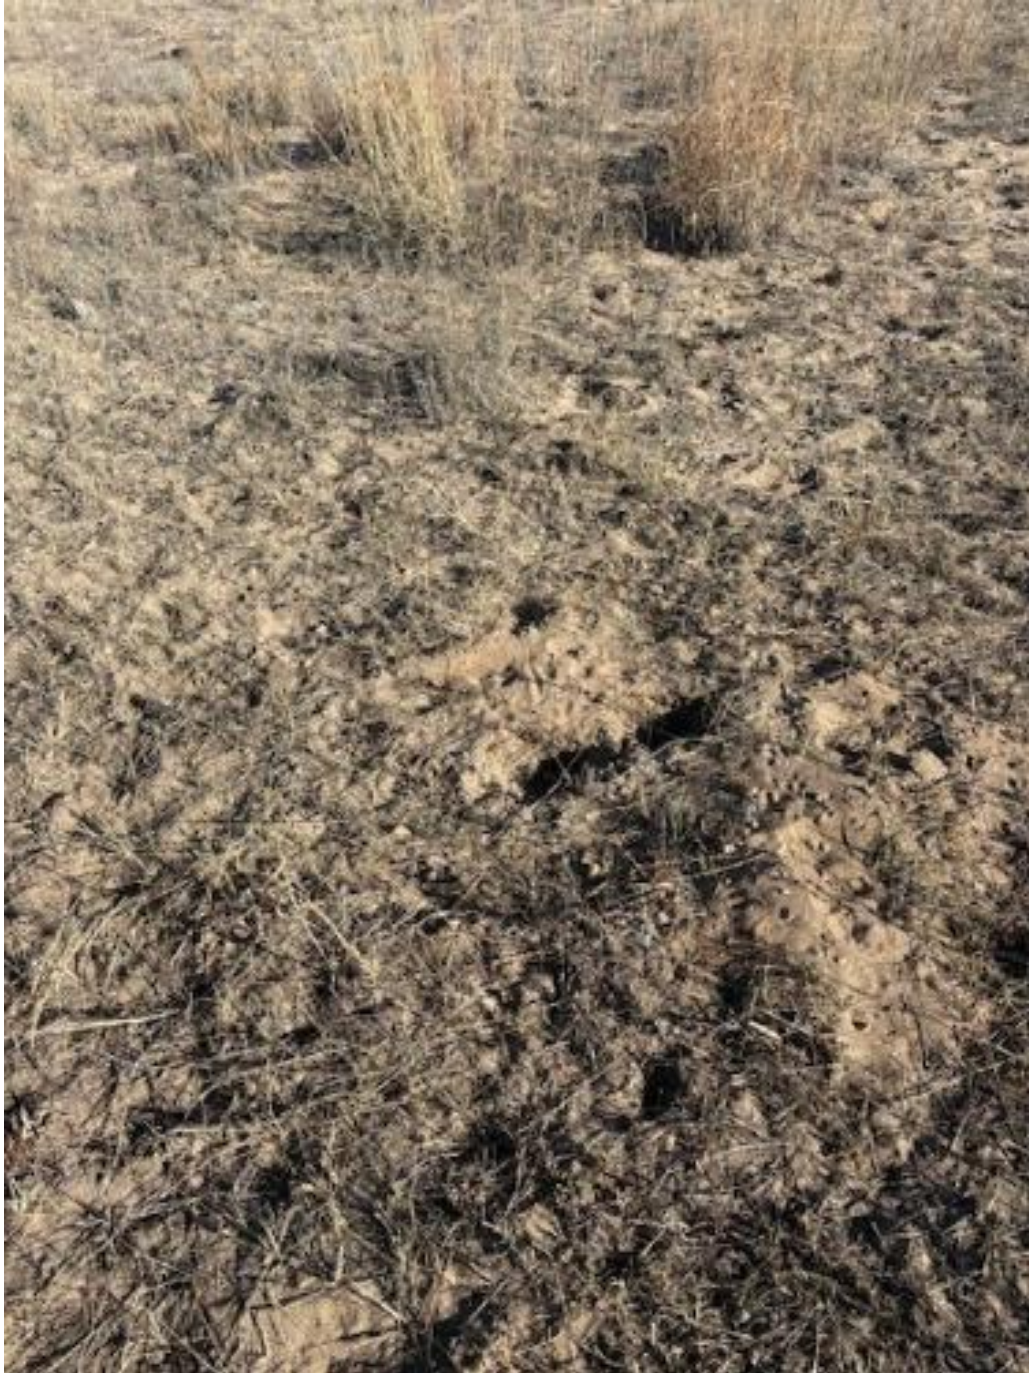
Photo 3. Reference area south of the location showing burrowing animal disturbance creating bare soils. Photo taken at lat/long 39.9383, -102.8575.
