Date of Inspection	12/30/2025
Inspector Name	Tyson Dilka, Stelbar
Location Name	Price 9
API	05-121-10437
COGCC Loc ID	317293
County	Washington
Location Directions	CR 22 & TT, E 2.5, N into
Lat/Long	39.896777, -102.8893
TB Inspected	Former well & tank battery
Equipment on Site	No
Livestock Grazing	Yes
Fences	No
Weeds or Debris	No
Visual of Vegetative Cover	Location is visually observed at 80% overall
Stormwater	No stormwater issues observed, cattle and burrowing animals have created minor disturbance
Recommendations	Final Reclamation Release
Photos	See below 1-6

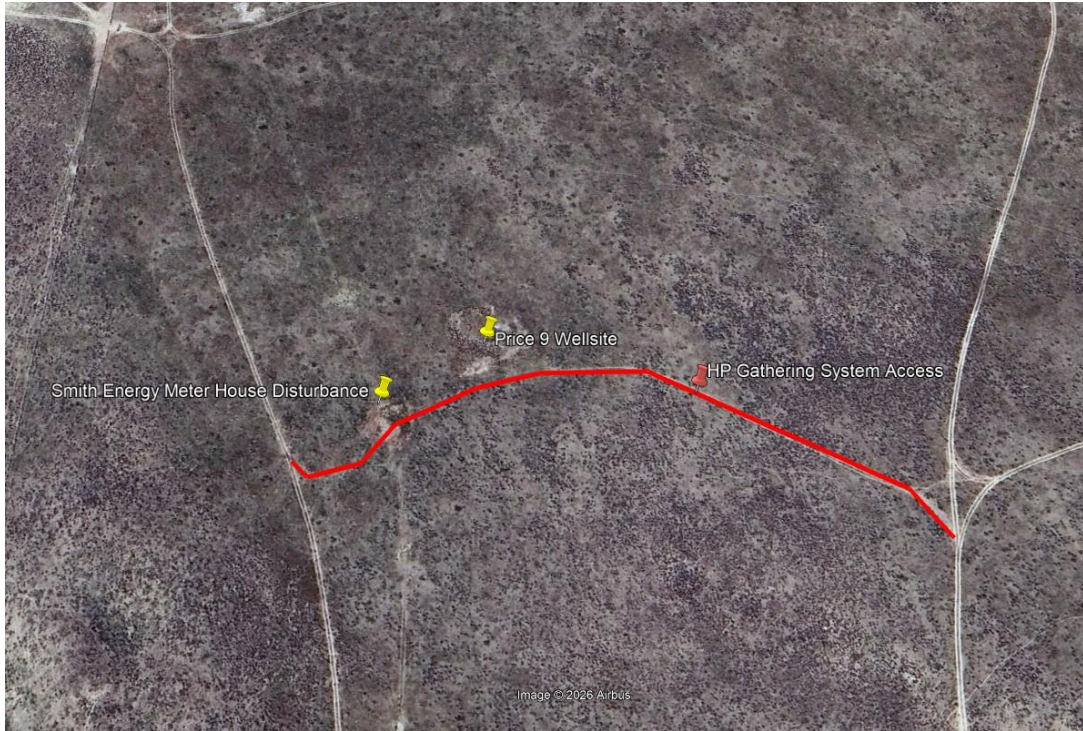
Photo 1. Map showing Smith Energy and High Plains Gathering access and disturbance.

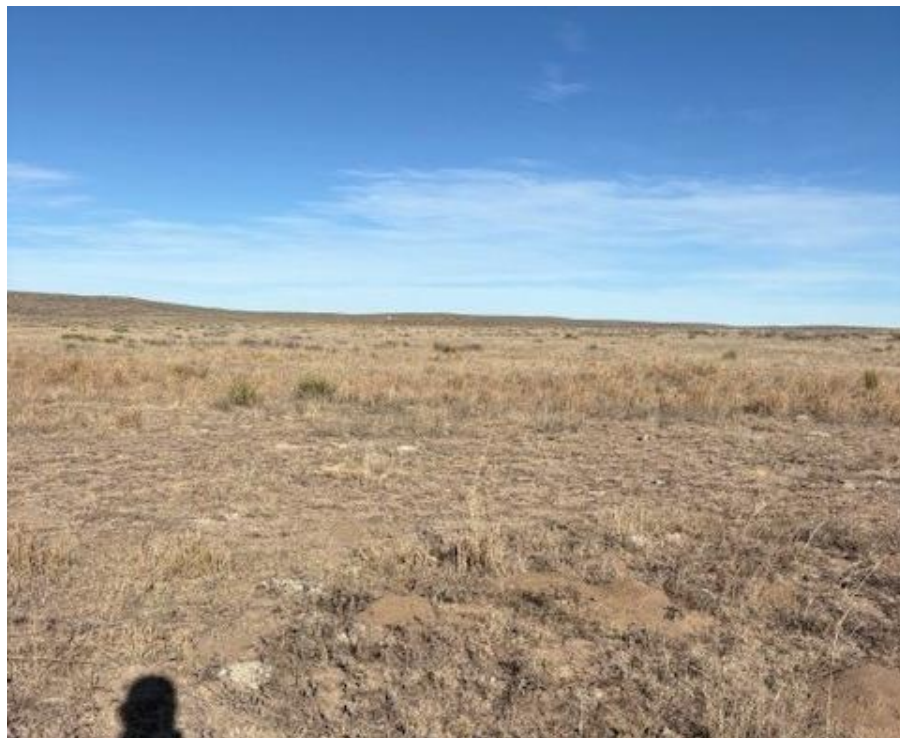
Photo 2. Photo from SW side of location facing NW showing progression of vegetation establishment at former separator location.

Response to Inspection	<p>The access roads east and west and the meter house disturbance west of the Price 9 location do not require reclamation by Stelbar, as it serves as access for the High Plains Gathering System. This HP Gathering operating interest was transferred to Smith Energy in 2018, after the Price 9 well was plugged and abandoned in 2017. Please reference photo 1 below and attached transfer agreements referencing T2S-R49W-S8.</p> <p>Photo 6 in document 708201894 indicates bare soil at the former separator location. This area was dormant seeded prior to the inspection by ECMC in Jan 2025 and now shows progression towards reclamation standards from the 2025 growing season. Please reference photo 2 below.</p>
