Flowline Closure Investigation and Environmental Summary

MCCLELLAN 3-32 Flowline
ECMC Remediation Project #37265
Weld County, Colorado

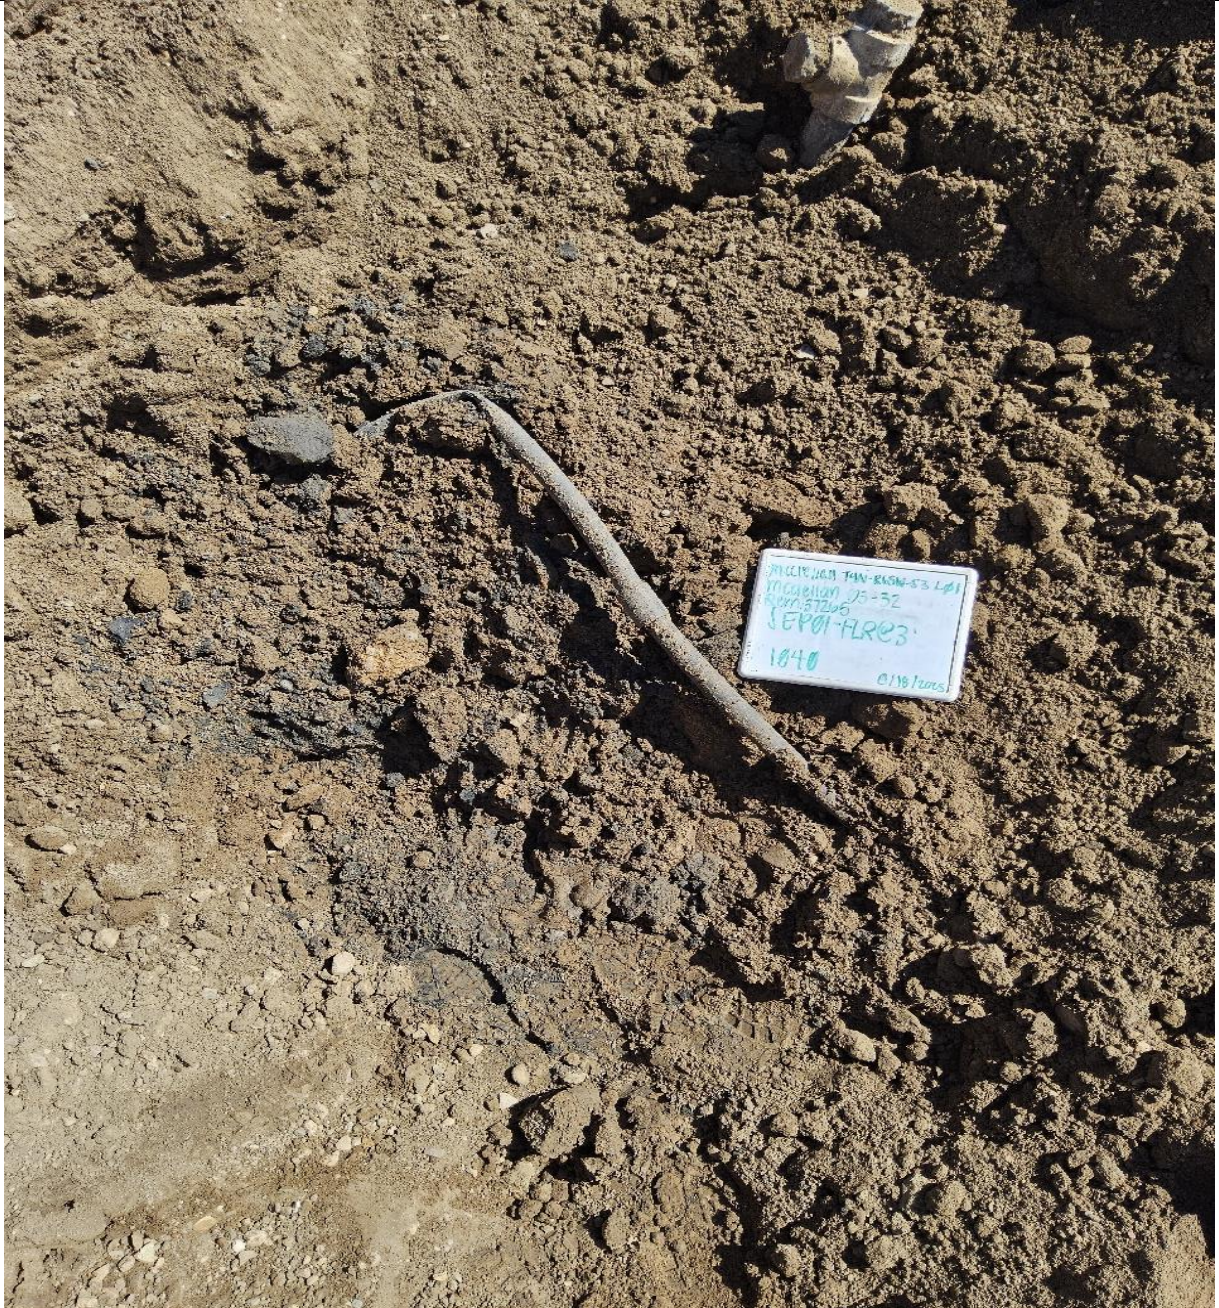
Photo: 1.	Date: 08.18.2025	Description: Representative picture of general conditions at soil sampling location SEP01-FLR@3' (Flowline Riser at Separator, 40.340588, -104.656086) in well sorted sand (SW) at a depth of three (3) feet bgs (PID: 15.7 ppm). Staining and odor were present.
---------------------	----------------------------	--

Hydrocarbon Impacted Soils / Spills: (Note estimated size and if impact appears to be surficial or extends to an unknown depth)
Strong petroleum odor and black staining on soil at flowline riser at separator (SEP-FLR@3'). Estimated size of impact 4' x4', could extend beyond 3 foot depth.

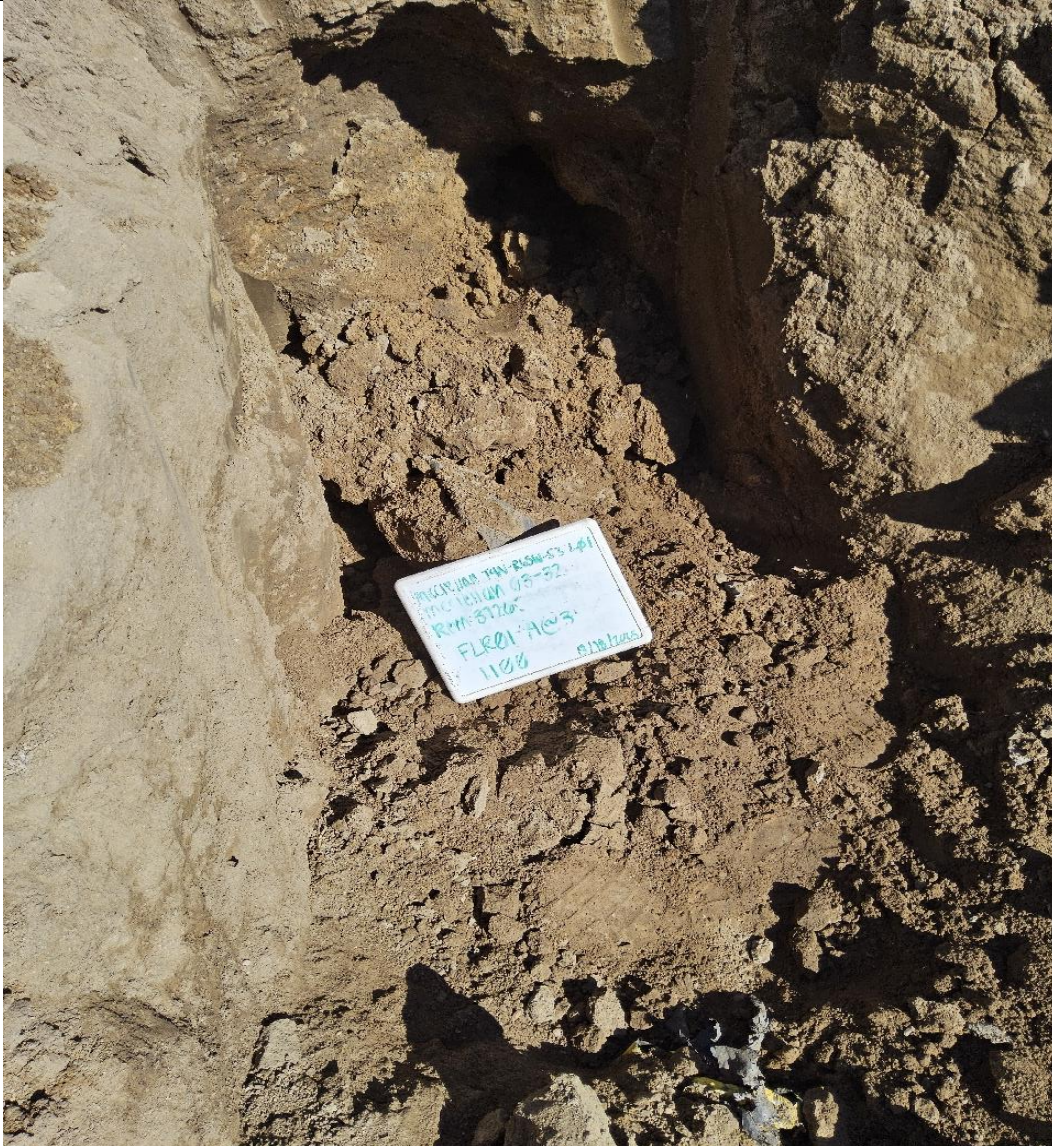
Photo: 2.	Date: 08.18.2025	Description: Representative picture of general conditions at soil sampling location FLR01-A@3' (Flowline Riser at Wellhead Terminus, 40.340197, -104.655991) in well sorted sand (SW) at a depth of three (3) feet bgs (PID: 2.7 ppm). No staining or odor were present.
---------------------	----------------------------	---
