# Inspection Photos

Operator: QB Energy Operating LLC #10844

Location ID: 334782

Inspection Doc: 719200674

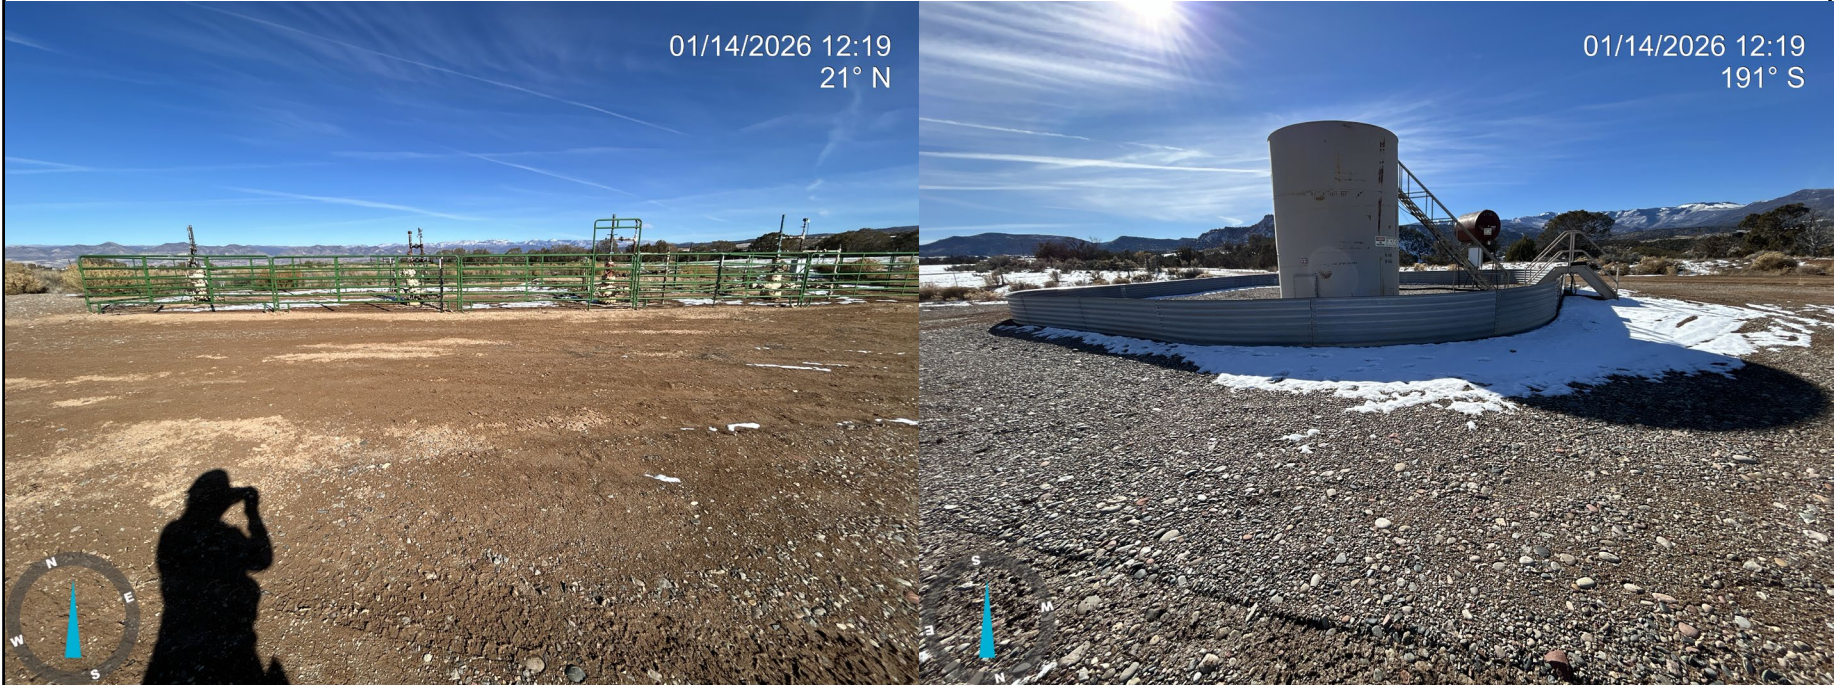
**Photo 1:** Photos showing an overview of the location looking north and south, respectively.

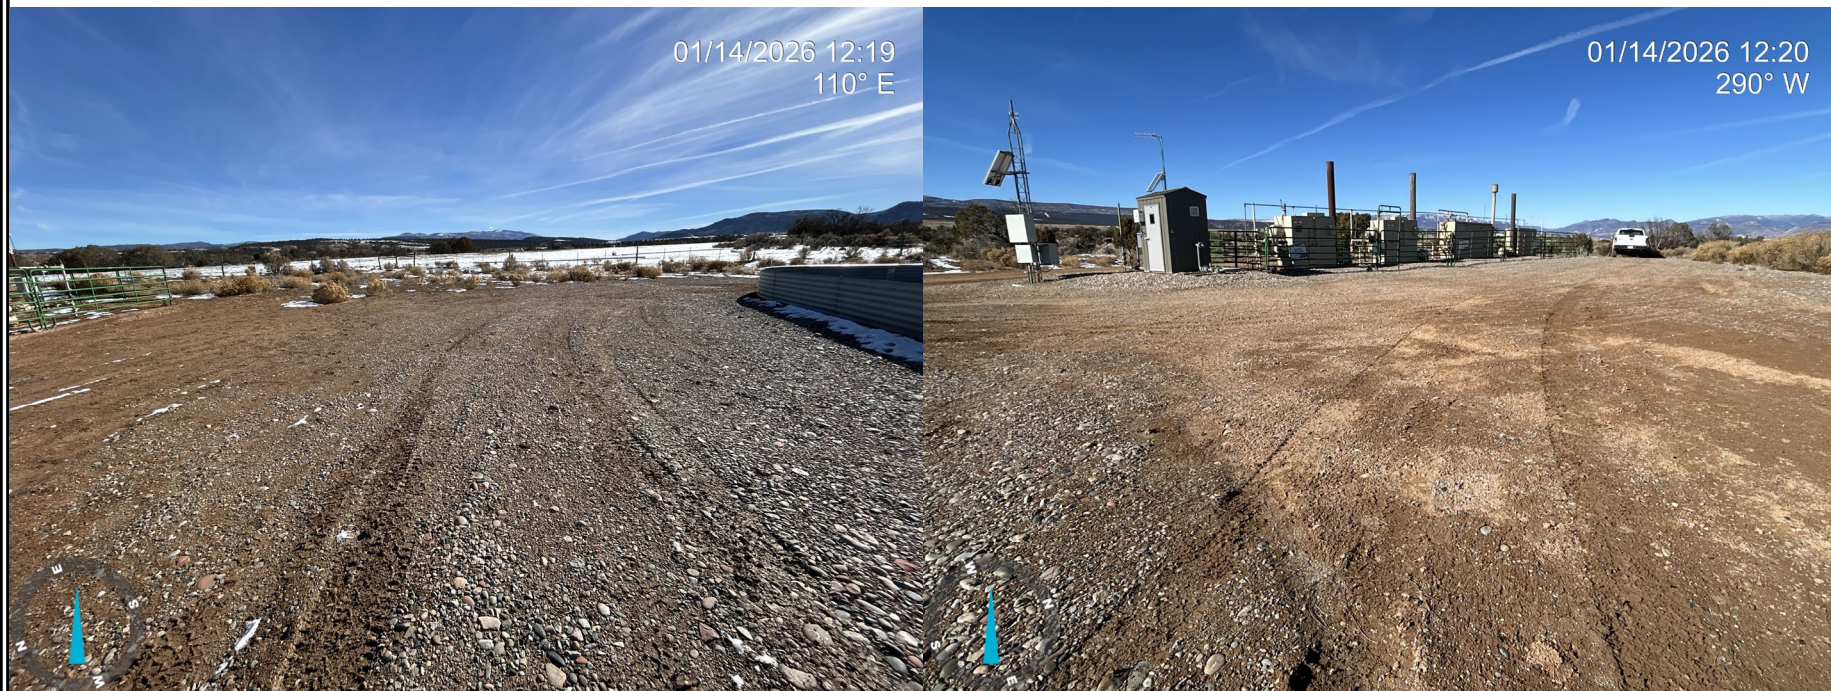
**Photo 2:** Photos showing an overview of the location looking east and west, respectively.

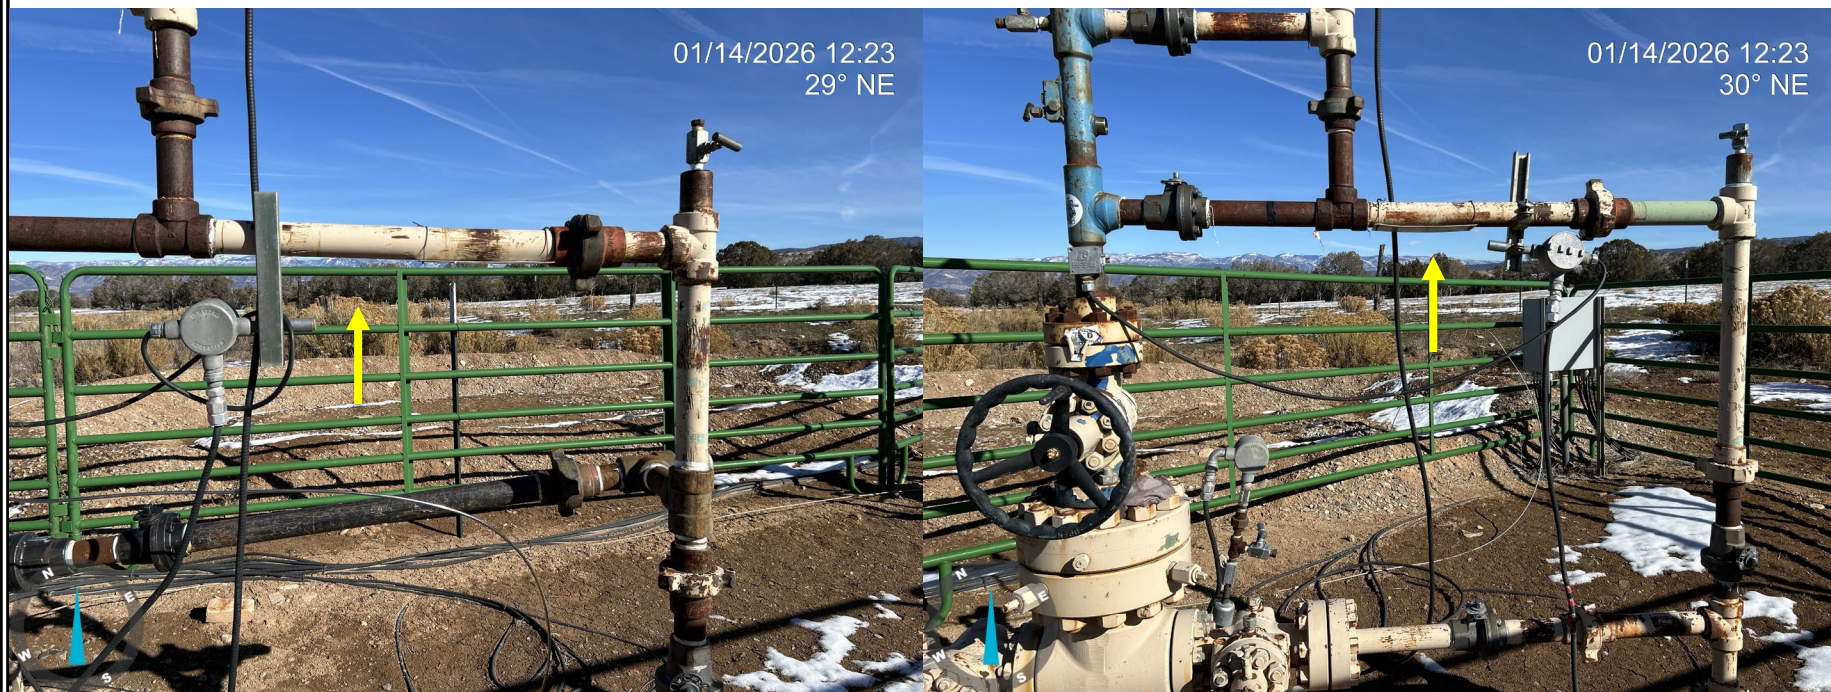
**Photo 3:** Photos showing examples of wellhead signage that has slipped downwards, rendering it inconspicuous and difficult to read. Maintenance is required; comply with Rule 605.g.

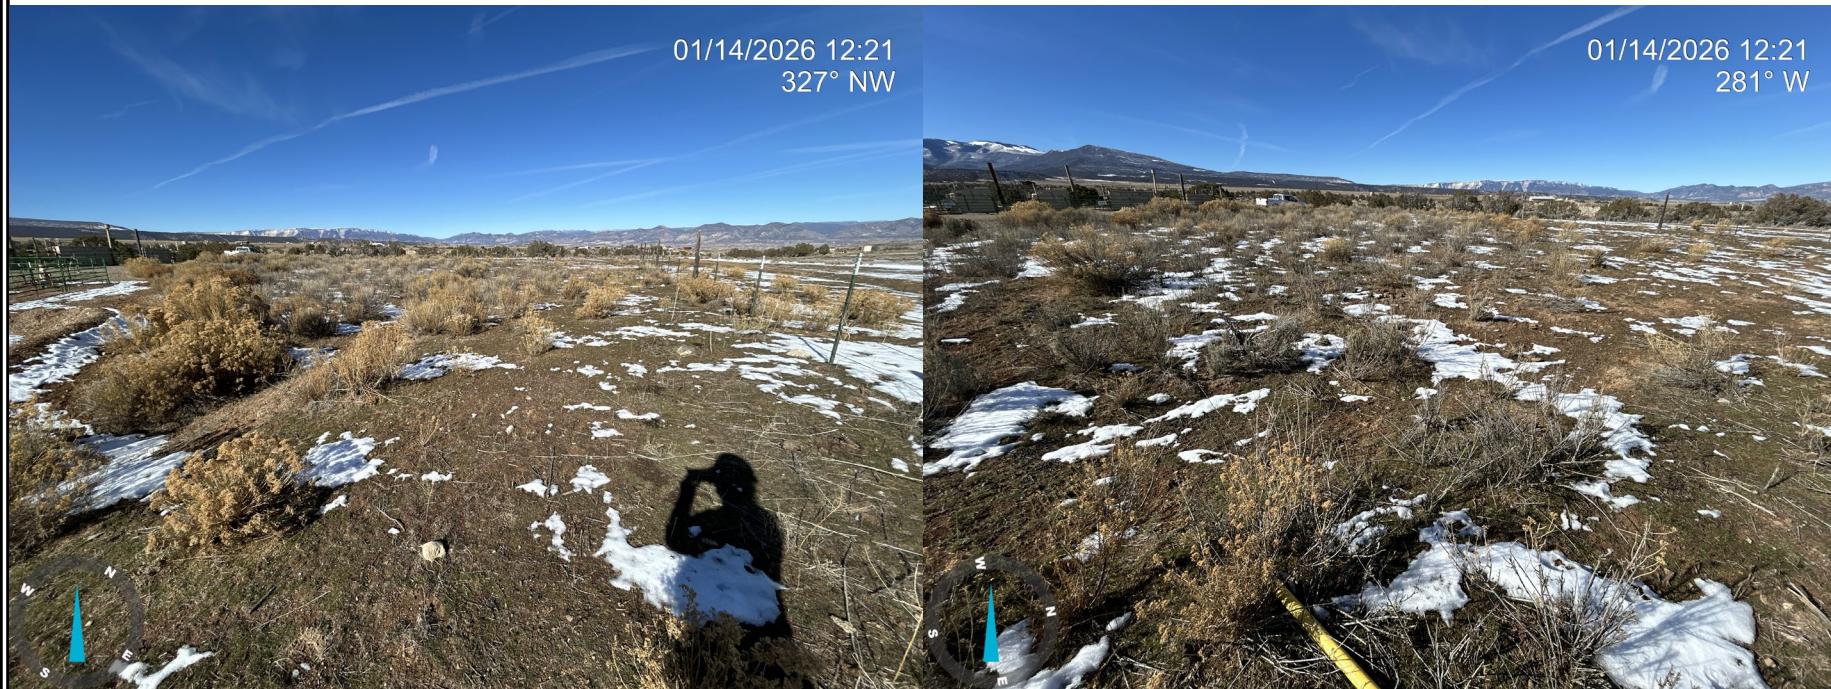
**Photo 4:** Photos showing an overview of the northeastern and northern interim area, respectively. Rubber rabbitbrush is present and interim areas are progressing towards 1003 reclamation requirements.

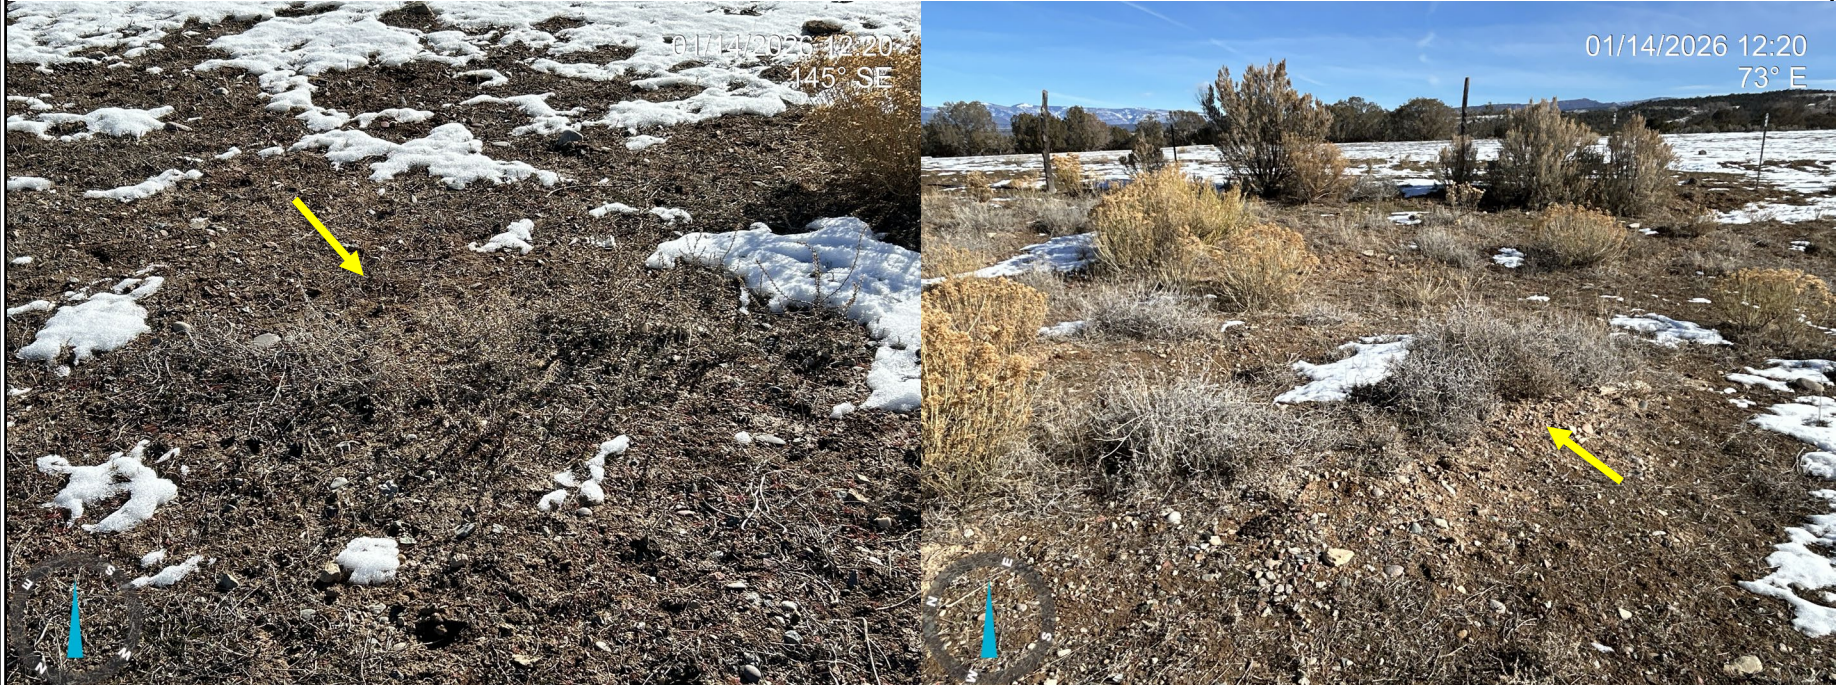
**Photo 5:** Photos showing examples of prickly Russian thistle, an undesirable plant species, is present in the interim areas. Weed control is required; comply with Rule 606.c.

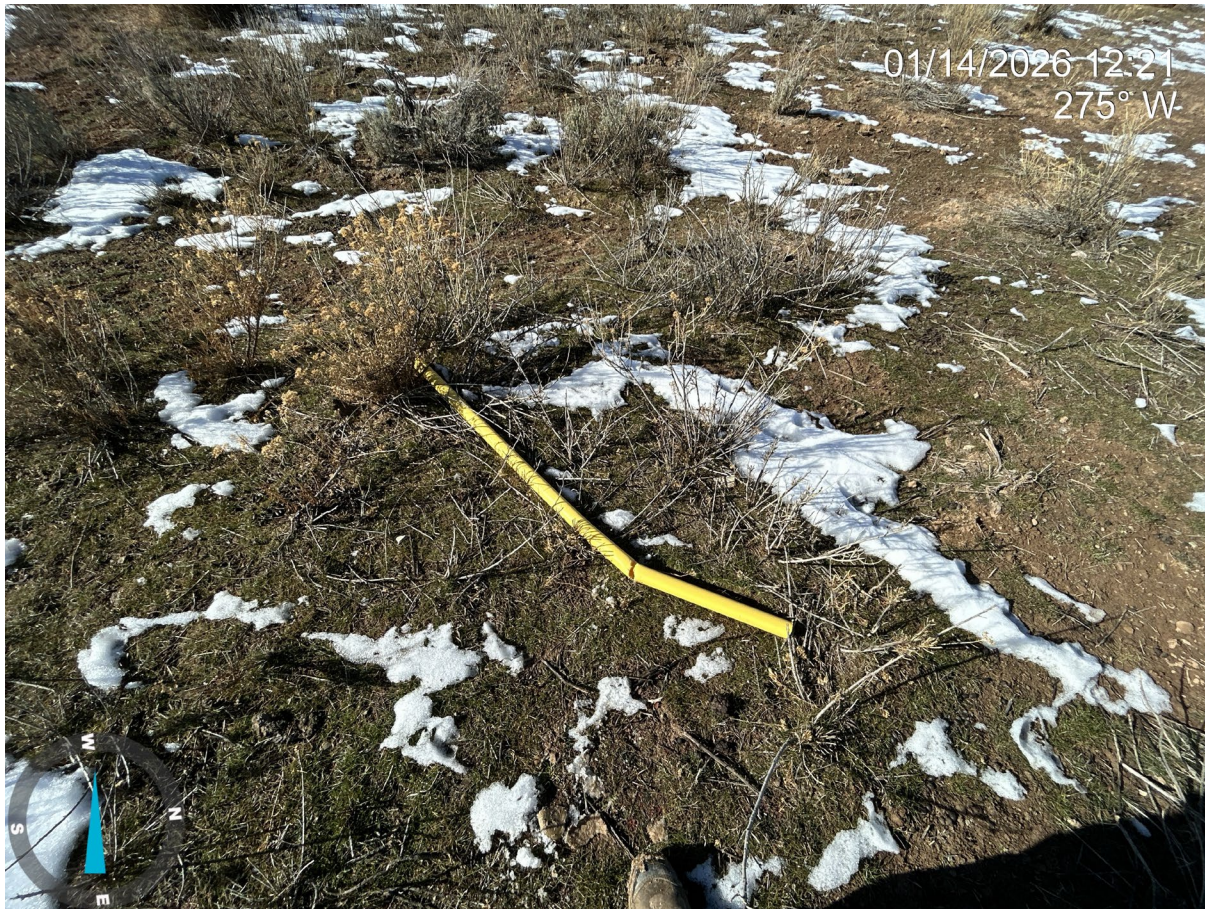
**Photo 6:** Photo showing some trash/debris that is present within the interim area. Comply with rule 606.d.
