Final Reclamation Inspection

Operator: NOBLE ENERGY INC - 100322

Location ID: 328268

Inspection Photos
Location Name: MCKENNEY #6-14
Location ID: 328268

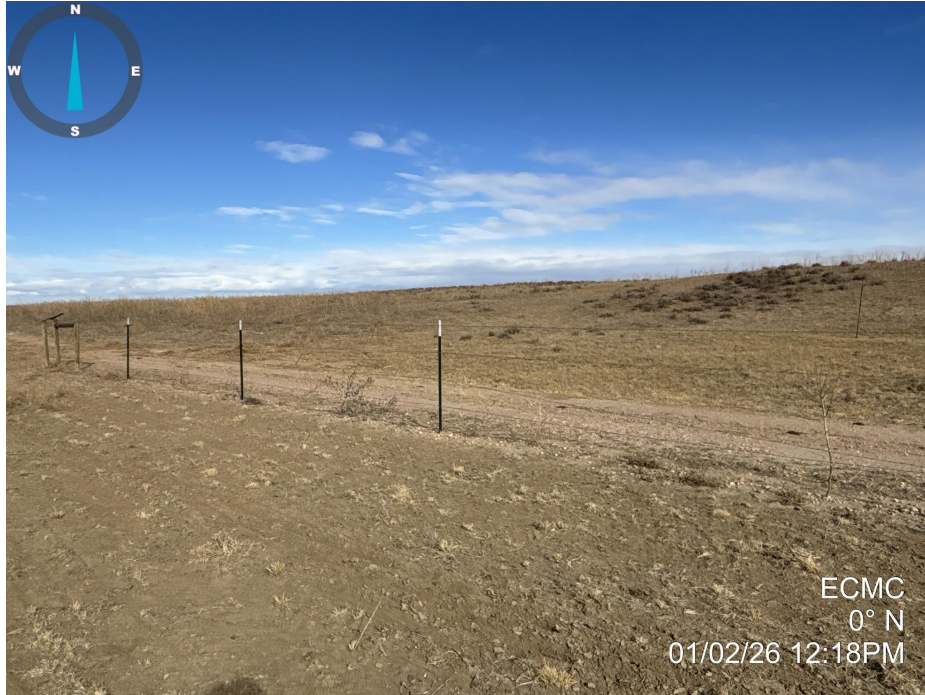
Photo 1. Photo taken of the well location, facing north. Photo illustrates that final reclamation activities appear to have taken place, with evidence of drill row seeding, but vegetation establishment does not meet Rule 1004 standards. Fencing is in place surrounding the location.

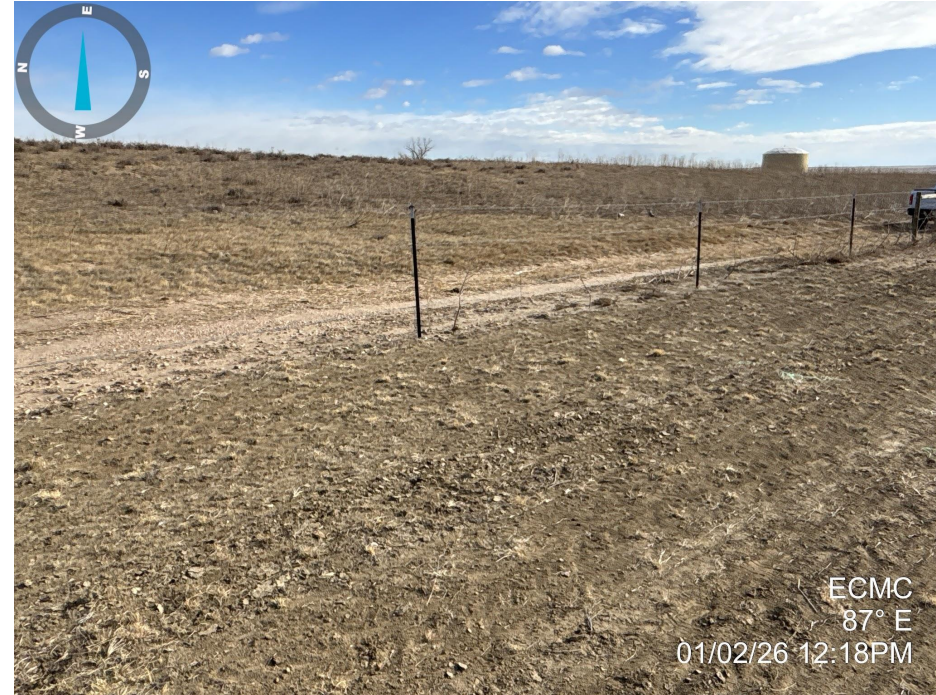
Photo 2. Photo taken of the well location, facing east. See comments under Photo 1.

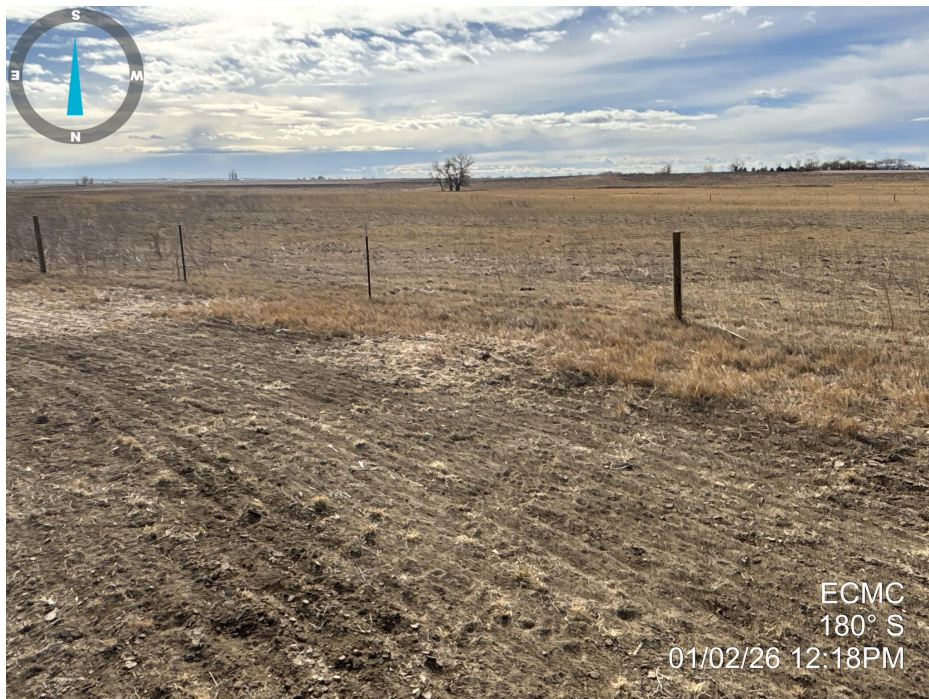
Photo 3. Photo taken of the well location, facing south. See comments under Photo 1.

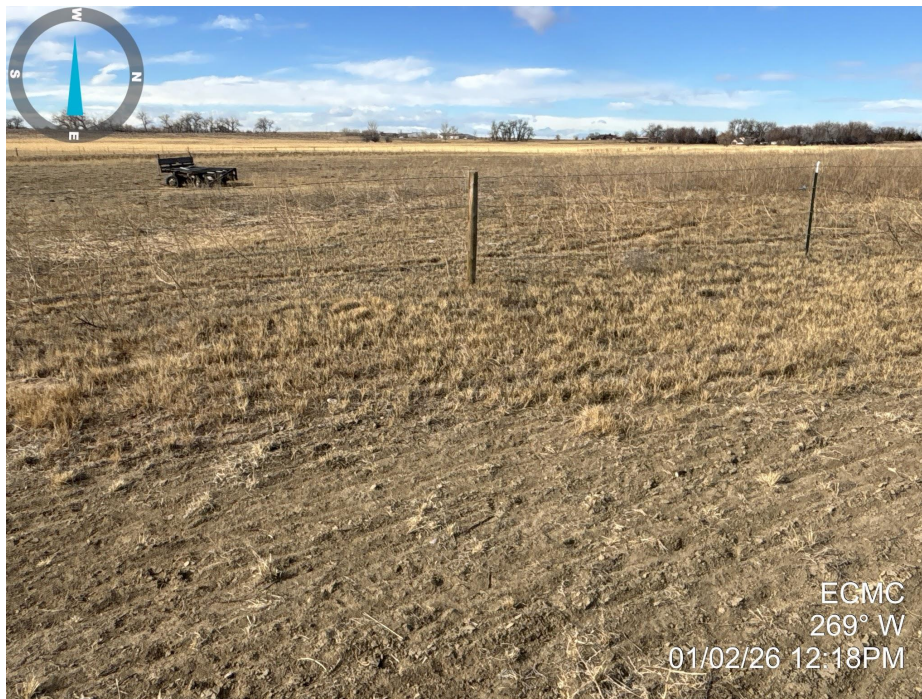
Photo 4. Photo taken of the well location, facing west. See comments under Photo 1.

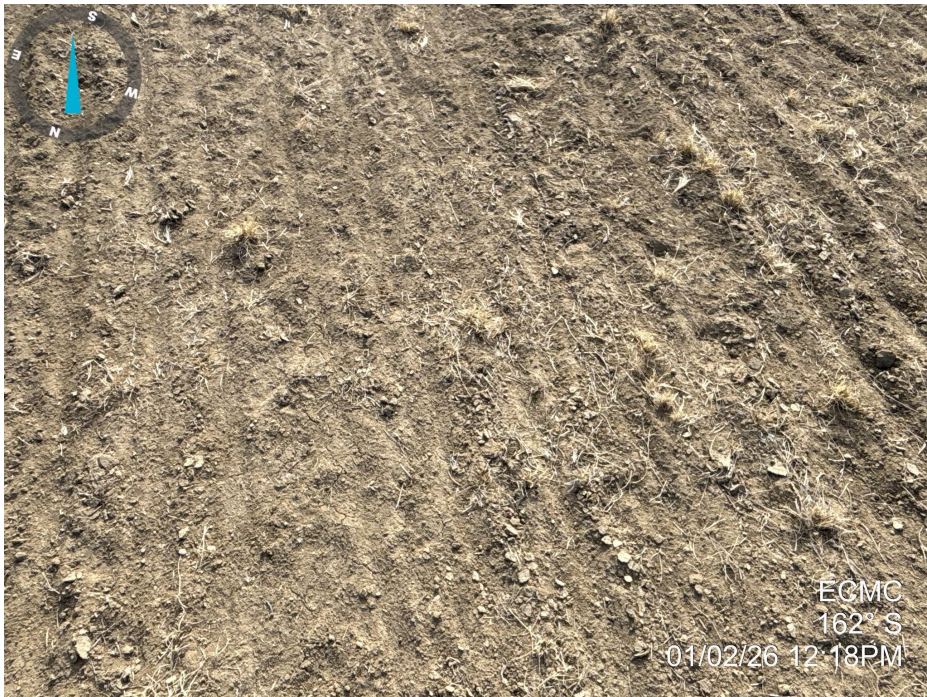
Photo 5. Photo taken of ground cover at the well location. Photo illustrates bare ground and perennial grass with evidence of drill rows from seeding.

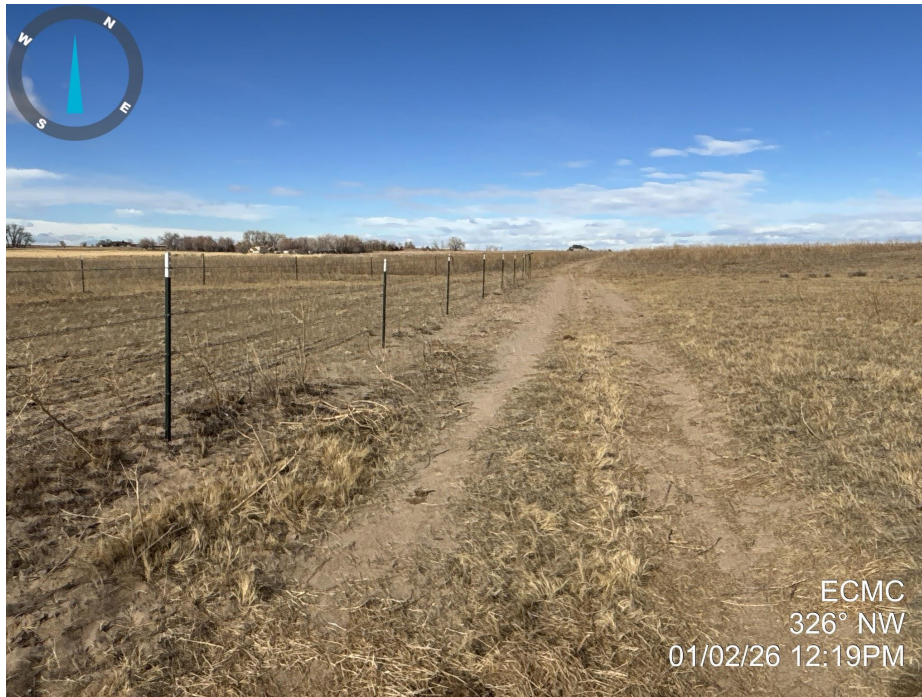
Photo 6. Photo taken of the access road to the well location, facing northwest. Photo illustrates that bare ground remains.

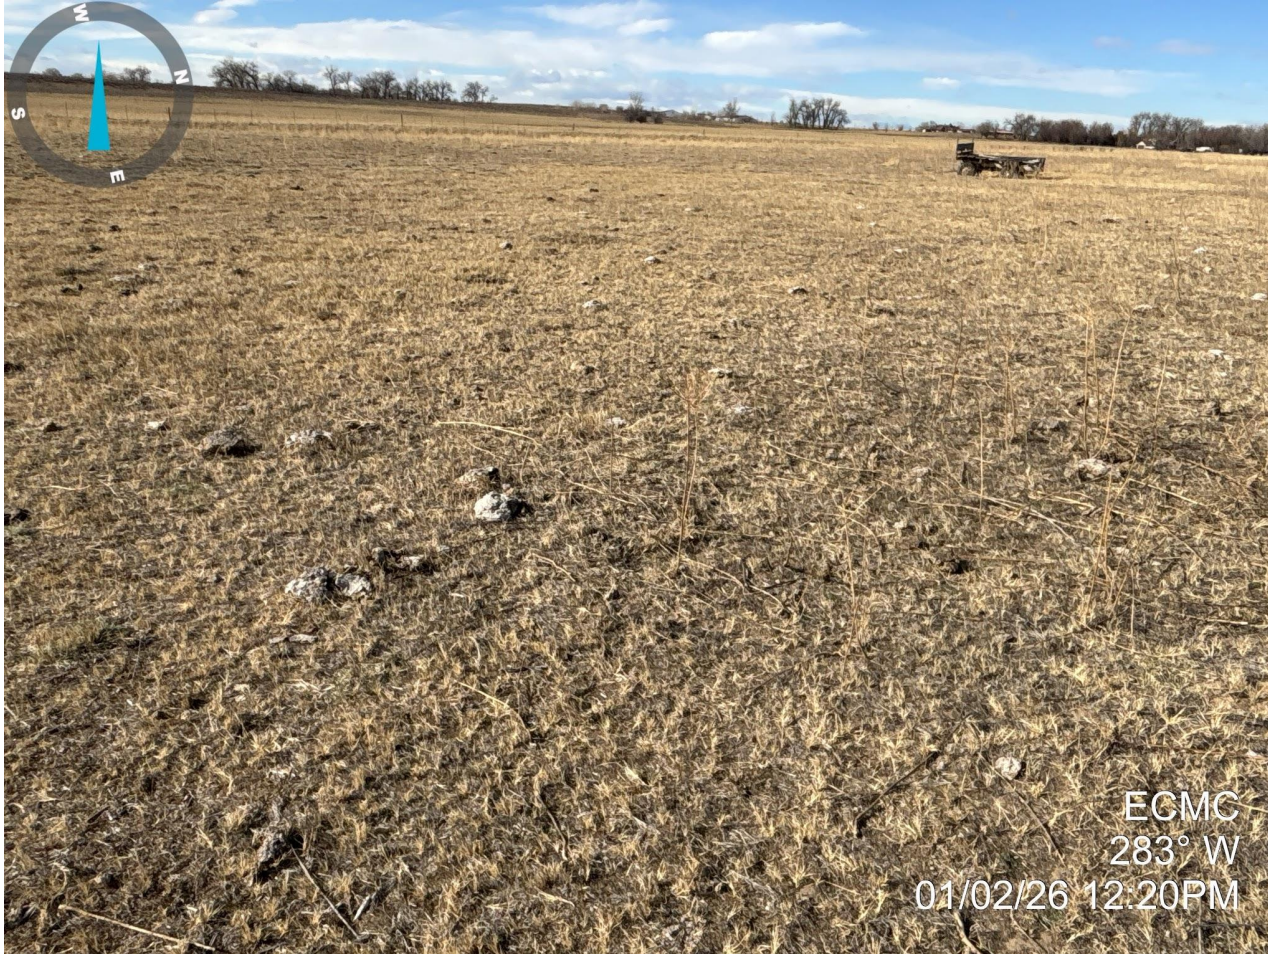
Photo 7. Photo taken of the reference area to the well location, west of the location, facing west. Photo illustrates perennial grass vegetation.
