Final Reclamation Inspection

Operator: PDC ENERGY INC - 69175

Location ID: 327836

Inspection Photos
Location Name: MCKENNEY #6-42
Location ID: 327836

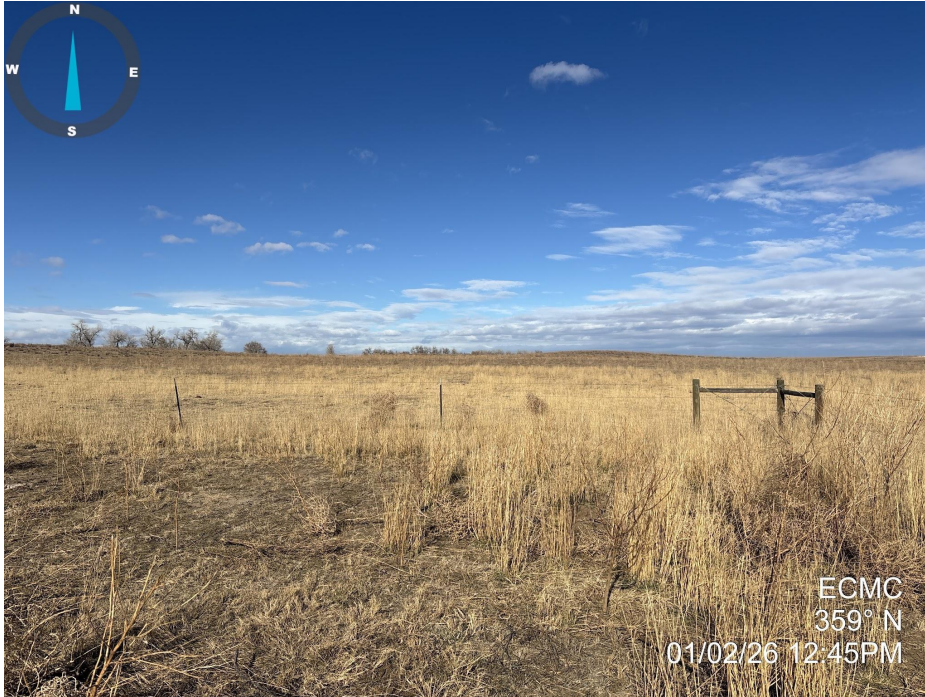
Photo 1. Photo taken of the well location, facing north. Photo illustrates that final reclamation activities appear to have taken place, but vegetation establishment does not meet Rule 1004 standards. Fencing is in place surrounding the location.

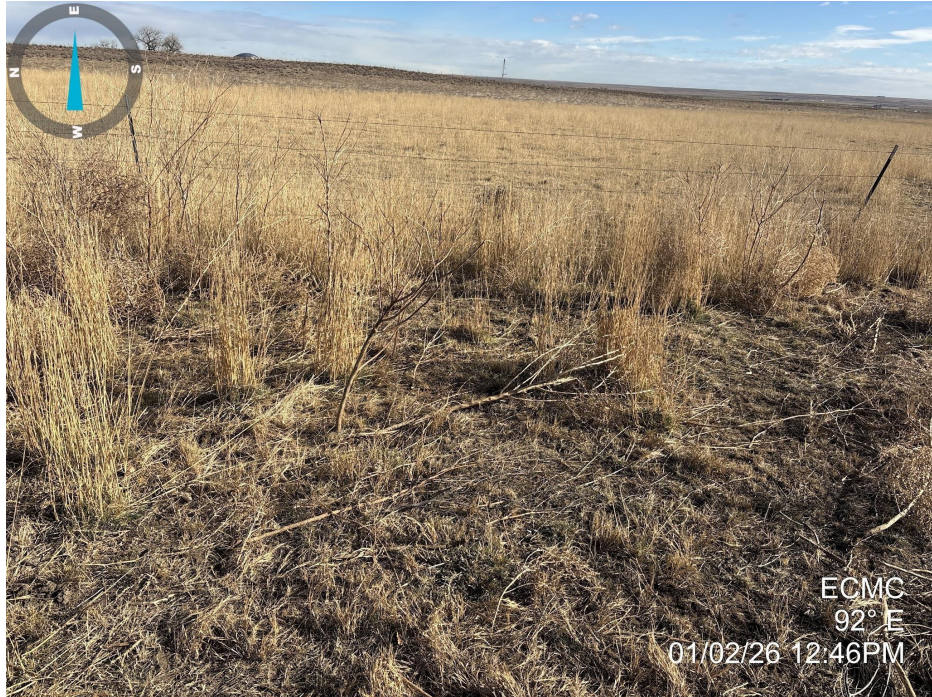
Photo 2. Photo taken of the well location, facing east. See comments under Photo 1.

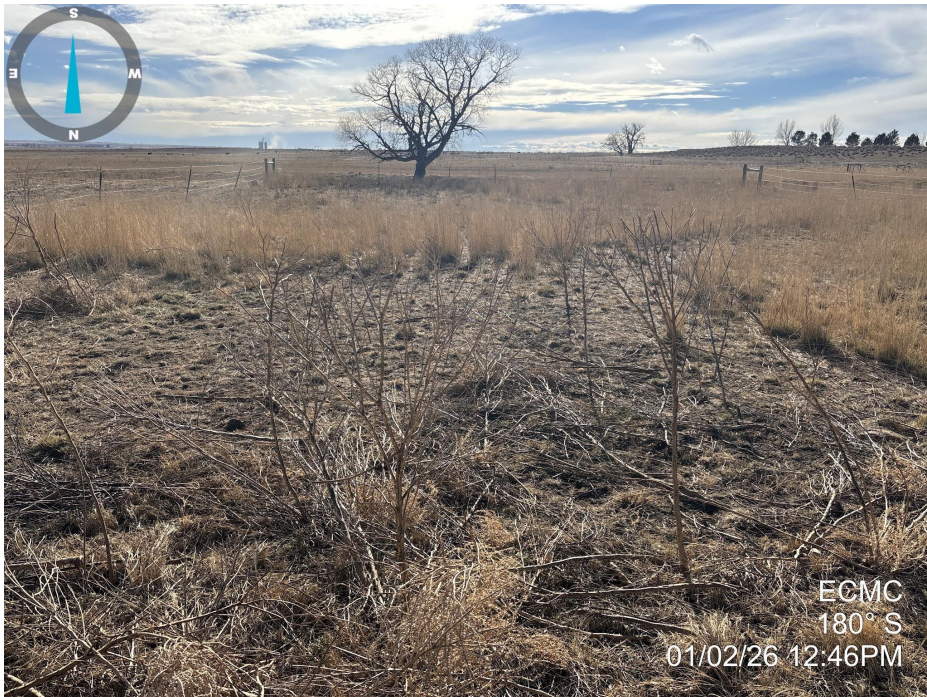
Photo 3. Photo taken of the well location, facing south. See comments under Photo 1.

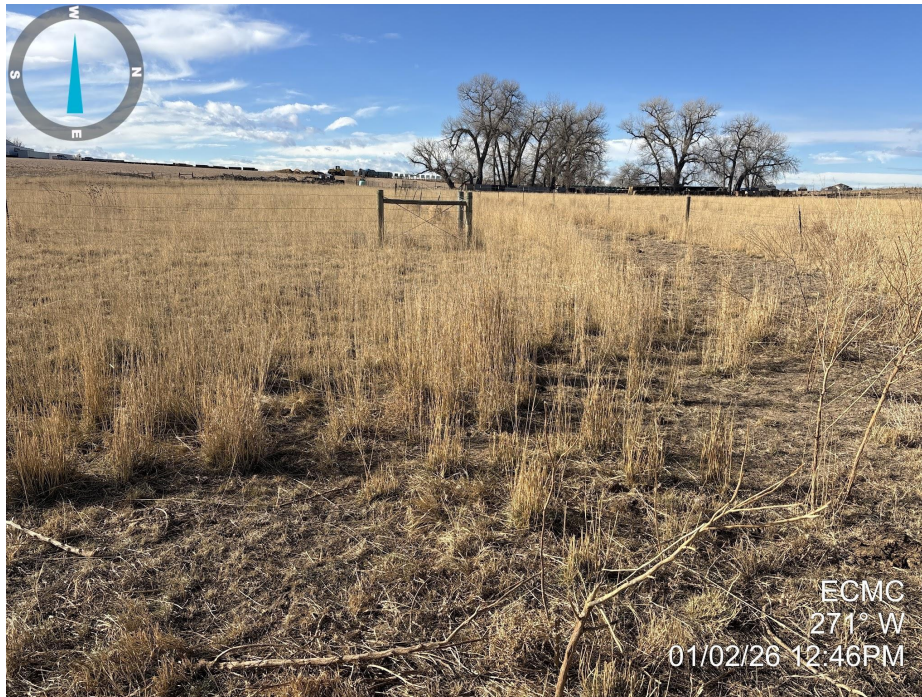
Photo 4. Photo taken of the well location, facing west. See comments under Photo 1.

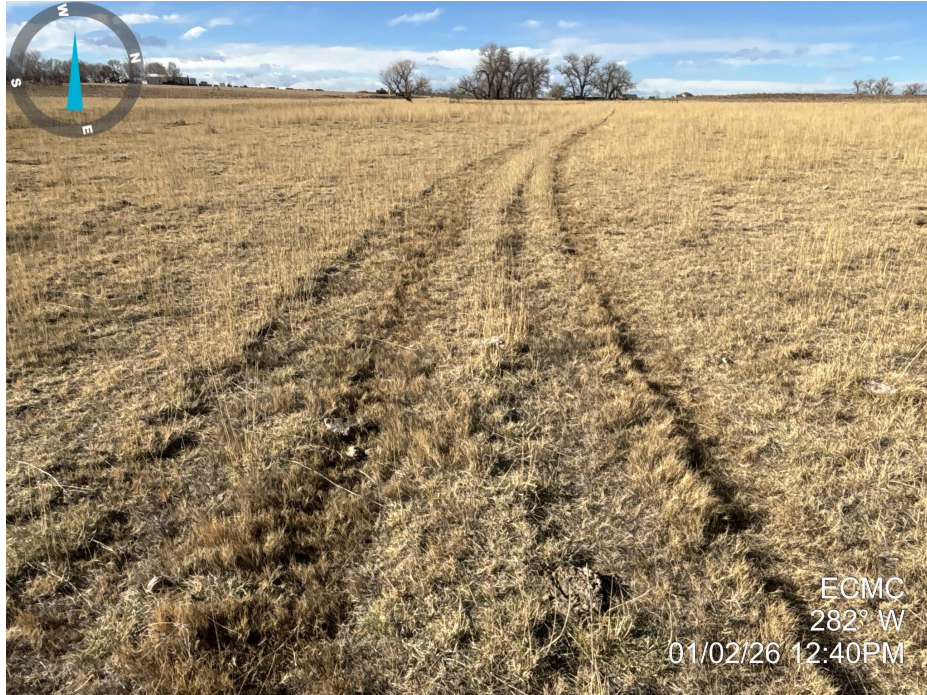
Photo 5. Photo taken of the access road to the well location, facing west. Photo illustrates that final reclamation along the access road does not meet Rule 1004 standards.

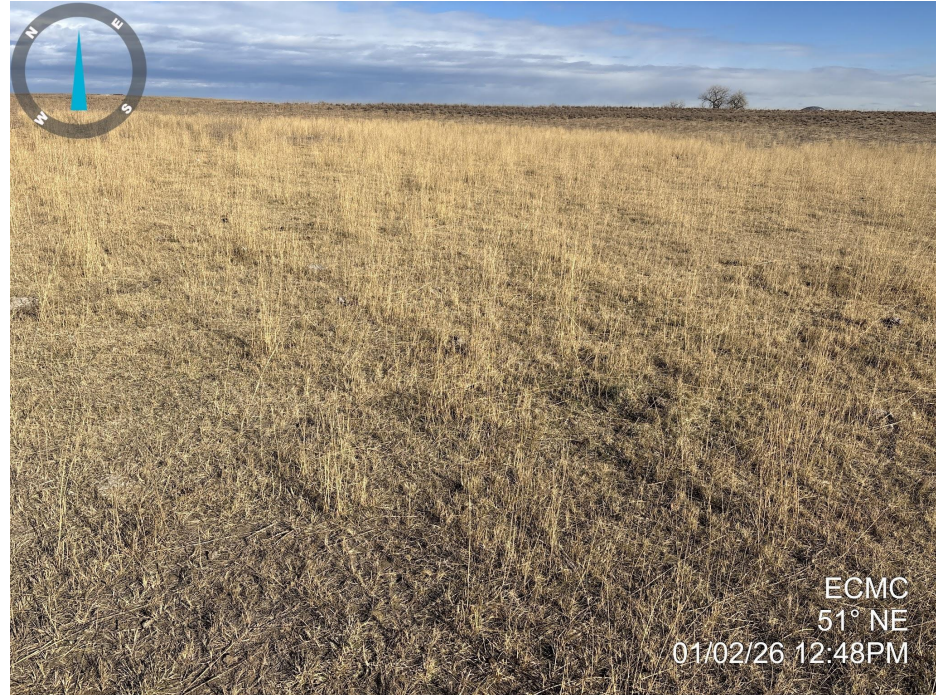
Photo 6. Photo taken of the reference area to the location, northwest of the location, facing northeast. Photo illustrates perennial grass vegetation.
