# Final Reclamation Inspection

Operator: NOBLE ENERGY INC - 100322

Location ID: 328267

Inspection Photos  
Location Name: MCKENNEY #6-12  
Location ID: 328267

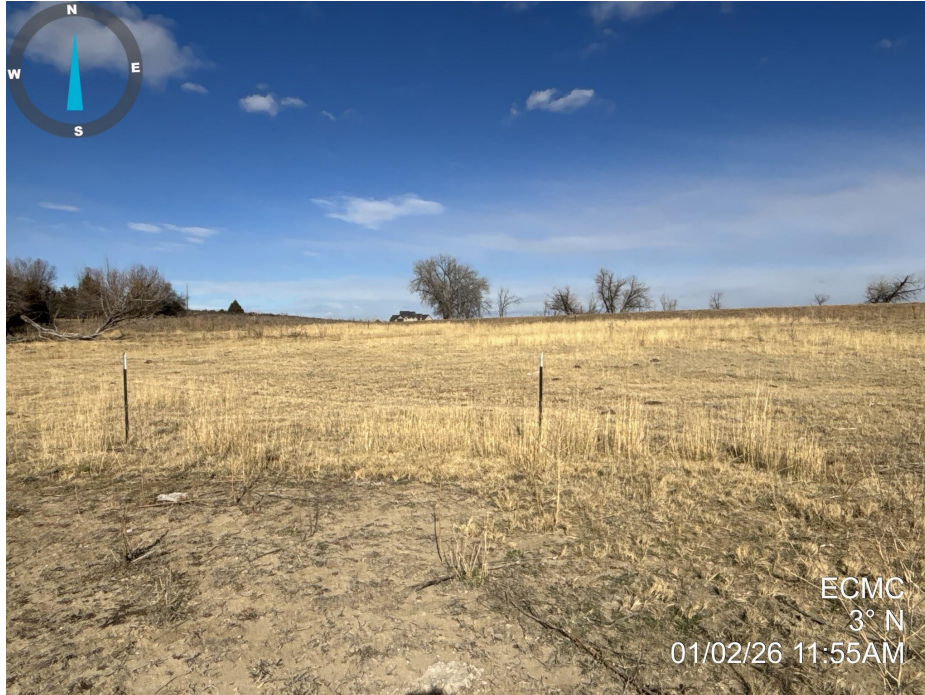
**Photo 1.** Photo taken of the well location, facing north. Photo illustrates that final reclamation activities appear to have taken place, but vegetation establishment does not meet Rule 1004 standards.

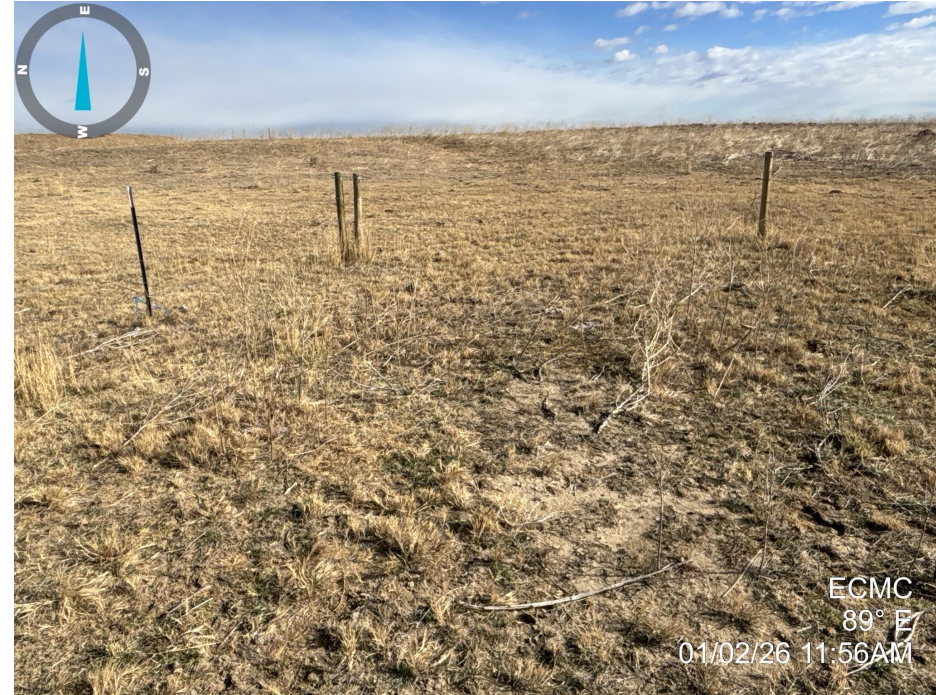
**Photo 2.** Photo taken of the well location, facing east. See comments under Photo 1.

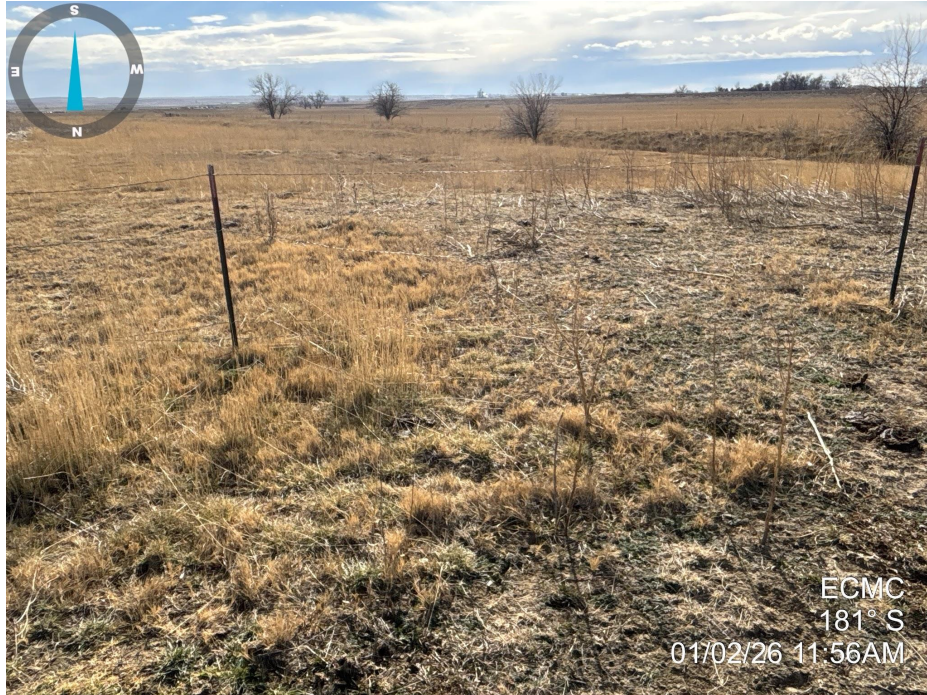
**Photo 3.** Photo taken of the well location, facing south. See comments under Photo 1.

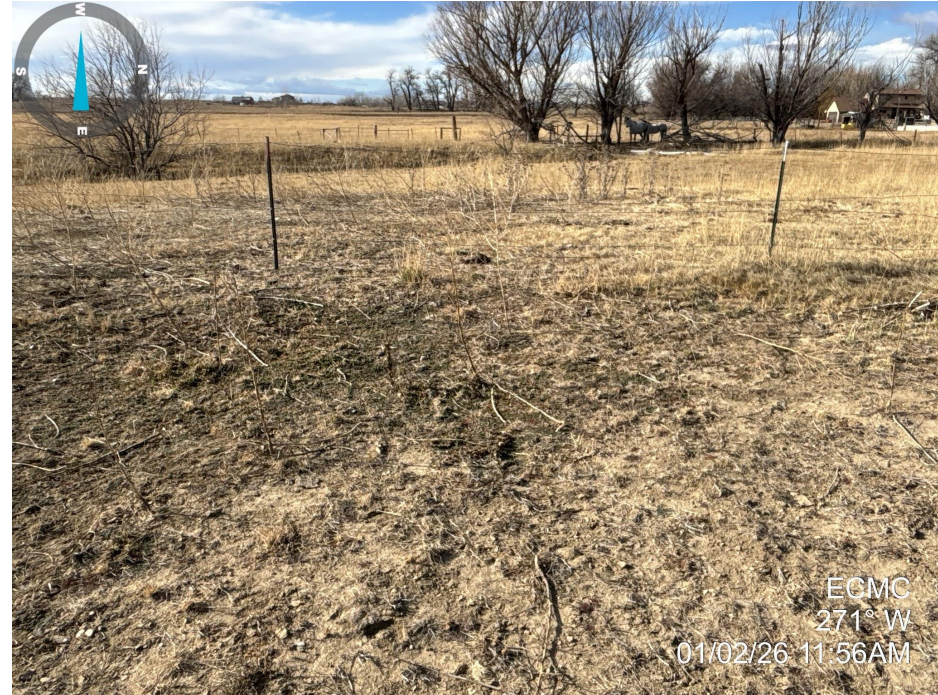
**Photo 4.** Photo taken of the well location, facing west. See comments under Photo 1.

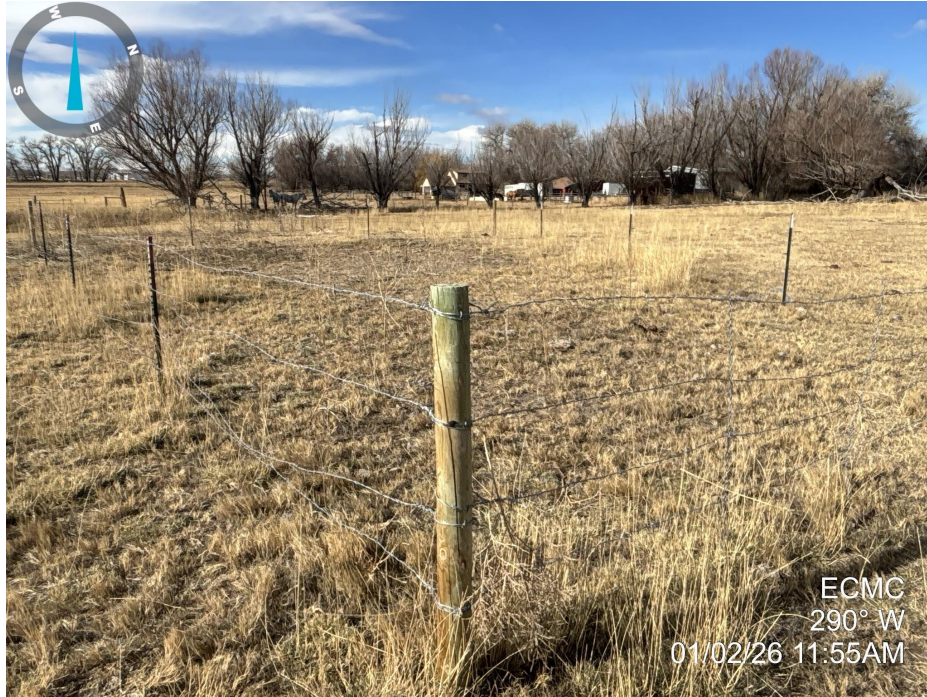
**Photo 5.** Photo taken of the well location, facing west. Photo illustrates fencing surrounds the well site.

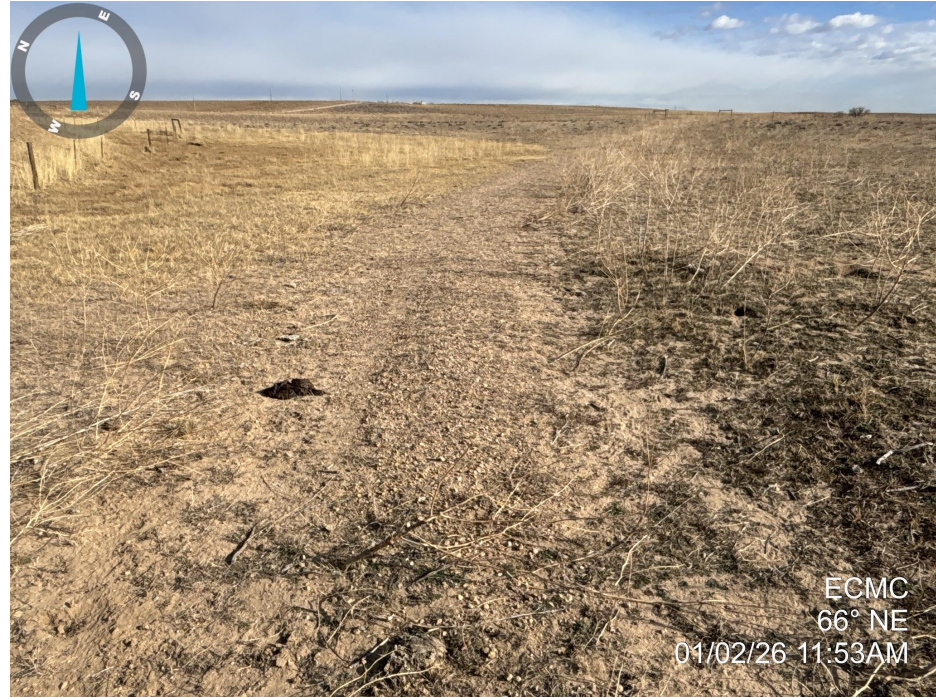
**Photo 6.** Photo taken of the access road the location, facing northeast. Photo illustrates that final reclamation does not meet Rule 1004 standards along the access road.

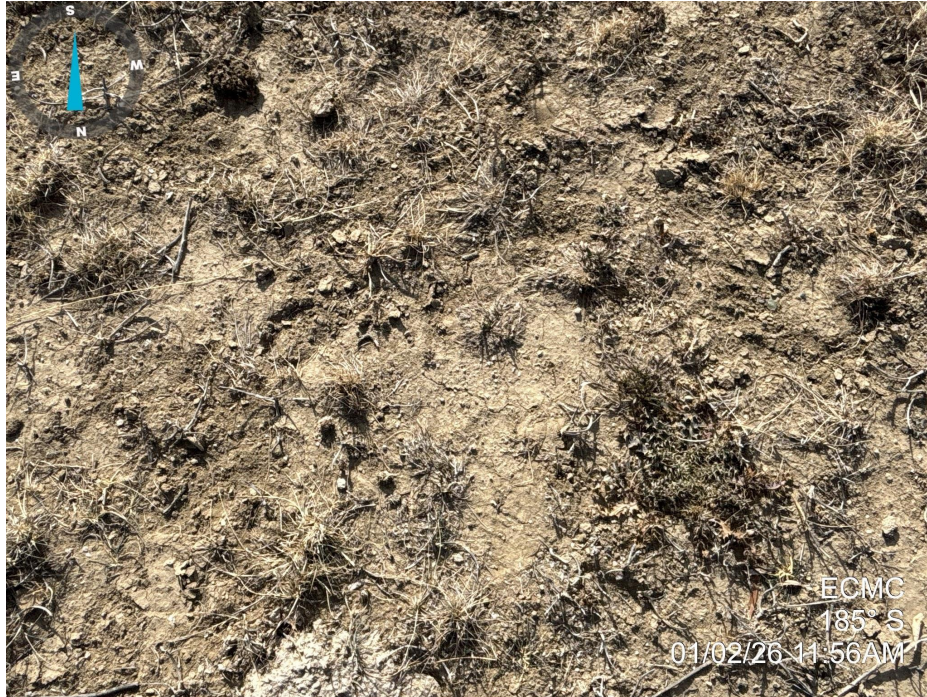
**Photo 7.** Photo taken of ground cover at the well location. Photo illustrates perennial grass vegetation which has not yet established to Rule 1004 standards.

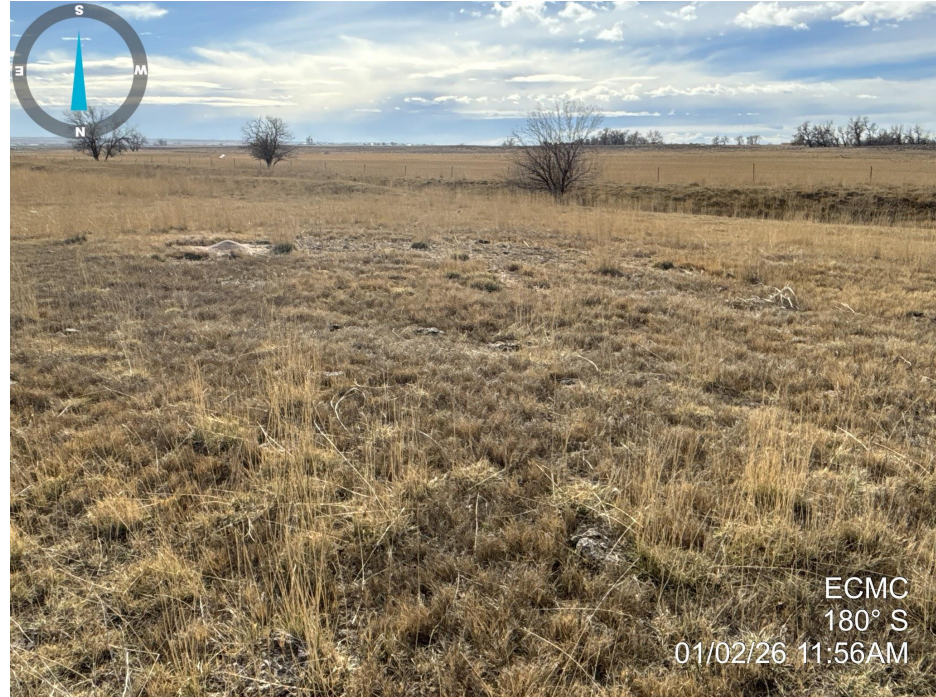
**Photo 8.** Photo taken of the reference area to the well location, south of the location, facing south. Photo illustrates perennial grass vegetation.
