# Final Reclamation Inspection

Operator: PDC ENERGY INC - 69175

Location ID: 329181

Inspection Photos  
Location Name: BECKER #5-10  
Location ID: 329181

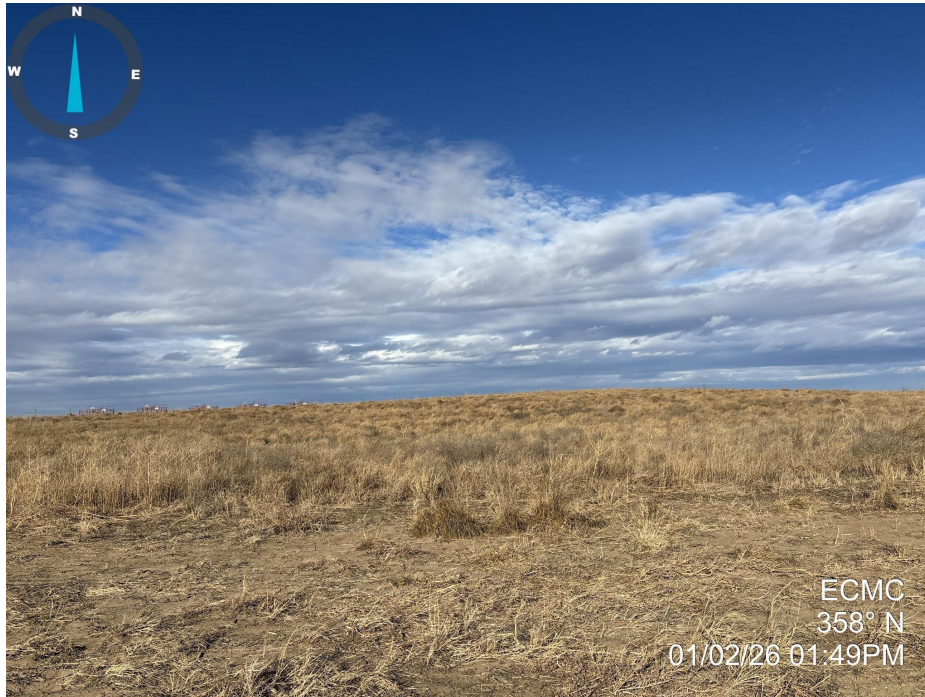
**Photo 1.** Photo taken of the well location, facing north. Photo illustrates that final reclamation activities appear to have taken place, with evidence of drill row seeding, but vegetation establishment does not meet Rule 1004 standards. Weedy annual vegetation including kochia (*Bassia scoparia*) was observed across the location.

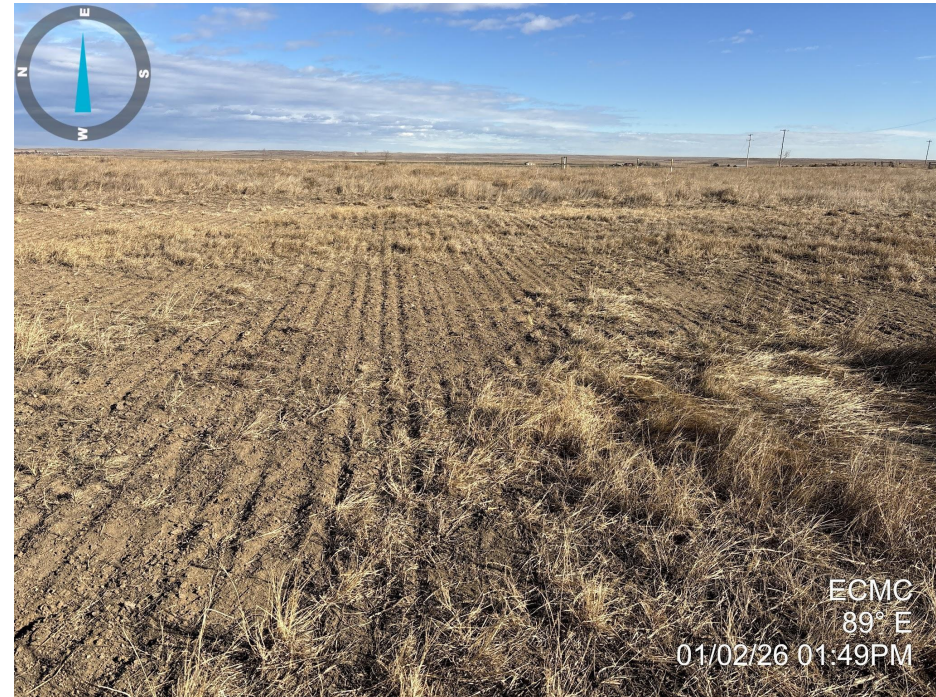
**Photo 2.** Photo taken of the well location, facing east. See comments under Photo 1.

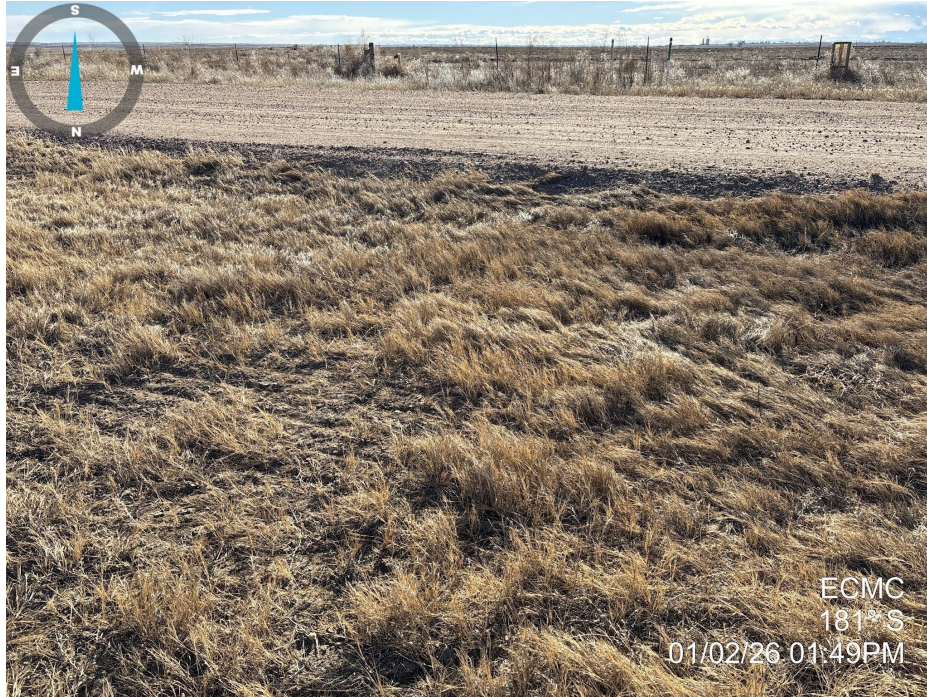
**Photo 3.** Photo taken of the well location, facing south. See comments under Photo 1.

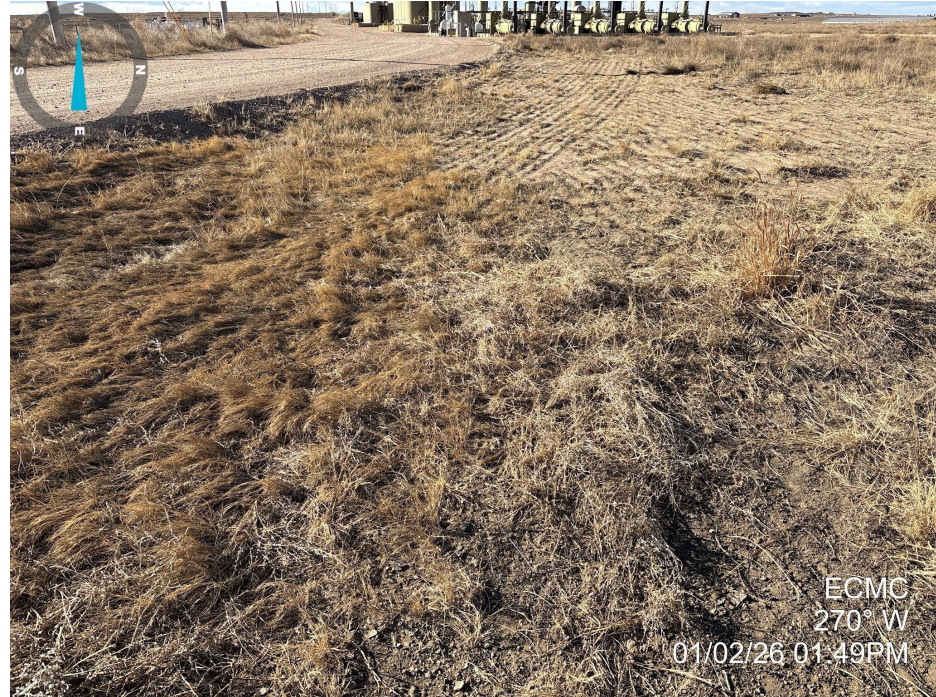
**Photo 4.** Photo taken of the well location, facing west. See comments under Photo 1.

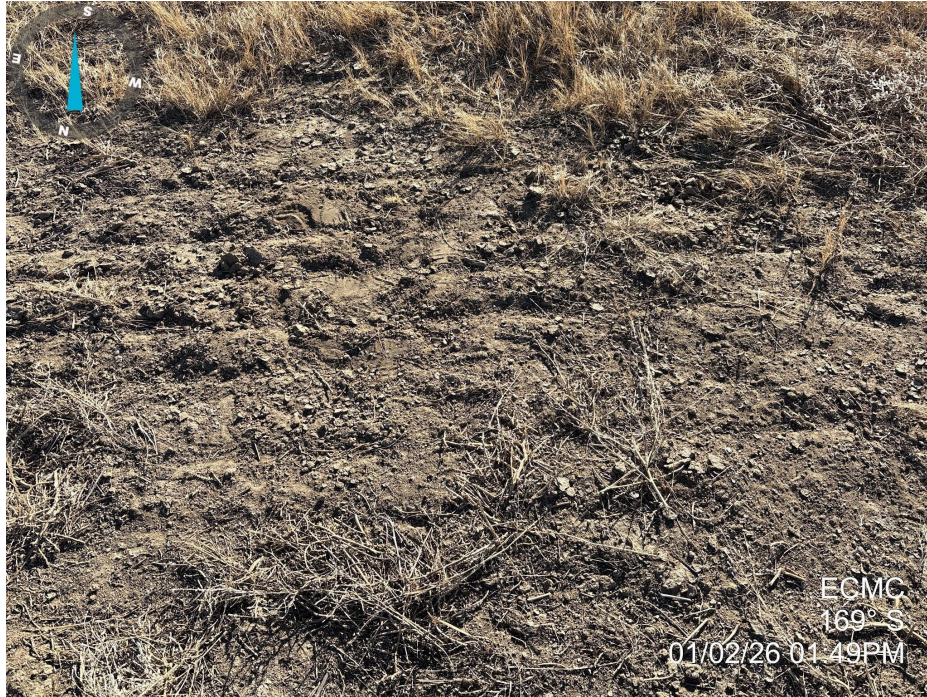
**Photo 5.** Photo taken of ground cover at the location. Photo illustrates perennial grass, bare ground, and drill rows from seeding.

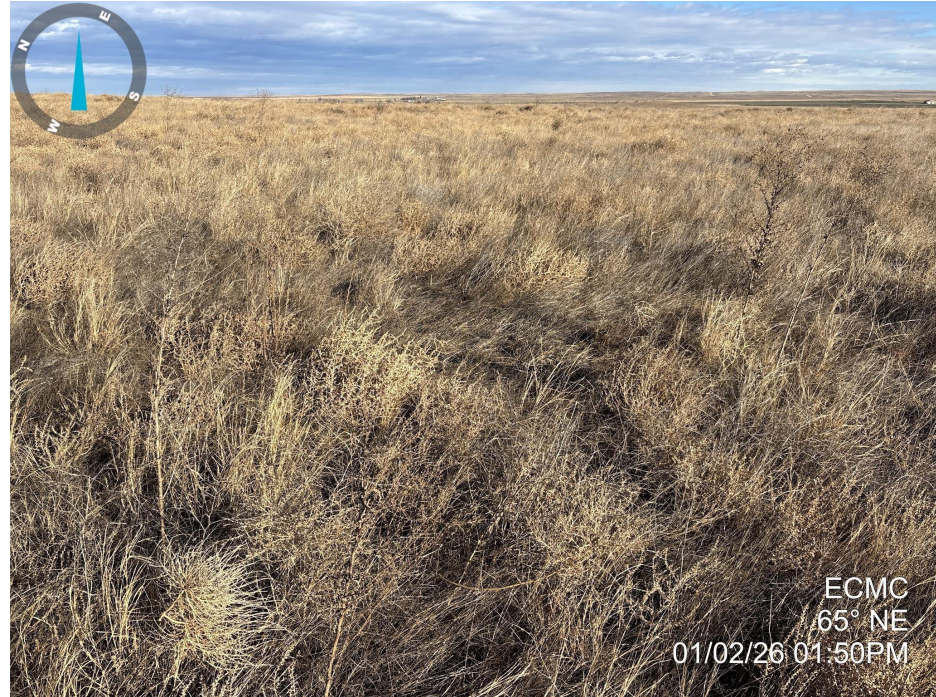
**Photo 6.** Photo taken of the reference area to the location, north of the location, facing northeast. Photo illustrates perennial grass and weedy annual vegetation.
