Final Reclamation Inspection

Operator: PDC ENERGY INC - 69175

Location ID: 330003

Inspection Photos
Location Name: BECKER #5-16
Location ID: 330003

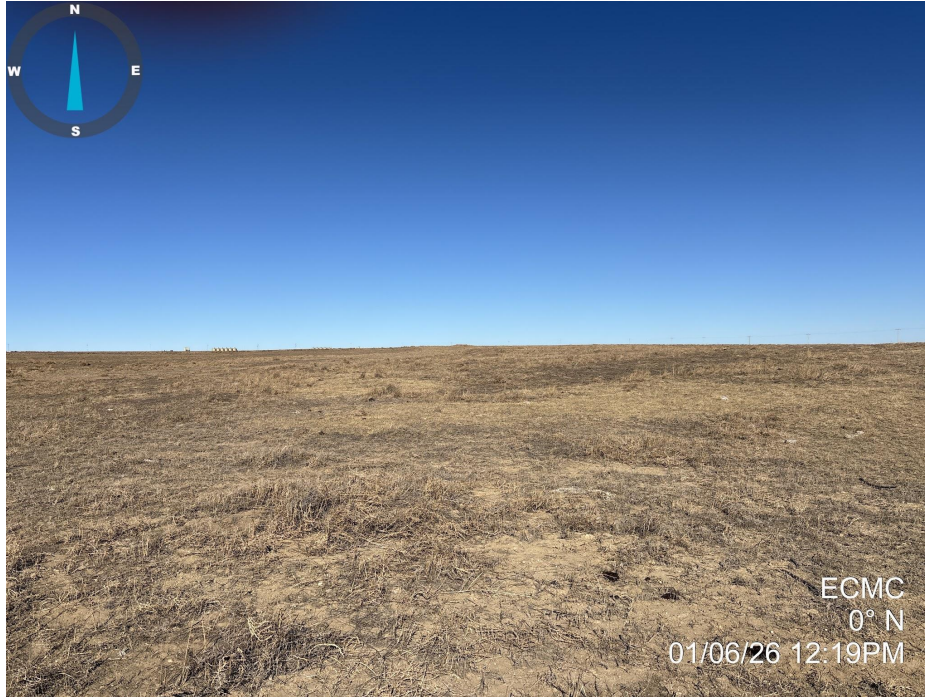
Photo 1. Photo taken of the well location, facing north. Photo illustrates that final reclamation activities appear to have taken place, but vegetation establishment does not meet Rule 1004 standards.

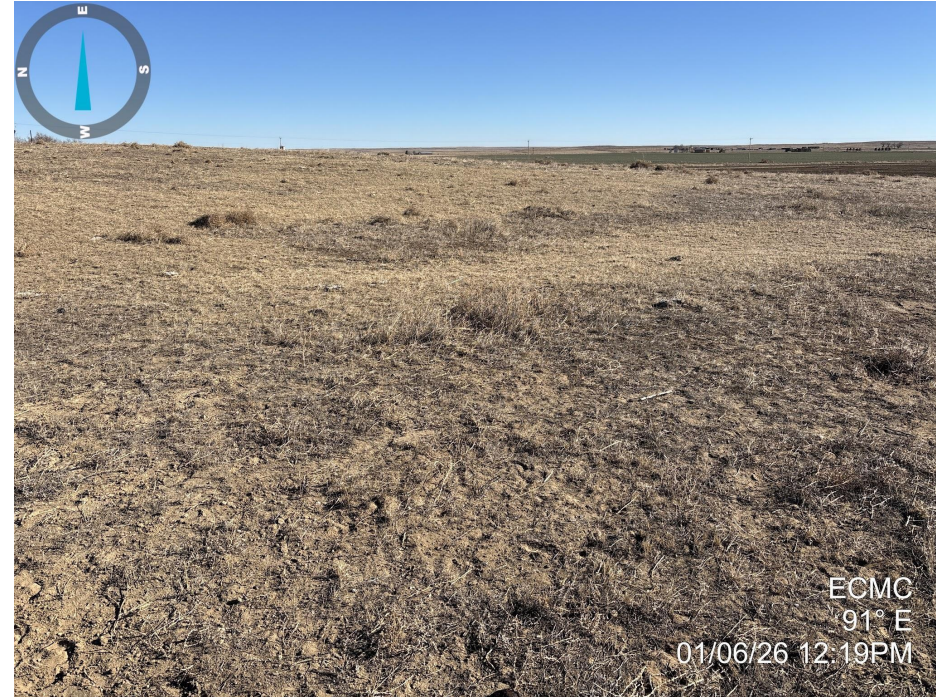
Photo 2. Photo taken of the well location, facing east. See comments under Photo 1.

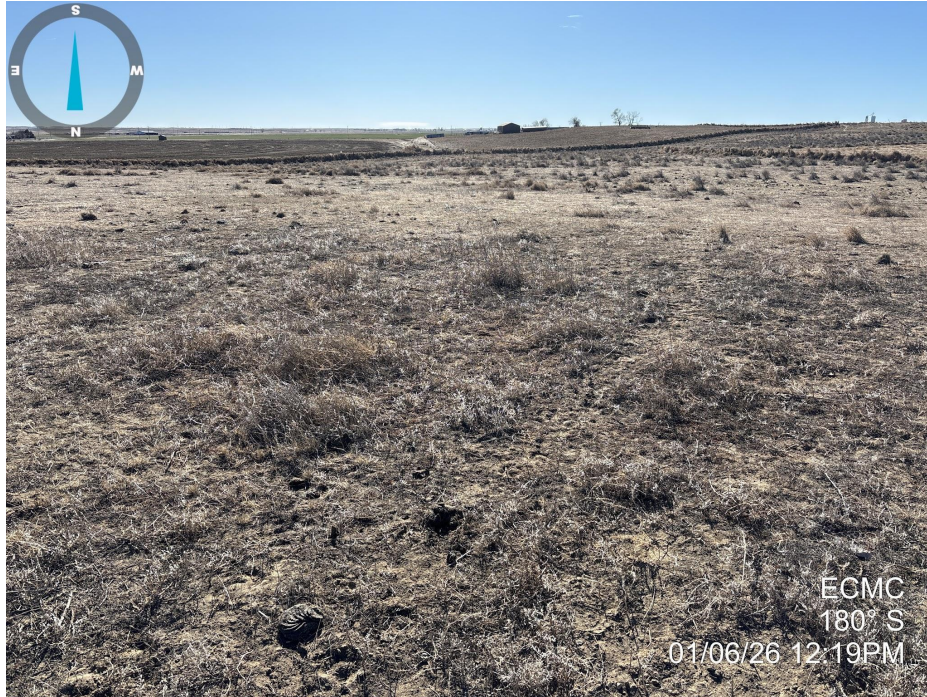
Photo 3. Photo taken of the well location, facing south. See comments under Photo 1.

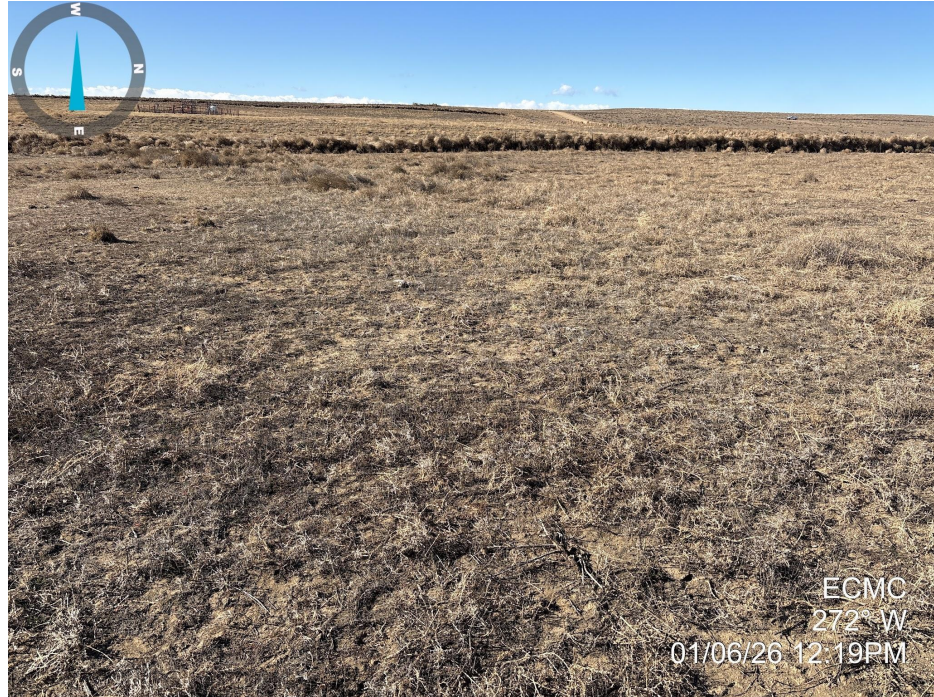
Photo 4. Photo taken of the well location, facing west. See comments under Photo 1.

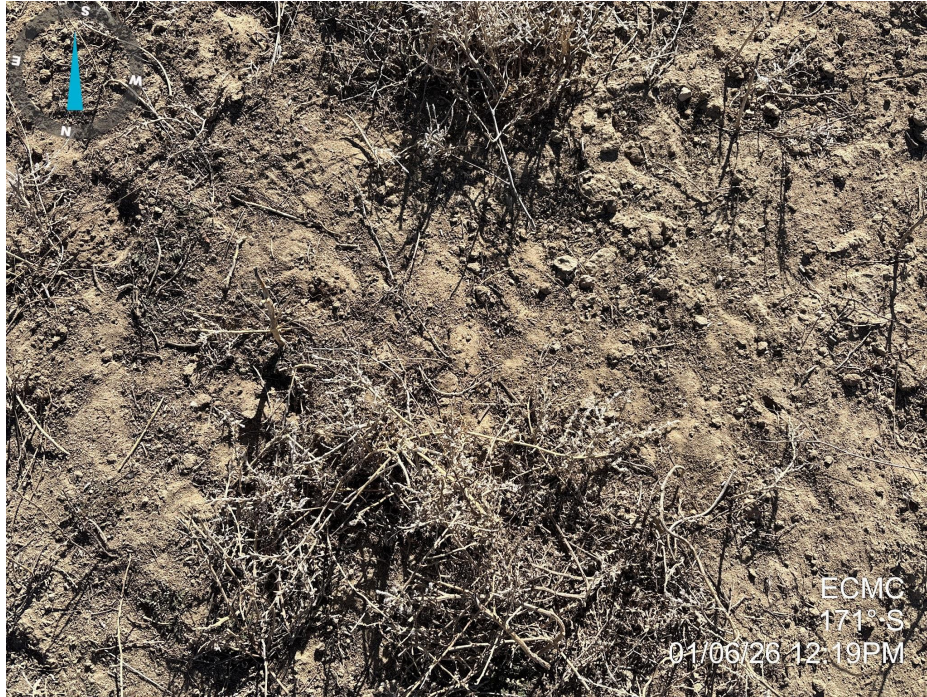
Photo 5. Photo taken of ground cover at the location. Photo illustrates bare ground and weedy annual vegetation including kochia (*Bassia scoparia*) and russian thistle (*Salsola tragus*).

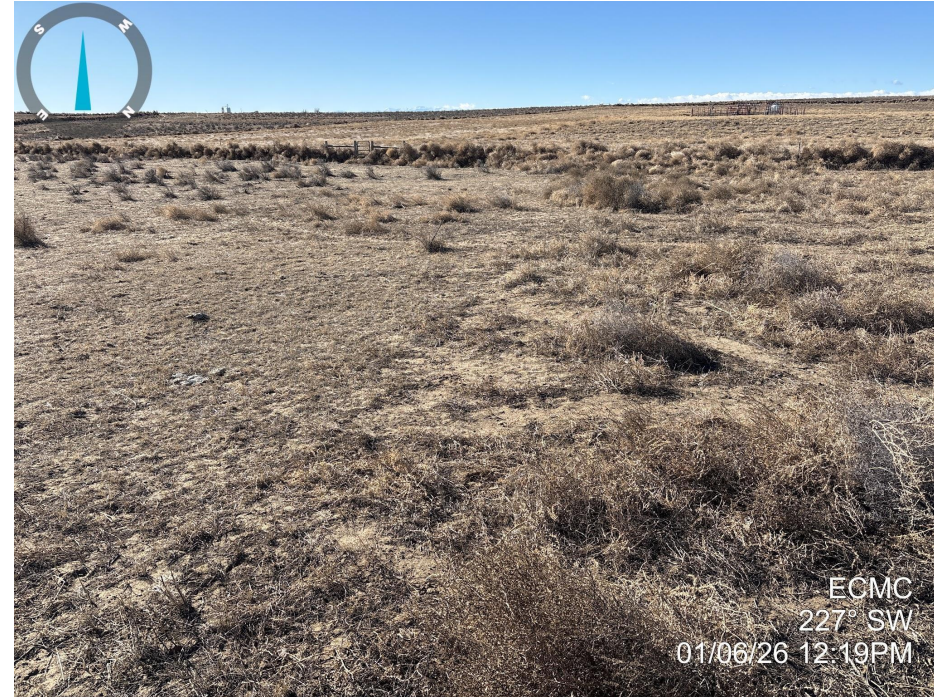
Photo 6. Photo taken of the access road to the location, facing southwest. Photo illustrates that final reclamation activities appear to have taken place, but vegetation has not established to Rule 1004 standards. Weedy annual vegetation including russian thistle (*Salsola tragus*) and kochia (*Bassia scoparia*) was observed across the road.

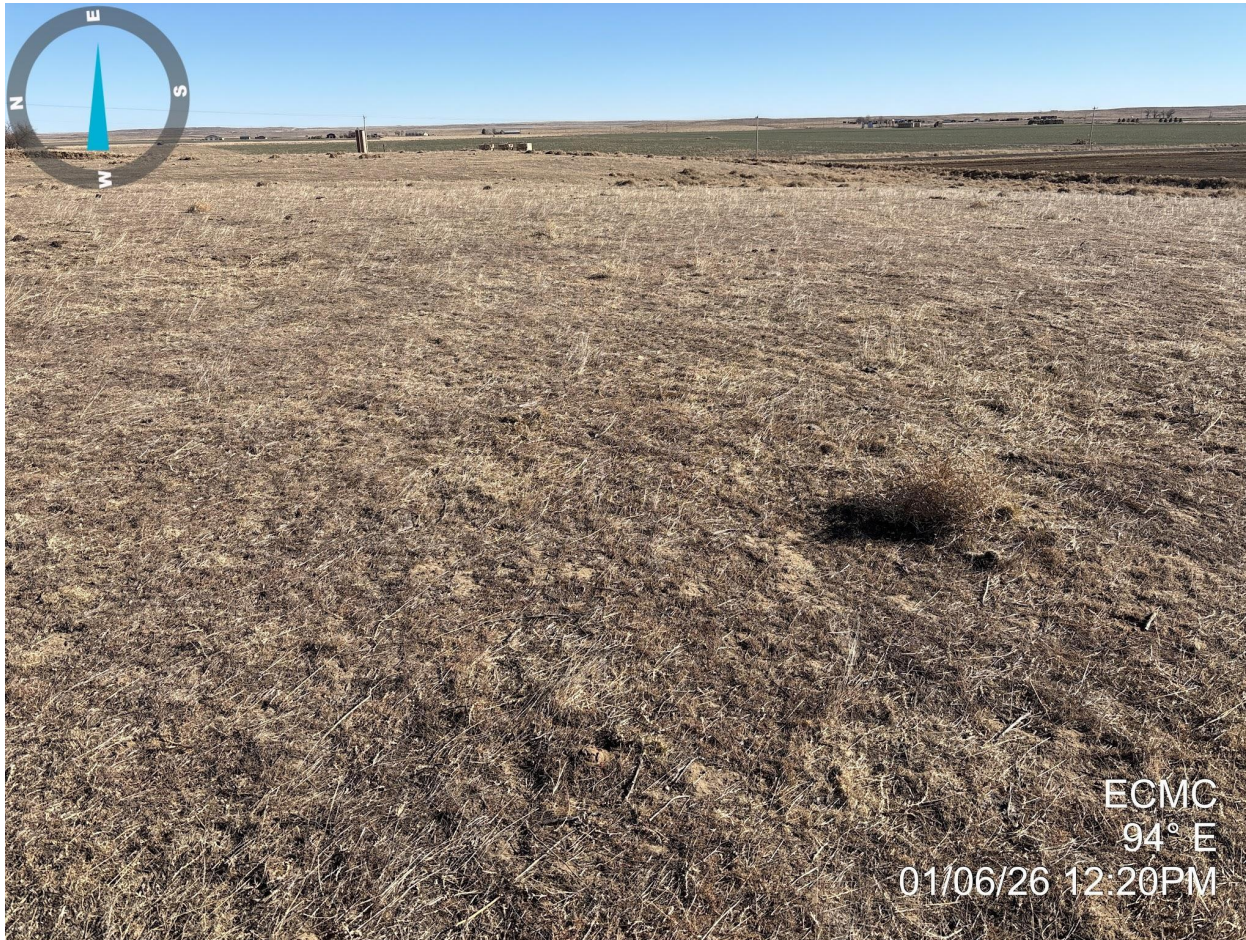
Photo 7. Photo taken of the reference area to the location, east of the location, facing east. Photo illustrates perennial grass and weedy annual vegetation.
