Final Reclamation Inspection

Operator: NOBLE ENERGY INC - 100322

Location ID: 306117

Inspection Photos
Location Name: Dietrich C #06-23
Location ID: 306117

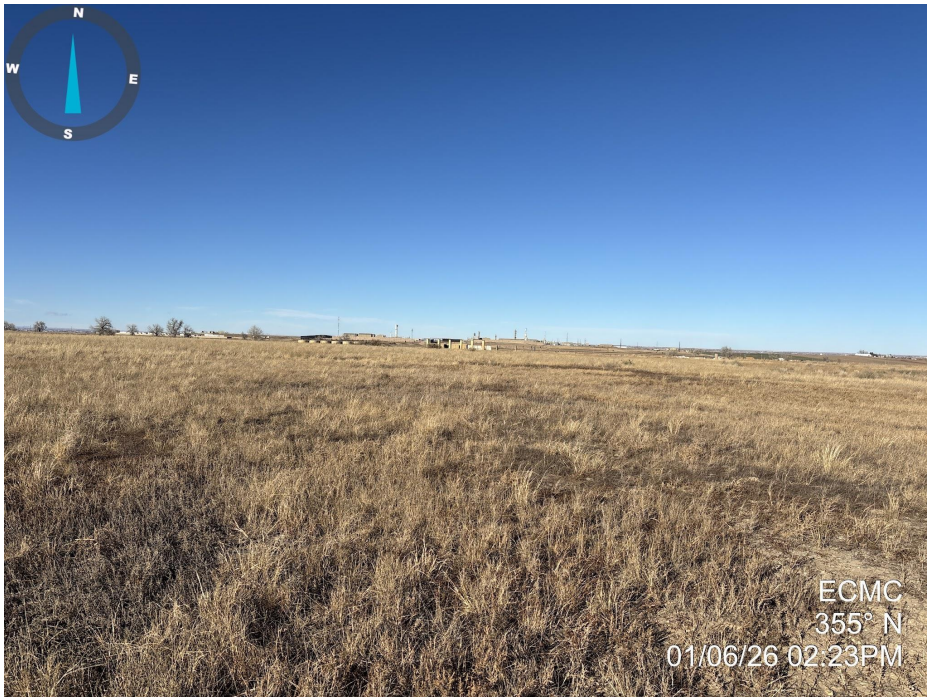
Photo 1. Photo taken of the well location, facing north. Photo illustrates that final reclamation activities appear to have taken place, but vegetation establishment does not meet Rule 1004 standards and weedy annual vegetation including kochia (*Bassia scoparia*) was observed across the location.

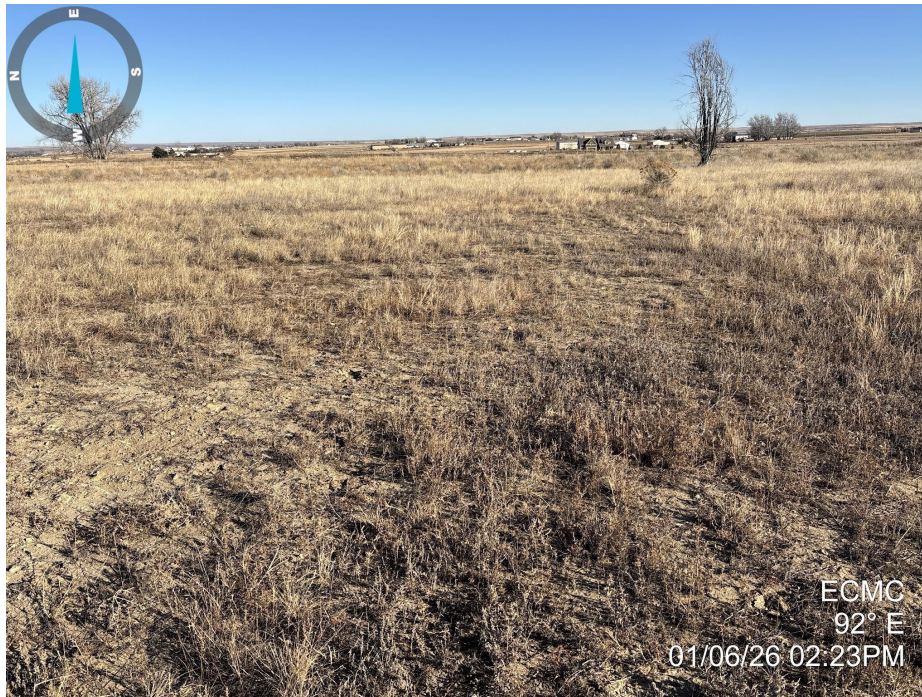
Photo 2. Photo taken of the well location, facing east. See comments under Photo 1.

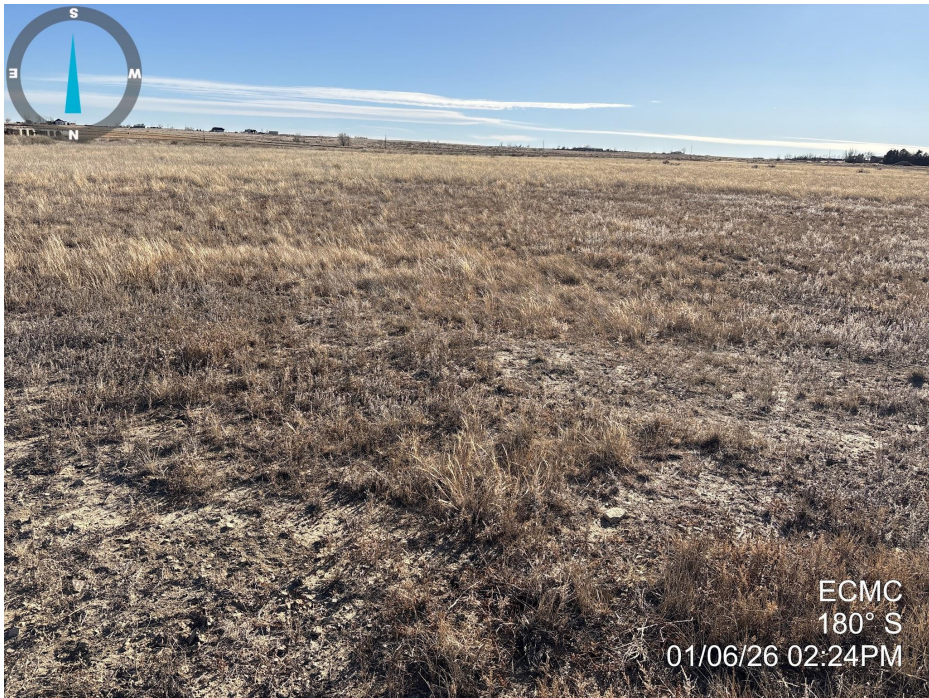
Photo 3. Photo taken of the well location, facing south. See comments under Photo 1.

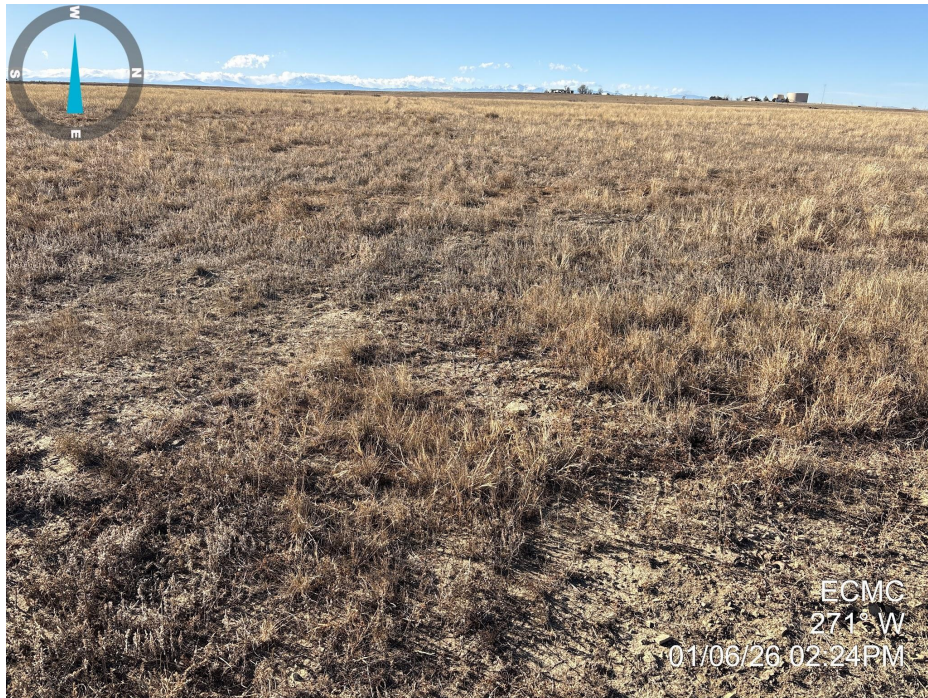
Photo 4. Photo taken of the well location, facing west. See comments under Photo 1.

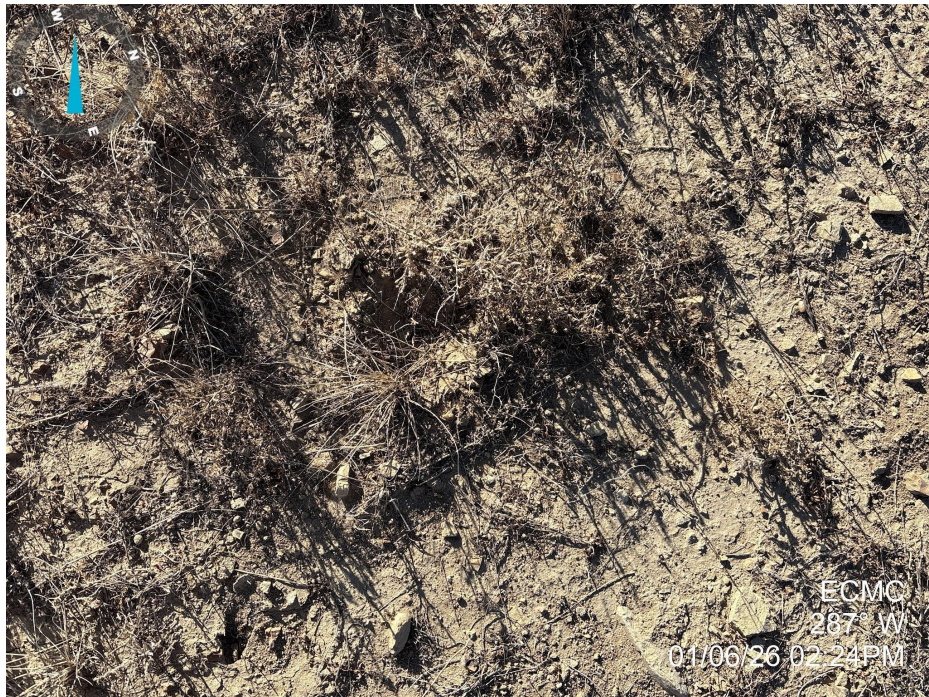
Photo 5. Photo taken of ground cover at the well location. Photo illustrates perennial grass and weedy annual vegetation including kochia (*Bassia scoparia*).

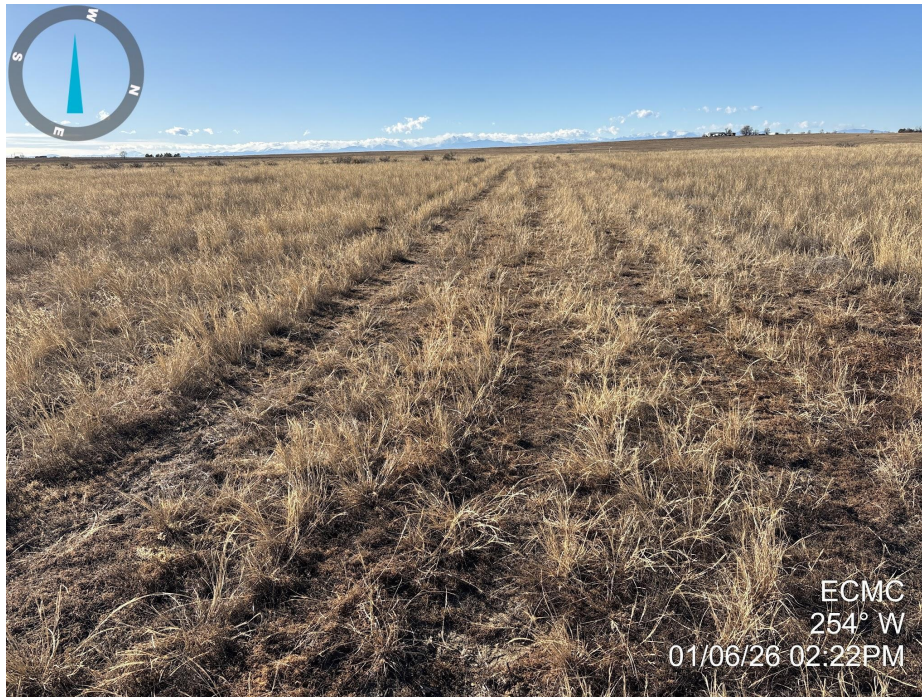
Photo 6. Photo taken of the access road to the location, facing west. Photo illustrates that final reclamation activities appear to have taken place along the road, but vegetation has not established to Rule 1004 standards.

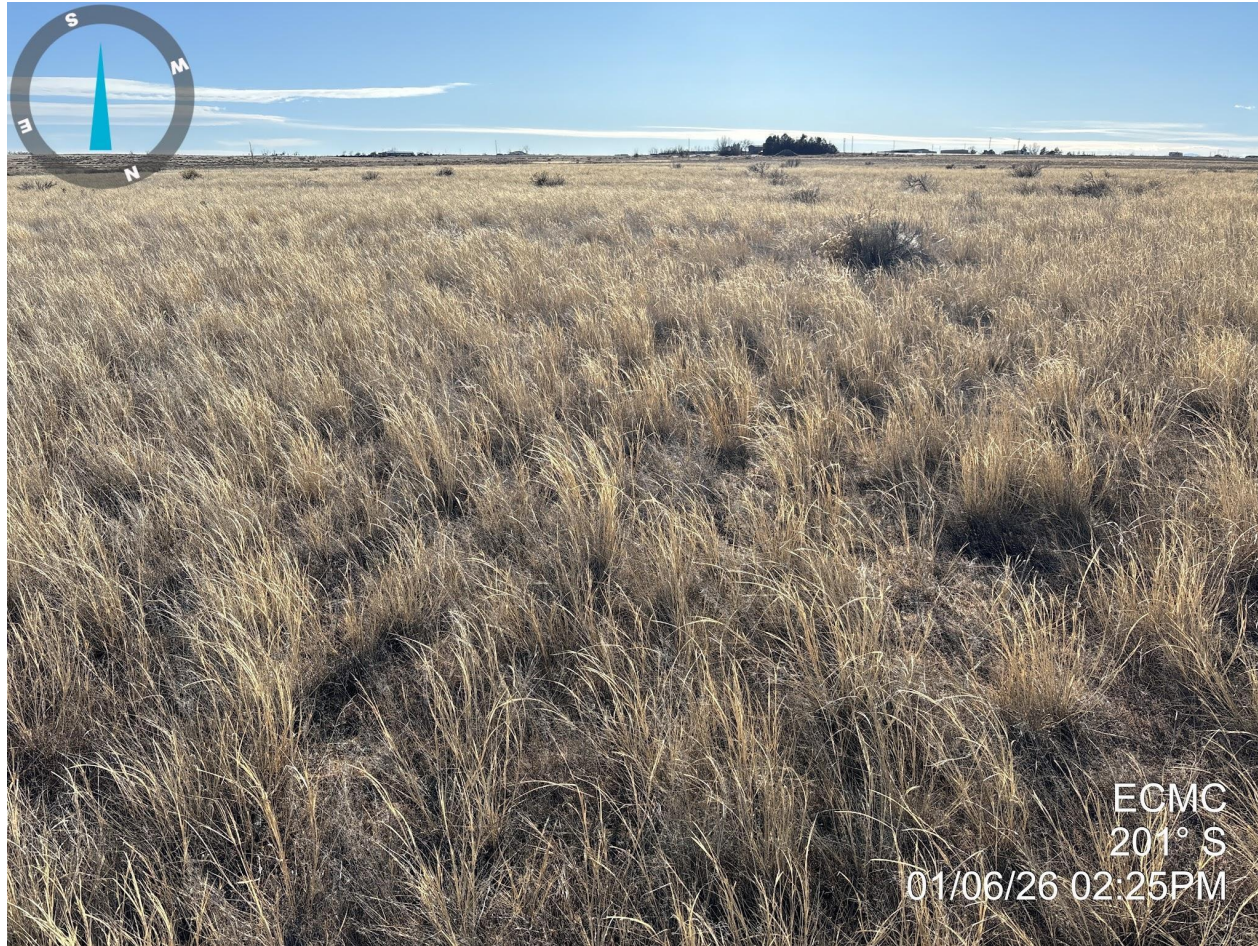
Photo 7. Photo taken of the reference area to the location, southwest of the location, facing south. Photo illustrates perennial grass vegetation.
