Final Reclamation Inspection

Operator: NOBLE ENERGY INC - 100322

Location ID: 330872

Inspection Photos
Location Name: DINNER #6-34
Location ID: 330872

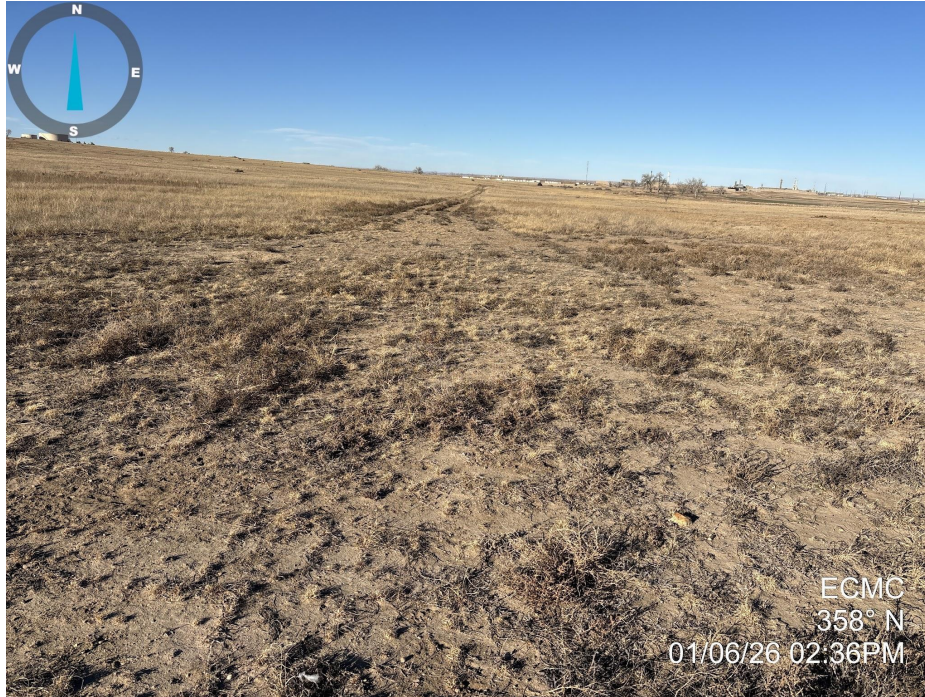
Photo 1. Photo taken of the well location, facing north. Photo illustrates that final reclamation activities appear to have taken place, but vegetation establishment does not meet Rule 1004 standards. Weedy annual vegetation including russian thistle (*Salsola tragus*) and kochia (*Bassia scoparia*) were observed across the location.

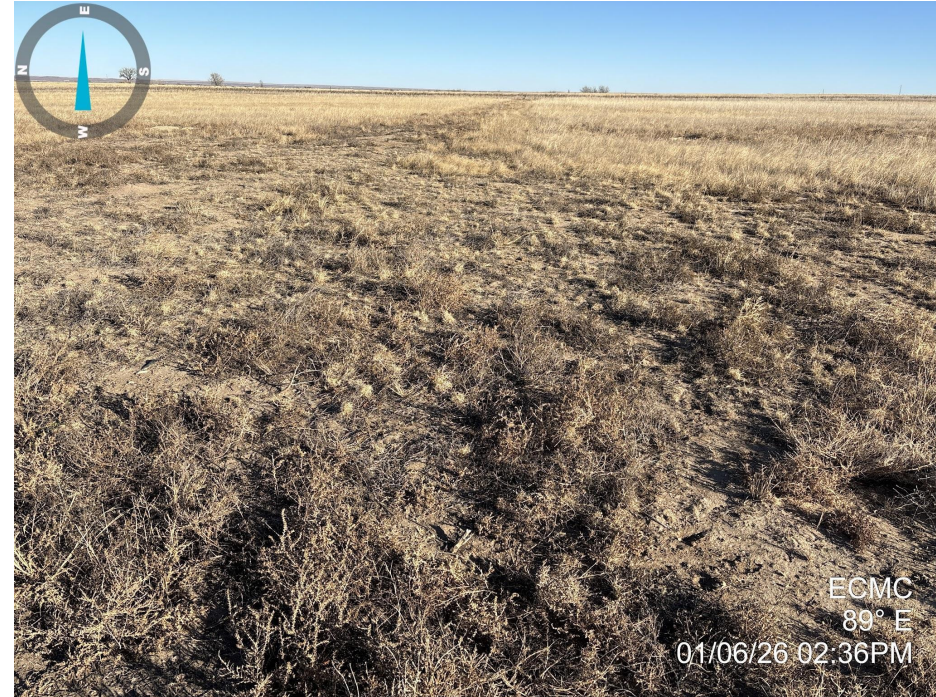
Photo 2. Photo taken of the well location, facing east. See comments under Photo 1.

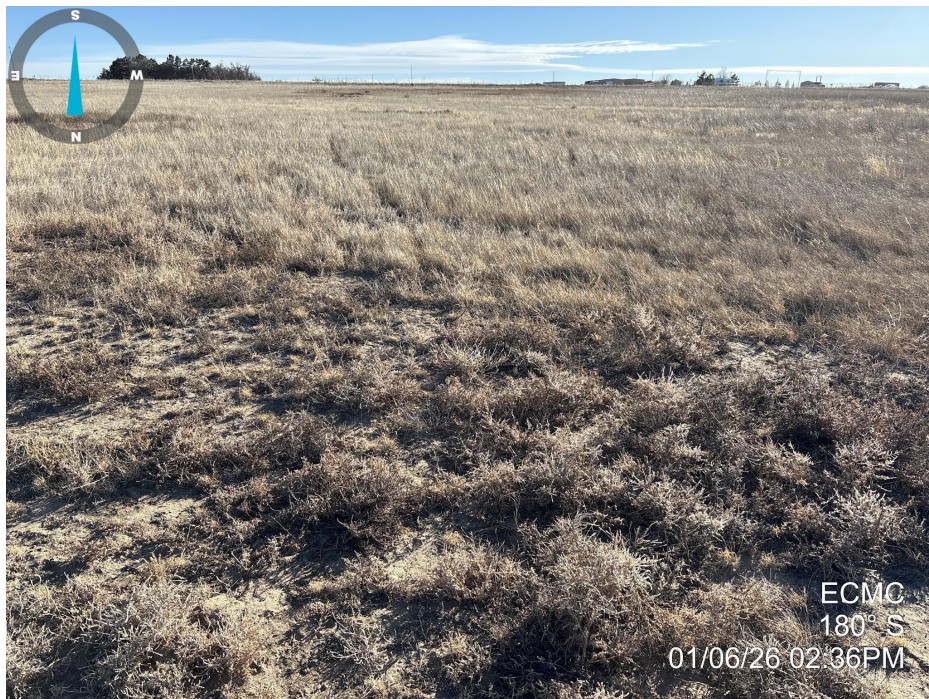
Photo 3. Photo taken of the well location, facing south. See comments under Photo 1.

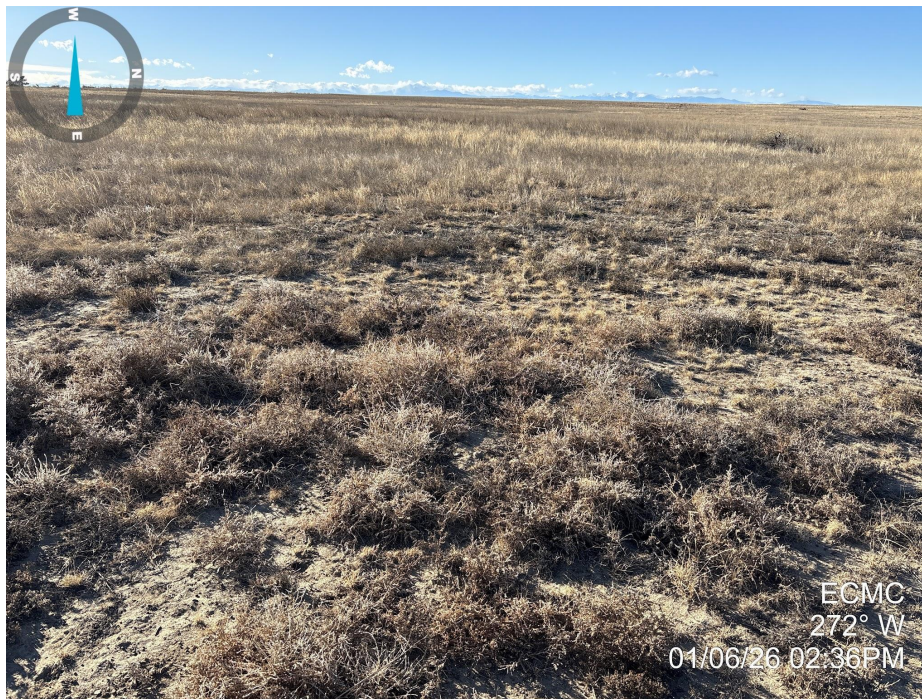
Photo 4. Photo taken of the well location, facing west. See comments under Photo 1.

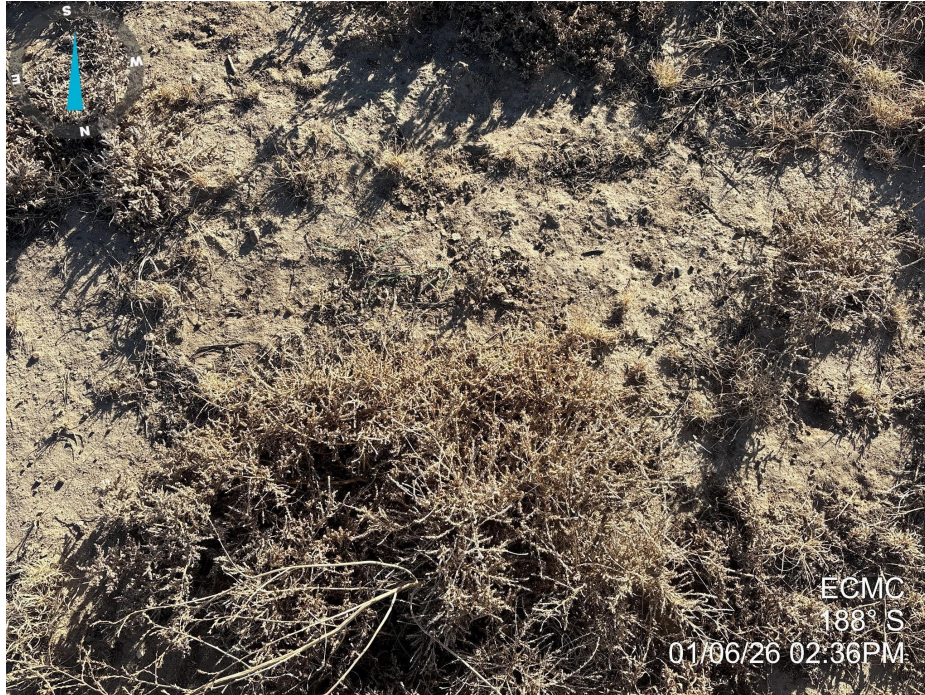
Photo 5. Photo taken of ground cover at the well location. Photo illustrates weedy annual vegetation including russian thistle (*Salsola tragus*) and kochia (*Bassia scoparia*).

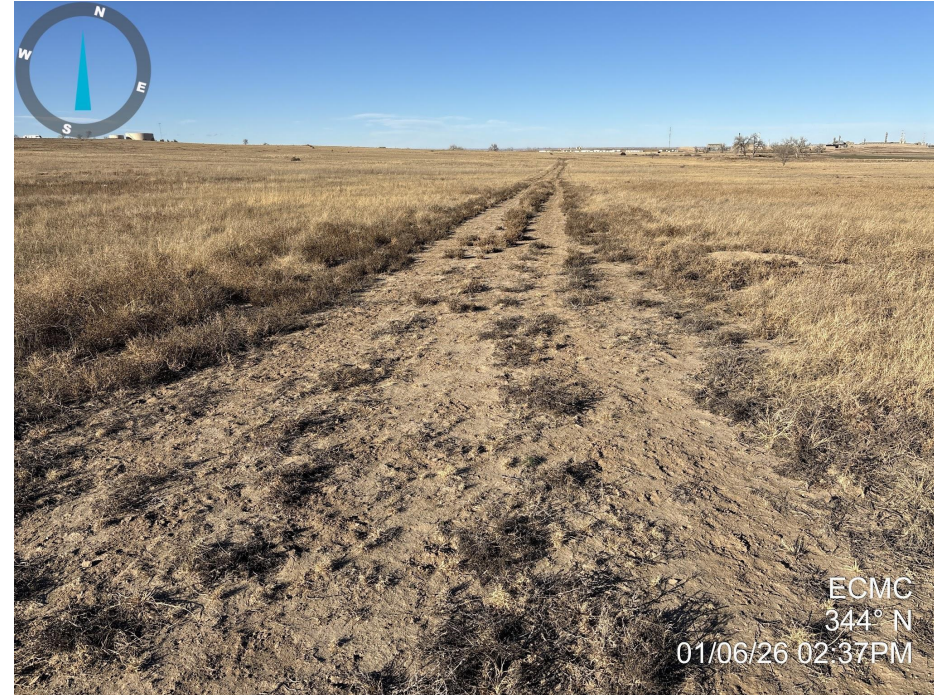
Photo 6. Photo taken of the access road to the location, facing north. Photo illustrates that bare ground and weedy annual vegetation, including russian thistle (*Salsola tragus*) and kochia (*Bassia scoparia*), were observed across the road.

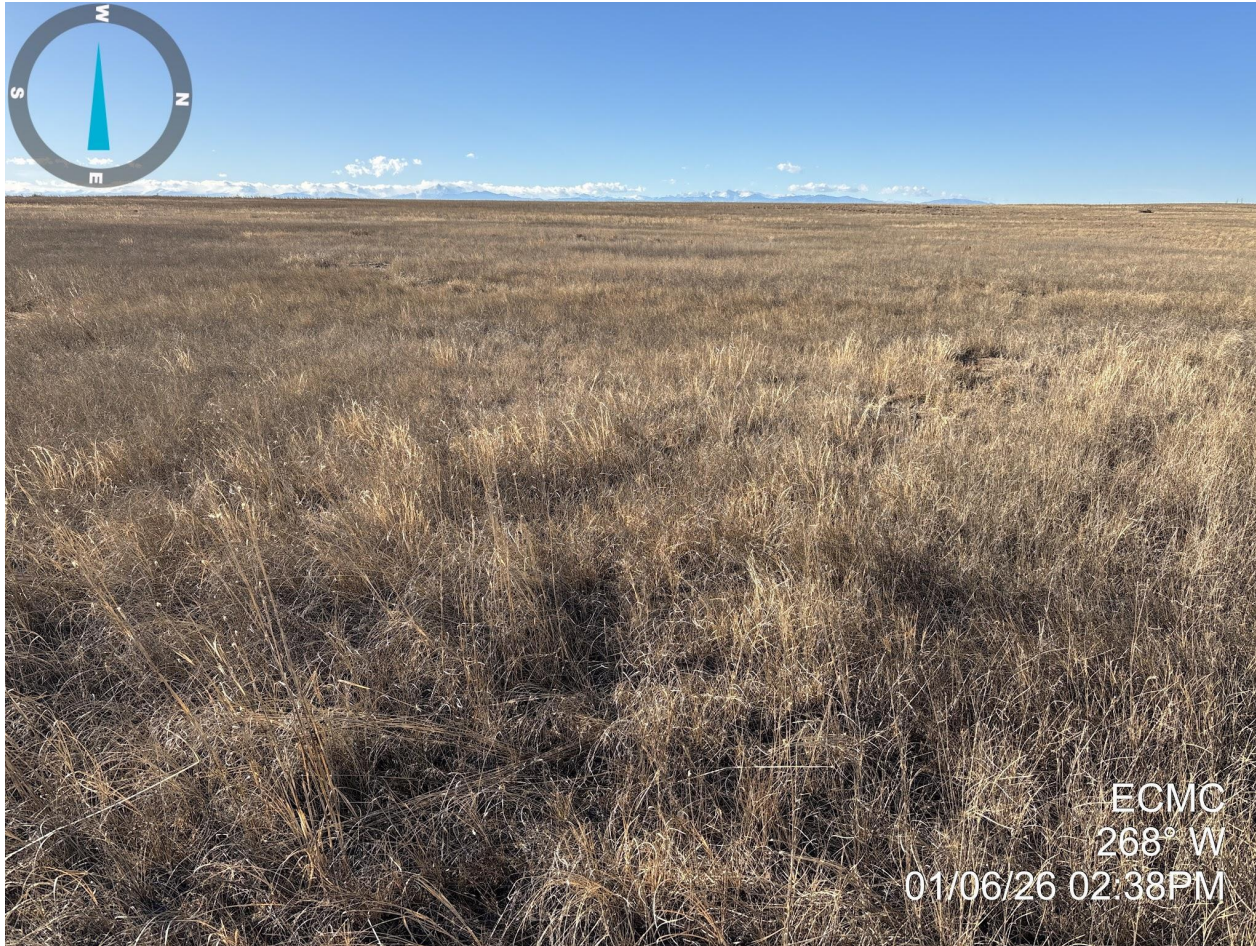
Photo 7. Photo taken of the reference area to the location, west of the location, facing west. Photo illustrates perennial grass vegetation.
