# Final Reclamation Inspection

Operator: NOBLE ENERGY INC - 100322

Location ID: 329442

Inspection Photos  
Location Name: DIETRICH #6-10  
Location ID: 329442

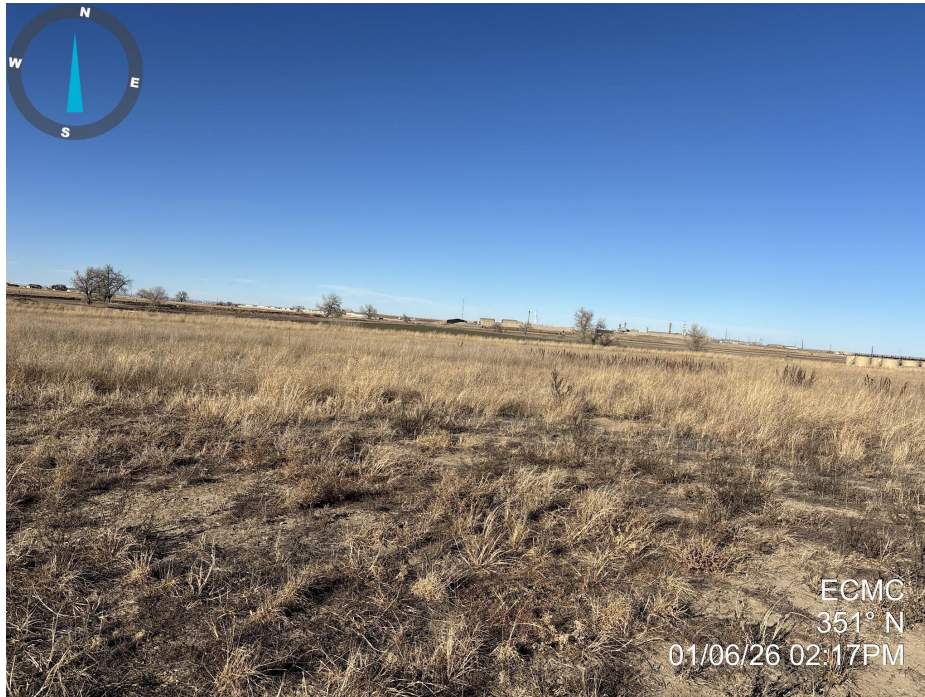
**Photo 1.** Photo taken of the well location, facing north. Photo illustrates that final reclamation activities appear to have taken place, but vegetation establishment does not meet Rule 1004 standards and weedy annual vegetation including russian thistle (*Salsola tragus*) was observed across the location.

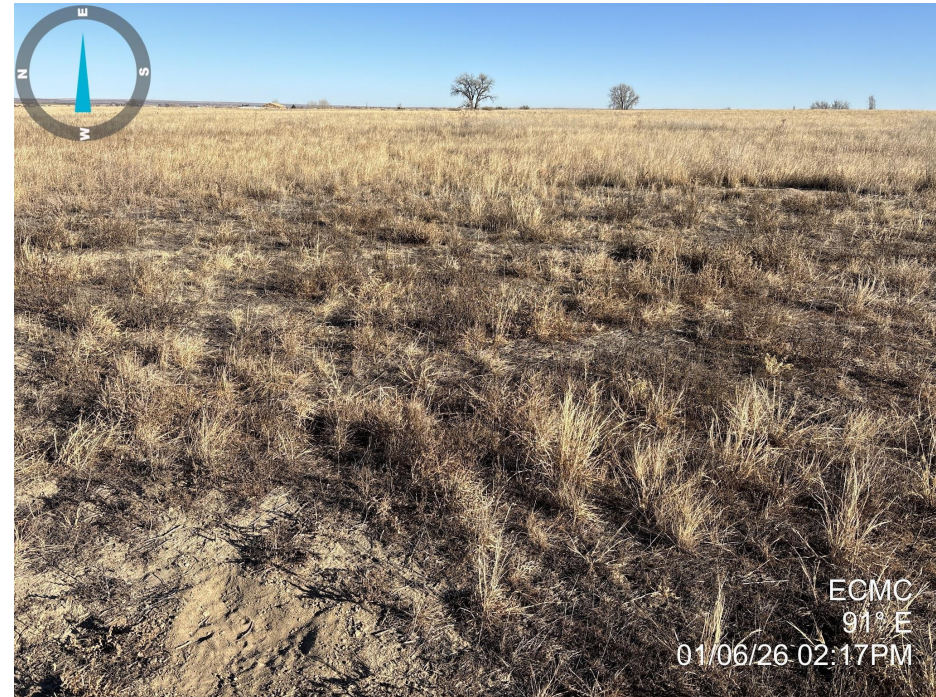
**Photo 2.** Photo taken of the well location, facing east. See comments under Photo 1.

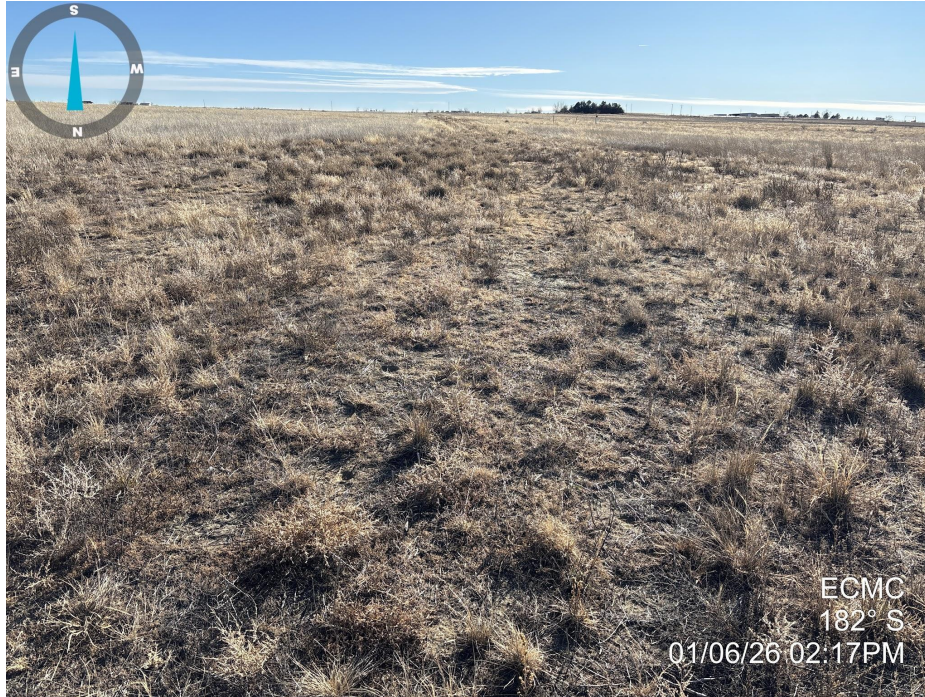
**Photo 3.** Photo taken of the well location, facing south. See comments under Photo 1.

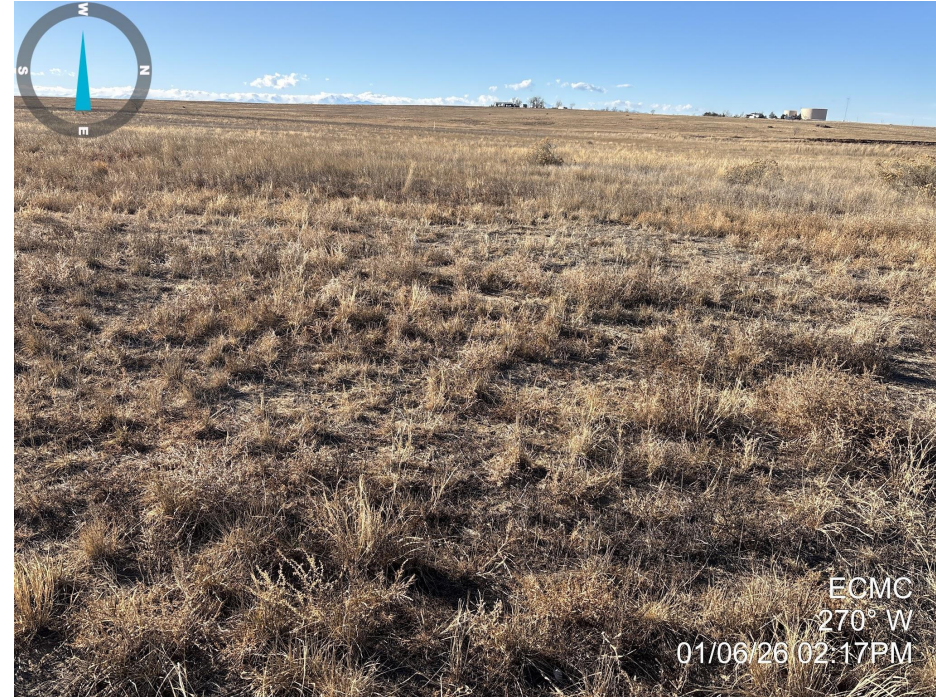
**Photo 4.** Photo taken of the well location, facing west. See comments under Photo 1.

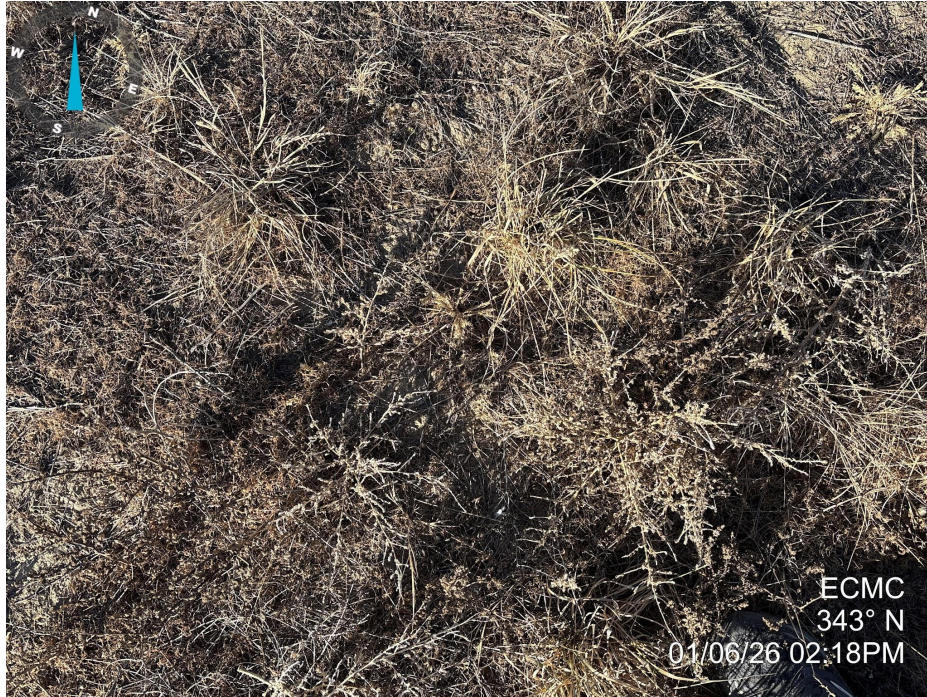
**Photo 5.** Photo taken of ground cover at the well location. Photo illustrates weedy annual vegetation including russion thistle (*Salsola tragus*) and kochia (*Bassia scoparia*).

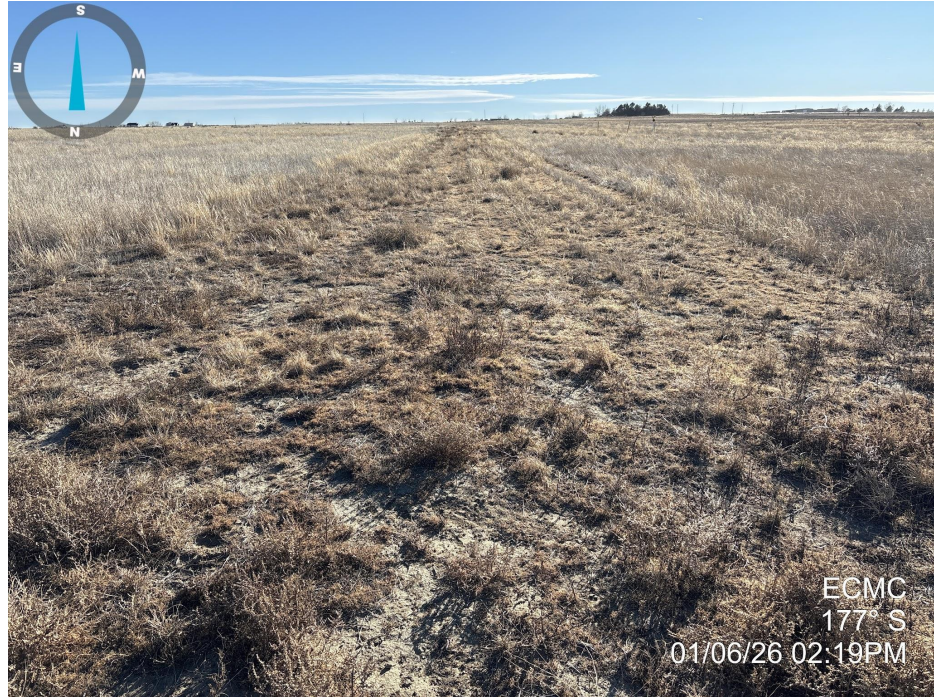
**Photo 6.** Photo taken of the access road to the location, facing south. Photo illustrates that final reclamation activities appear to have taken place along the road, but vegetation has not established to Rule 1004 standards.

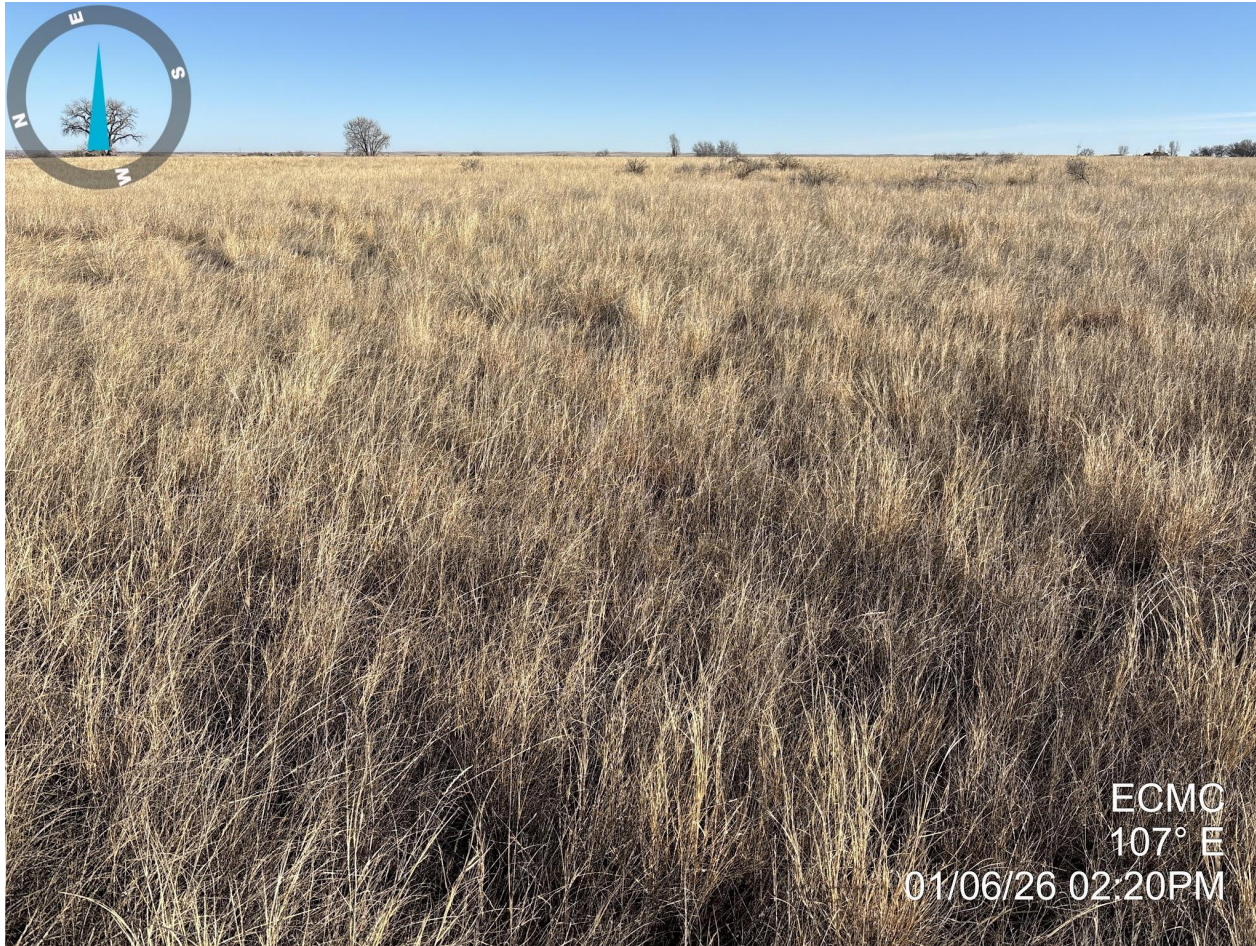
**Photo 7.** Photo taken of the reference area to the location, south of the location, facing east. Photo illustrates perennial grass vegetation.
