Final Reclamation Inspection

Operator: NOBLE ENERGY INC - 100322

Location ID: 322713

Inspection Photos
Location Name: LEY #1
Location ID: 322713

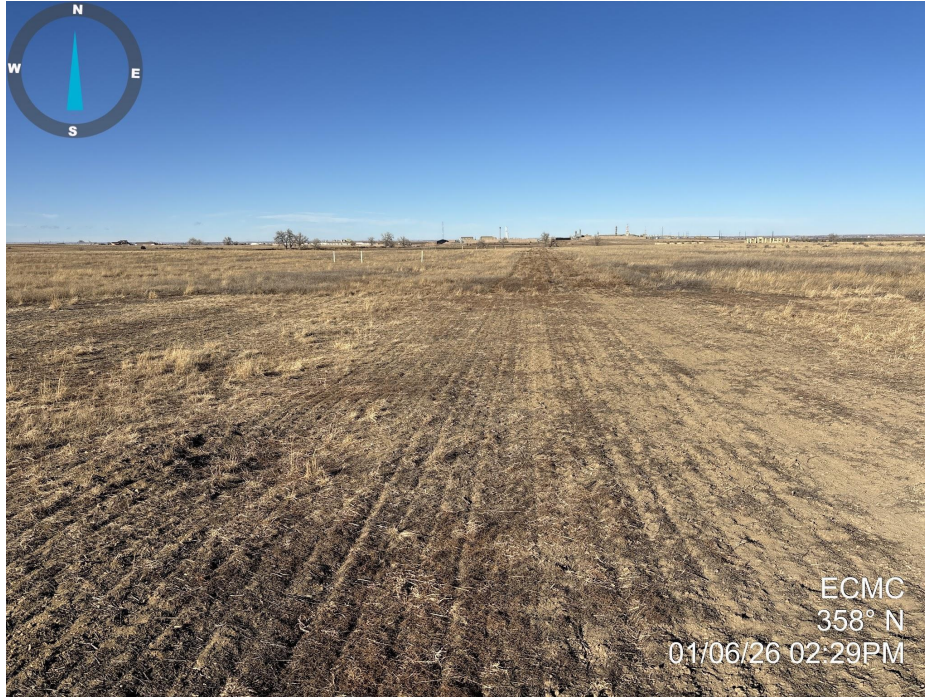
Photo 1. Photo taken of the well location, facing north. Photo illustrates that final reclamation activities appear to have taken place, with evidence of drill row seeding, but vegetation establishment does not meet Rule 1004 standards.

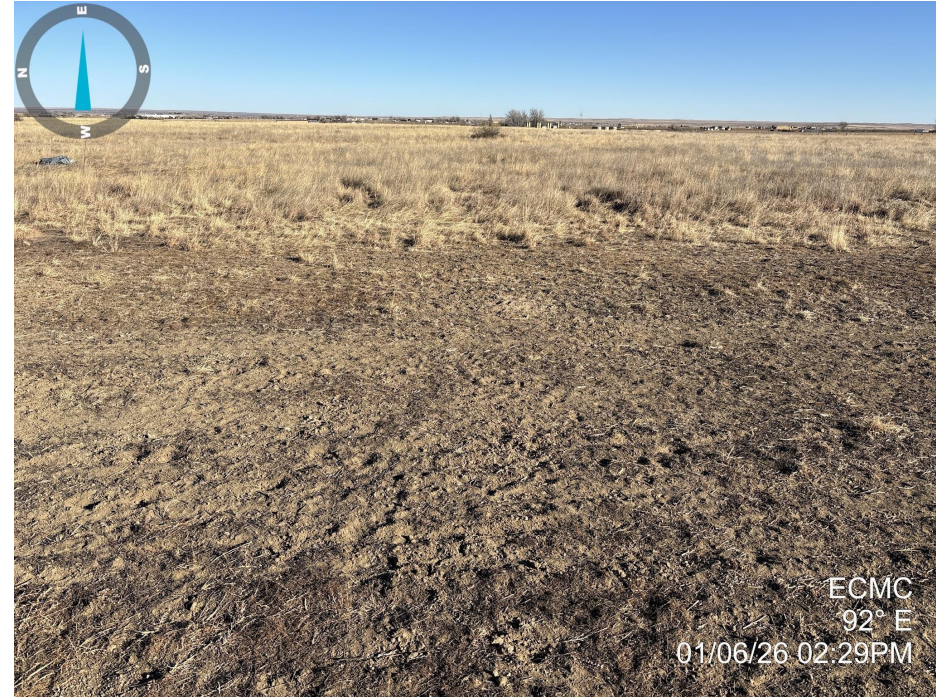
Photo 2. Photo taken of the well location, facing east. See comments under Photo 1.

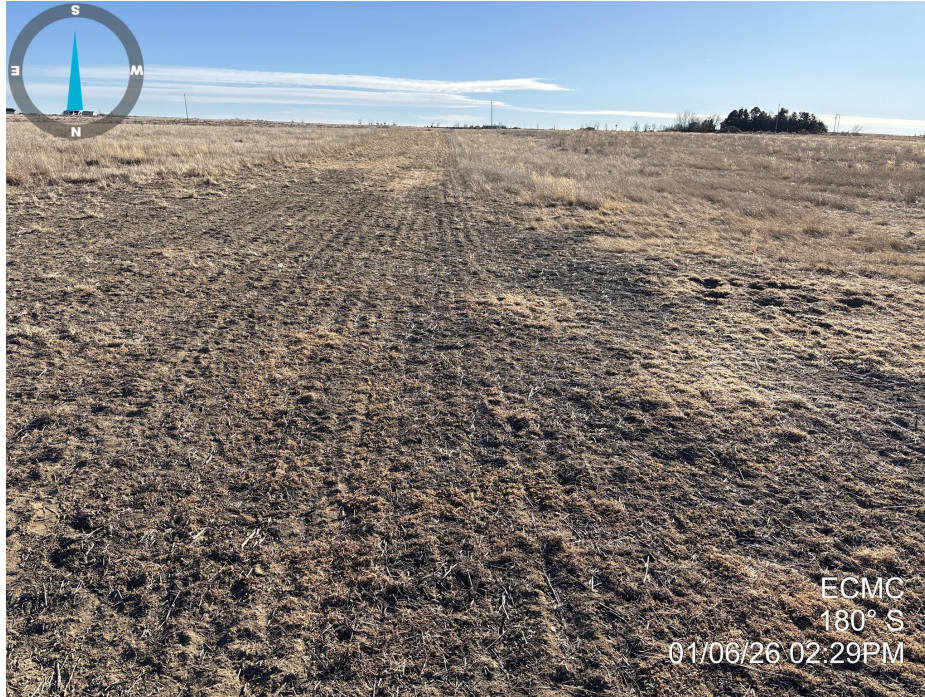
Photo 3. Photo taken of the well location, facing south. See comments under Photo 1.

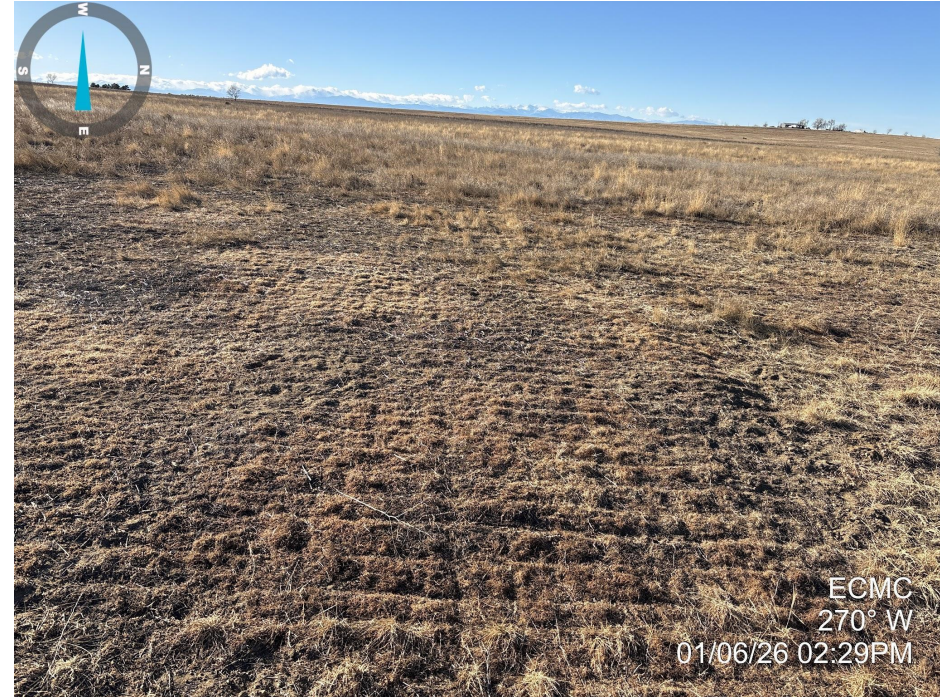
Photo 4. Photo taken of the well location, facing west. See comments under Photo 1.

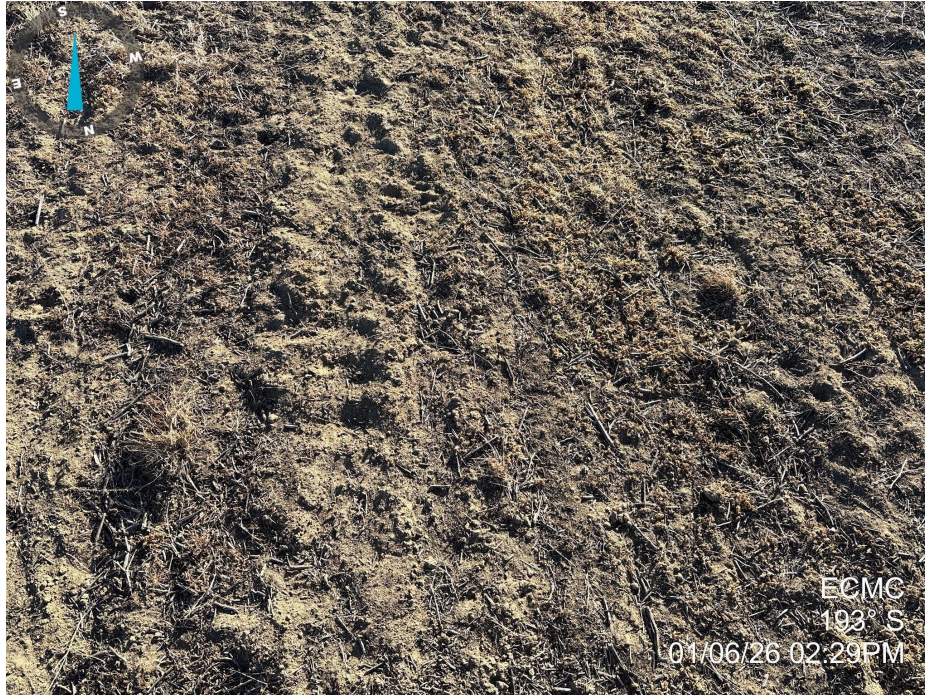
Photo 5. Photo taken of ground cover at the well location. Photo illustrates perennial grass and drill rows from seeding.

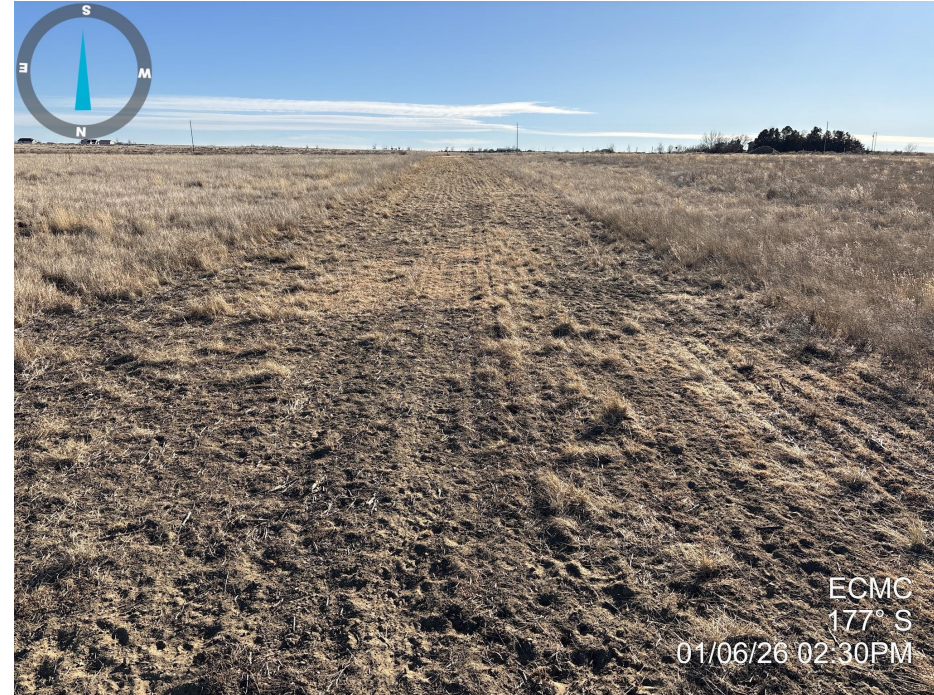
Photo 6. Photo taken of the access road to the location, facing south, away from the location. Photo illustrates that final reclamation activities appear to have taken place along the road, but vegetation has not established to Rule 1004 standards.

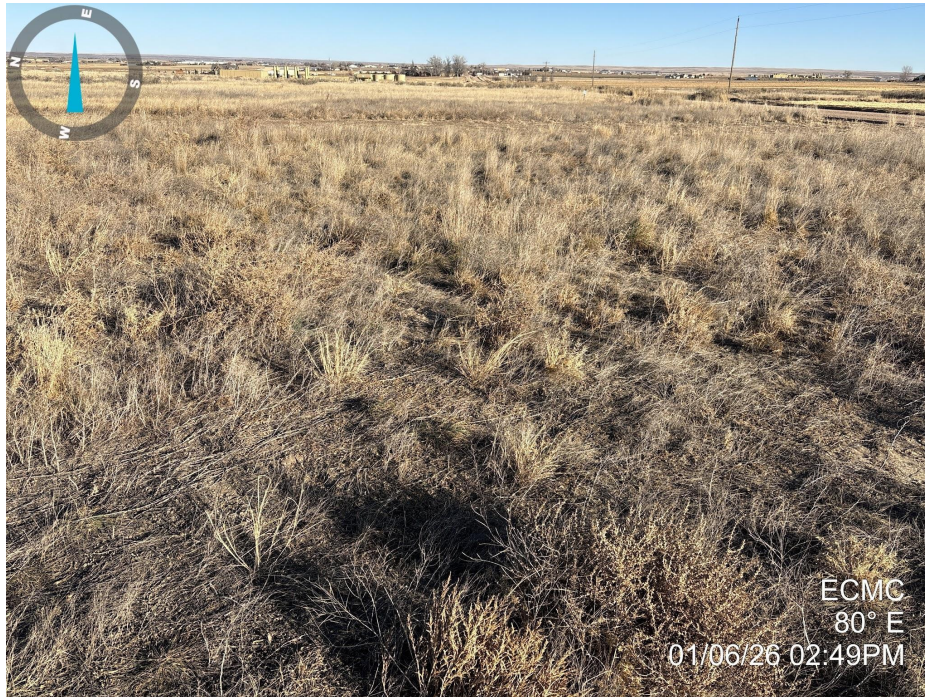
Photo 7. Photo taken of the tank battery location, facing east. Photo illustrates that final reclamation activities appear to have taken place at the location, but vegetation has not established to Rule 1004 standards. Weedy annual vegetation including russian thistle (*Salsola tragus*) and kochia (*Bassia scoparia*) was observed across the location.

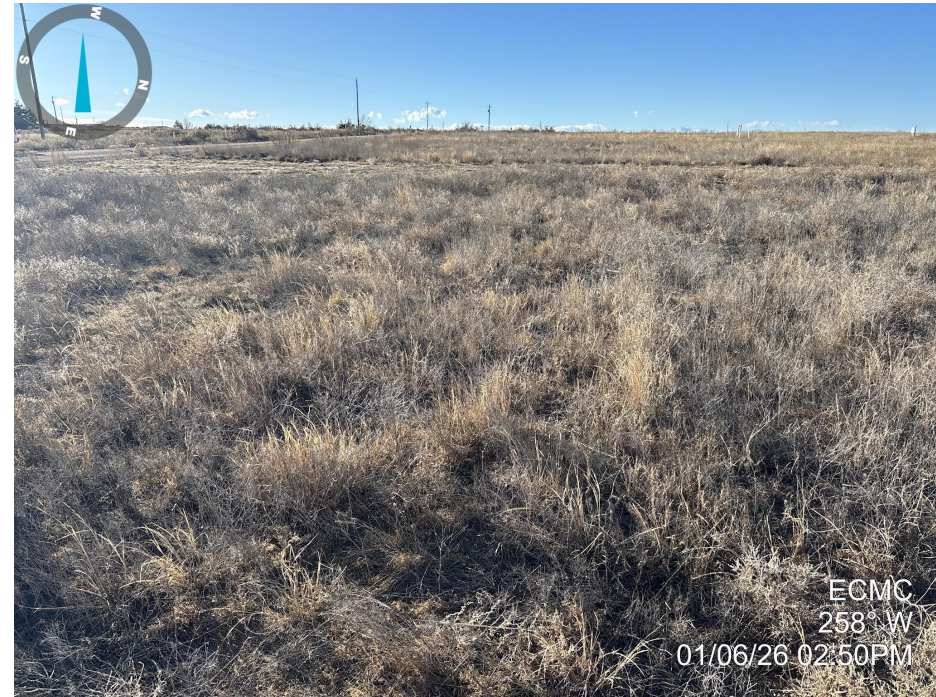
Photo 8. Photo taken of the tank battery location, facing west. See comments under Photo 7.

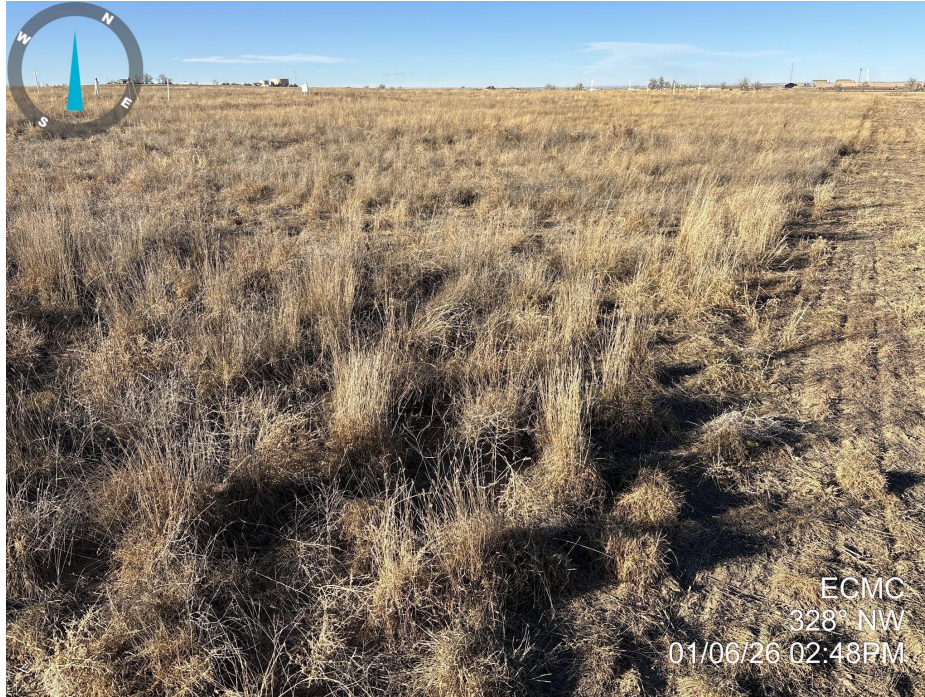
Photo 9. Photo taken of the tank battery location, facing northwest. See comments under Photo 7.

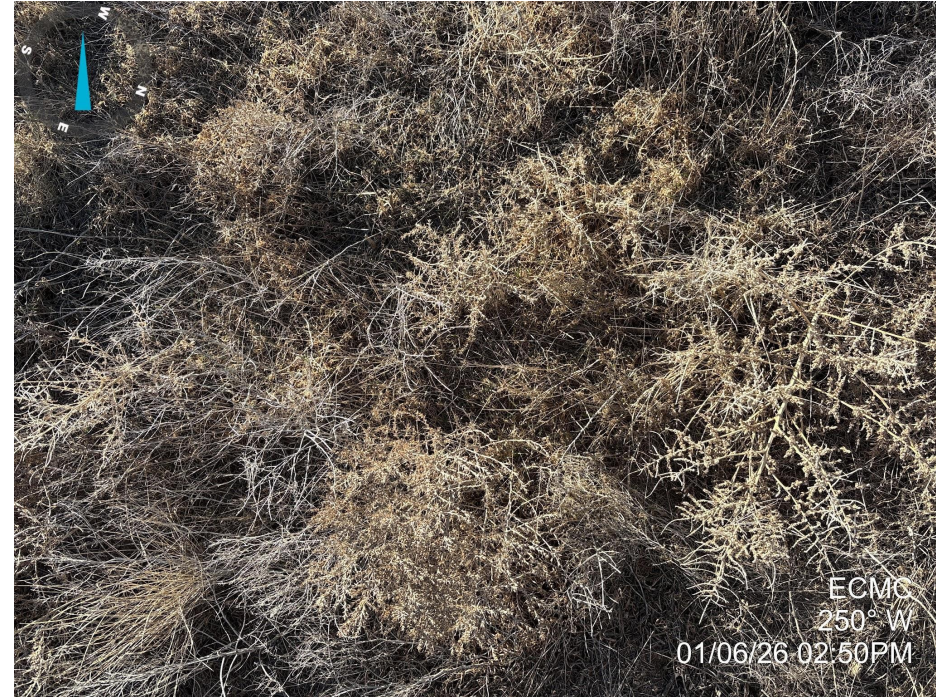
Photo 10. Photo taken of ground cover at the tank battery location. Photo illustrates weedy annual vegetation including kochia (*Bassia scoparia*) and russian thistle (*Salsola tragus*).

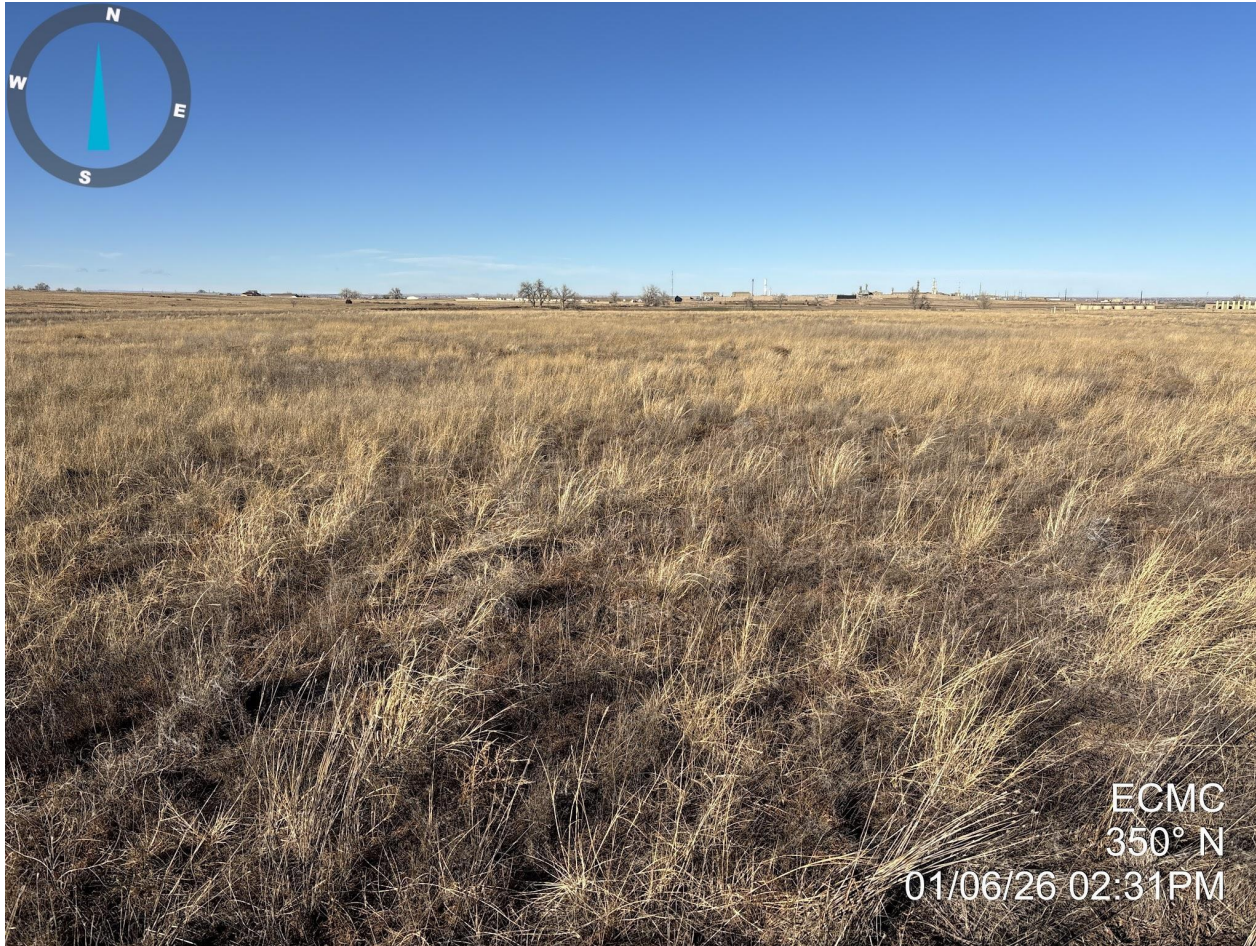
Photo 11. Photo taken of the reference area to the location, west of the well location, facing north. Photo illustrates perennial grass vegetation.
